Final report RL 2019:12e

**Serious incident south of Norrköping/
Kungsängen Airport 17 October 2018
involving the aircraft G-RJXF an aero-
plane of the model EMB-145EP, operated
by BMI Regional and SE-VKA of the
model Zephyr 2 000C, operated by a
private individual.**

File no. L-123/18

8 October 2019

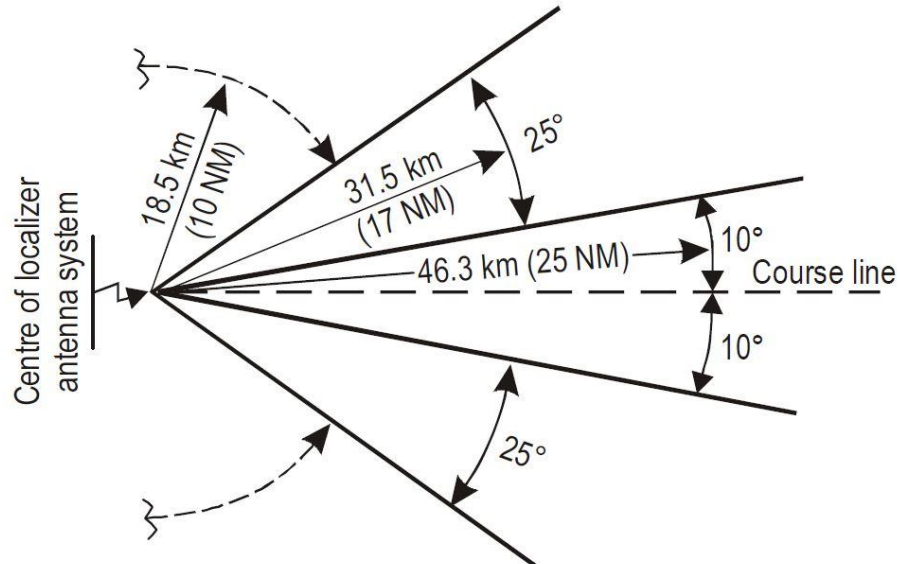
Figure 4. Localizer coverage area. Picture ICAO Annex 10.

According to *ICAO Annex 10, 3.1.3 Coverage*, the localizer signal covers a sector out to 46.3 km (25 NM) \pm 10 degrees from the front or back course and to 31.5 km (17 NM) \pm 35 degrees (See figure 4). In this area, therefore, no false signals may occur.

According to LFV, there is a "false" localizer with a centre line indication 42 degrees from the inbound course to runway 27 at Norrköping/Kungsängen Airport. This is common on certain types of localizers and does not violate the specification requirements (\pm 35°). However, an aircraft that is 42° from the localizer's centre line will get an instrument indication as if it was centred on the correct approach path. This is the reason why the ILS approach into Kungsängen/Norrköping must be verified with ADF and DME according to the approach chart for runway 27.

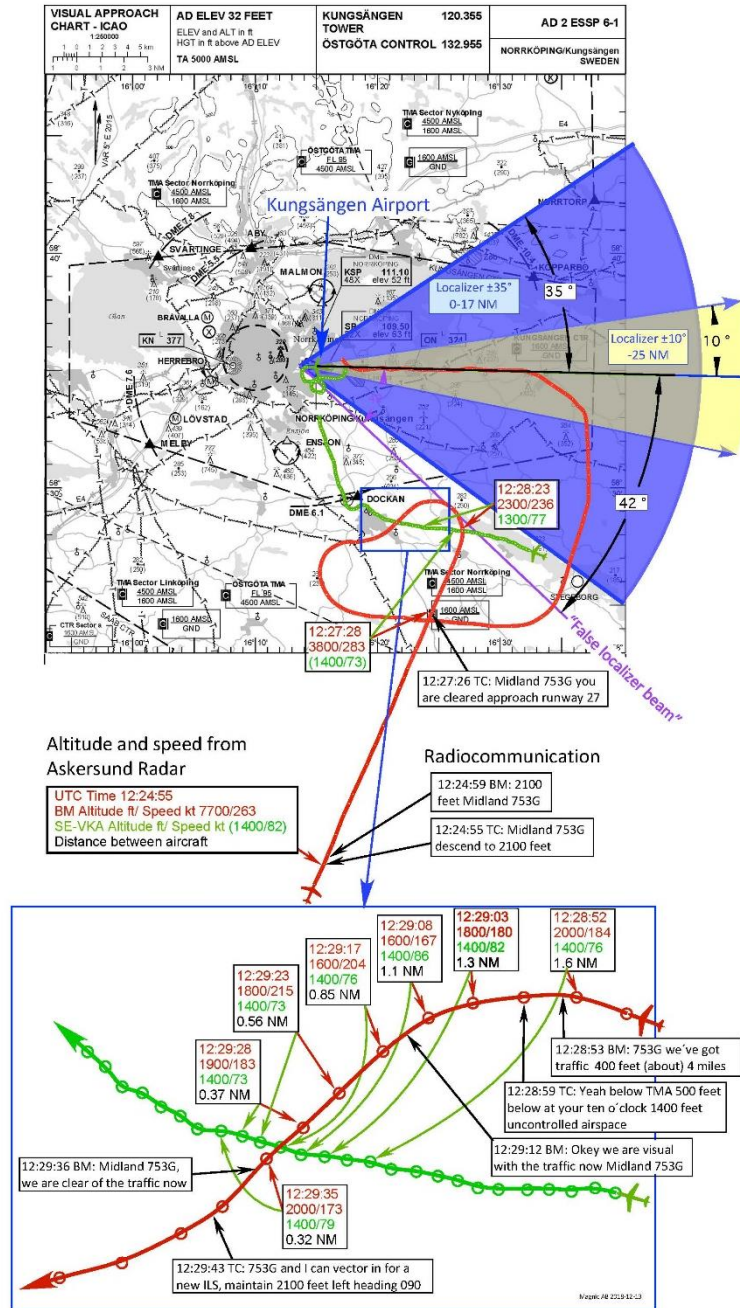
British Midland 753G (red) and SE-VKA (green) flight paths
 Figure 5. Map of the event. Midland in red and SE-VKA in green.

Figure 5 shows the position of the event and aircraft routes. The box below details how Midland (red line) gradually approaches SE-VKA (green line) in a descend, ending up 200 feet above it at a lateral distance of 0.85 NM. It is also from this time in the event that Midland's action to increase vertical speed has begun to take effect. During the seconds that follow, the sequence shows how Midland's altitude increases and that the two aircraft's routes no longer caused any direct collision risk.
