Report RL 2003:08e

***Incident involving aircraft G-FLTA at
Arvidsjaur airport, BD County, Sweden,
on the 22nd of February 2002***

Dnr L-006/02

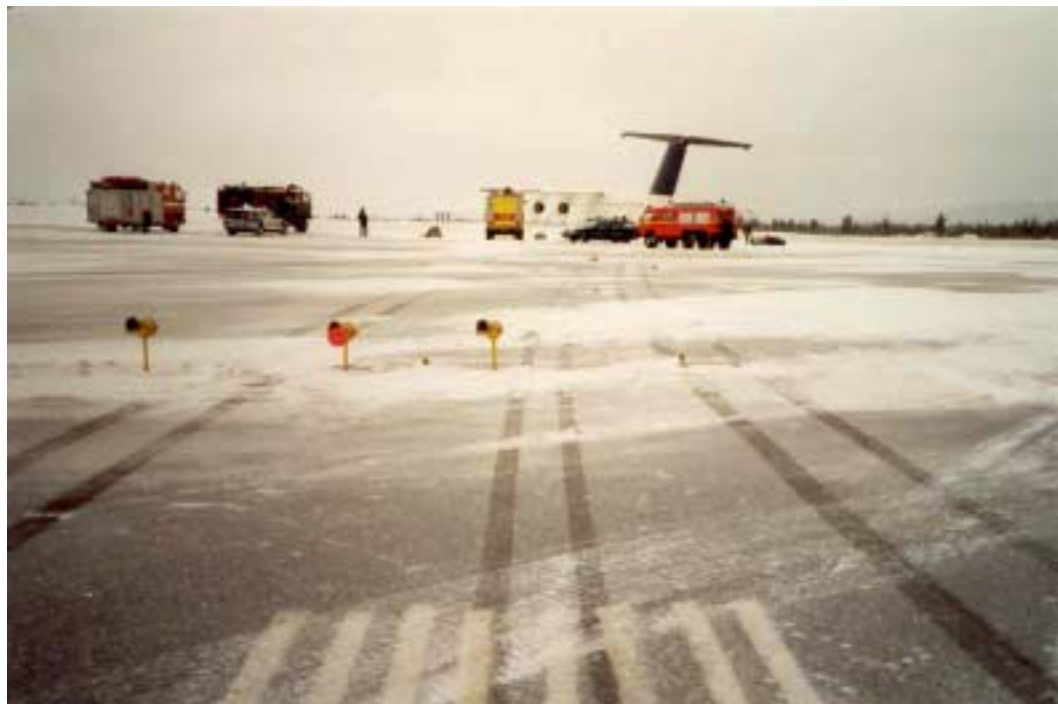
During the test runs, the presence of ice patches on the runway was noted. The majority of these were located near the runway centerline in section A. The picture below was taken from the runway end shortly after the incident.

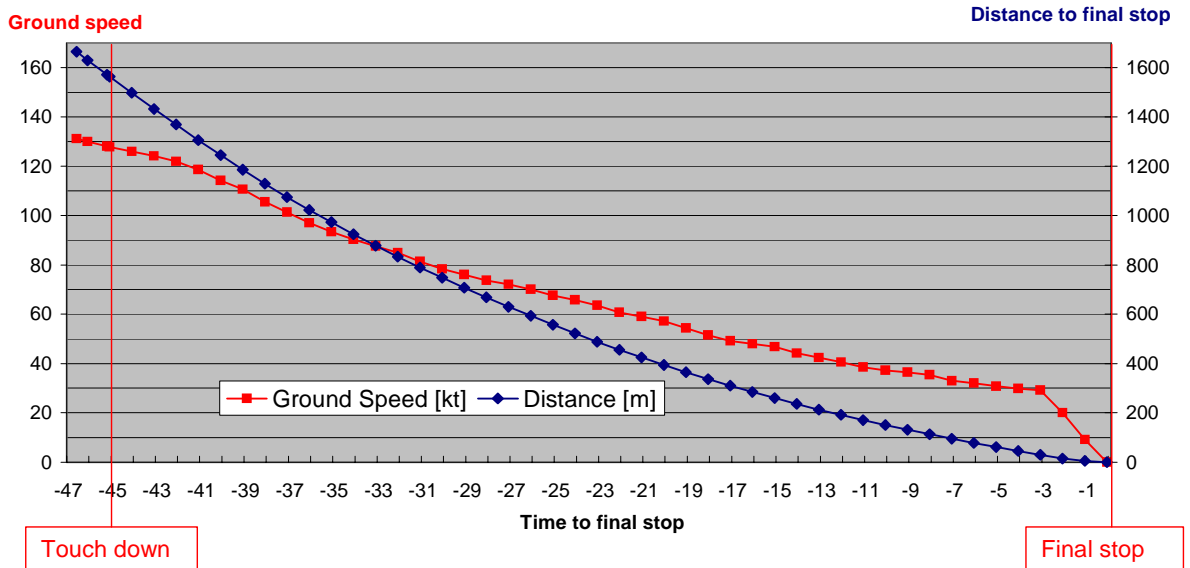
By means of the data registration, it can be determined that the landing was smooth and that the final touchdown on the runway took place approximately 45 seconds prior to the final stop. Less than three seconds after touchdown the Lift Spoilers² were completely deployed and after 9 more seconds the engine thrust was reduced from Flight Idle³ to Ground Idle⁴.

Based on recorded accelerometer data (NORM G and LONG G) the GS of the aircraft at touchdown has been calculated to have been between 125 and 130 knots (232–241 km/h). Using this same basic data, a touchdown point along the runway can be calculated which coincides well with that which was measured by the ground personnel. The diagram below depicts GS and the distance to the final stop of the aircraft as a function of time.

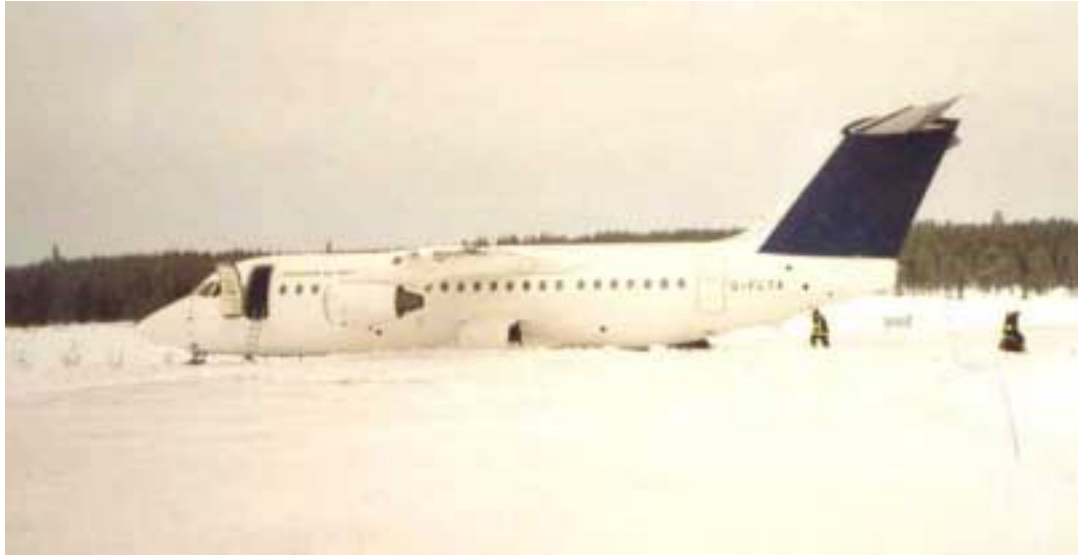
The touchdown point of the aircraft, determined by the ground personnel, was 475 meters down runway 30 from the runway threshold. The aircraft collided with a runway 12 threshold light and thereafter continued out onto a level snow-covered surface along the extended centerline of the runway, where it came to a stop in an approximately 50 centimeter deep snow bank, 83 meters from the runway (12) threshold, measured from the main landing gear.

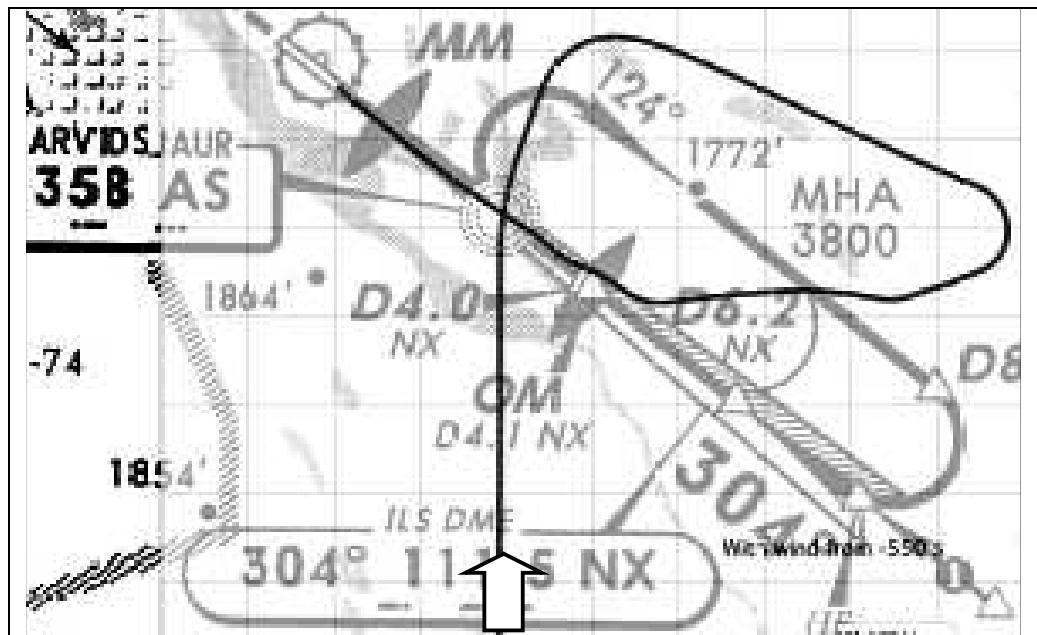
Based on FDR data and estimated winds in the area, an approximate approach path has been compiled and superimposed on the actual instrument approach chart shown below.

Instead of as he had planned, turning east and subsequently joining the ILS straight-in to runway 30 after a left turn, he was now suddenly forced to rethink and instead perform a full procedure turn approach via the initial approach beacon "AS". This caused the later portion of the approach to become forced, which possibly contributed to the fact that the pilot did not correct sufficiently for the strong crosswind, with the result that the approach path deviated considerably from the prescribed procedure.

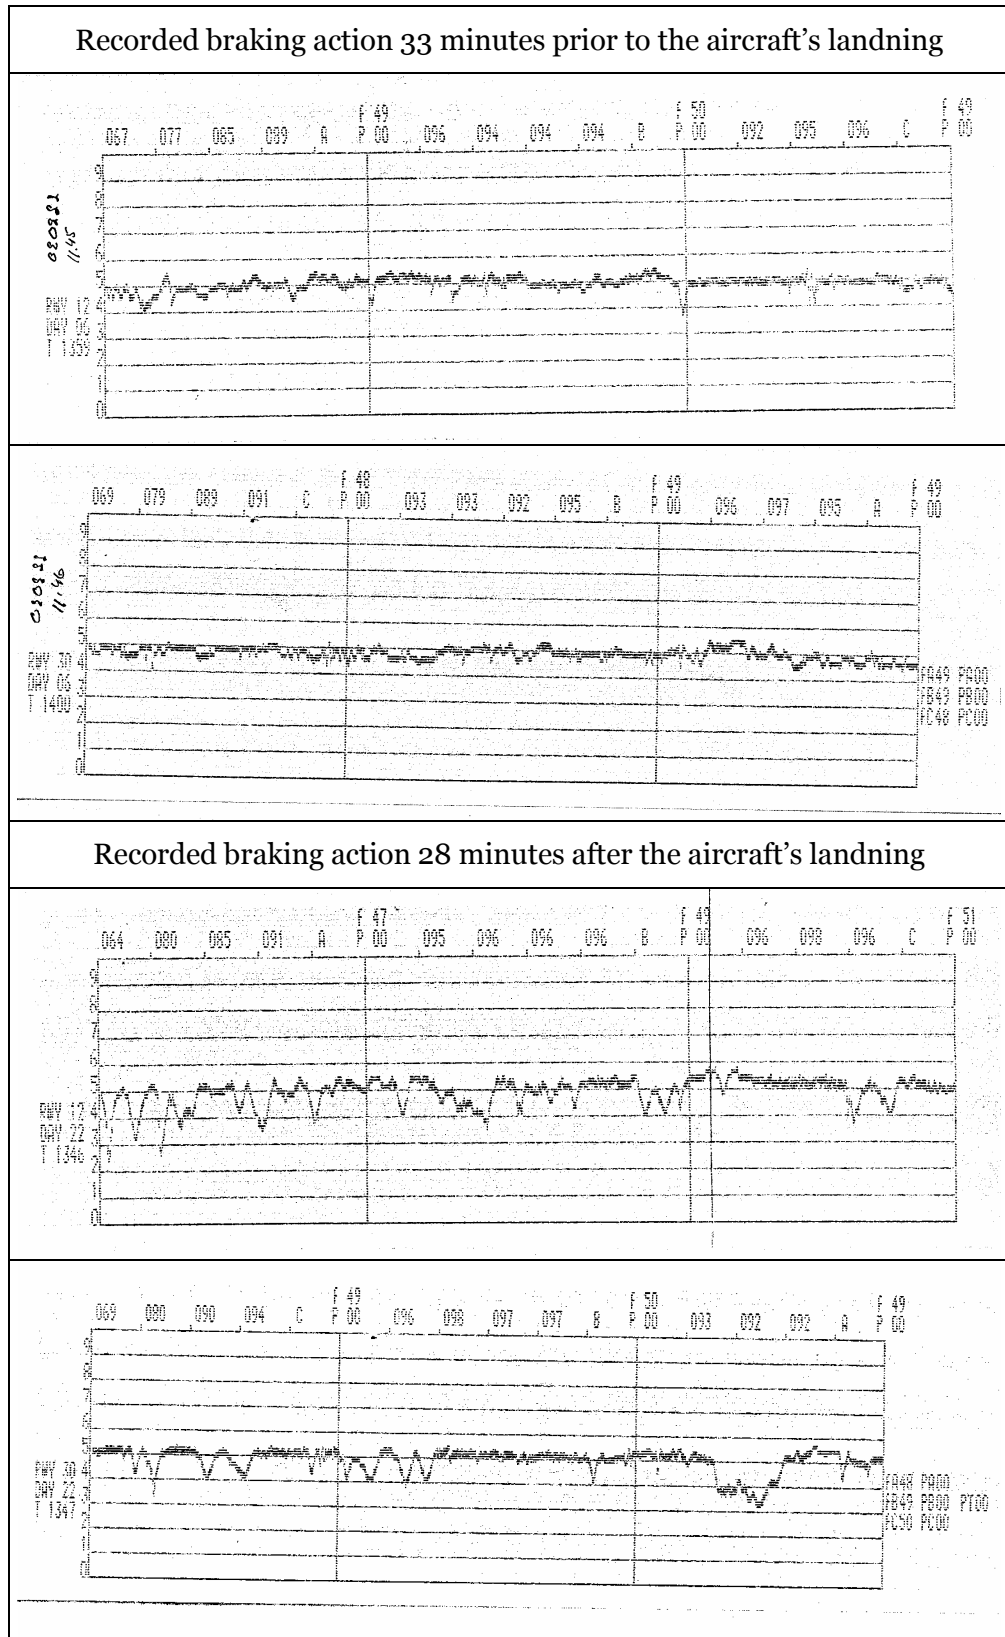
Appendix 2

The runway braking action was measured with the assistance of a SAAB Friction Tester prior to and after the aircraft's landing. On both occasions the friction tester vehicle was driven along the entire length of the runway and back again at a distance of 5 to 10 meters from the runway centerline. A compilation of the measurement record from the four runs along the runway has been accomplished. (Appendix 2.)

Time	Section A	Section B	Section C	Note
12:45-12:46	49	49	48	33 min. before landing
13:46-13:47	48	49	50	28 min. after landing
