Report RL 2003:01e

***Incident between aircraft LN-RON
and TF-FIP in the airspace above
Stockholm/Arlanda airport, AB County,
Sweden, on 25 January 2002***

Dnr L-007/02

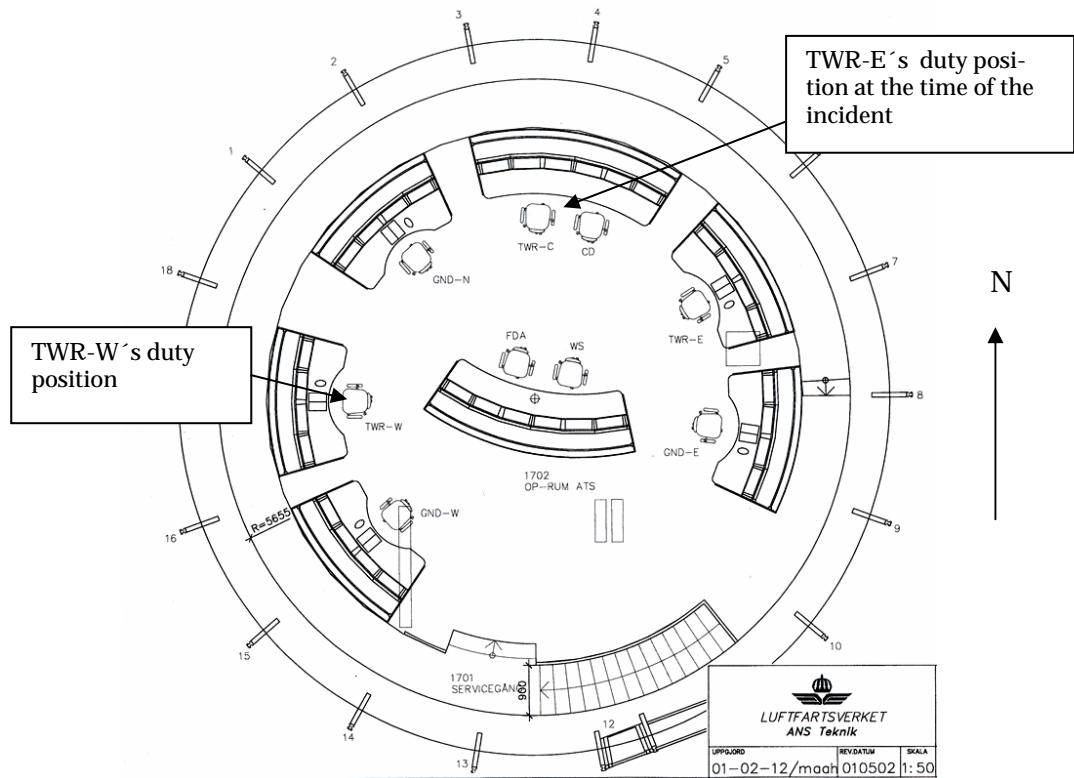
TWR-W was to visually determine when landing was accomplished on runway 26 in order to be able to issue takeoff clearance for departures from runway 01L. TWR-W did not have the possibility to monitor the radio communication between landing aircraft and TWR-E. To attract attention when an aircraft discontinues a landing, there is warning signal, audible within the tower, which the controller is to activate. The tower controller in position TWR-E activated the alarm at the same time that the controller in position TWR-W instructed SAS 1551 to reject the takeoff.

Image: Depicts duty position placement when runway three is in use. At the time of the actual occurrence TWR-E was working from TWR-C's duty position, see arrow. (Source: LFV 2002-1843-002)

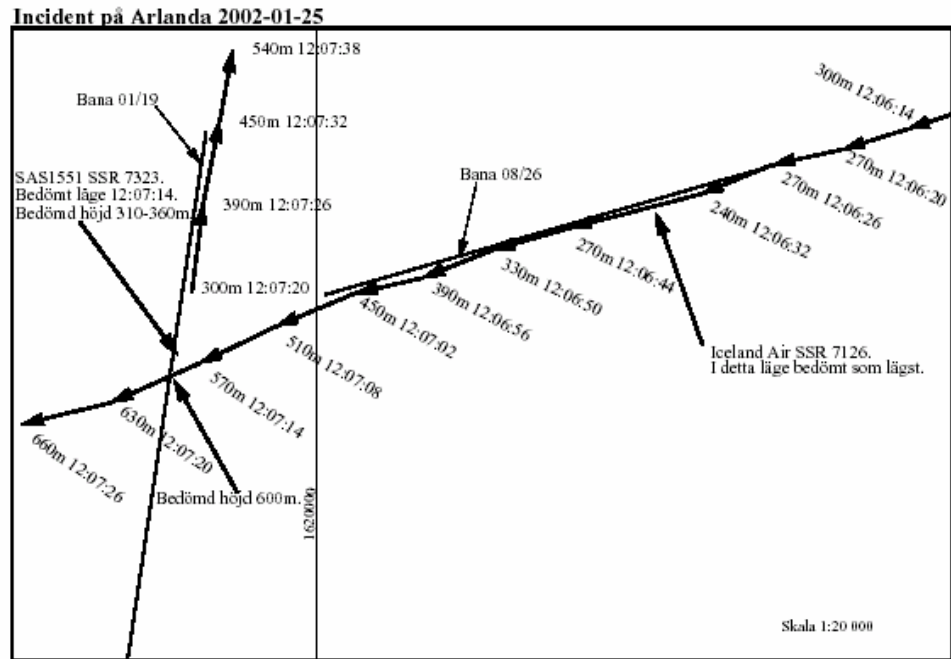
The route of flight of both aircraft has been registered by MUST and presented according to the diagrams below. From the registration, it has been calculated that the minimum distance between the aircraft horizontally was 75-100 meters and vertically about 300 meters. This took place at time 12:07:14. (See below)
