## **MARINE SAFETY INVESTIGATION REPORT**

**Joint safety investigation into the collision between  
the Maltese bulk carrier**

***GOLDEN TRADER***

**21 nautical miles west of Thyboroen, Denmark  
on 10 September 2011**

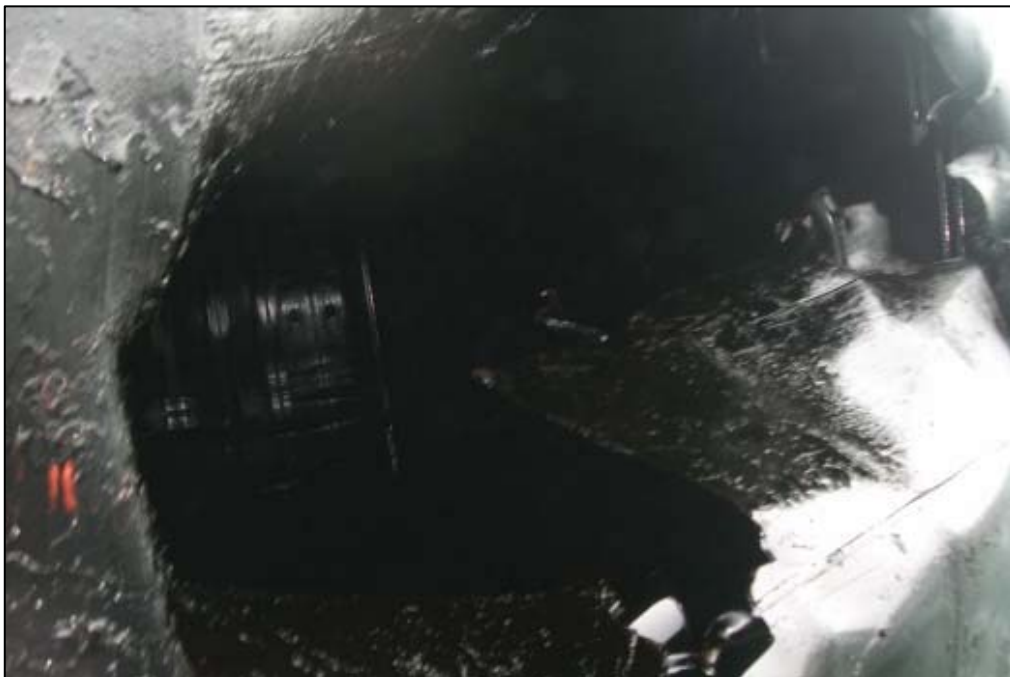
As a result of the collision, *Golden Trader* sustained damage to its side shell plating over an area approximately 3800 mm by 1600 mm between frames 30 and 34 at the lower end of the sheer strake, which is i.w.o. no. 1 heavy fuel oil storage tank (Figures 2 to 5).

**Figure 2: Breached hull i.w.o. no. 1 starboard side heavy fuel storage tank**

The breach in the hull i.w.o. no. 1 heavy fuel oil storage tank resulted in loss of heavy fuel oil over board. The precise amount of heavy fuel oil lost over board remains undetermined. Initially, the master estimated that a small amount of heavy fuel oil was lost. In fact, an entry in the deck log made at 1455 indicated “no leakage outside.” Subsequently, the master reported that approximately 4 m<sup>3</sup> of heavy fuel oil were lost<sup>9</sup>.

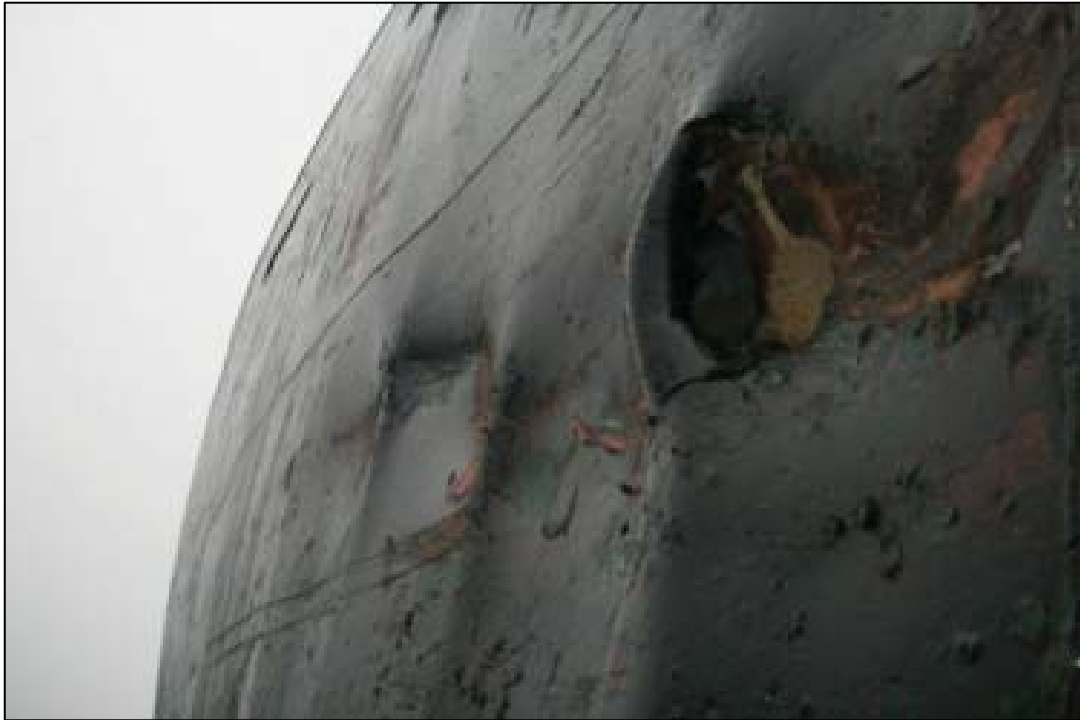
**Figure 3: Breached hull above the vessel's water line**

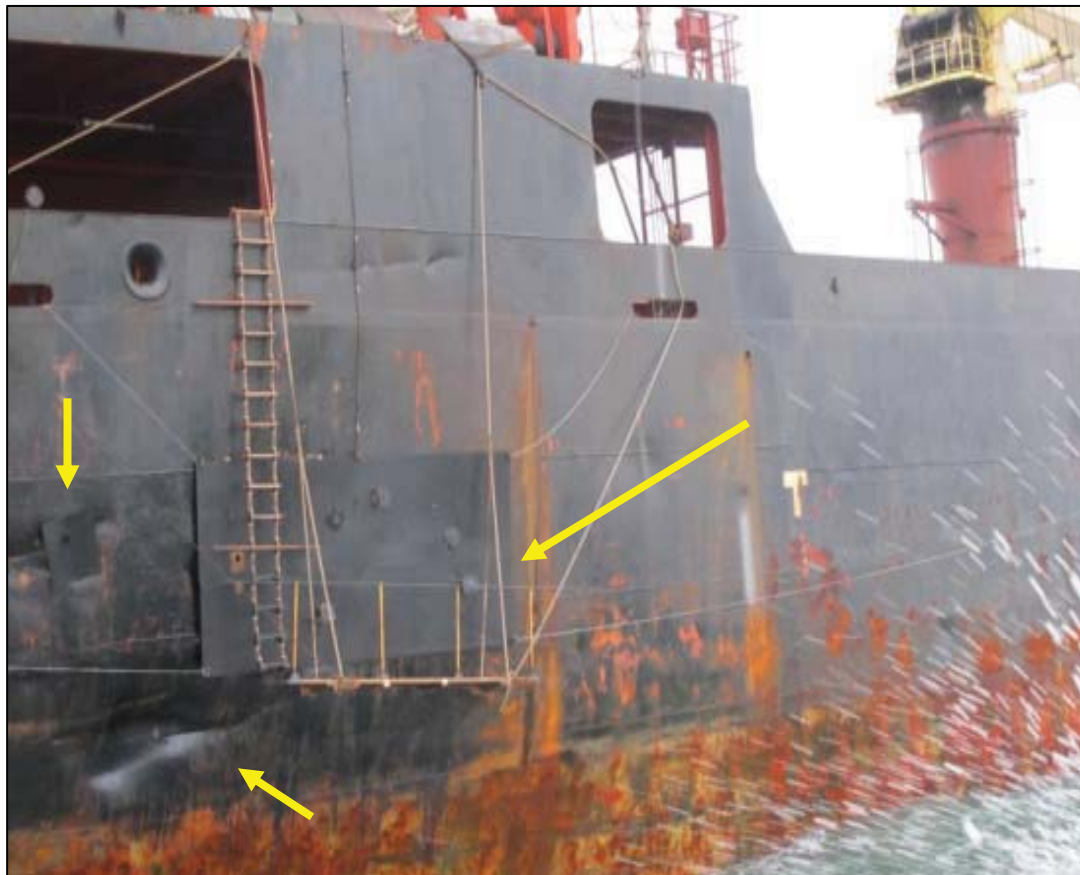
**Figure 4: Temporary repairs i.w.o no. 1 starboard heavy fuel oil storage tank**

After the necessary repairs had been carried out at the roads off Ålbæk under Class supervision, *Golden Trader* was released by the Danish authorities in the evening of 20 September 2011 and allowed to proceed with her voyage to Port Said, Egypt.

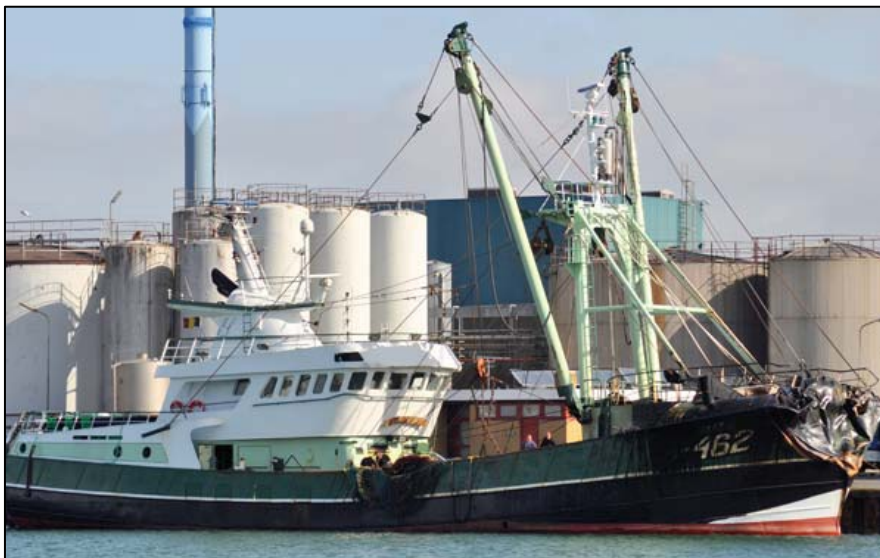
**Figure 6: *Vidar* moored alongside with her bow area with heavy fuel oil, which had leaked from *Golden Trader*'s heavy fuel oil storage tank**

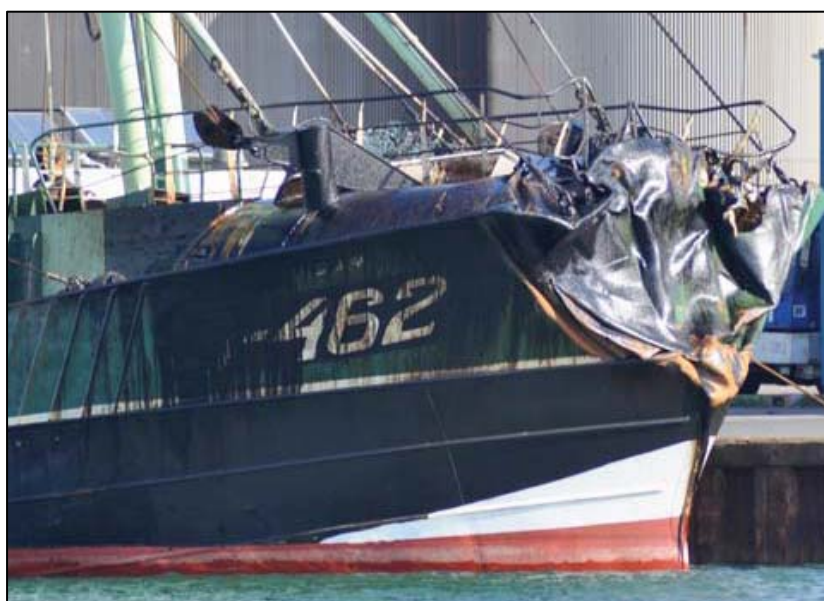
The fishing vessel also appeared to have sustained substantial damage to her stem and forecastle store area with the foredeck area and sides awash with heavy fuel oil for a length of six to eight metres abaft the stem (Figures 6 to 8).

**Figure 7: Damage to *Vidar*'s stem as seen from the starboard side**

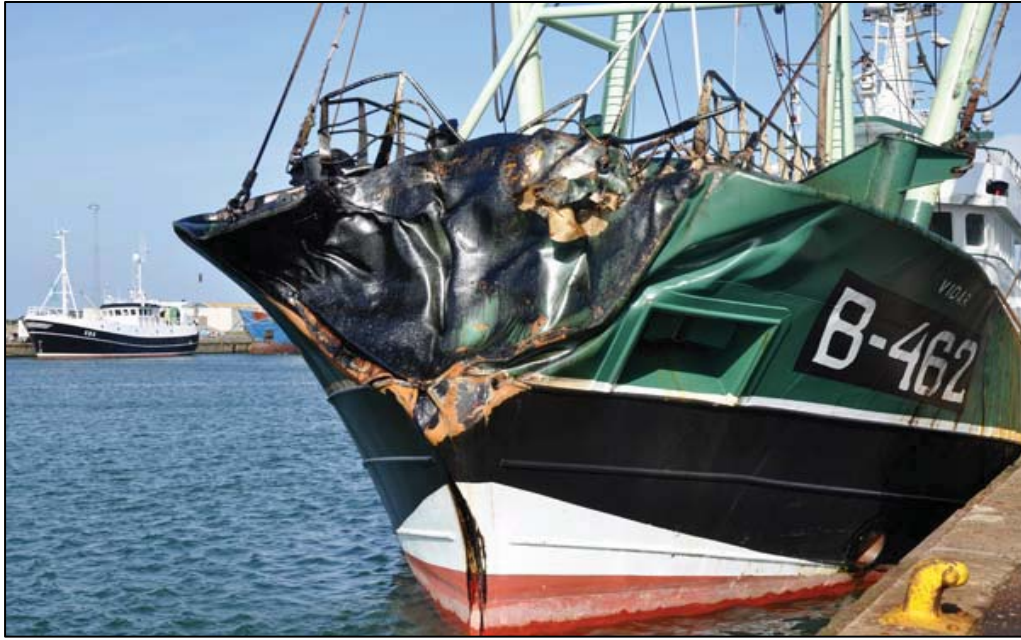
Figure 8: Damage to *Vidar*'s stem as seen from the port side

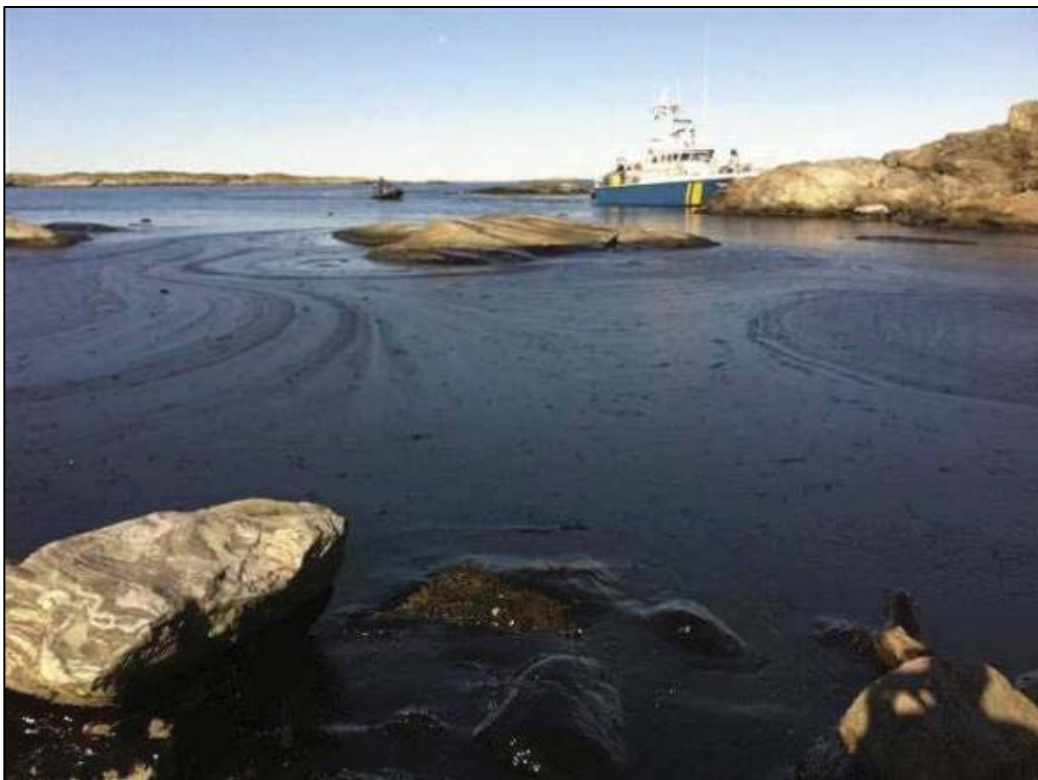
The first indication of pollution on the Swedish west coast was observed around noon on 15 September 2011 at Klädesholmen and Skärhamn, but it was not until 16 September 2011 that it stood clear that it was a major oil spill, which demanded a full scale operation from the Swedish Coast Guard (Figure 15). In order to get more reliable data of the extent of the oil spill, the Swedish Coast Guard carried out an aerial reconnaissance operation by helicopter during the morning and early afternoon of 16 September 2011. The amount of oil was estimated to be between 25 and 30 mt.

It was later discovered that the oil layer was very thick - up to one metre. This necessitated that the estimates had to be revised successively during the collection and decontamination operations.

**Figure 15: A Swedish Coast Guard vessel in one of the oil-affected archipelago bays of the Swedish coast**
