Accident involving the rollercoaster Jetline at Gröna Lund

The Swedish Accident Investigation Authority has investigated an accident at Gröna Lund in Stockholm on 25 June 2023.

14 June 2024

File number: O-6/23

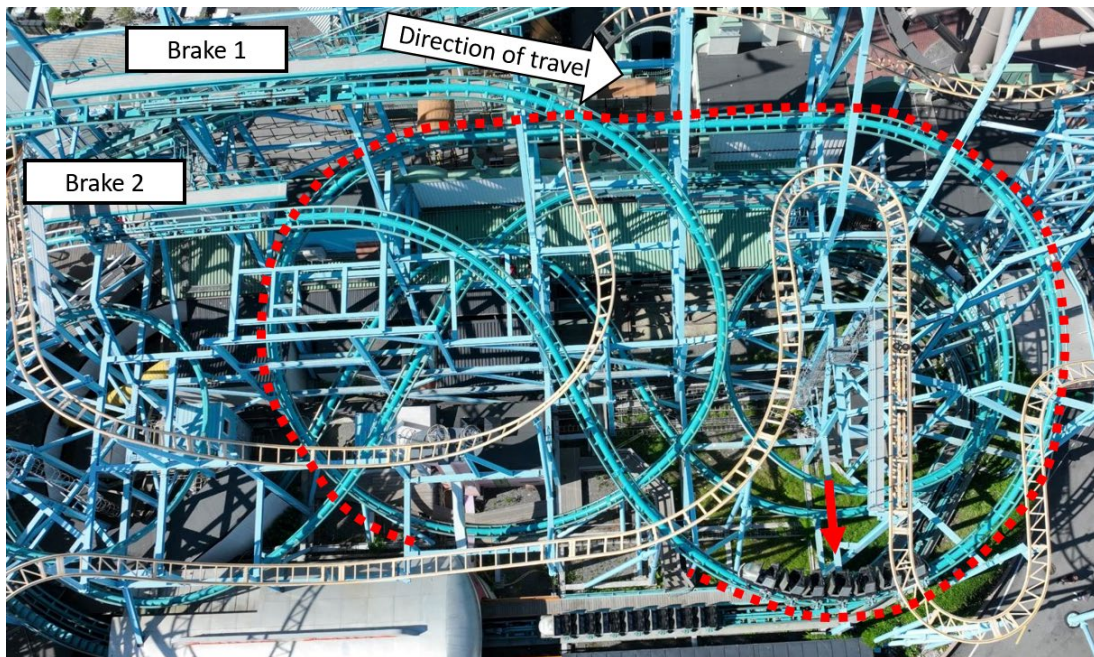
Figure 10. The section of track between brakes 1 and 2. The red dotted line is the part of the track where scratches and impact damage were found. The arrow points towards the train involved in the accident, which is in the bottom right of the picture on the dotted line. The station and the train that stopped there are visible at the bottom edge of the picture.

Scratches and impact damage were found during the examination. The first location where there was damage was a joint in the dip after the steep turn from the rise where brake 1 was located.

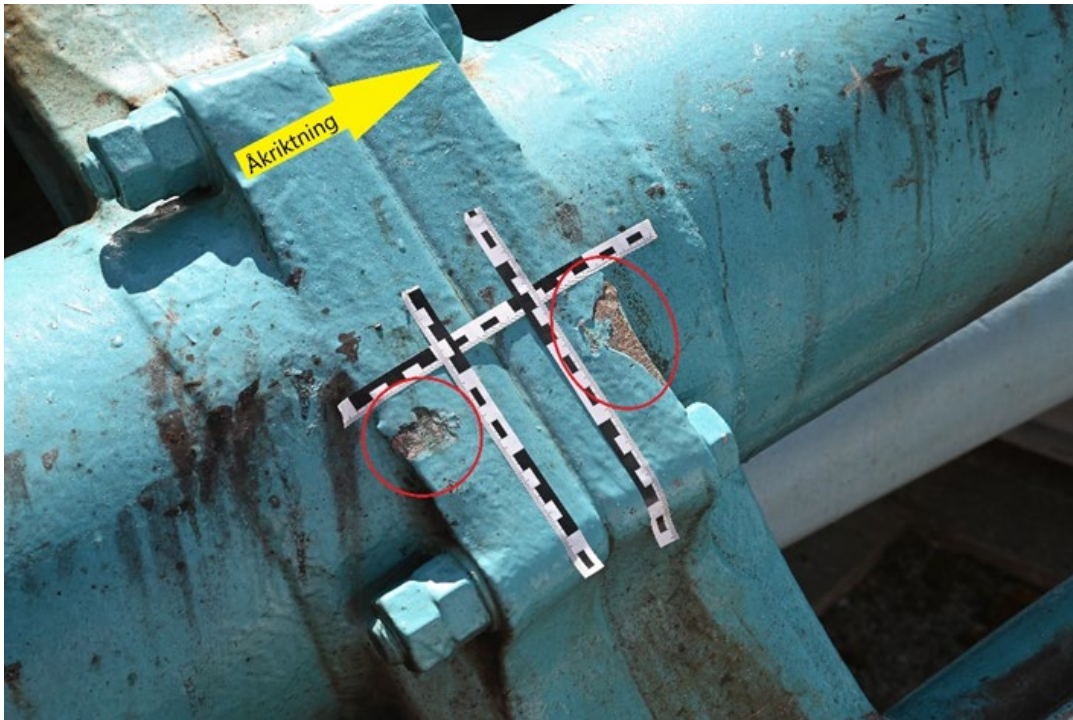
Figure 11. The first impact mark on the track. The red markings drawn in by SHK show where the impact occurred and the yellow arrow indicates the direction of travel. The black and white tape markings were added by the Swedish Police Authority.

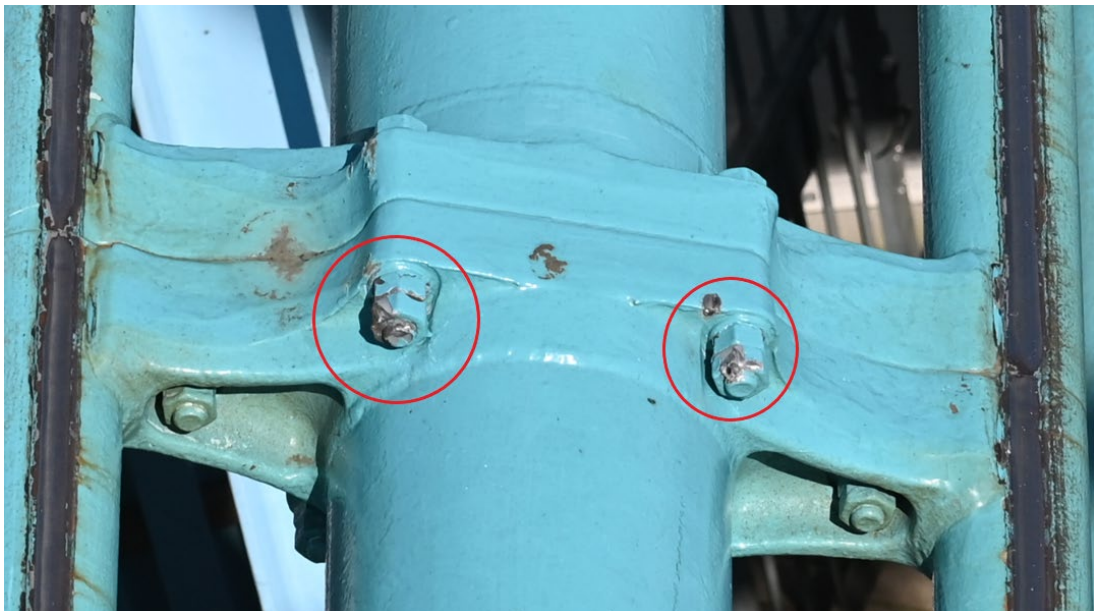
After the first location where there was damage, sites of impact damage on the joints and scratches on the centre tube were found up to the location where the train came to a stop in conjunction with the accident. Sites where the impact damage was more severe than on the other sections of damaged track were noted up on the rise that came after the location in the dip where the first damage was found. Damage was found on one side of the nuts and bolts at two joints in a row. At this location the track leaned slightly to the right and the height of the track was measured at 13 metres.

Figure 12. The sites where the impact damage was more severe on the nuts and bolts at the joints are visible within the red circles.

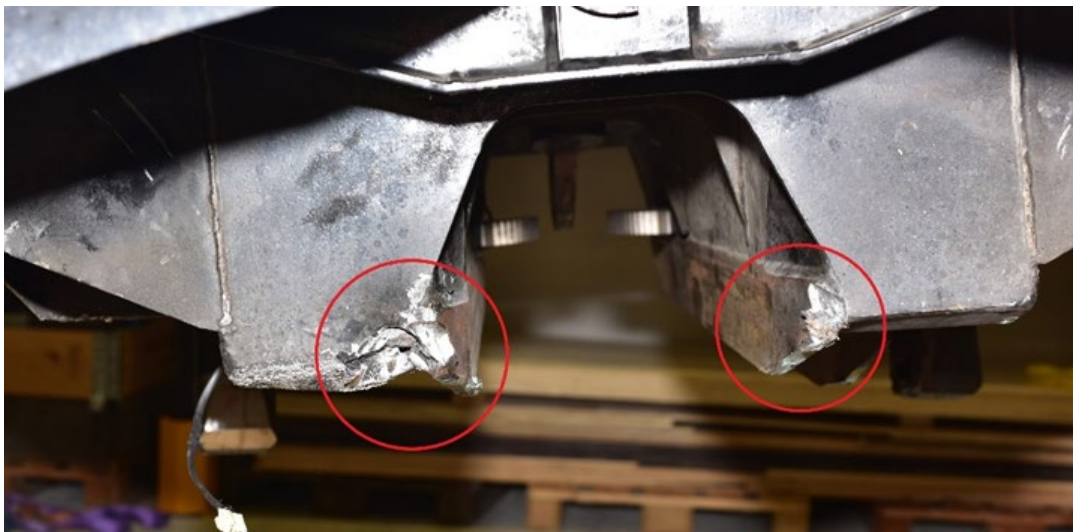
Figure 13. Damage to the underside of the front car. The red markings show where the impacts occurred.

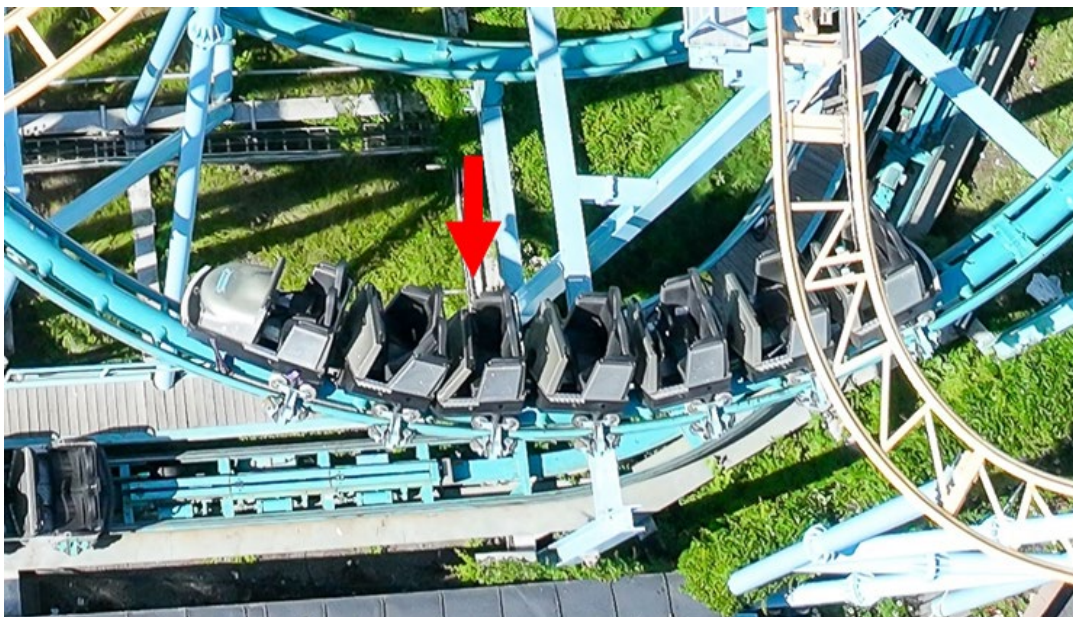
Figure 14. Picture of the train following the accident. Note that the front of car three has bent backwards (marked with an arrow).

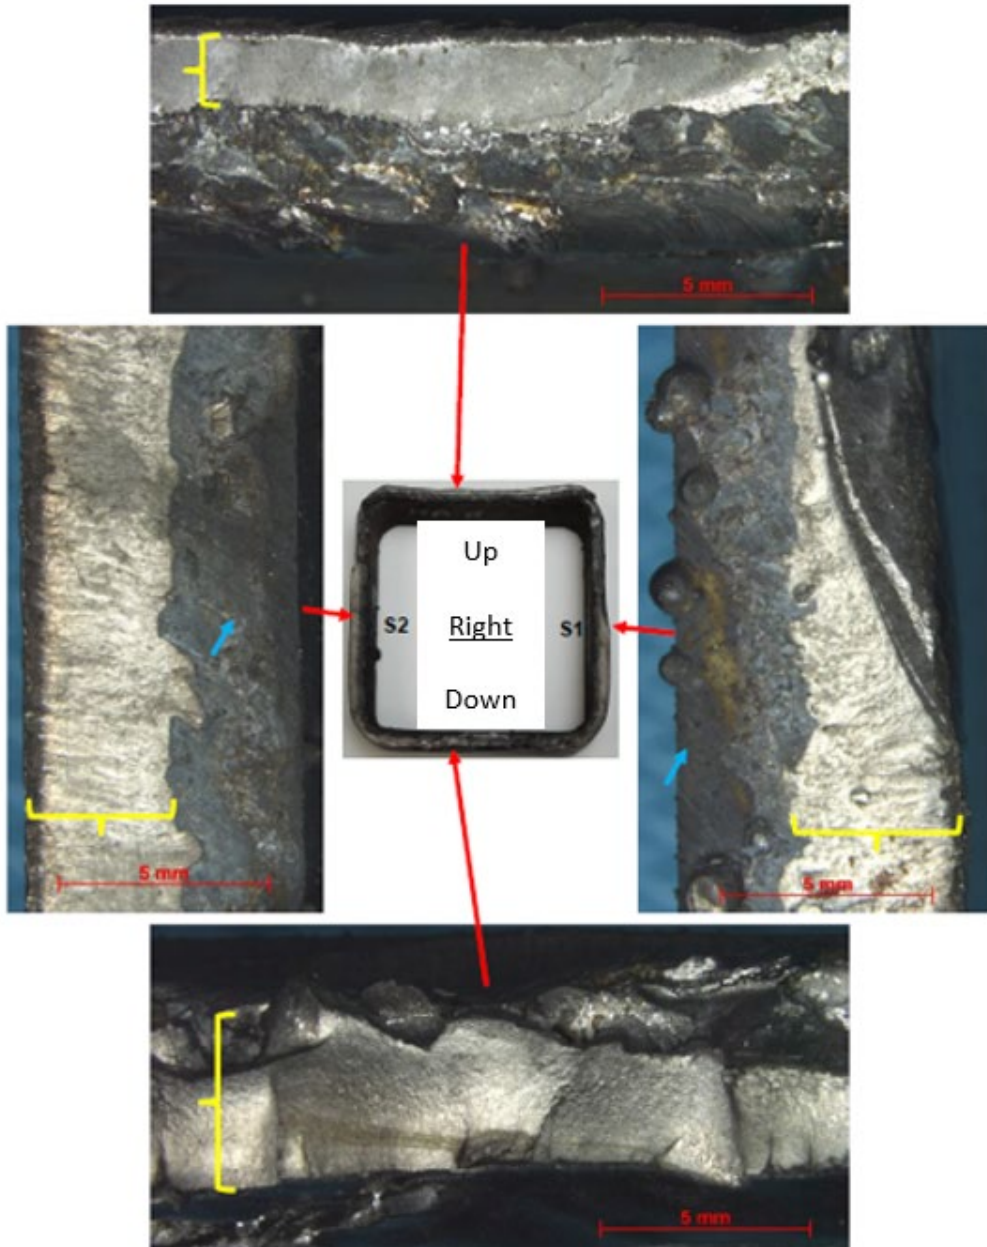
The starting point for the examination was the remaining middle part of the control arm that broke. The fracture surfaces were examined on both the right and the left sides. The examination showed that the weld encompassed only around half of the wall thickness. The welds also had continual and extensive adhesive defects³ along the entire root (inside of the weld). This was deemed to be a serious welding defect that, at this extent, has a major impact on both static strength and on resistance to fatigue. In some places, grooves from the processing prior to welding were still present (see Figures 15 and 16).

Figure 15. Stereomicroscopic image of the fracture surface on the right side of the centre part of the control arm. The thickness of the weld is indicated with yellow brackets in the images. Blue arrows in the figures show processing streaks that are still present from before the welding. Image: Element Materials Technology AB.

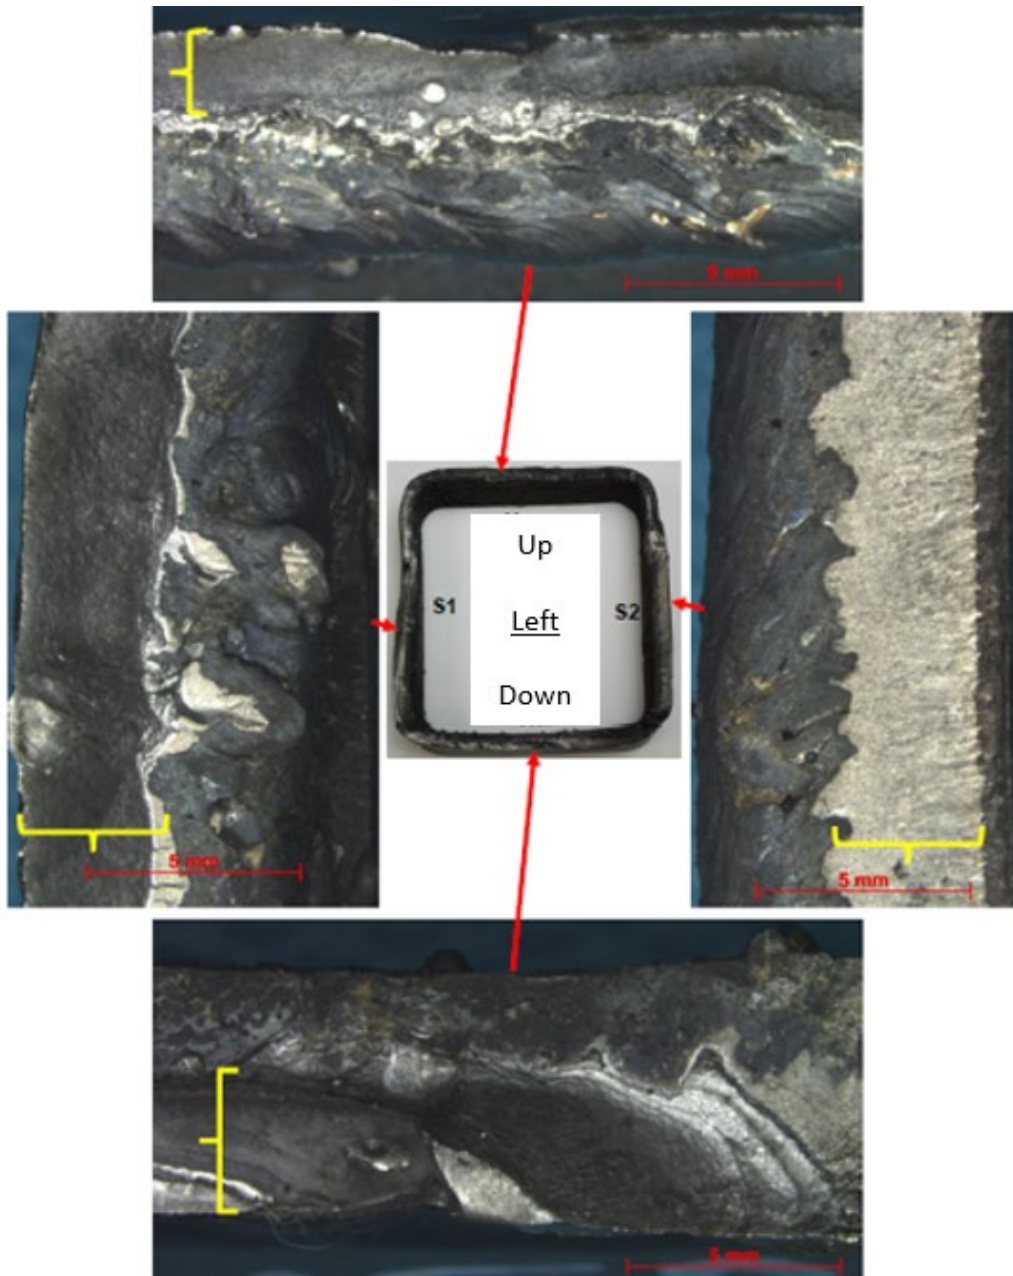
Figure 16. Stereomicroscopic image of the fracture surface on the left side of the middle part of the control arm. The thickness of the weld is indicated with yellow brackets in the images. Image: Element Materials Technology AB.

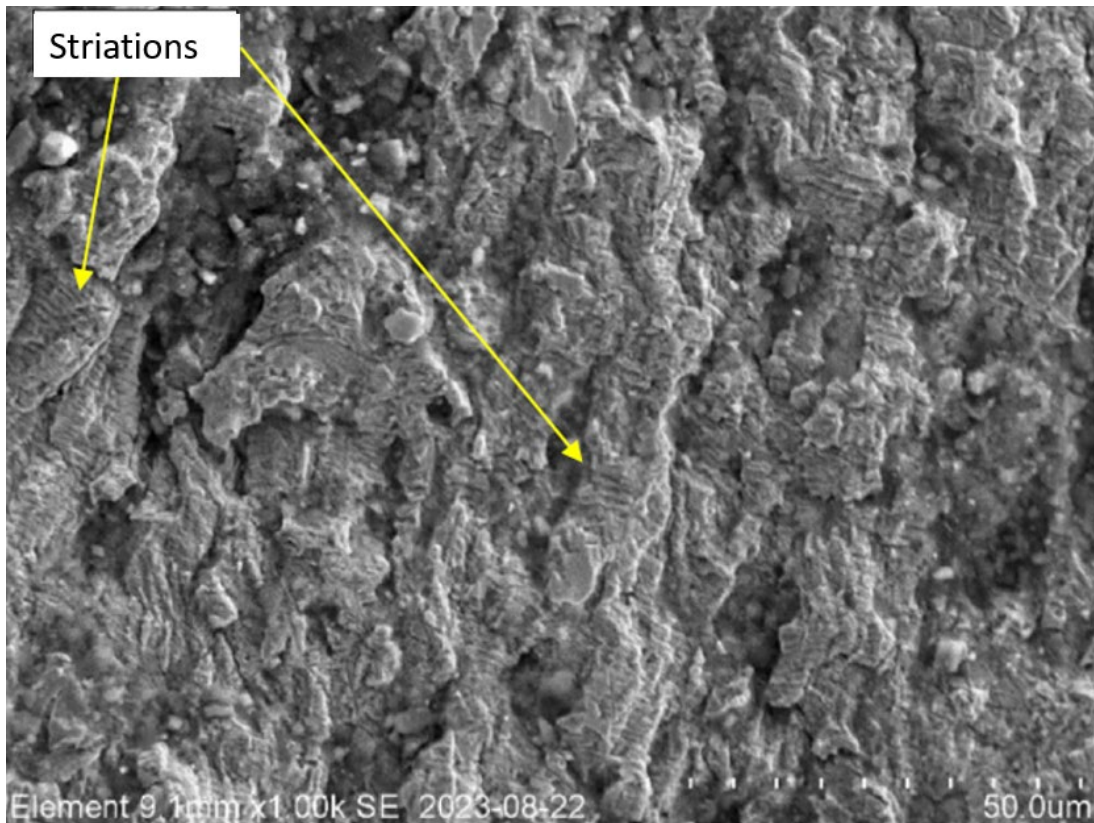
The fracture surfaces were also examined using a scanning electron microscope. During this examination it was possible to establish striations⁴ on both the right and left fracture surfaces. This showed that a fatigue fracture had started from the root side/inside of the control arm (see Figure 17).

Figure 17. SEM image of one of the fracture surfaces on the right side of the control arm. Image: Element Materials Technology AB.

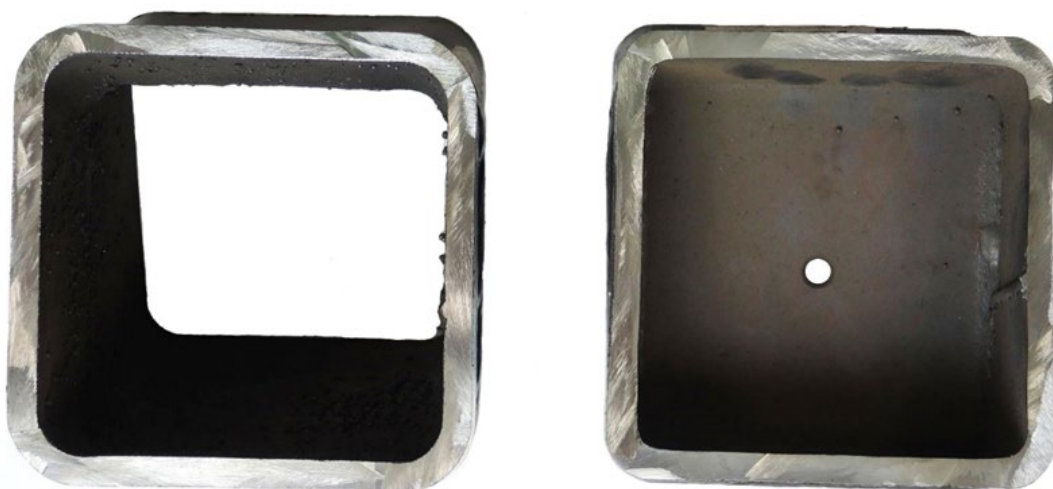
A control arm manufactured in 2019 that had not been installed and an original control arm were cut up in order to facilitate a visual inspection of the inside of the part that corresponded to the place where the welds failed. The newly manufactured control arm did not have the transverse metal plate that was present in the original on the inside of the tube at the welded joint. X-ray examinations showed that the metal plate was also absent on the other newly manufactured control arms.

Figure 18. Cross-sections of two cut-up control arms. Original control arm manufactured in 1986/87 on the right and control arm manufactured in 2019 on the left. Image: Element Materials Technology AB.

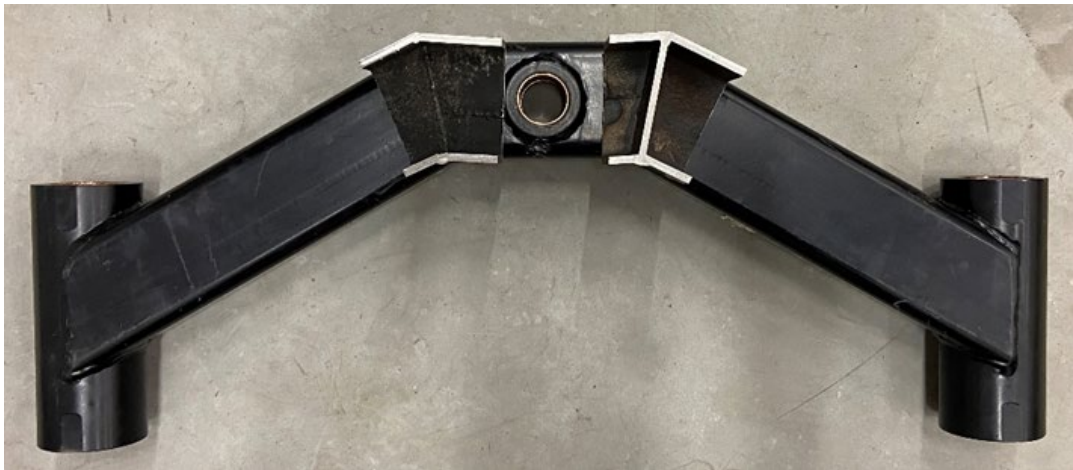
Figure 19. The picture shows a control arm with cut-out samples laid on top. The sample on the left is from a control arm manufactured in 2019 and the one on the right is from an original control arm. The transverse metal plate that is absent on the left is visible in the section on the right.

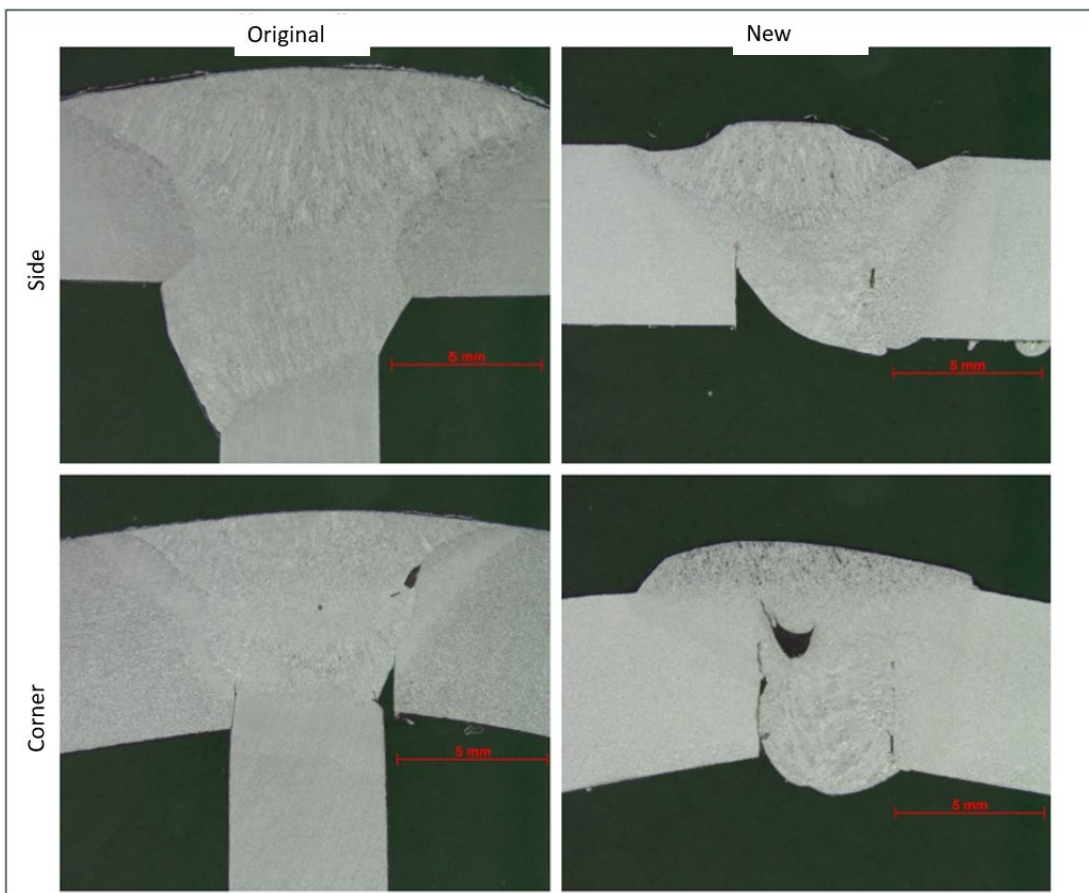
Two cross-sections were cut out of the weld on the original control arm and two from one of the newly manufactured control arms, one sample from a corner and one from a side. There was nothing remarkable about the weld on the side of the original, but the weld on the newly manufactured control arm had improper welding fusion. The weld in the corner showed adhesive defects in both of the samples.

Figure 20. Cross-sections of the weld on an originally manufactured and a newly manufactured control arm. Image: Element Materials Technology AB.

The weld joints on the newly manufactured control arms had extensive adhesive defects in the roots and were so uneven that they could cause cracks. A crack that had begun in the adhesive defect in one of the corners of the weld was found on the inside of the control arm that had been in use on train B since 2022. The crack had a length of approximately 40 μm .

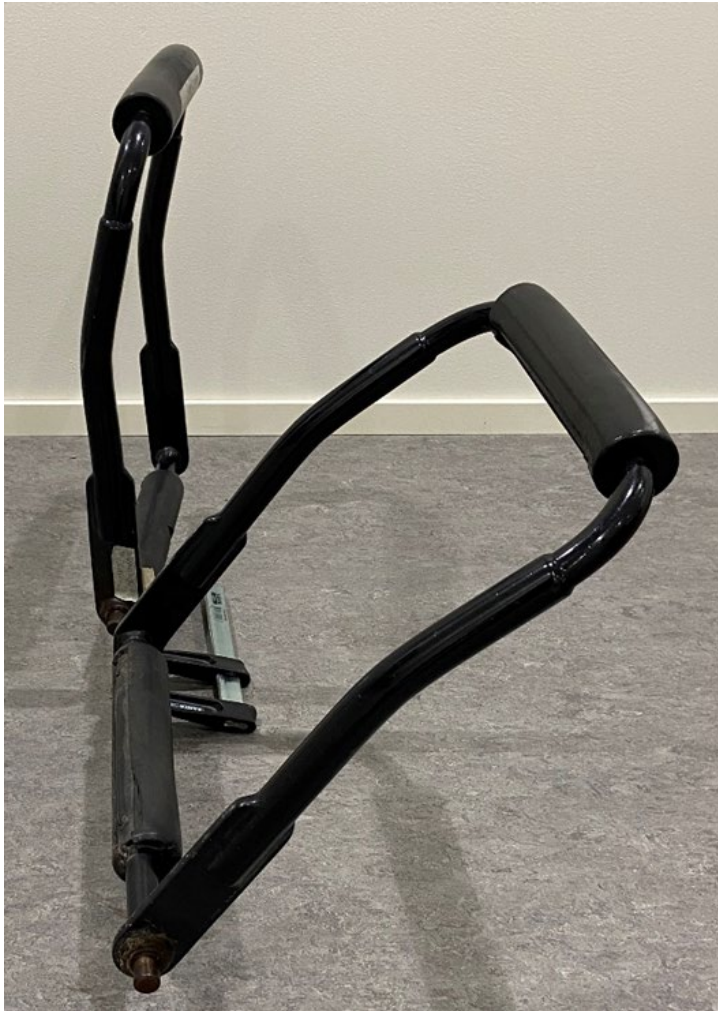
All but one of the bars from where people had been sitting showed deformations; they had been bent forward to varying degrees. The largest bend was found in the lower part where the tubing of the bar transitions to an angled sheet metal. The bars in cars 5 and 7 had the

Figure 21. The lap bar from car 5, left, has been placed behind an undamaged bar. The bar from car 5 was bent forward c. 30 degrees to an almost open position during the accident.

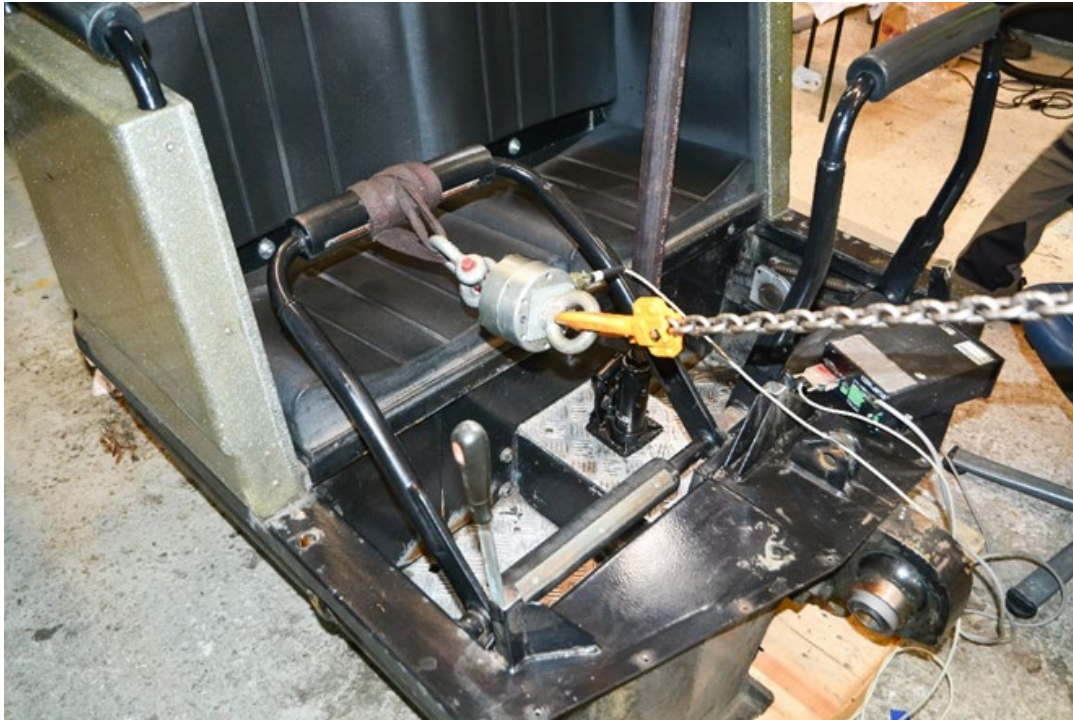
Both tests had similar results; at approximately 1,400 newtons (just over 140 kg) the bars deformed in the same place as the bars had deformed in the train that was involved in the accident. Before the bars deformed they bent elastically, i.e. in such a way that they returned to their original shape when unloaded. During the test running of Jetline (see section 1.6.6), the force from a dummy against the bar was measured at 31.3 kg during sharp braking equivalent to an emergency stop.

Figure 22. Rigging used during load tests on a lap bar.

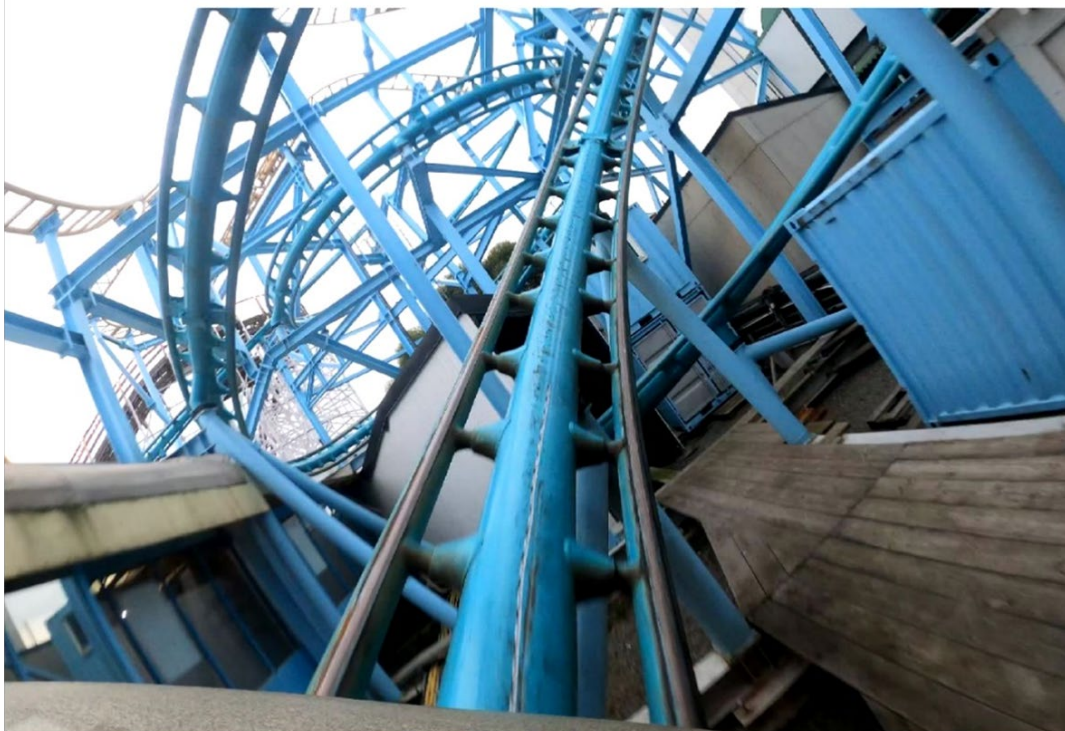
The results of the test run showed that the maximum load downwards in the car during a ride was 4.7 g and this was measured in the front car on the train. This force was measured at the position on the track where the impact damage was noted. At this point, the train had a speed of 88.0 km/h. The maximum speed recorded was 93.2 km/h, just before the location of the first impact damage to the track. A speed of 54.7 km/h was measured at the point where there were most powerful impacts on the nuts and bolts had been noted.

Figure 23. Picture from the test run that shows the train in the position of the first impact on the track. At this time, the speed was 88 km/h and the load was 4.7 g in the front car.

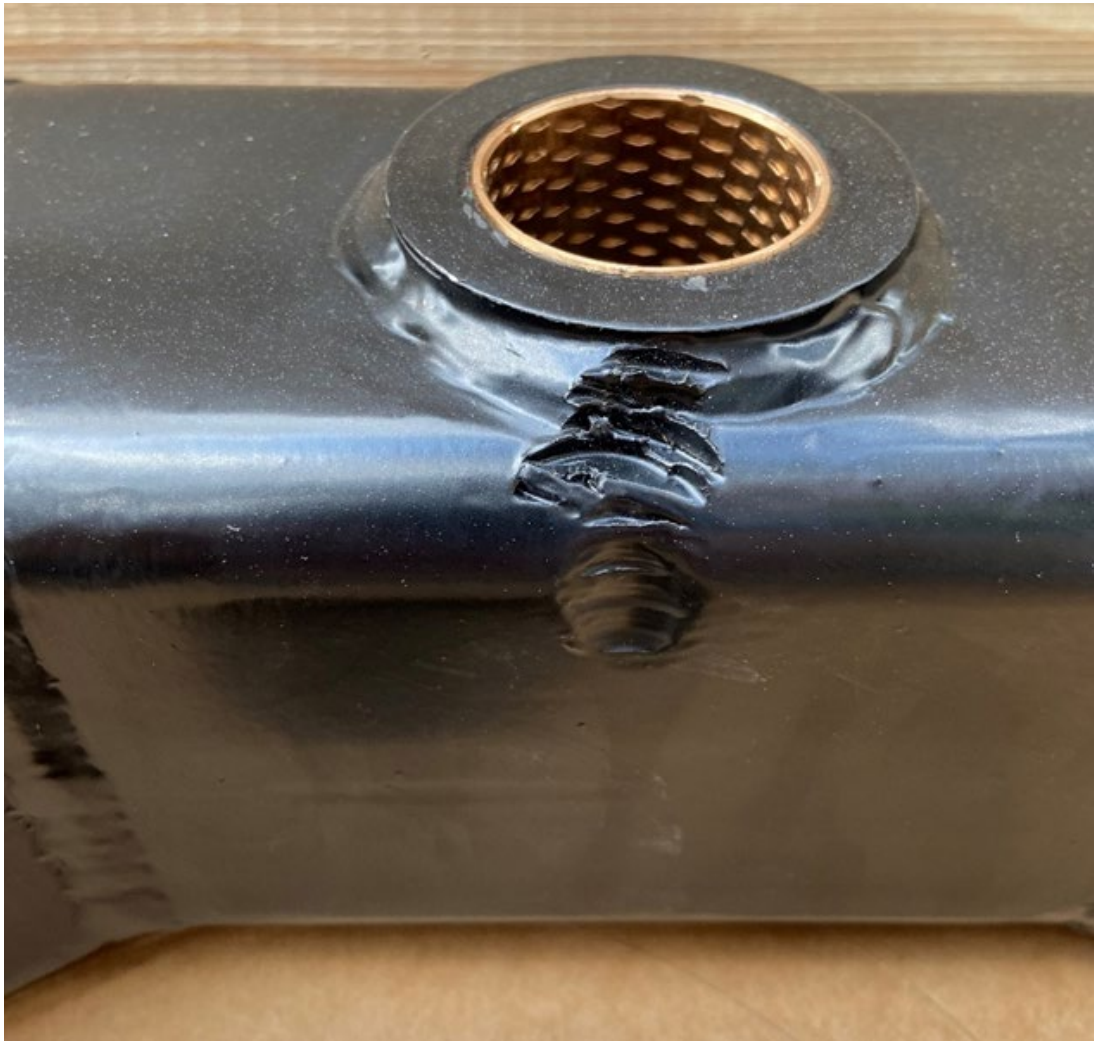
Figure 26. The damage that probably occurred during the manufacture of one of the five control arms that was supplied in 2019.

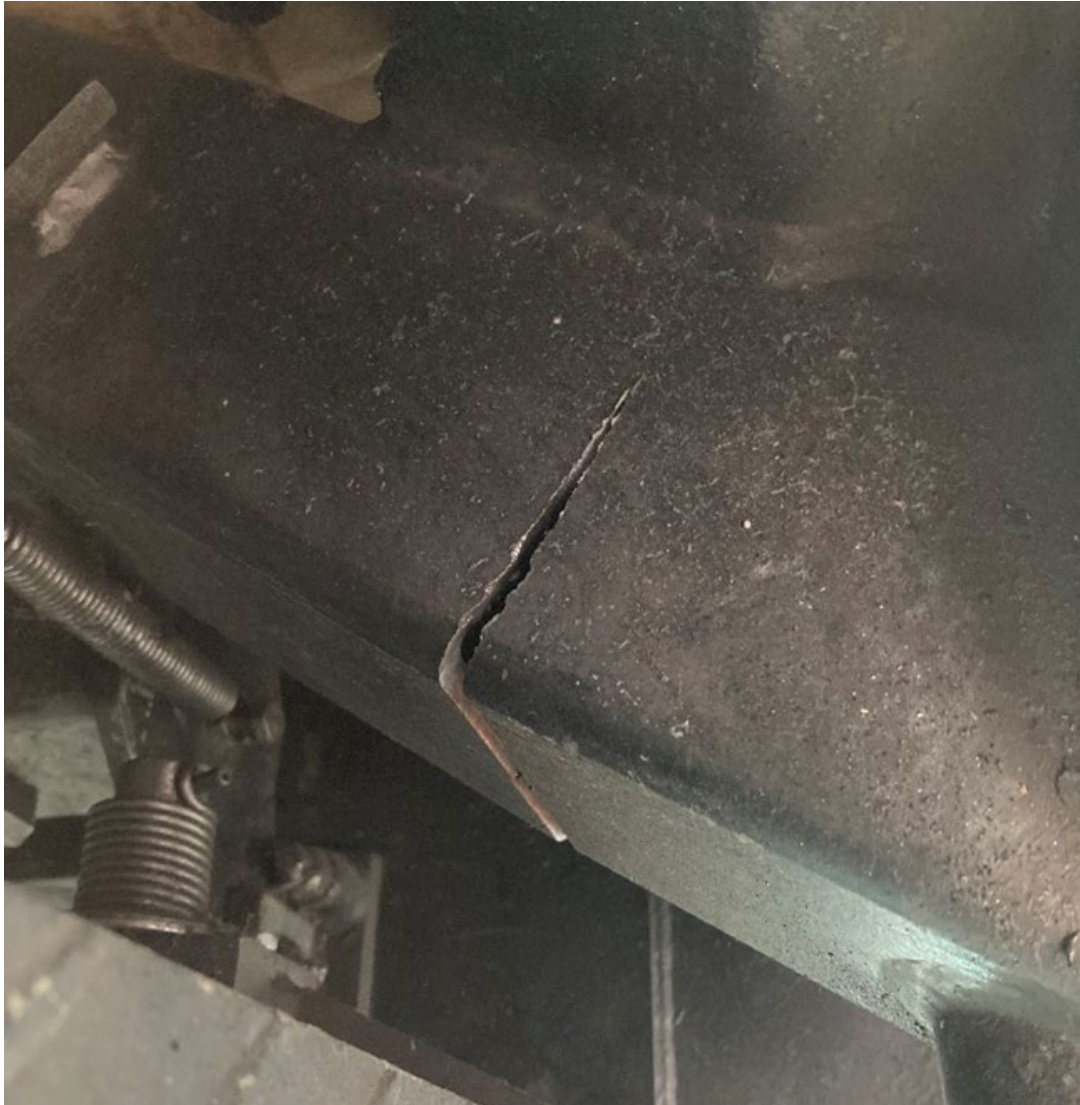
On 28 August 2022 it was noticed that one car in train E was not aligned with the other cars. The train was taken out of service immediately and a crack was discovered in the rear control arm on the first car (original control arm from 1988). The crack had appeared in the wall of the square tube (see Figure 27).

Figure 27. The crack that was discovered on 28 August 2022 in an original rear control arm from 1988. Photo: Gröna Lund AB.

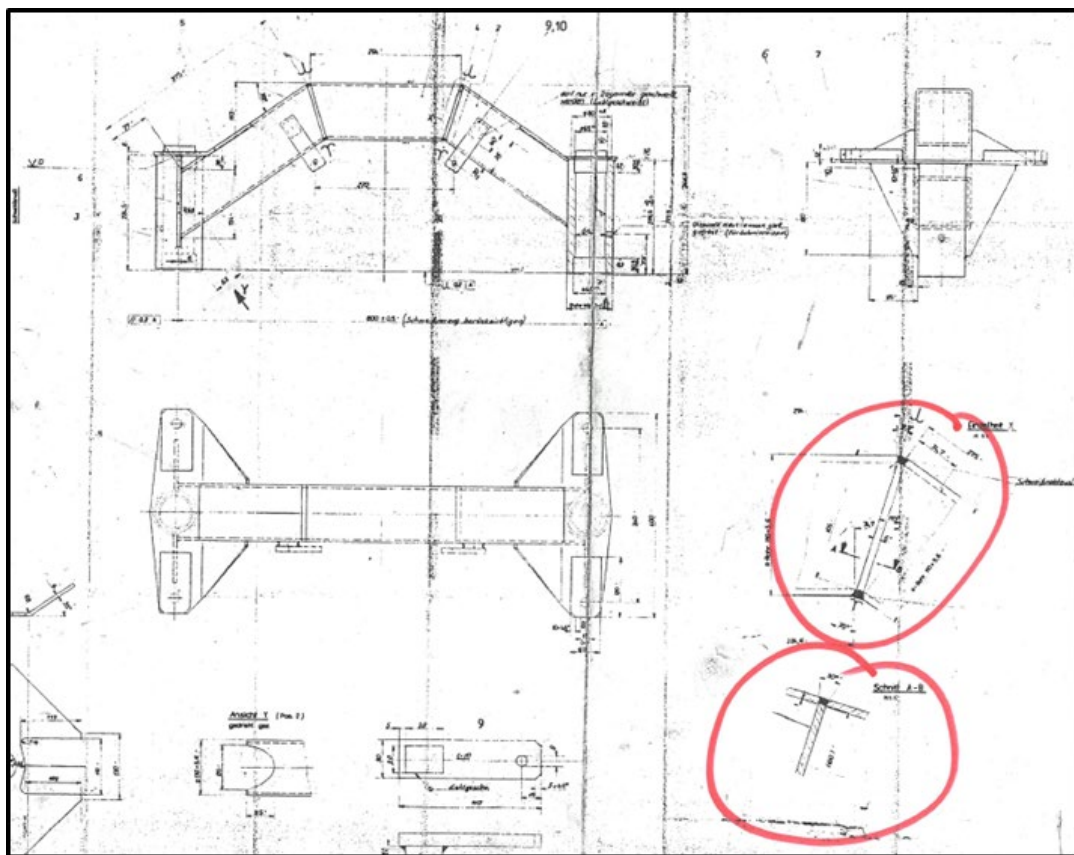
An initial delivery of 15 rear control arms was made to Gröna Lund in March 2023. A visual inspection by staff at Gröna Lund showed that the control arms had not been manufactured correctly. Among other things, certain measurements were not consistent with the drawing and the welds were deemed to have anomalies. The control arms were sent back to the supplier in order to be scrapped and with the instruction that new ones be manufactured. The manufacture of new control arms took a long time and none of these control arms were installed on any train.

Figure 28. Excerpt from the drawing that was sent with the order of rear control arms in 2022. The red rings have not been drawn in by SHK but the outside of a joint in the control arm is shown in more detail in the upper ring and a cross-section (the inside) of the joint is shown in the lower ring. It can be seen in the cross-section that there should be material on the inside of the joint where the parts are to be welded together.

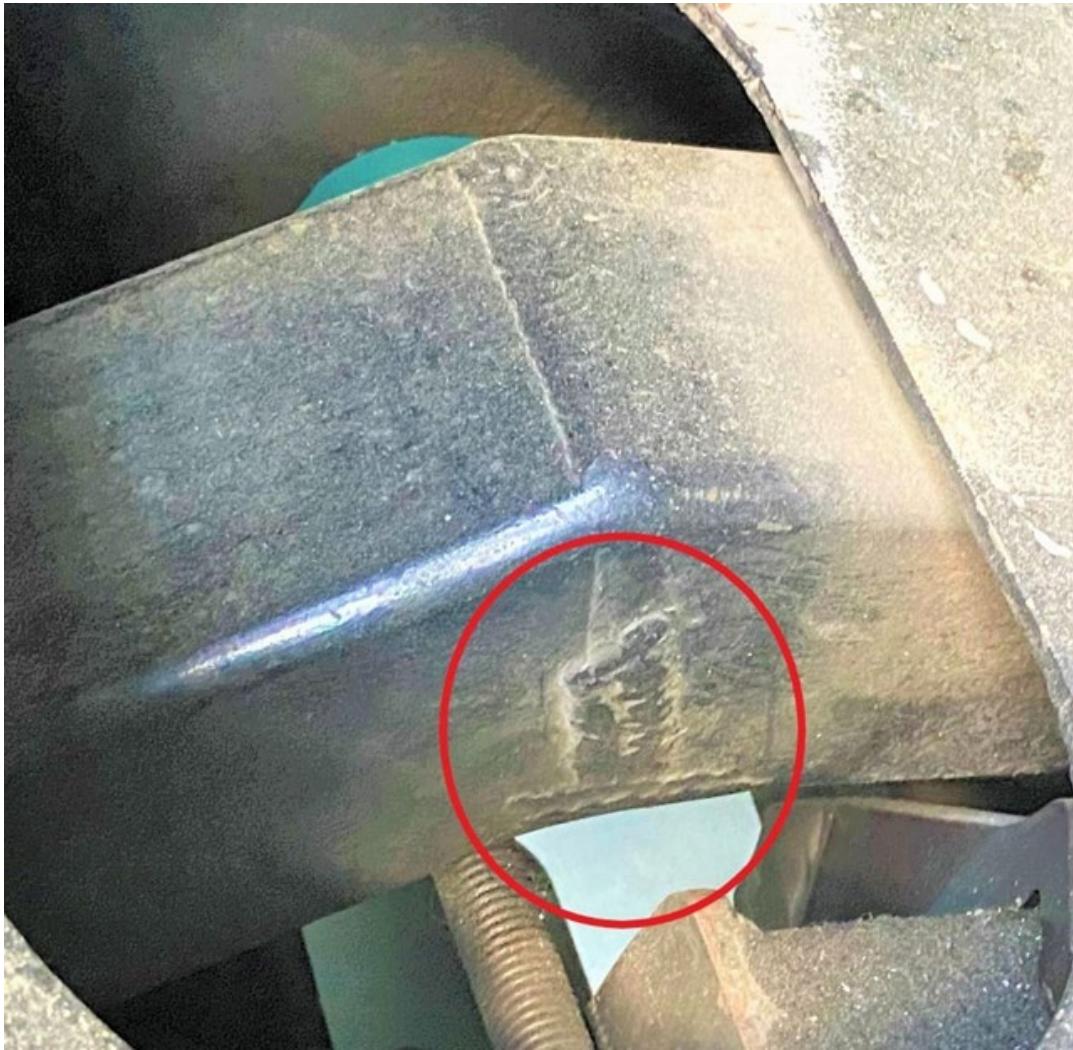
The welding repairs were not registered in any logbook or service record but number and year had been registered in another way, including in DEKRA's testing record. It is reported that twelve cracks were welded and checked between 2006 and 2023.

Figure 29. Weld repair on a control arm marked with a red ring. The photo is of a control arm installed on train C. The weld repair is on the weld between the outer and middle parts of the control arm.
