# RON JEREMY– the sinking of the vessel off the coast of Piteå

The Swedish Accident Investigation Authority has investigated a marine accident that occurred off Piteå, in Norrbotten County, on 1 June 2025

29 May 2026

File number: S-127/25

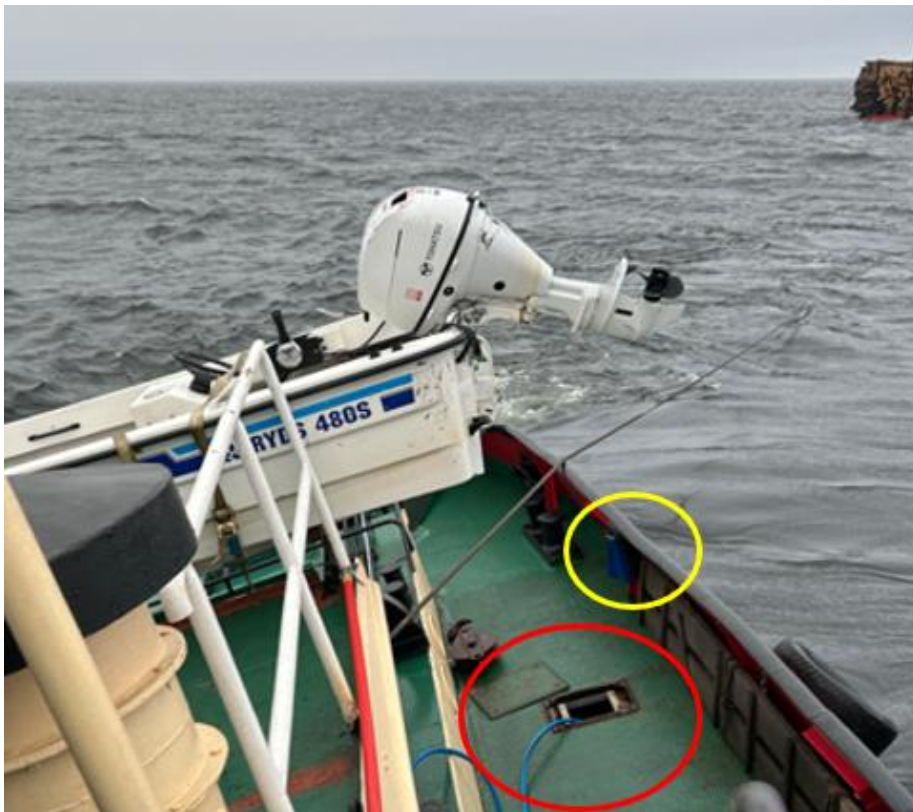
Finally, the crew decided to attempt to counterflood the port ballast tank. Due to problems with the main ballast system, the tank had to be filled using a portable bilge pump. This was done through a manhole on the freeboard deck. Deckhand 2 was ordered to open the manhole and fill the tank. In Figure 5 below, the open manhole is visible on the right, along with the hose from the portable bilge pump protruding from it.

Figure 5. The red marking shows the open manhole to the port ballast tank, where a blue pump hose is inserted. The yellow marking shows the gooseneck for the same tank. In the upper right corner, the barge can be seen, connected to the vessel by the towing wire running out over the port rail. Photo taken by the crew at 04:47. Image: The Shipping company. Annotations added by SHK.

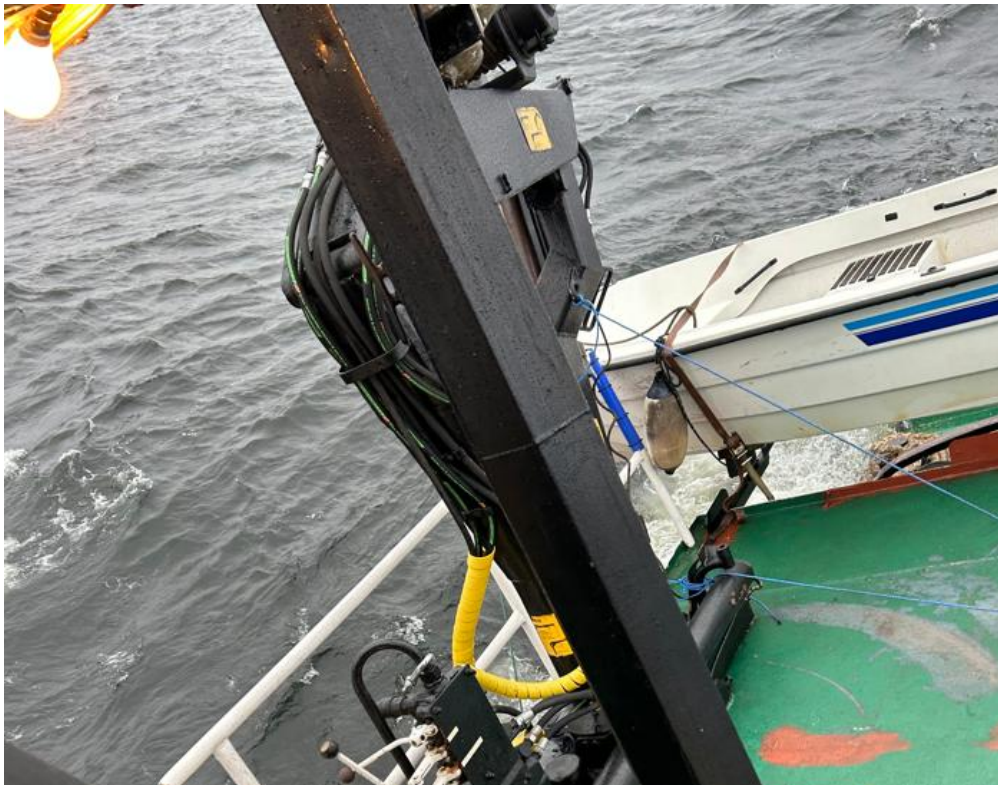
Deckhand 1 noted that the goosenecks on the starboard side were below the waterline and informed the others that they now had to abandon the vessel. The master fetched lifejackets and immersion suits from his cabin behind the bridge and threw them out on the port side of the cabin. The chief officer and deckhand 1 had some difficulty putting on the suits but assisted each other. At this point, the crew took photographs that clearly show that the starboard rail was below the waterline, see Figure 6.

Figure 6. In the image, it can be seen that the water level has reached above the starboard rail and walkway; the photo was taken by the crew at 04:47 from aft of the funnel and the bridge. Image: The Shipping company.

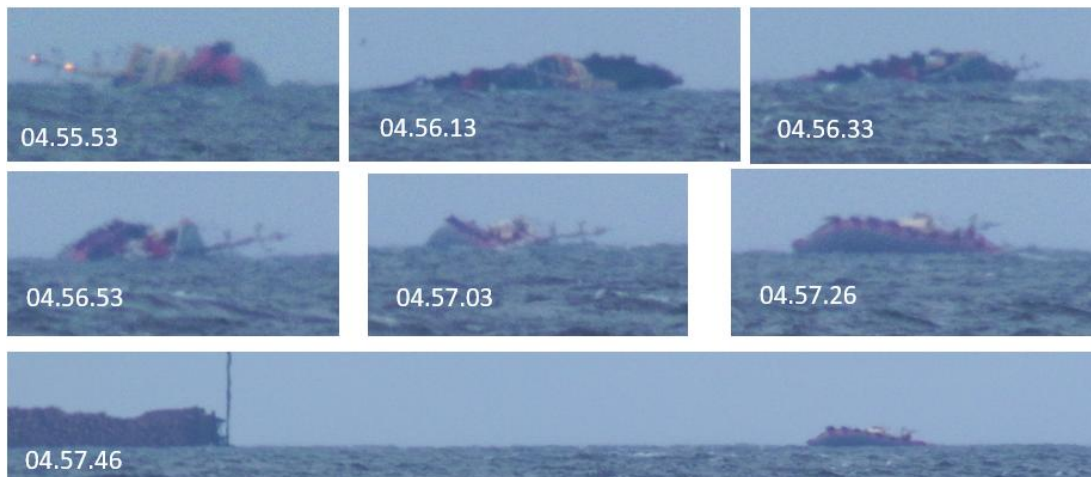
The list increased further until the vessel lay completely on its side. When the vessel was on its side, the navigation lights remained lit for a short while before going out. After another minute, the stern sank and the bow rose above the water surface for about 30–50 seconds before the vessel disappeared completely beneath the surface. As the vessel sank, the crew ended up in the water. When the master surfaced, he saw the bow of the vessel disappear beneath the water. At 04:59, the vessel foundered<sup>8</sup>. The sequence of events in the final stage of the foundering is shown in Figure 8 below.

Figure 8. The sequence of images shows frames from the moment when the navigation lights go out until just before the vessel rises and sinks. The images are taken from video footage filmed by two witnesses on Rödkallen. Image: private. Time indications added by SHK.

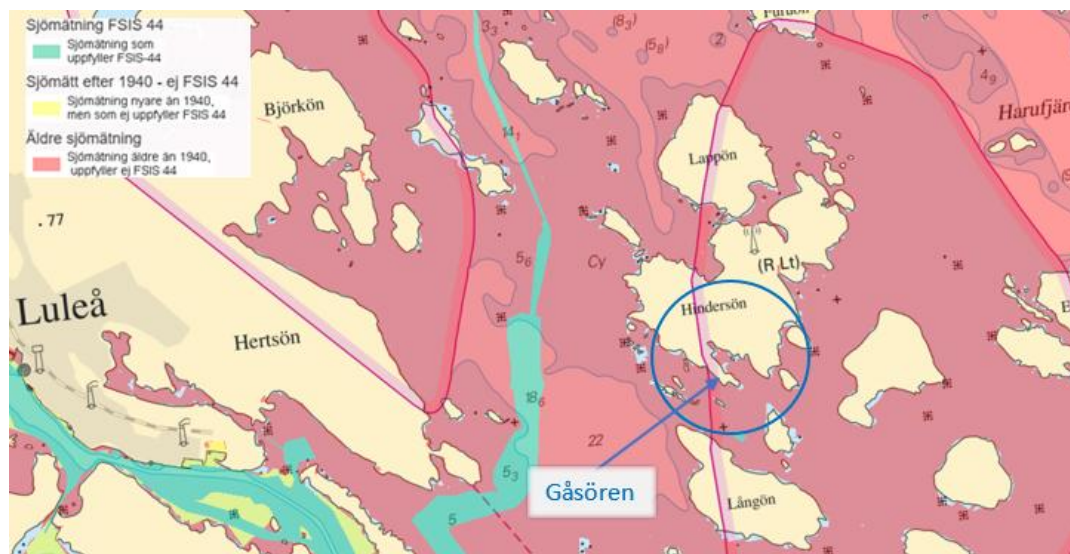
The route taken by the vessel from Gåsören is largely well charted, with the exception of the area closest to Hindersön. The depth soundings forming the basis for depth information in this area were carried out between 1894 and 1896. The distance between the measurement points ranges from 40 to 100 metres. The fact that the area around Hindersön is covered only by older depth soundings is evident from the Swedish Maritime Administration's chart viewing service, see Figure 9.

Figure 9. In the Swedish Maritime Administration's chart viewing service, the area around Hindersön and the approach to Gåsören is marked in red (see blue circle), indicating that the depth information is of low quality. © Swedish Maritime Administration no. 26-00511. Annotations added by SHK.

The Swedish Maritime Administration has stated that orthophotos<sup>11</sup> of the area show several visible boulders along the shoreline and in the shallow waters. Given the age of the original depth surveys and the limitations of the measurement method (lead line), the Swedish Maritime Administration has indicated that the nautical charts are unreliable. It cannot be ruled out that certain shoals or stones have not been recorded, and furthermore, the seabed conditions may have changed since the surveys were conducted.

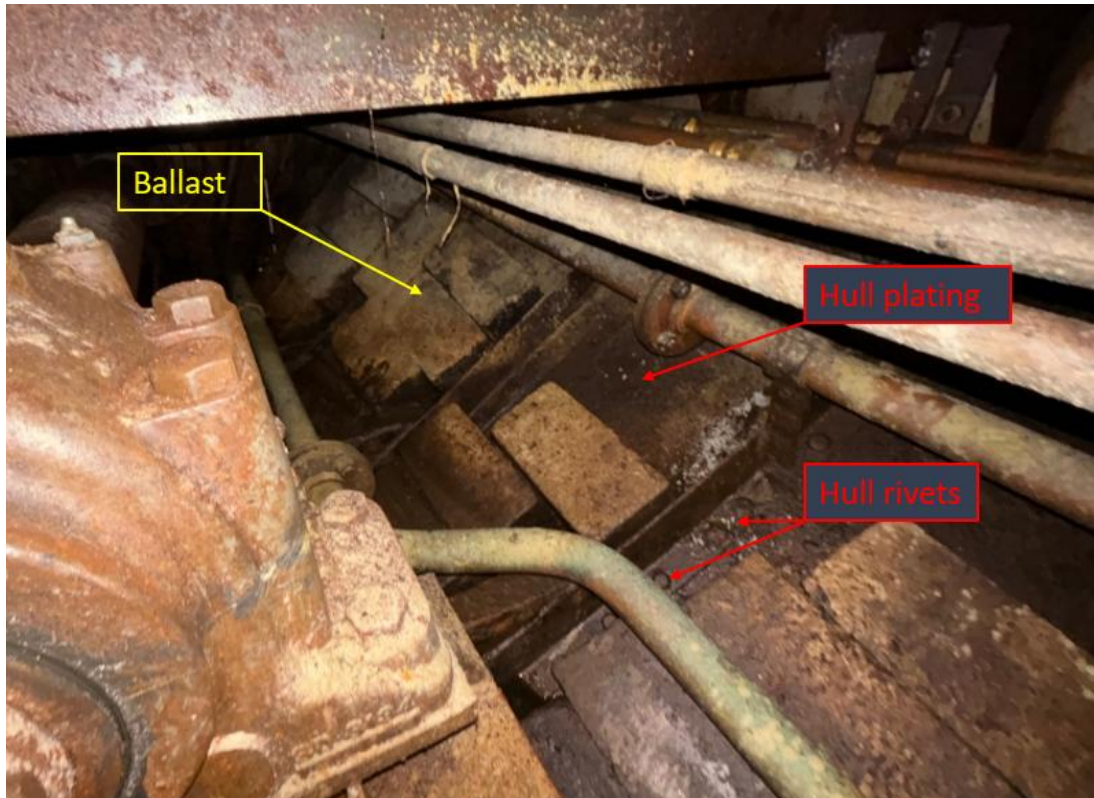
The propeller shaft first passed through the storeroom and then, in a stern tube, through the aft ballast tank. The casing was oil-filled and fitted with seals towards the storeroom and out to the water. The oil maintained a constant pressure with the help of a gravity tank. Reportedly, the stern tube was tight and oil for the gravity tank did not need to be refilled often. Figure 13 shows the keel space beneath the storeroom. The image shows various pipes, the hull with riveted joints, as well as some form of fixed ballast blocks lying against the hull.

Figure 13. Port side of the keel beneath the storeroom. The image highlights the hull plating, hull rivets, and ballast blocks. Several pipes for the ballast, cooling water, and bilge systems are also visible in the image. Image: Klaravik. Annotations added by SHK.

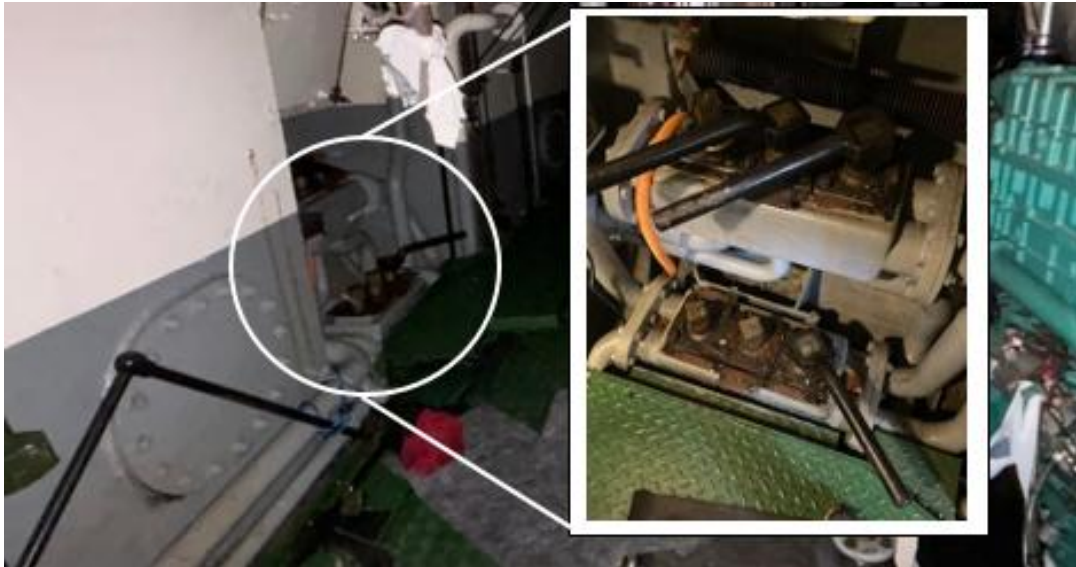
The bilge system was operated by a combined bilge and ballast pump. It is unclear whether the pump also functioned as a fire pump. The pump was electrically powered and has been described as large. It was connected to the respective pipe systems via a so-called bilge box. This consisted of two rows of three-way valves, with three valves in each row, see Figure 14.

Figure 14. The image shows the bilge box, consisting of two rows with three valves in each. These are connected to several different pipe systems. Image: Klaravik and Swedish Transport Agency (inserted image). Annotations added by SHK.

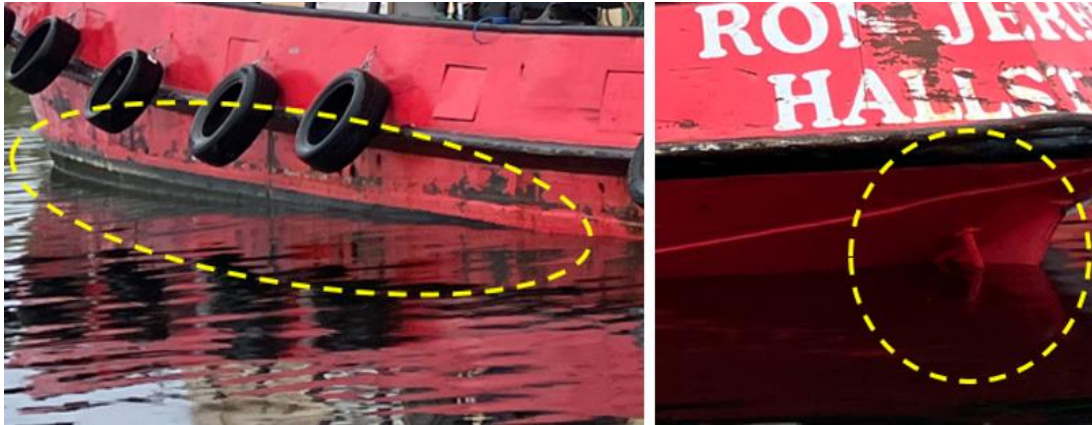
According to older drawings (from 1961), the vessel's draught in an unladen condition was just over 2.4 metres. The vessel's draught marks<sup>14</sup> had been painted over, and it was therefore no longer possible to read the exact draught. The crew stated that they normally aimed for a draught of 2.8 metres at the stern.

Figure 15. The images are enlargements from Figure 1. The image on the left shows the port forward half of the hull. The waterline, indicated by the transition from black antifouling paint to red hull paint, is clearly visible at the bow but disappears towards the stern. In the right-hand image, which shows the stern, the waterline is not visible at all. This suggests that the draught was significant at the stern. Photo: Swedish Coast Guard. Annotations added by SHK.

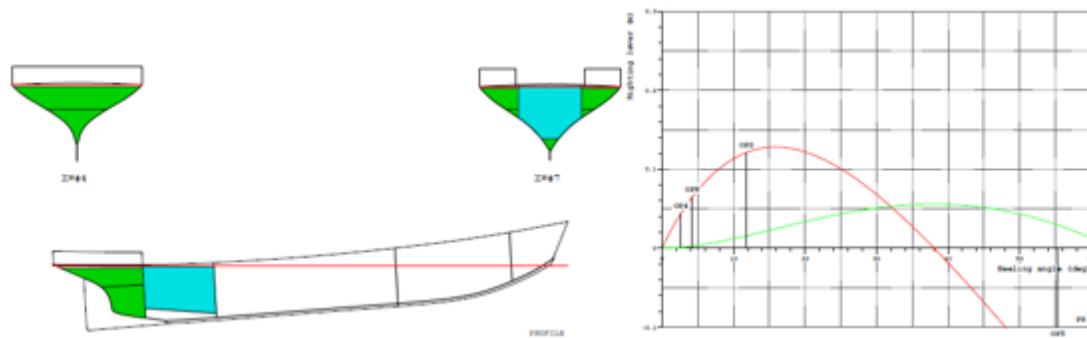
The calculations show that if just over 17 cubic metres of water enter the storeroom, the aft deck and the aftmost freeing ports will be level with the water surface. At this point, the vessel has no remaining freeboard at the stern. In this situation, the freeing ports risk letting in as much water as they let out. The vessel's trim at this stage has increased from the original approximately 0.7 metres to about 1.3 metres aft trim. This difference is barely perceptible to the crew, see Figure 16.

Figure 16. Excerpt from the stability report by SALTECH. The figure shows the vessel's floating position when 17 cubic metres of water have filled the storeroom. The red curve in the diagram indicates that the maximum righting lever is greatest, at 0.11 metres, at 15 degrees of heel.

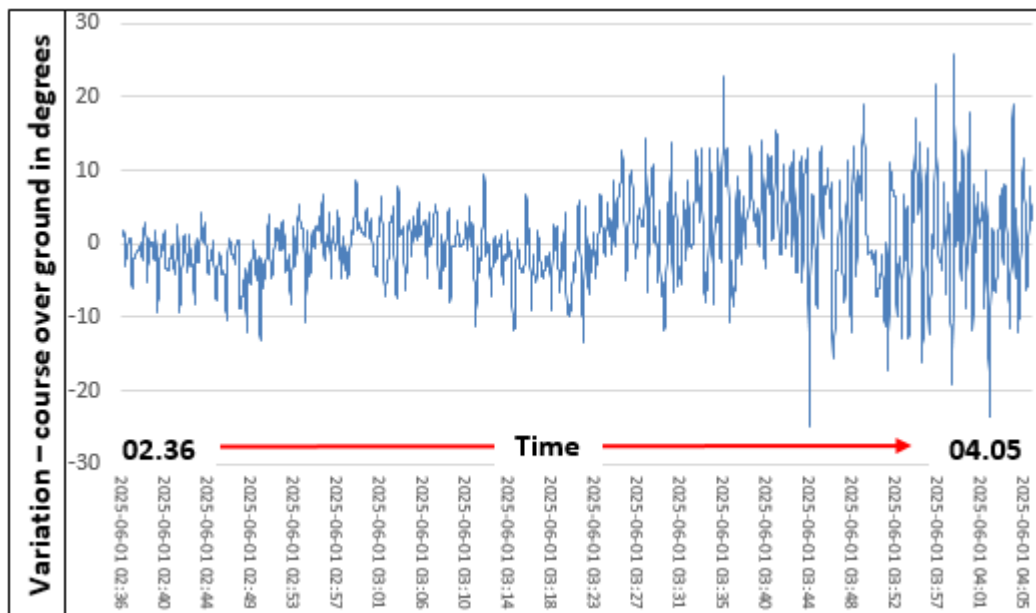
The speed remained relatively constant after the vessel reached open water, which is consistent with the crew's statements. However, the variation in course over ground gradually increased from just before 03:00. A summary of the variation in course over ground during the last three hours is shown in Figure 17.

Figure 17. The diagram shows a gradual increase in the variation of the vessel's course over ground. Source: Swedish Transport Agency. Annotations added by SHK.

During the final hour, the course variation increased to over 25 degrees, having previously been less than 10 degrees. A comparison of AIS data from the vessel's previous passages in the same area between 2024 and 2025 did not show the same variation in course over ground.
