Notes, Observations and Findings Regarding Ro-Ro Passenger Vessel ESTONIA

Background and Introduction

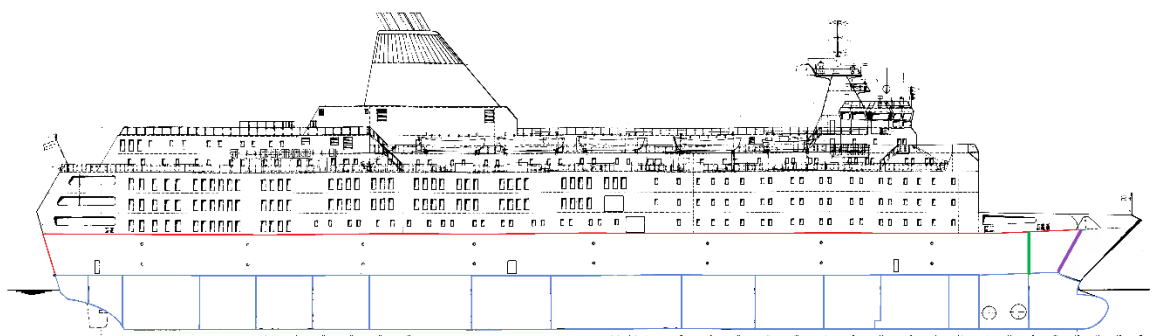
According to SOLAS-legislation, applied to MV ESTONIA, the collision bulkhead should be prolonged weathertight up to the deck above. The prolonged collision bulkhead should be placed within certain distances aft from the forward perpendicular.³ (See Fig. 1.1.)

Fig. 1.1. As the vessel should have been built if no exemptions had been applied. Blue indicate watertight hull and bulkheads, red and purple indicate weathertight hull, where purple is also car ramp, and green indicate the extended weathertight forepeak bulkhead (collision bulkhead).

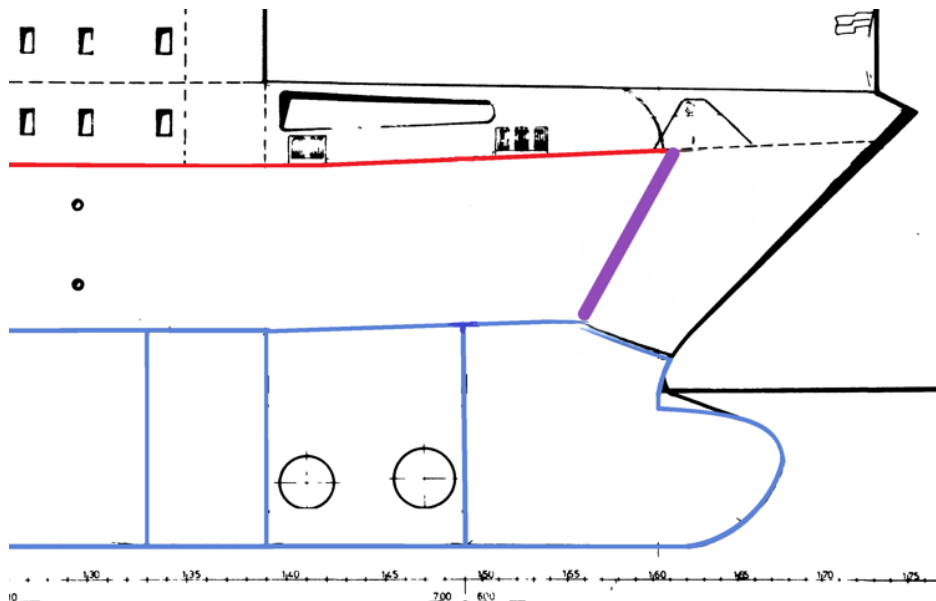
However, the legislation made exemptions possible with the condition that the trade of the vessel should not exceed 20M from nearest land.⁴ In the case of MV ESTONIA this resulted in the weathertight front bulkhead (including the car ramp) having a dual function, and also being the weathertight collision bulkhead. This was as she was supposed to be built if she was built in accordance to legislation and accepted exemptions (see Fig. 1.2).

Fig. 1.2. As the vessel could have been built if exemptions had been applied. Blue indicate watertight hull and bulkheads, red weathertight hull, and purple indicate weathertight front bulkhead (also car ramp). Given the exemption from extended weathertight forepeak bulkhead, the trade area should have been restricted to 20M from nearest land. The exemption should have been noted in vessel's certificate.

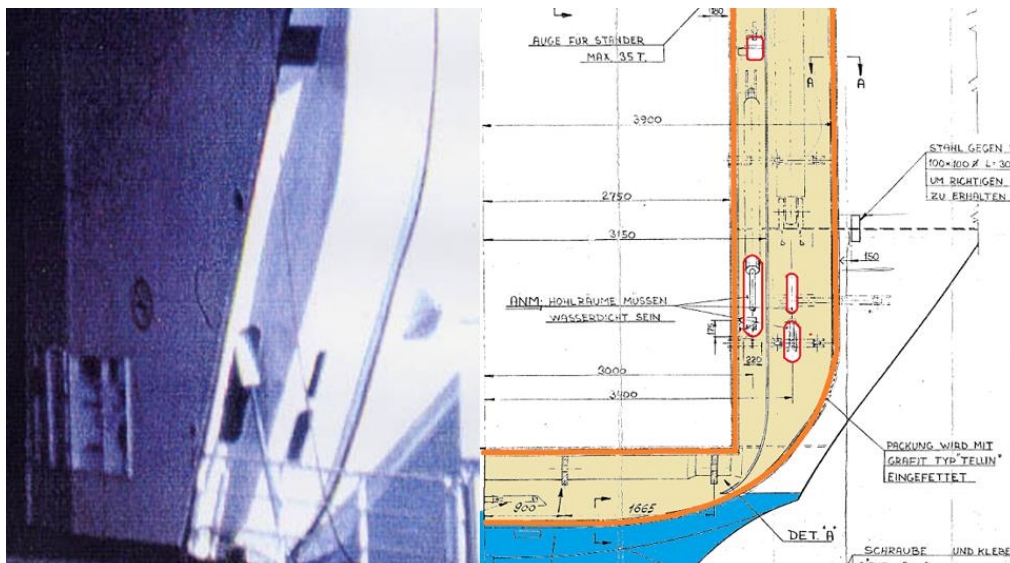
Footage of the vessel shows openings for hoisting/lowering and locking arrangements through the front bulkhead on both sides of the car ramp. Shipyard drawings of this part say that the front bulkhead should be to some extent tight (in German "wasserdicht").

Fig. 1.3. The left picture shows four openings in the front bulkhead on port between the sealings for the visor and the ramp (inside of the visor sealing, but outside of the ramp sealing). This means that if there is any water inside the visor, it may pass through the openings into the space behind (port wing house). The drawing on the right shows sealings (in amber) the openings (in red) and the note that it should be tight ("ANM: Hohlräume müssen wasserdicht sein"). The same circumstances apply for starboard side. Coloring of the drawing is made by SHK. Both picture and drawing are cropped.

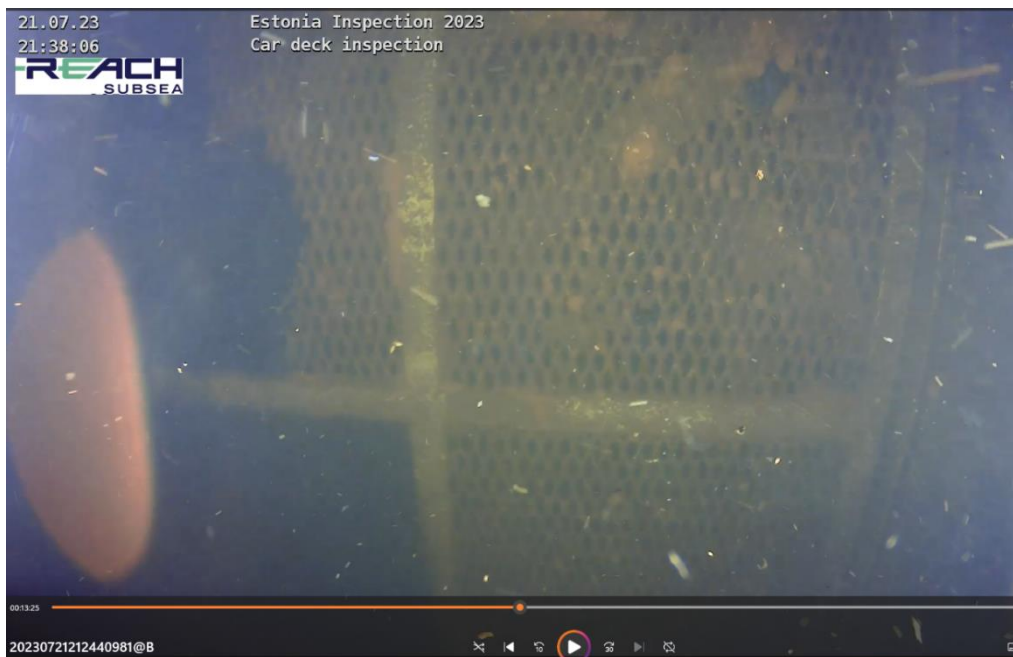
This requirement could be upheld by the bulkhead to both wing houses. Footage from the diving operations in summer 2023, however, show that the doors into the wing houses are grille doors, i.e., they do not uphold the standards of either the hull or the bulkhead.

Fig. 1.4. Door from car deck to port wing house. This type of door is on drawings called "Drahttür", which is German for grille door. Image from ROV- film made in July 2023.

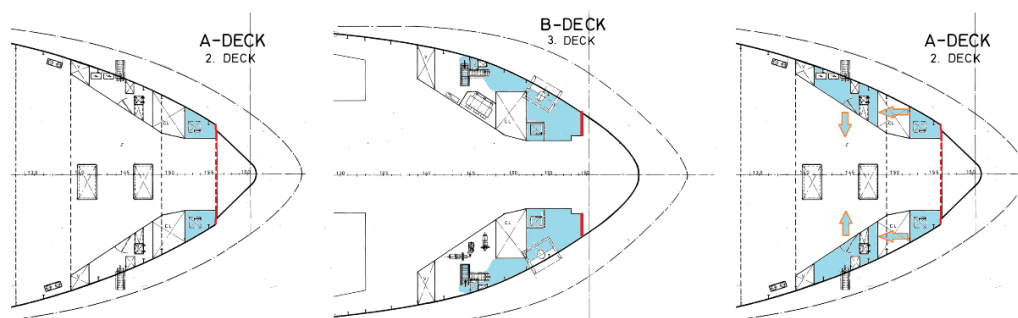
This means that, in case there would be much water inside the visor, there actually would be free entrance for water ingress from the bow visor. Water could pass through the front bulkhead openings into the wing-houses, between the anchor chain lockers and the outside hull board. From there it could continue down to the wing house area aft of the chain locker. It could then be possible to continue through the grille door to car deck, or via the opening of the ramp/visor maneuver stand. Another possible way for water to ingress would be through potential leak at the bottom corner of the ramp.

Fig. 1.5. Scheme for possible water ingress from inside the visor to car deck. Water flow through the openings and fill the area on deck 2 fore of the anchor chain locker (image left), then reaches the area between the chain locker and outer hull board on deck 3 (image middle), and eventually flow down to deck 2 aft of the chain locker and through the grille door (image right).

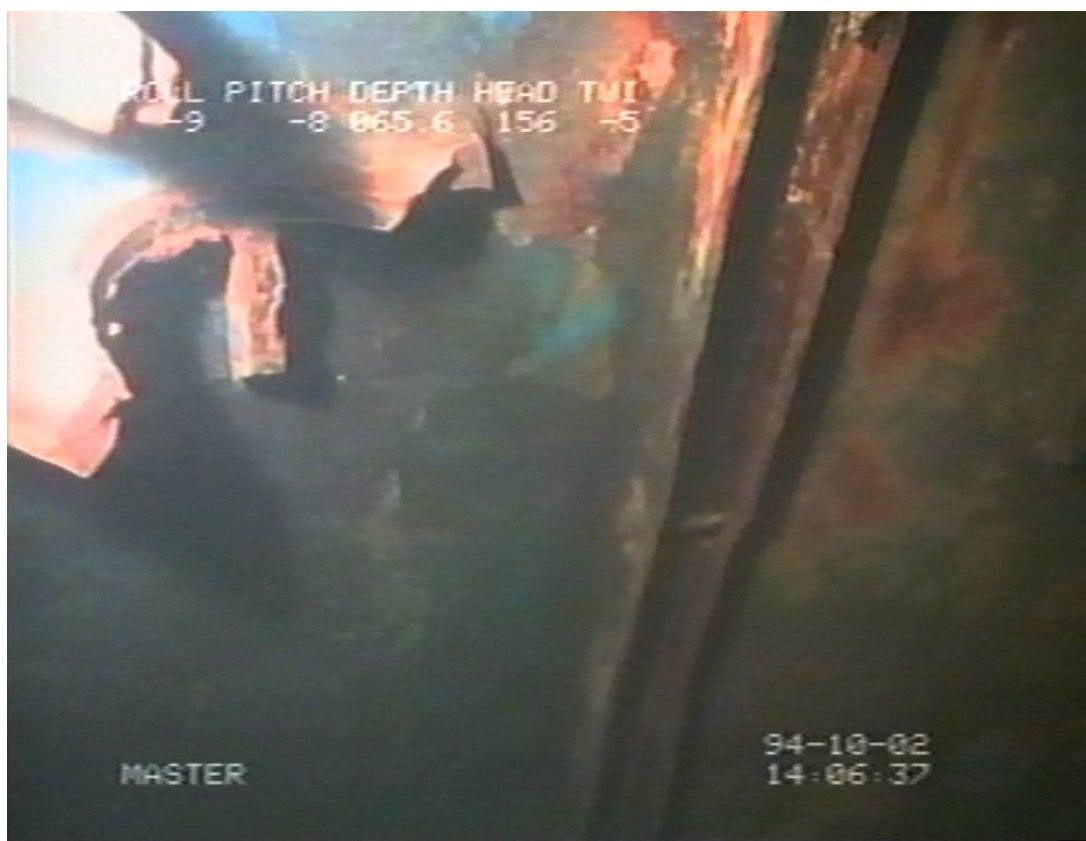
A crew member from MV ESTONIA's previous trade between Sweden and Finland has stated that there were problems from time to time with water ingress into the bow visor.⁵ Hence, it was important to keep the sealing in good condition. Still, it could happen that water came all the way to car deck. Consequently, it could happen that water, raising to the maneuver stand for operation of the ramp and visor, caused electrical short-circuit. According to this witness, the visor sealing was put in place by bolts (he had himself put the bolts in place) but has noted that parts of the sealing is now missing. His conclusion is that this cannot have happened during the accident since the bolts are still in place, as can be seen from footage.

The existence of bolts is confirmed by the manufacturer's manual. However, it cannot be definitely determined whether the bolts have been replaced without any sealing in place (which the witness claims) or if the sealing has been ripped of due to the accident though the bolts have been in place.

Fig. 1.6. The picture shows both a screw to keep the sealing in place as well as that the visor sealing is missing. The picture is from footage made in October 1994.

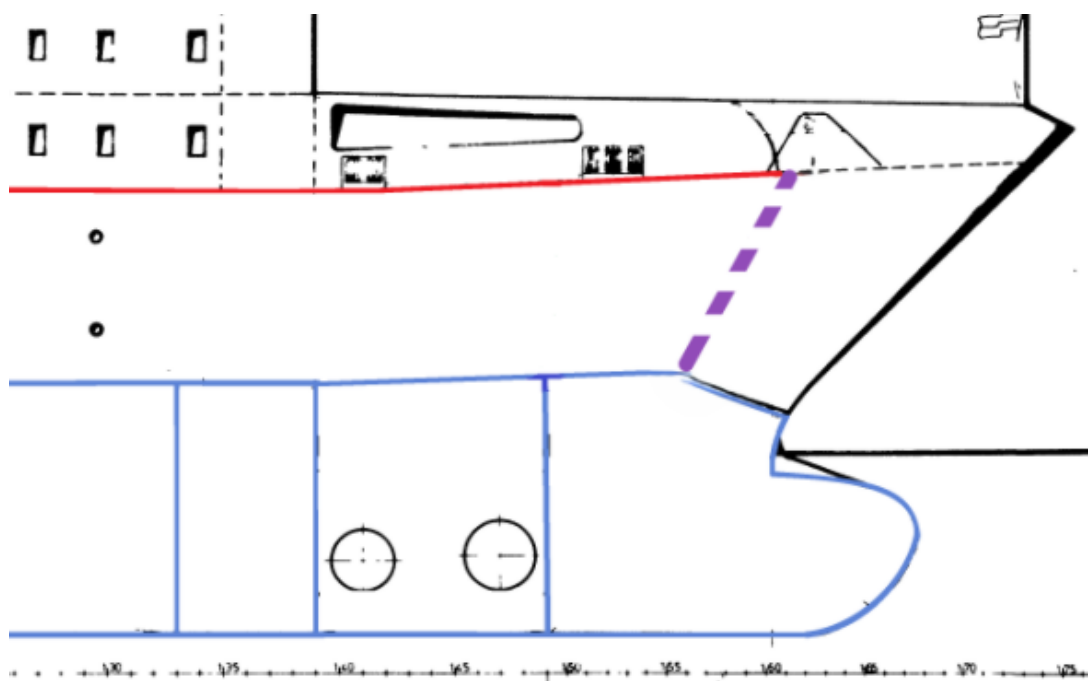
A consequence of these findings is that the vessel MV ESTONIA never had a fully weathertight front bulkhead with ability to resist water ingress (indicated in purple in Fig. 1.7). This is obviously not according to drawings or legislation at the time she was built.

Fig. 1.7 This is how MV ESTONIA actually was built and operated through her time in service since delivery. Blue indicate watertight hull and bulkheads, red weathertight hull. The purple front bulkhead was neither fully weathertight nor watertight.

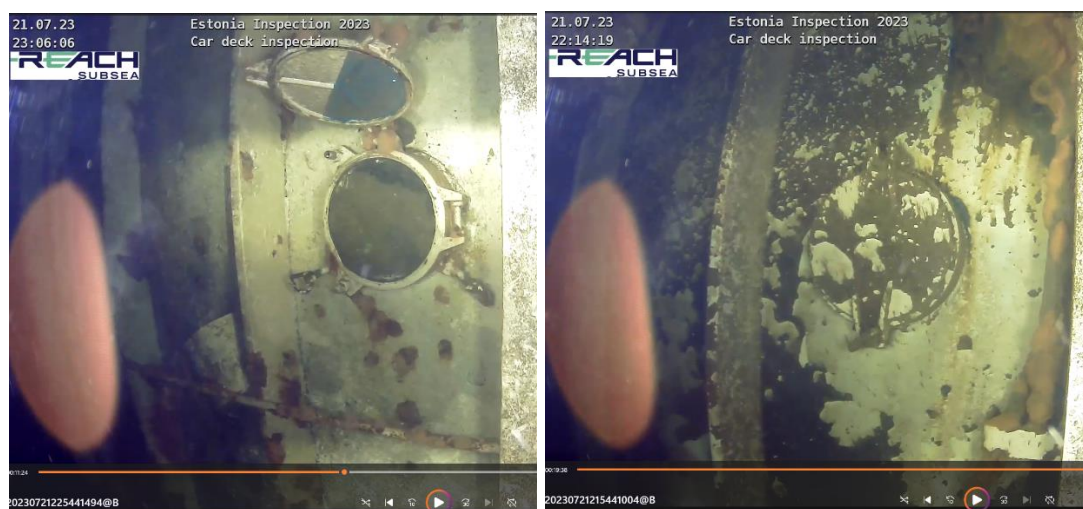
Fig. 2.1. Images from footage made in summer 2023. Left a porthole on deck 2 where the deadlight is not clamped, and right is a clamped deadlight, securing a porthole on deck 3.

Footage made in the summer of 2023 shows that some of these portholes are secured, and some not secured. This means that the crew obviously did not take any consequent action to secure the portholes by clamping the deadlights. This is, on the other hand, not considered to have had any impact on the cause or the outcome of the accident.

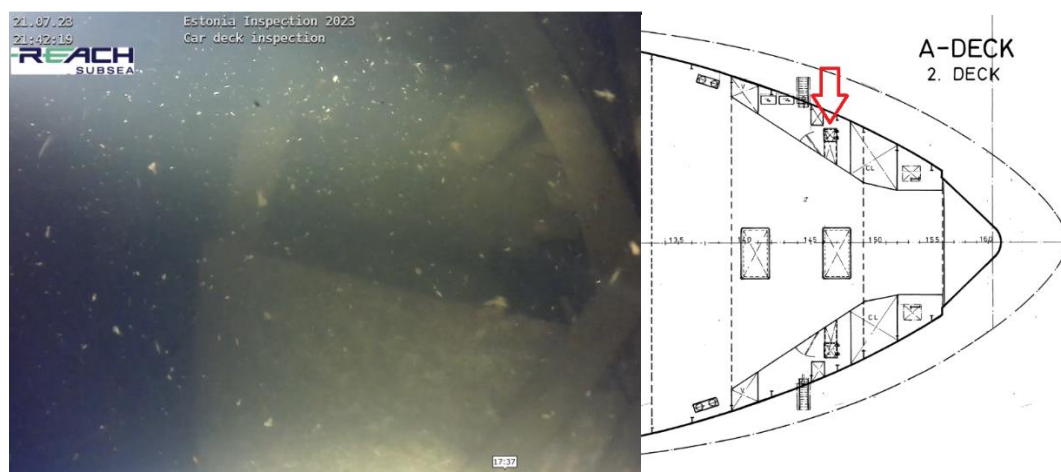
During the summer of 2023 footage from the car deck showed that the port side hatch to the bow-thruster room is open. It cannot be determined whether the hatch was open during the voyage, or if it was closed and later opened as a consequence of the vessel hitting the seabed. Nevertheless, it has to be concluded that the latches of the hatch were not secured enough to keep the hatch closed. This hatch was on port side (i.e., the upper, “dry” end of the vessel) and status of the starboard side hatch is not known. If the hatch was already open when the accident occurred, this may have contributed to the water ingress in the specific watertight compartment below.

Fig. 2.2. Picture on the left is from car deck footage, made in summer 2023 and shows the open hatch to bow-thruster room on port side. The ROV is at the time maneuvered up-side-down. The image to the right shows a drawing where the hatch is marked with a red arrow.

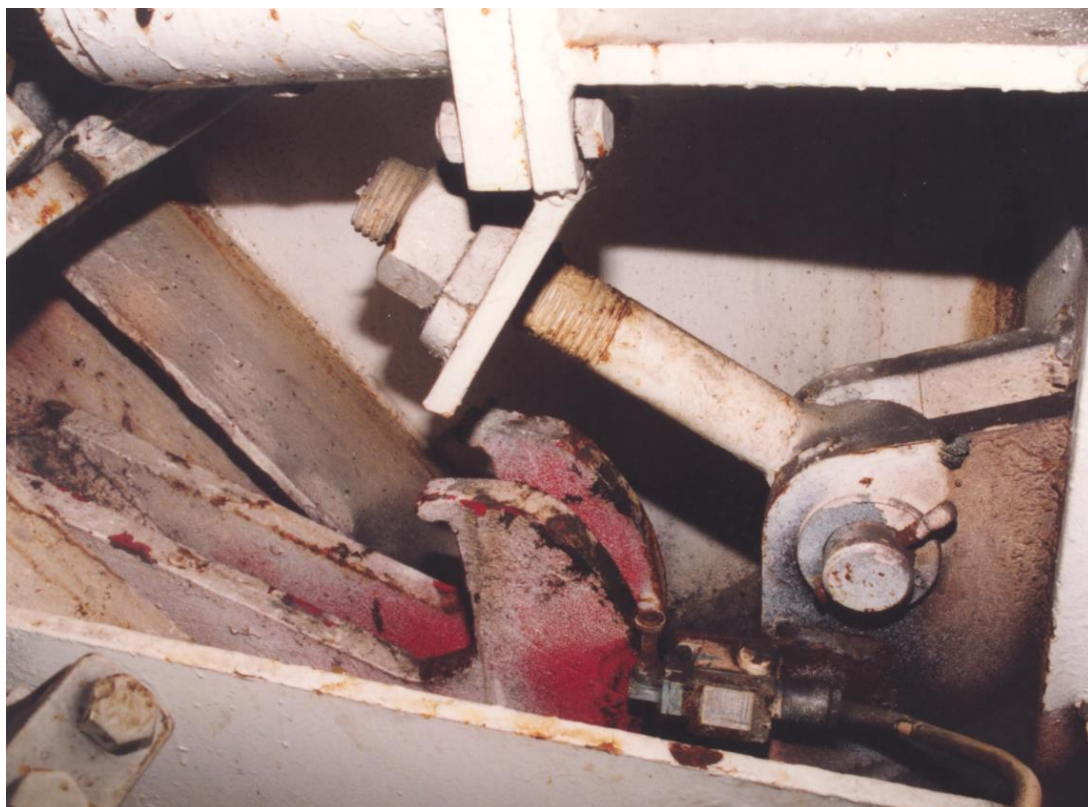
In addition to the three hydraulic lockings, there were two manual side lockings for the bow visor on MV ESTONIA. These were not included in daily routines, and there were no instructions for their use. Hence, they were not regarded as part of the operational locking system (JAIC 15.6). In the vessel’s manual they were described as spare.

It has via technical calculations been concluded that the force added, if these additional manual lockings had been activated, had not been enough to keep the visor in place during the weather conditions prevalent at the time and with the same speed.

Fig. 2.3. The image shows one of the visor manual lockings on MARE BALTICUM. The vessel had a similar construction as MV ESTONIA. The sensor seen on bottom of picture is not part of the manual locking. Image from Swedish National Archive (taken 7 November 1995 by JAIC).

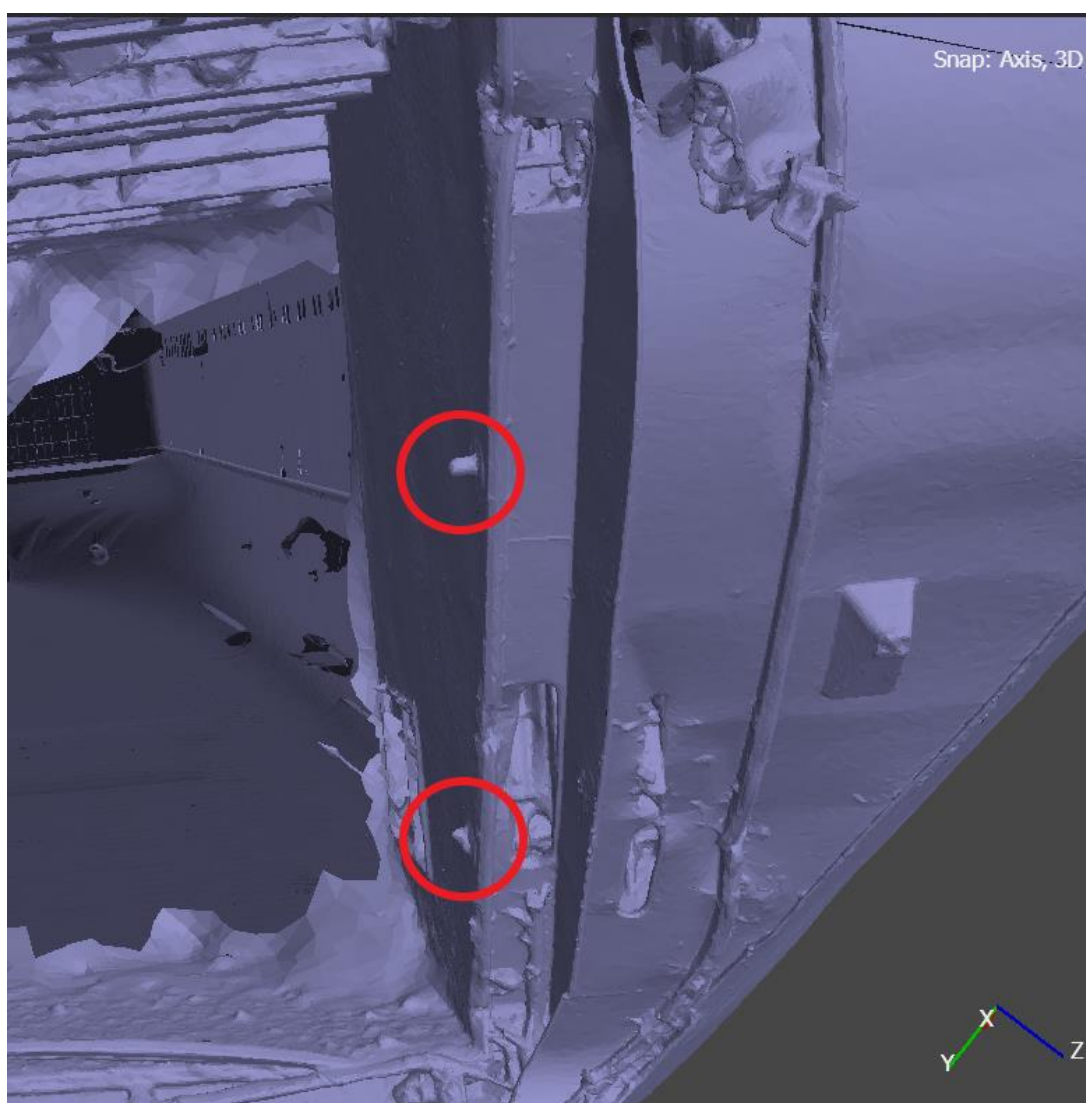
During the surveys in 2021-2022 at the wreck site, it was found that the lower ramp locking on port side of the hull was not in locked position (i.e., not fully extended). This confirms footage from 1994, and is mentioned in the JAIC report (JAIC 8.6.5, 15.8 and 13.4). The mating part on the ramp is still on the ramp, though partly twisted open, wearing less damage than the other three. This confirms that the lower bow ramp locking on port side was not fully, but partly, engaged when the ramp was forced open. All the four lockings were hydraulically operated.

If this locking had not been fully extended when the vessel left Tallinn, the indication would not have shown green light, and the vessel should not have departed. However, it cannot be ruled out that the locking has moved inwards during the ramp breaking-open process (JAIC 13.2.3).

Fig. 3.1. The picture is from photogrammetry in 2022 and shows the both bow-ramp lockings on port side, hull part. The lower is not in fully extended position. A diver estimated in 1994 the degree of extension to "1.5 inches" (some 3 cm) instead of the full length, about 15 cm. If this was the circumstance when leaving Tallinn, a green light would not have shown on the indication panel at departure.

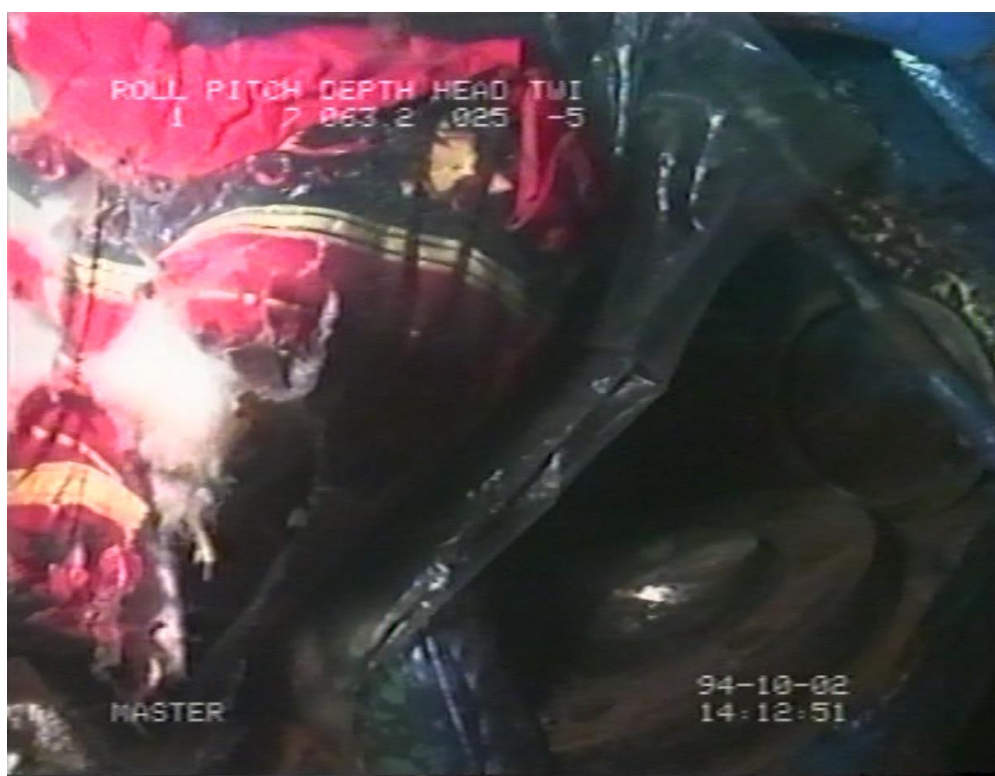
Fig. 3.2. Footage from ROV-film made in 1994, showing the outer port side bow ramp hinge, and a subject made of fabrics (possibly a jacket).

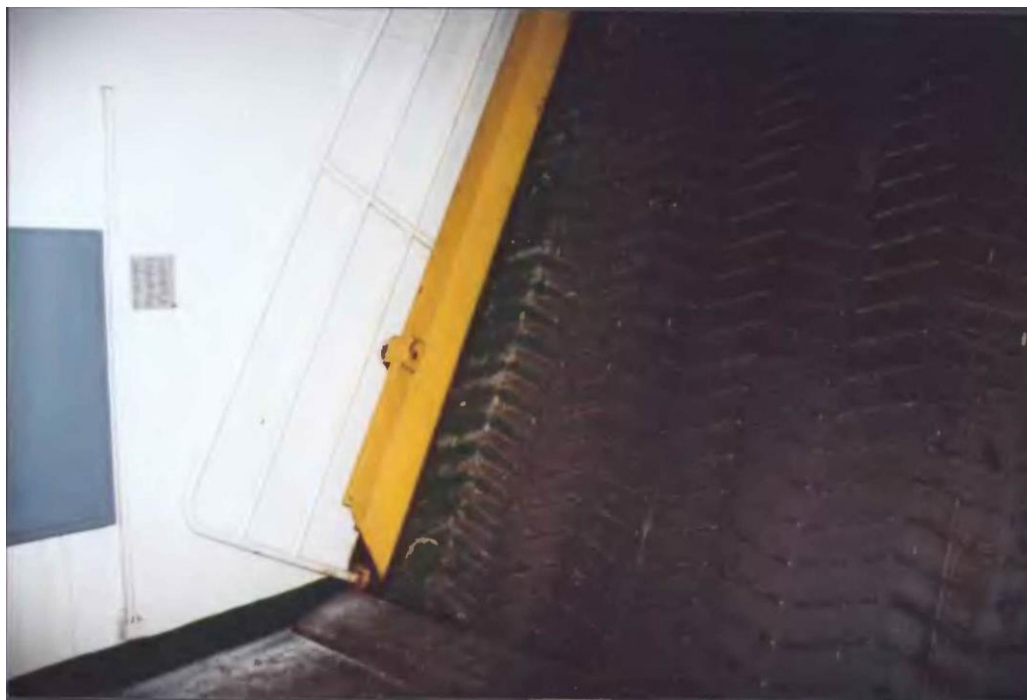
However, except from the obvious inefficiency in using such a method, there is restricted access to the zone in question to manually put things there. The lower side parts are very difficult to reach due to a built-up edge on both sides of the ramp (Fig. 3.3 and 3.6). The ramp railings on top of the built-up edge efficiently obstruct access to the sealing area. Hence, it would be dangerous to act in this area while the ramp is closing.

Fig. 3.3. As can be seen from this picture, there is a built-up edge at the side of the ramp, coming close to the bulkhead. Above the edge, the ramp railing hinders access to the area between edge and hull. At the bottom of the ramp, a flap can be seen. The flaps may be folded up to reach the area below for maintenance. The picture is from the vessel MARE BALTICUM, which was constructed in the same way as MV ESTONIA.

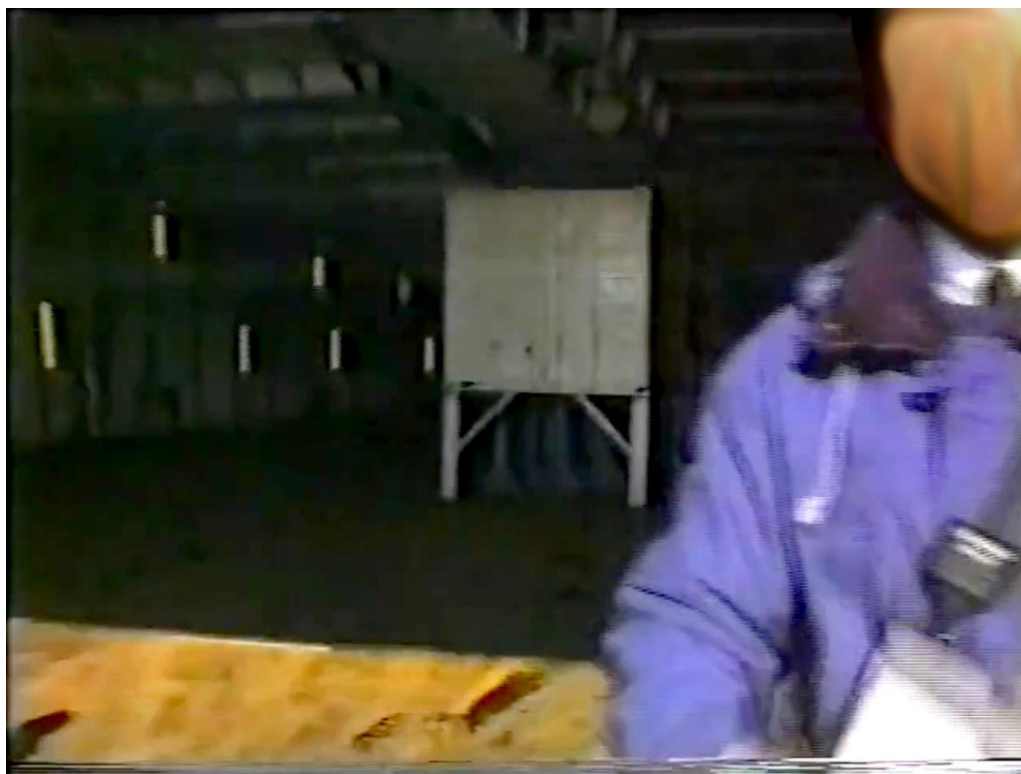
The existence of fabric material in the area may instead be explained by the existence of the vessel's dirty-linen container close by, as well as content of cars and trucks being moved around during the accident. All floating objects would gather in the uppermost part of the hold, which would be the port lower corner of the ramp, considering the position of the vessel when sunk.

Fig. 3.4. Linen container on MV ESTONIA, seen from close to the bow ramp, looking aft. Dirty linen were thrown from upper decks into the container through a shaft. Image: www.estline.ee © Evi Järvelaid.

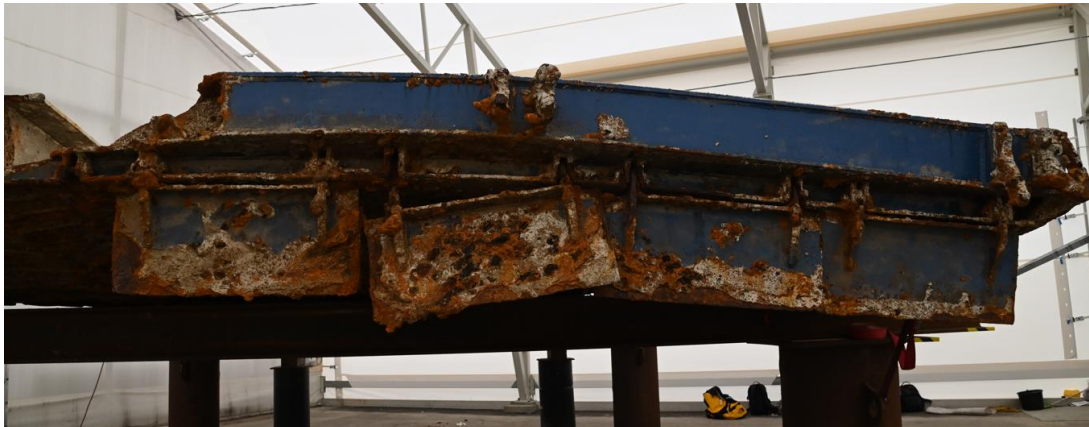
Fig. 3.5. The car deck bow ramp, port side to the right (the ramp is up-side-down on the picture). Four flaps are still connected to the ramp, hanging in their hinges. The picture is cropped.

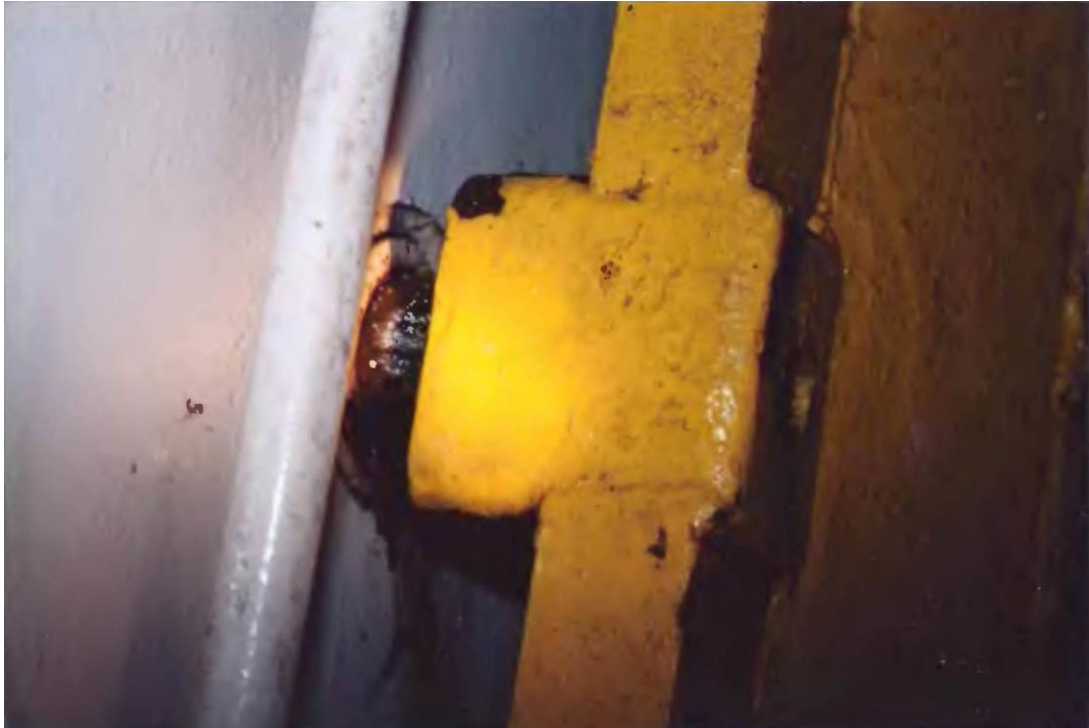
Fig. 3.6. The picture shows bow ramp lower locking, seen from car deck. The locking itself is inside the wing house (on the other side of the white painted hull). When locked, the locking pin is hydraulically pushed (to the right in the picture) into the yellow housing and to unlock, the locking pin is to be hydraulically pulled out (to the left). This shows that it is not possible to hit the locking from car deck. However, it would be possible to hit the yellow housing into which the locking pin is to be pushed or pulled, having the vibrations to facilitate the movement of the locking pin. The picture is from the vessel MARE BALTICUM. Compare to Fig. 3.3 above.

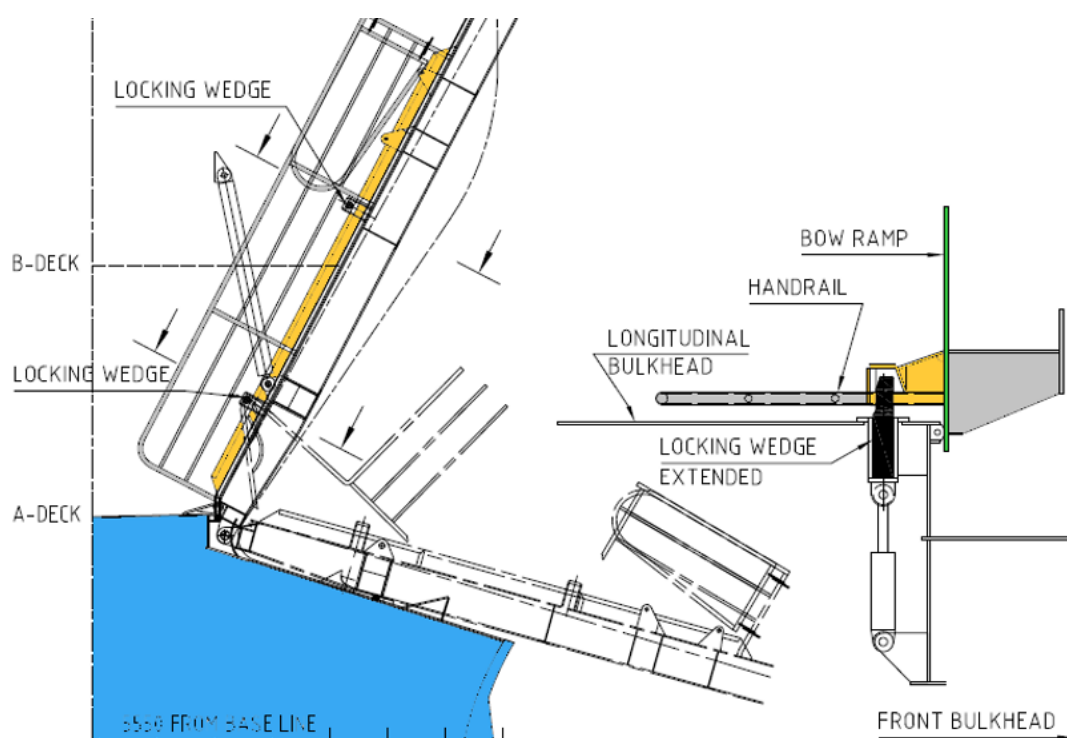
All bow ramp railings have come off the ramp, and have been found on different sites around the vessel. One of these has been salvaged. Examination of the attachment points of the ramp and the broken end of the brought-up piece of railing confirm that no machine tool or cutting has been used for them to separate.¹² Instead, it is assessed that they have separated as a consequence of the accident, being caught by the ramp locking pins, being in extended position, and torn loose (see Fig. 3.1 and 3.7).

Fig. 3.7. The image shows how the handrails may have come off. Left is seen from starboard side, and right is seen from above. Image: Jan-Ove Carlsson, CAD 17 Handrail Detachment (coloring by SHK).

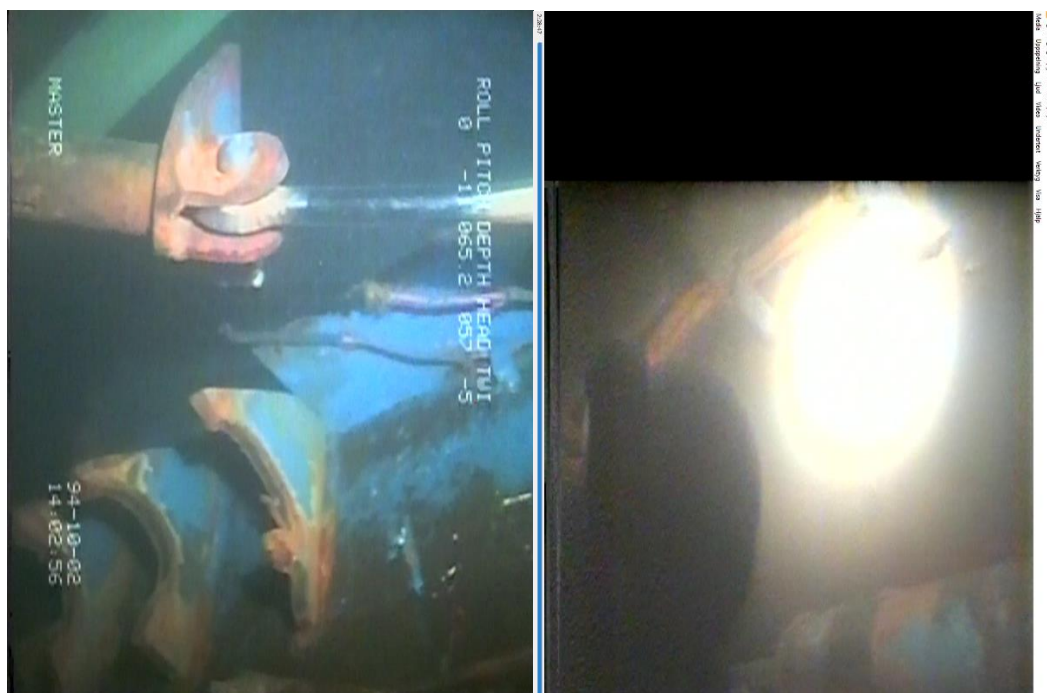
During the diving operations in 1994, the magnetic sensors for the bottom locking could not be found. However, the empty ends of the sensor cables were found nearby. Since the sensor mounting bracket was undamaged, it appears like the

sensors had been removed before the accident. This is denied by the company. It cannot be ruled out that the sensors were ripped off during the accident (JAIC 13.2.3). During the diving operations in 1994, loose end cables, which are supposed to be the two bow visor sensor cables, are cut by a diver. The exact reason for this is not known.

Fig 3.8. Images from footage made in December 1994. Left shows two loose end cables very close to remains of the bottom locking on the hull. Right shows the hand of a diver cutting cables in the same area. Videos 6555 and 6571 respectively.

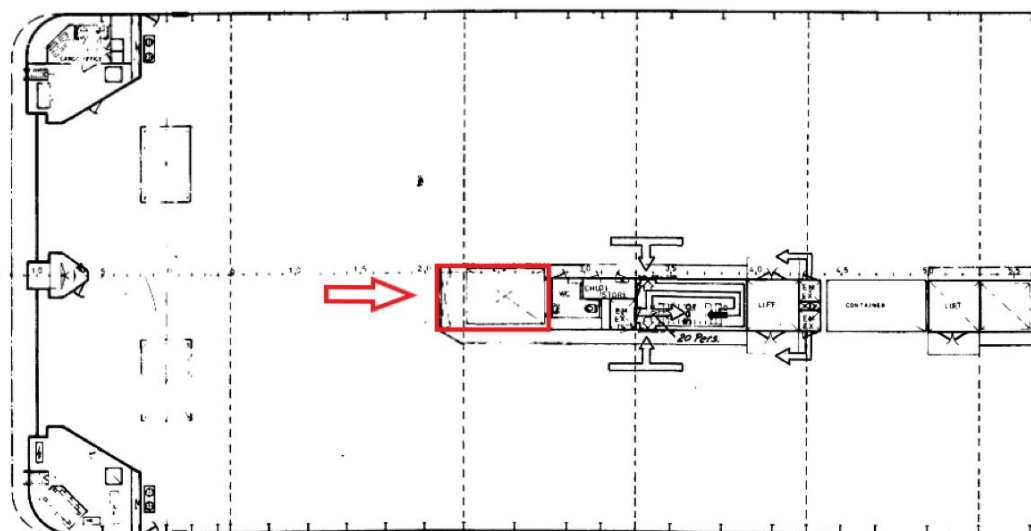
One witness, being a crew member on the vessel for previous owner, has stated that this provision hatch was complicated to close and that it could happen that the hatch was not closed all the time when it should be. On the other hand, the witness has no knowledge about how this hatch was handled by the new management.

There is no available information to confirm the status of the provision hatch. If it was left open, or went open during the sinking process, this would have accelerated the process, and the opposite: was it closed and properly secured, it

Fig. 3.9. Provision hatch on aft part of car deck, showed in red.

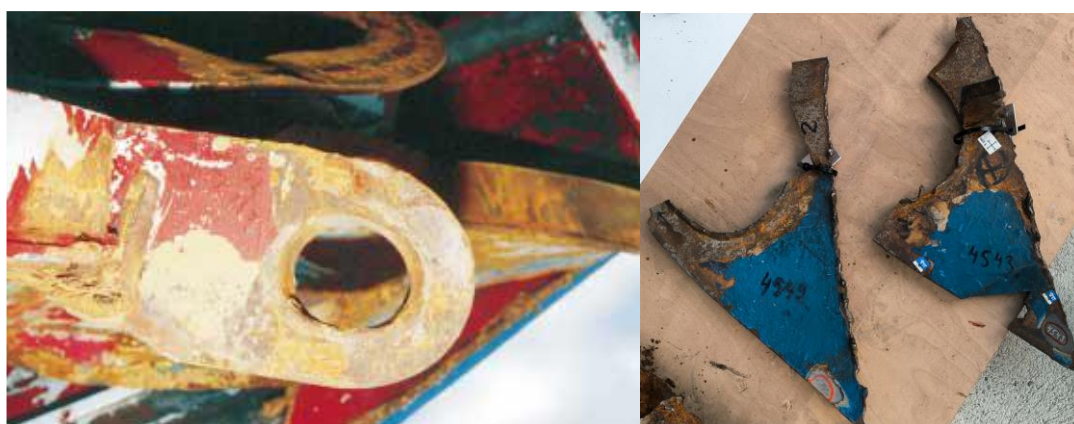
The bow visor was salvaged on 18 November 1994. On this were still parts of the bottom locking, i.e., the bottom locking lug. This was damaged, but not failed. (Fig. 3.10).

Fig. 3.10 and Fig. 3.11. Fig. 3.10 (left) shows the bottom locking lug on the visor. Fig. 3.11 (right) shows the failed bottom lock lugs from the hull, as found in February 2025. Image left: JAIC 8.10.

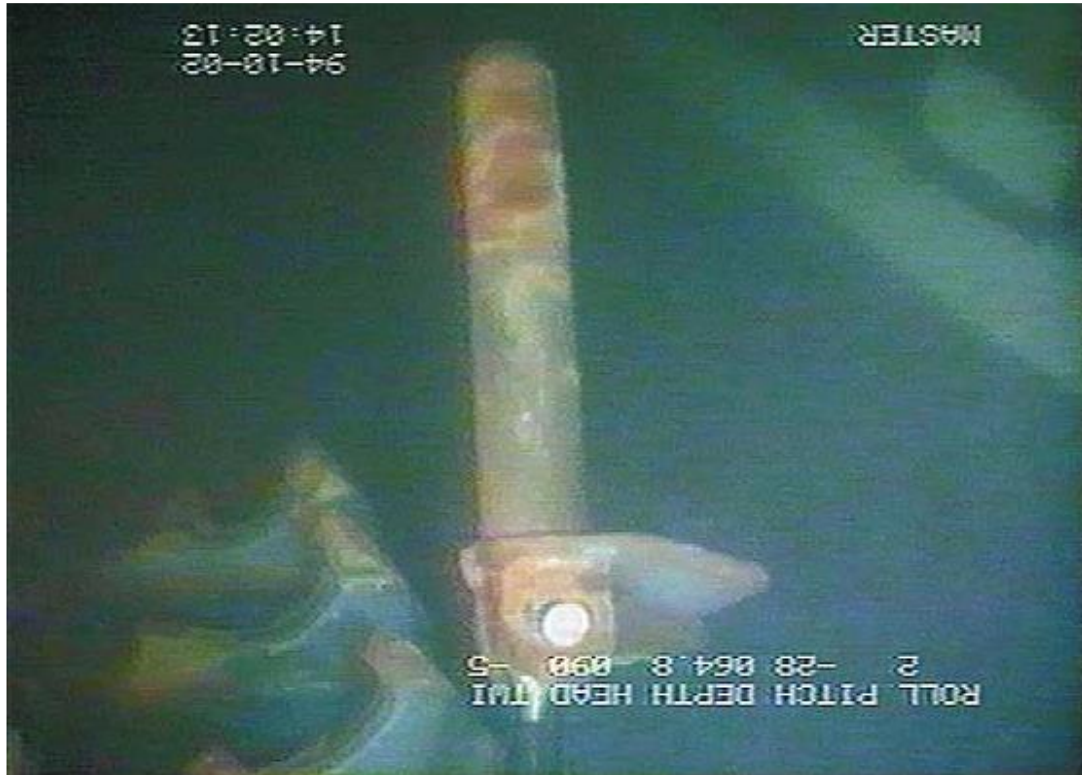
Fig. 3.12. The bottom locking bolt as found in footage from 1994. Bottom left, the failed matching lugs, mounted on the vessel's hull, can be seen. Image: JAIC Fig. 8.15.

The examination of the arrangement showed that the locking bolt was fully extended, i.e., in an engaged position. The piston rod was bent upwards, and the hydraulic hoses were still connected. The examination of the bolt showed that the bolt was straight with a diameter of about 78 mm. Only a slight variation was measured at the contact area between the bolt and the visor lug. No other damage to the bolt was noted. (JAIC 8.6.1). The failure of the bottom locking lugs, mounted on the vessel's hull, indicates that the part of the bottom locking that failed was the lugs, mounted on the vessel's hull.

The fact that the locking bolt was not preserved was unfortunate, but more of transparency reasons than technical. The bolt itself had not failed nor contributed to the accident. The failing parts were instead the bottom locking lugs, mounted on the vessel's hull, which were salvaged and thoroughly examined.
