Serious Incident involving an aircraft of type Embraer-550 Praetor 600

The Swedish Accident Investigation Authority has investigated a serious incident at Stockholm/Bromma Airport, Stockholm County, on September 11, 2024.

11 December 2025

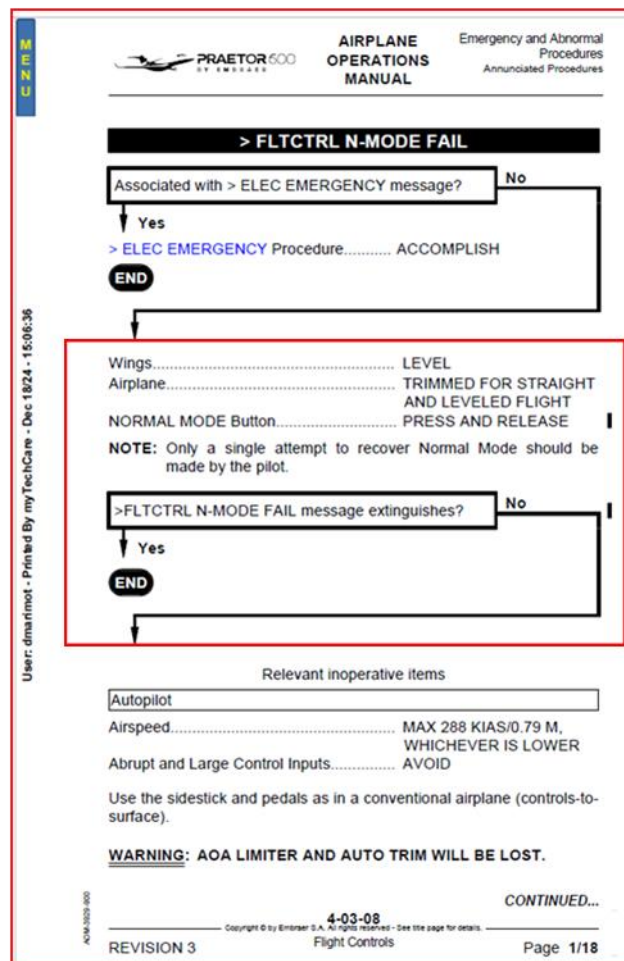
Figure 8. Emergency checklist for FLTCTRL N-MODE FAIL. The pilot's system action is marked inside the red frame, added by SHK. Note that the use of manual pitch trim is not included in the checklist. Source: Embraer AOM.

One step in the pilot's emergency procedure is to press the FCS NORMAL MODE button. However, there was no mention of manual trimming. This was clarified in Transport Malta (TM) bulletin SIAN 01/24 and Embraer operational bulletin 550-002/24, which were published after the earlier Le Bourget incident.

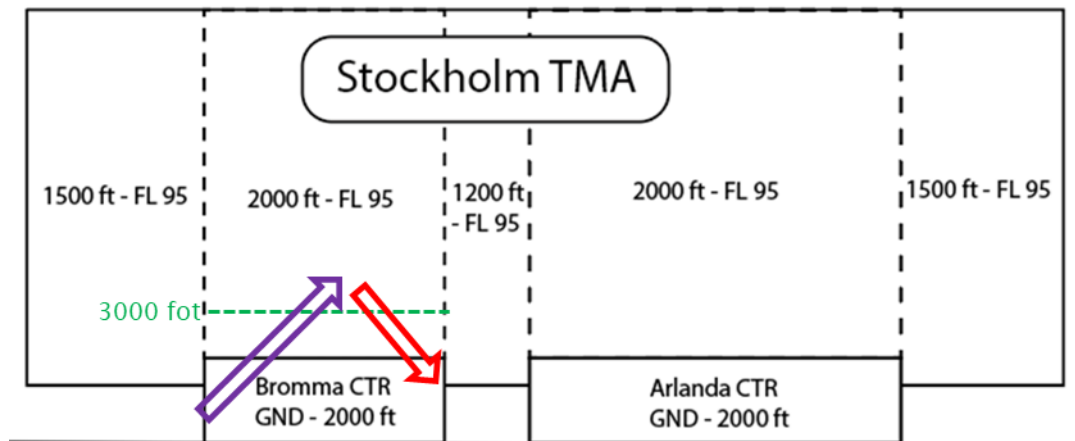
Figure 9. A side view of the airspace above Bromma Airport. The green line indicates the cleared altitude of 3,000 feet. The arrows illustrate the aircraft's approximate flight path within the airspace. The purple arrow shows the aircraft's climb beyond the cleared altitude. The red arrow represents the descent back to below the cleared altitude and the approach to Bromma. Source: Luftfartsverket (provider of Air Traffic Management and Air Navigation Services in Sweden) with graphics added by SHK.

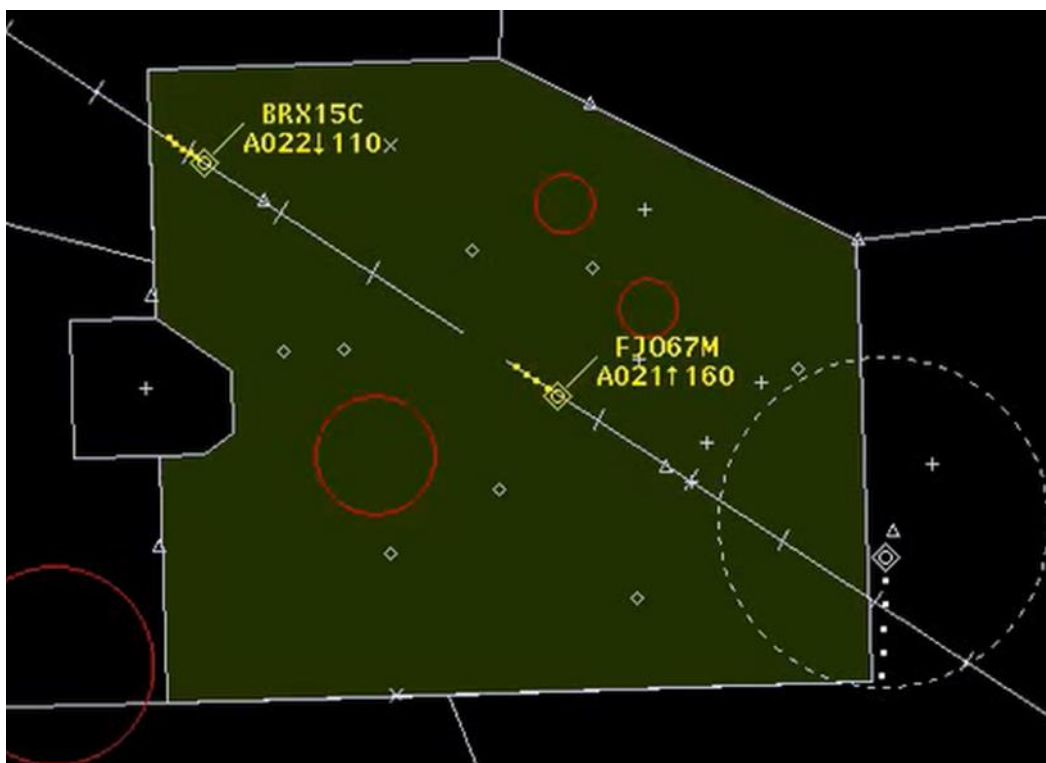
Figure 10. Radar image at 17:03 shows the moment the crew declared Mayday. The aircraft ID, FJ067M, indicates 2,100 feet climbing and an indicated airspeed of 160 knots. The runway is located at the break in the diagonal white line. Source: Swedish Civil Aviation Authority.

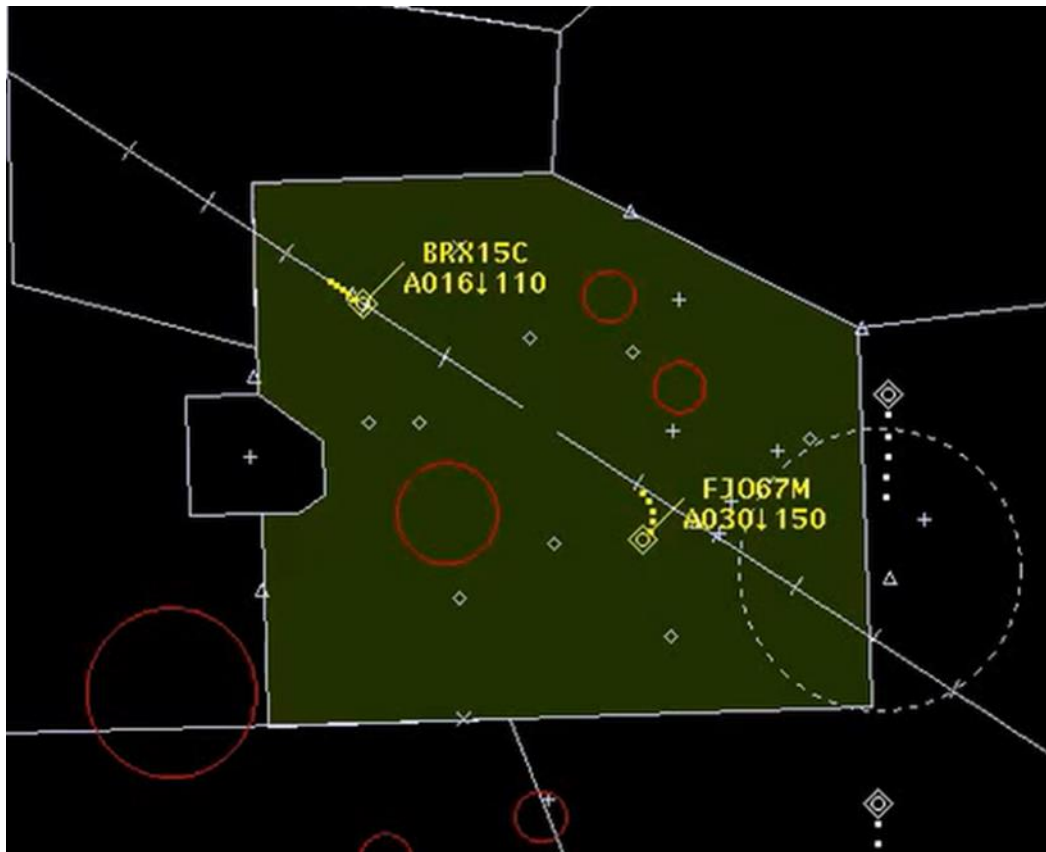
Figure 11. Radar image at 17:04 shows the aircraft descending again below 3,000 feet and turning to a southerly heading with an indicated airspeed of 150 knots. Source: Swedish Civil Aviation Authority.

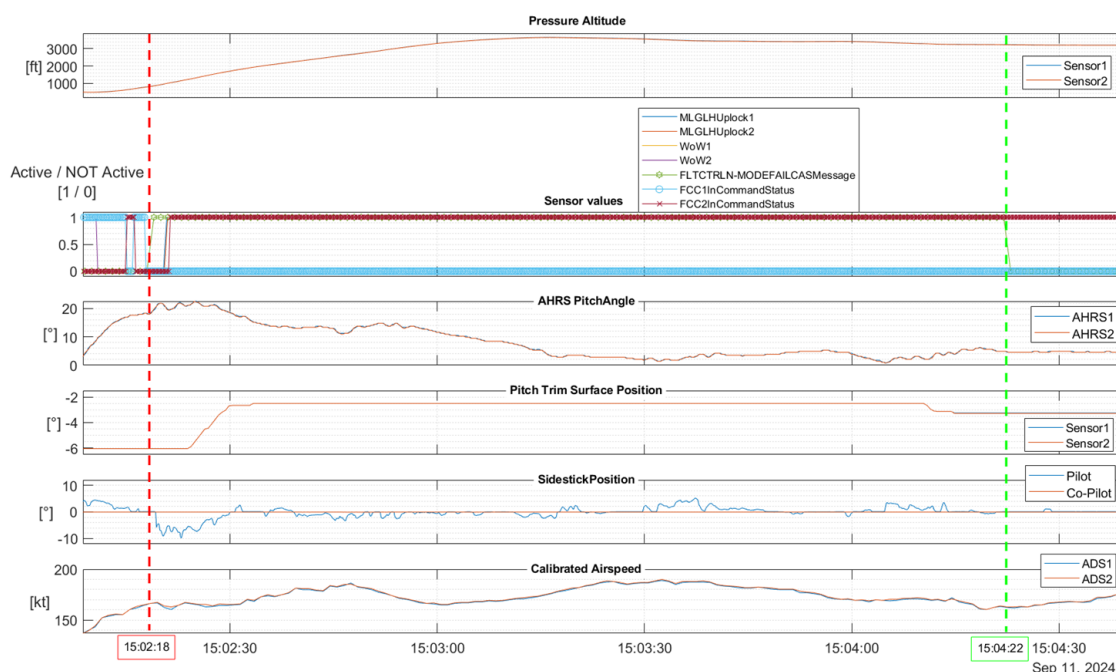
Figure 12. Some important parameters that were recorded on the aircraft's memory unit. The X-axis shows the time in UTC. Top-down graphs: barometric altitude, logical sensor values including FCC control status and landing gear position, aircraft tilt angle, stabiliser trim angle, tilt position and calibrated airspeed (CAS). The error occurred at 15:02:18 and was reset at 15:04:22, which in the figure is marked with a red and green dashed vertical line.

The recordings presented in Figures 12 and 13 show that approximately five seconds after lift-off, FCC control of the flight control system switched from FCC1 to FCC2 and then back to FCC1, after which both flight control computers failed, and the FLTCTRL N-MODE FAIL warning was presented to the pilots. The aircraft's Flight Control System was now in Direct Mode.

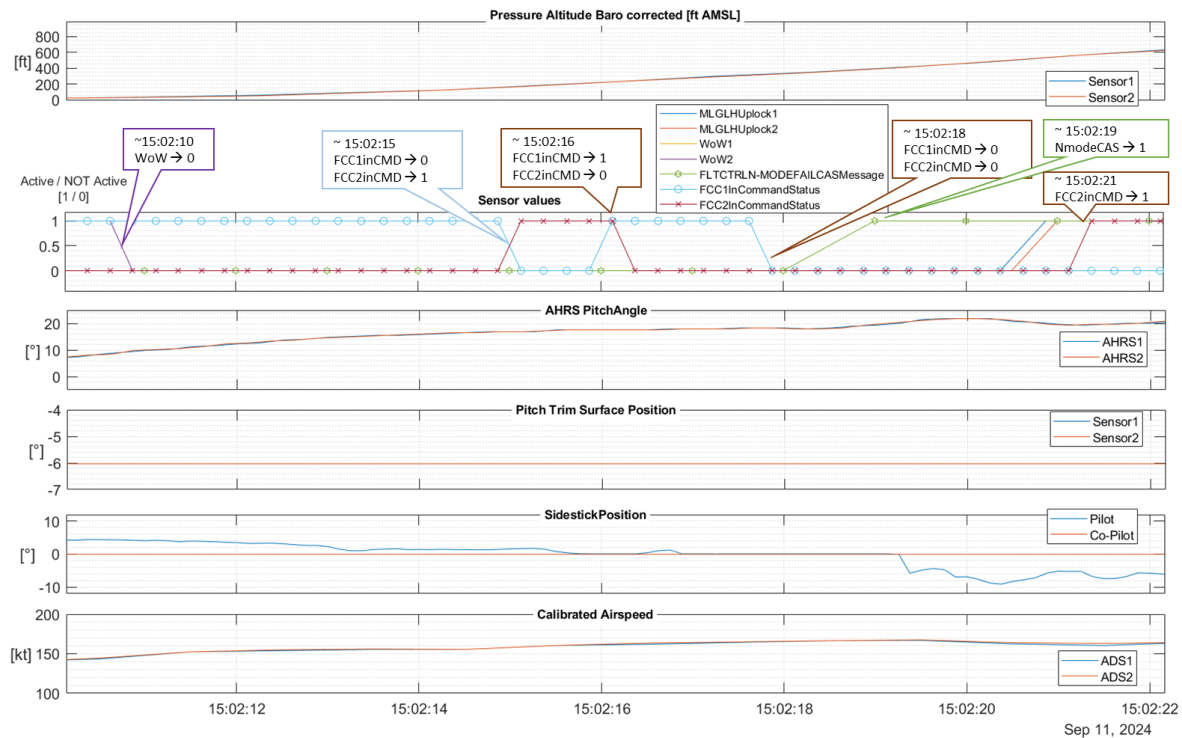
Figure 13. Zoomed-in view of FDR data. Top-down graphs: barometric altitude, logical sensor values including FCC control status and landing gear position, aircraft pitch angle, stabiliser angle, stick position and calibrated airspeed (CAS). In the second graph from above (sensor values), the times of important events are shown, from the left: WoW → 0, first time FCC1 → 0, etc.

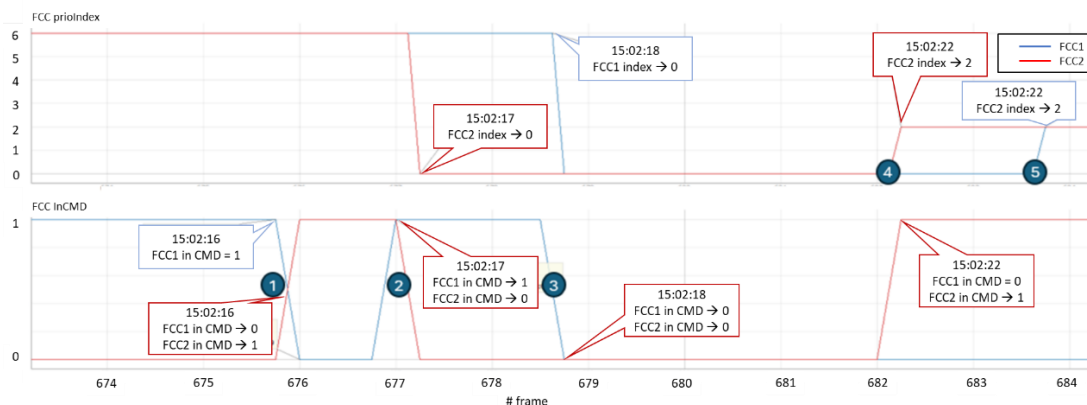
- 1) The difference between FCC1's COM and Mon lanes exceeds the threshold value, and data on the TTP bus becomes stale → FCC2 takes over.
- 2) The difference between FCC2's COM and Mon lanes exceeds the threshold value, and the CIM issues a priority index of 0, while data on the TTP bus becomes valid (non-stale), making FCC1 available, and FCC2 is disconnected. A reboot of FCC2 is initiated.
- 3) The CIM in FCC1 triggers a restart of FCC1, rendering both FCC1 and FCC2 unavailable.

- 4) FCC2 completes its reboot and becomes available (*DM* only).
- 5) FCC1 completes its reboot (*DM* only).

Figure 14. QAR data from Embraer, upper graph priority index for FCC1 & FCC2, lower graph status index for FCC in command, 1 = in command, 0 = not in command.

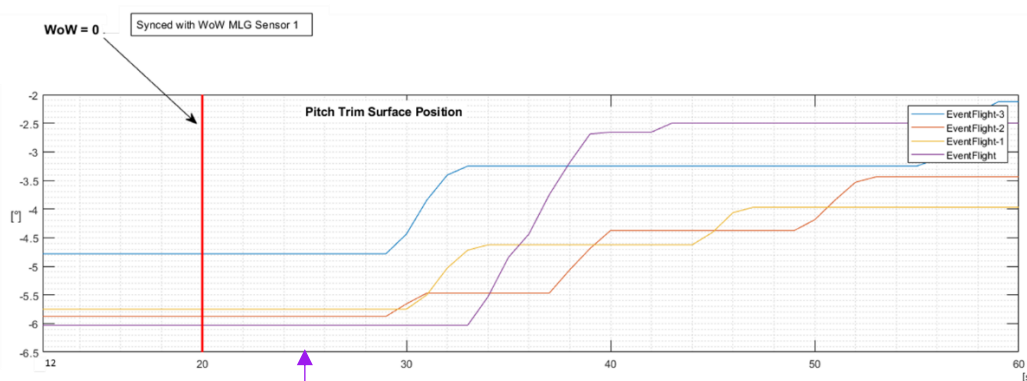
The three previous flights and their take-offs proceeded normally, and no faults or deviations were found in the recorded data. Figure 5 presents a graph showing the stabiliser's trim angle. The times have been synchronised to the moment the aircraft lifted off (WOW → 0). In the figure, it can be observed that during the three previous flights, the stabiliser trim angle began adjusting approximately 8–9 seconds after the aircraft lifted off, whereas for the incident flight, it took approximately 13 seconds.

In the first three cases, the autotrim system sent commands to adjust the stabiliser angle, while during the incident flight, the adjustment occurred because the manual trim button was pressed.

Figure 15. The trim angle of the stabiliser as a function of time. Take-off progress during the incident flight (purple line) compared to three previous take-offs on the same day with the same flight individual (yellow, orange and blue lines). The red line indicates the time when the aircraft takes off from the runway. The purple arrow indicates the approximate time when both control computers were disconnected.
