**Bundesstelle für Seeunfalluntersuchung**  
Federal Bureau of Maritime Casualty Investigation

## **Occupational Accident Involving Chemicals on Board the LNG Tanker CORALIUS in the Port of Travemünde on 5 August 2024**

Investigation Report 385/24

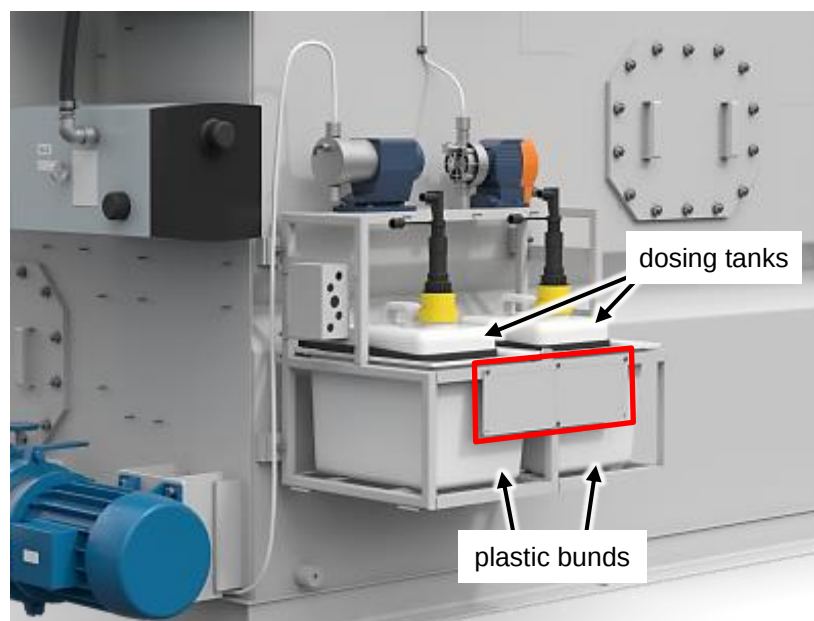
Figure 3: Dosing tanks for  $\text{NaHSO}_3$  (left) and NaOCl (right)<sup>6</sup>

On board CORALIUS, the righthand plastic bund in which the NaOCl dosing tank is located was black instead of white, as shown in the model above. Additionally, signs were mounted on the blank plate (indicated in red above), as shown in Figure 11. (cf. 3.2.3.1.1)

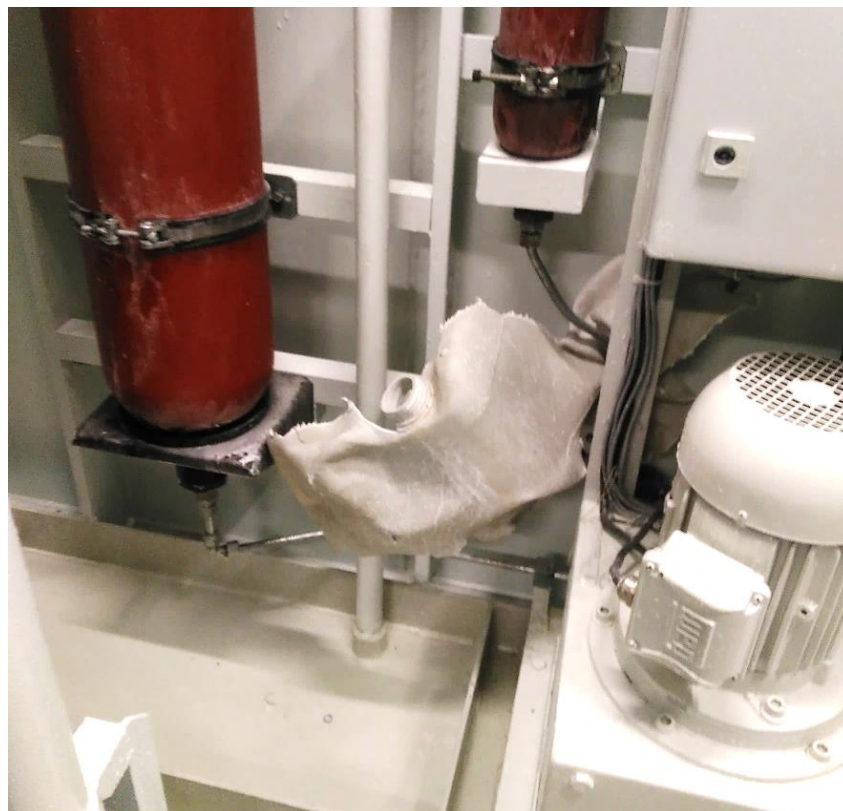
The bursting of the NaOCl dosing tank occurred due to an attention-based unsafe action (slip) that went unnoticed until both chemicals mixed in the NaOCl dosing tank and reacted violently. This led to its bursting, as it was made of plastic. The safety investigation focussed on the underlying conditions that (may have) contributed to this accident. Several aspects, including personal and organisational factors, task features, and ergonomic conditions, were identified as contributory to the accident.

Back at the STP, the Motorman removed the ten-litre dosing tank to be refilled from its holder, which is mounted on the plant. Initially, when he filled the chemical from the transfer container into the dosing tank, nothing unusual happened. However, just as he was putting the dosing tank back into its holder, the tank burst with a loud bang. A violent reaction had occurred and the Motorman was injured in multiple locations on the right side of his body from being sprayed with the mixture of chemicals as well as from the impact of the bursting container. The chemicals soaked his coverall and part of the spray reached beneath his face shield and came into contact with both of his eyes. Additionally, he suffered second-degree chemical burns to approximately 5% of his body.

Figure 4: Burst dosing tank as found after the accident<sup>7</sup>

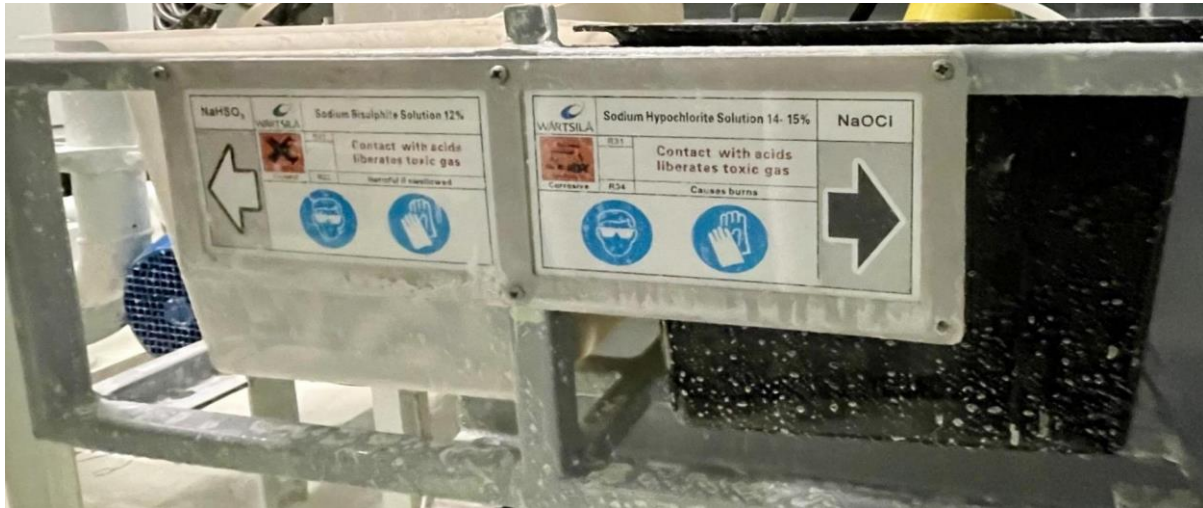
Figure 11: Signs at dosing tanks on CORALIUS<sup>26</sup>

At the time of the accident, the signs depicted in Figure 11 were the only written indication of which chemical is designated for which dosing tank. There were no additional signs or labels. However, the plastic bunds underneath the dosing tanks as well as the arrows shown on the signs were colour-coded in black (NaOCl) and white (NaHSO<sub>3</sub>). The colour code originally also included the containers in which the OEM (original equipment manufacturer) chemicals were supplied. On board CORALIUS, the OEM container for NaOCl was dark grey and the container for NaHSO<sub>3</sub> from a different supplier was green. Therefore, the colour-coding on board CORALIUS did not include any items or signs beyond the plastic bunds and arrows.

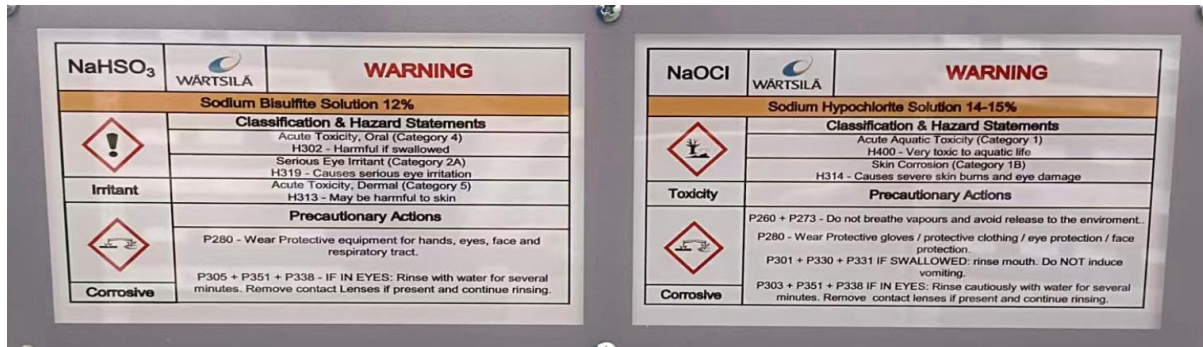
- increased PPE-requirements: protective gloves, protective clothing, eye protection, face protection; (This was changed due to new requirements by the chemical manufacturer in the respective MSDSs around 2015.)
- the warning “**Contact with acids liberates toxic gas**” was removed.

Figure 12: Updated signs at STP dosing tanks<sup>29</sup>

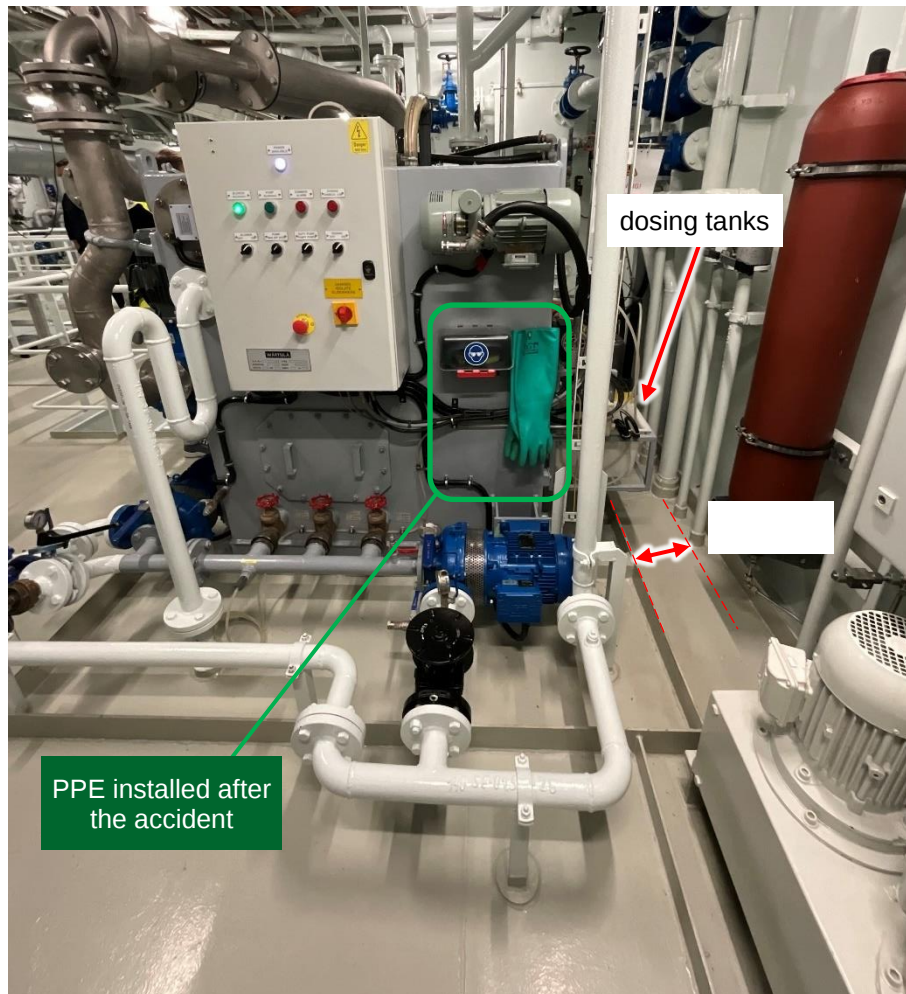
Figure 13: STP on board CORALIUS<sup>32</sup>

In the above picture, the restricted access to the dosing tanks' holder due to pipes, other machinery and dip trays welded to the floor is clearly visible.

- Plant installed close to a wall and piping, not according to the manufacturer's recommendation → The dosing tanks were difficult to access and therefore had to be moved to a different location for refilling. On the one hand, the insufficient space made it more difficult to exchange the chemical containers and therefore less safe, as it was more likely for someone to bump into something and suffer bruises or abrasions. On the other, the installation made it more difficult to see the (warning) signs at the dosing tanks' holder, low above the floor;

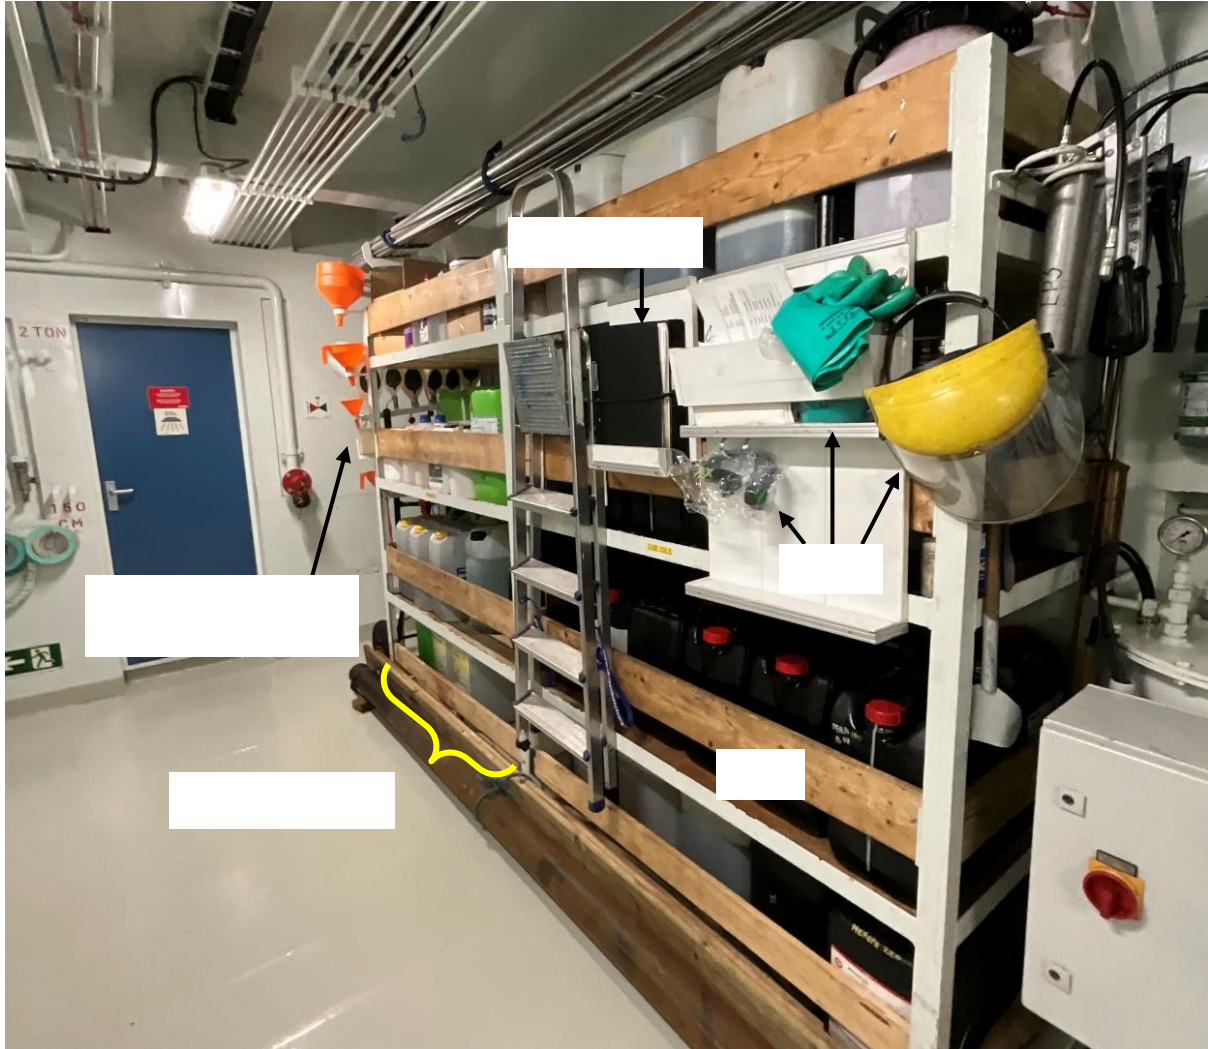
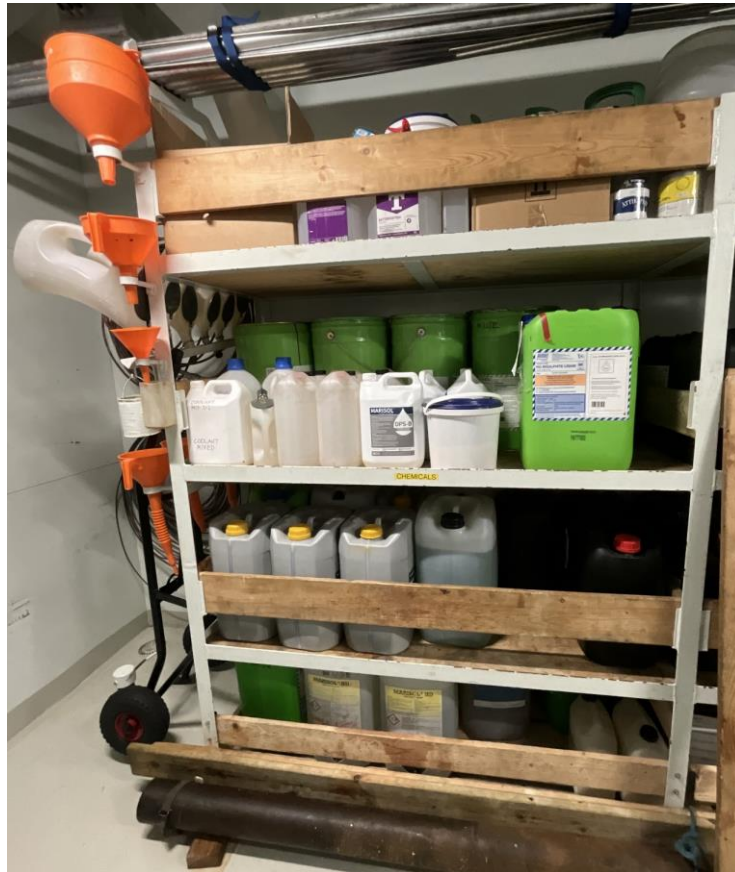
Figure 14: Chemical and lubricant store on board CORALIUS<sup>41</sup>

Figure 15: Chemical shelves inside the chemical and lubricant store<sup>42</sup>

As can be seen in the pictures above, the chemicals were not separated or marked by their properties (e. g. pH-value) on the shelves. A folder with all MSDSs was available as well as different kinds of PPE, such as rubber gloves, goggles and a face shield/visor. On the left side of the shelves, different funnels and transfer containers were mounted, some marked for specific uses.

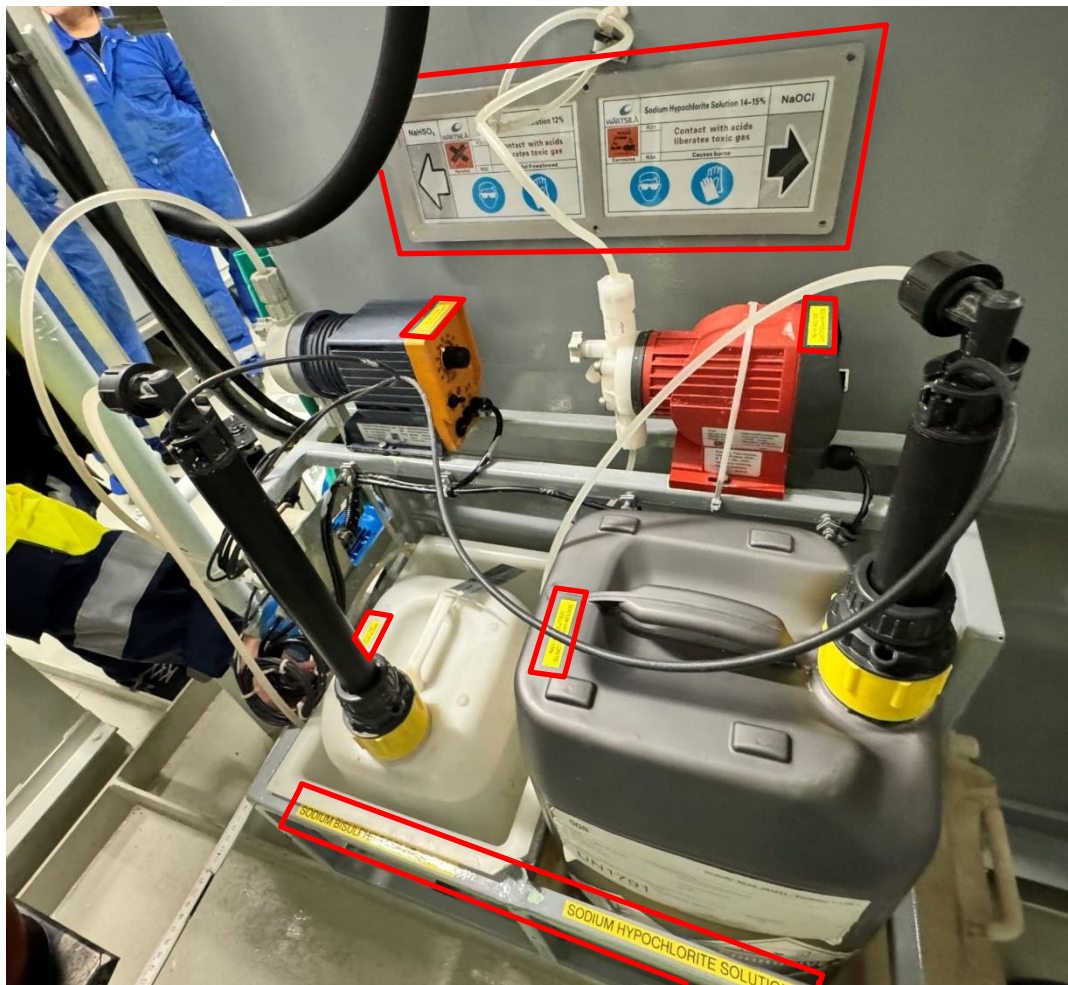
Figure 18: Highlighted changes of signs and labels<sup>59</sup>

Shortly after the accident, the names of the substances and the risk phrases posted at each tank were moved up to be visible in the normal line of sight. The dosing tanks, the connections, the dosing pumps as well as the holder of the plastic bunds were marked with the name of each required chemical to clearly identify the related system components. These labels were initially all yellow with black writing.

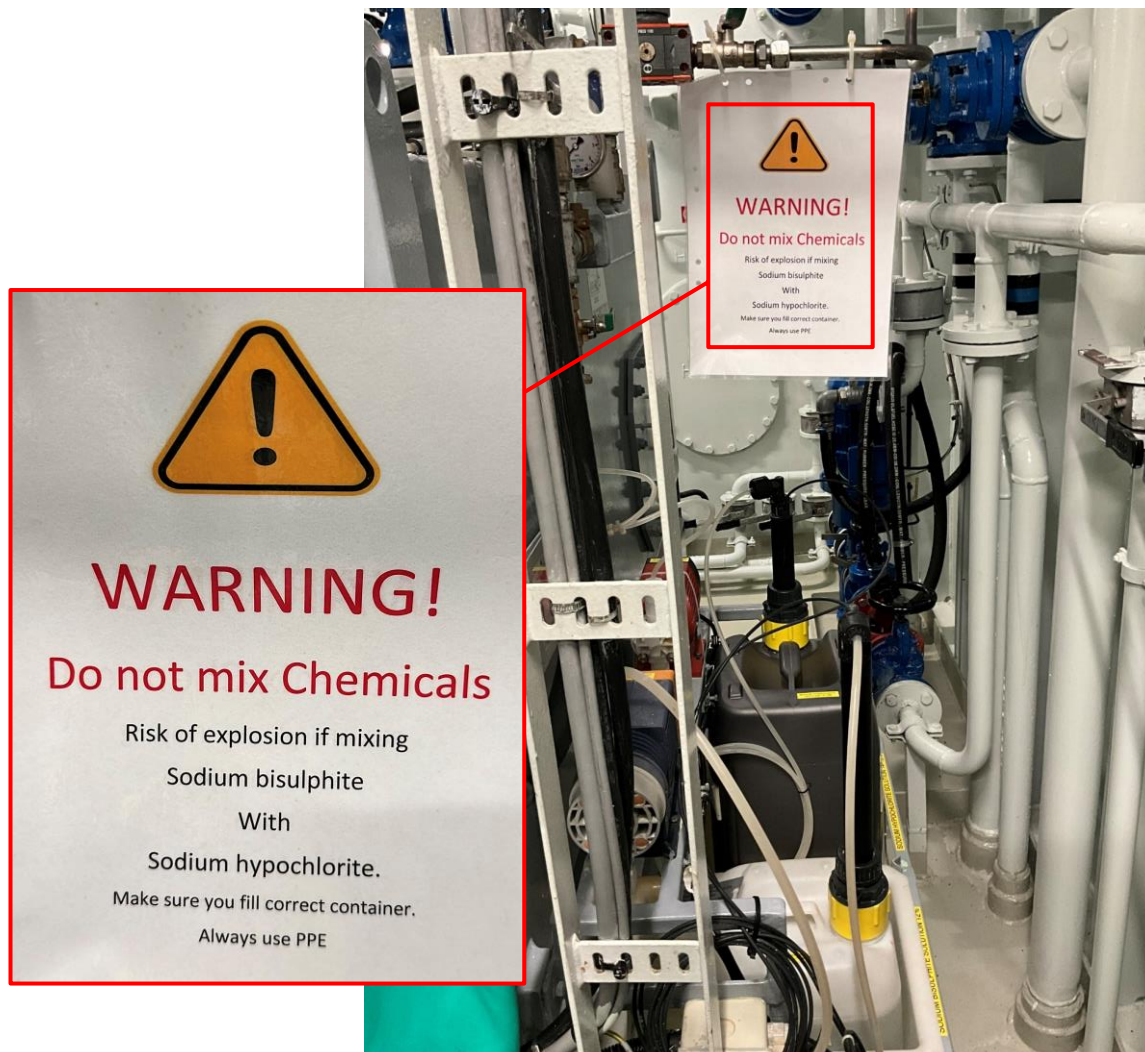
Figure 19: Warning sign above the dosing tanks<sup>60</sup>

Additionally, a notice was posted with a warning/information regarding risk of violent reaction if mixing these substances.

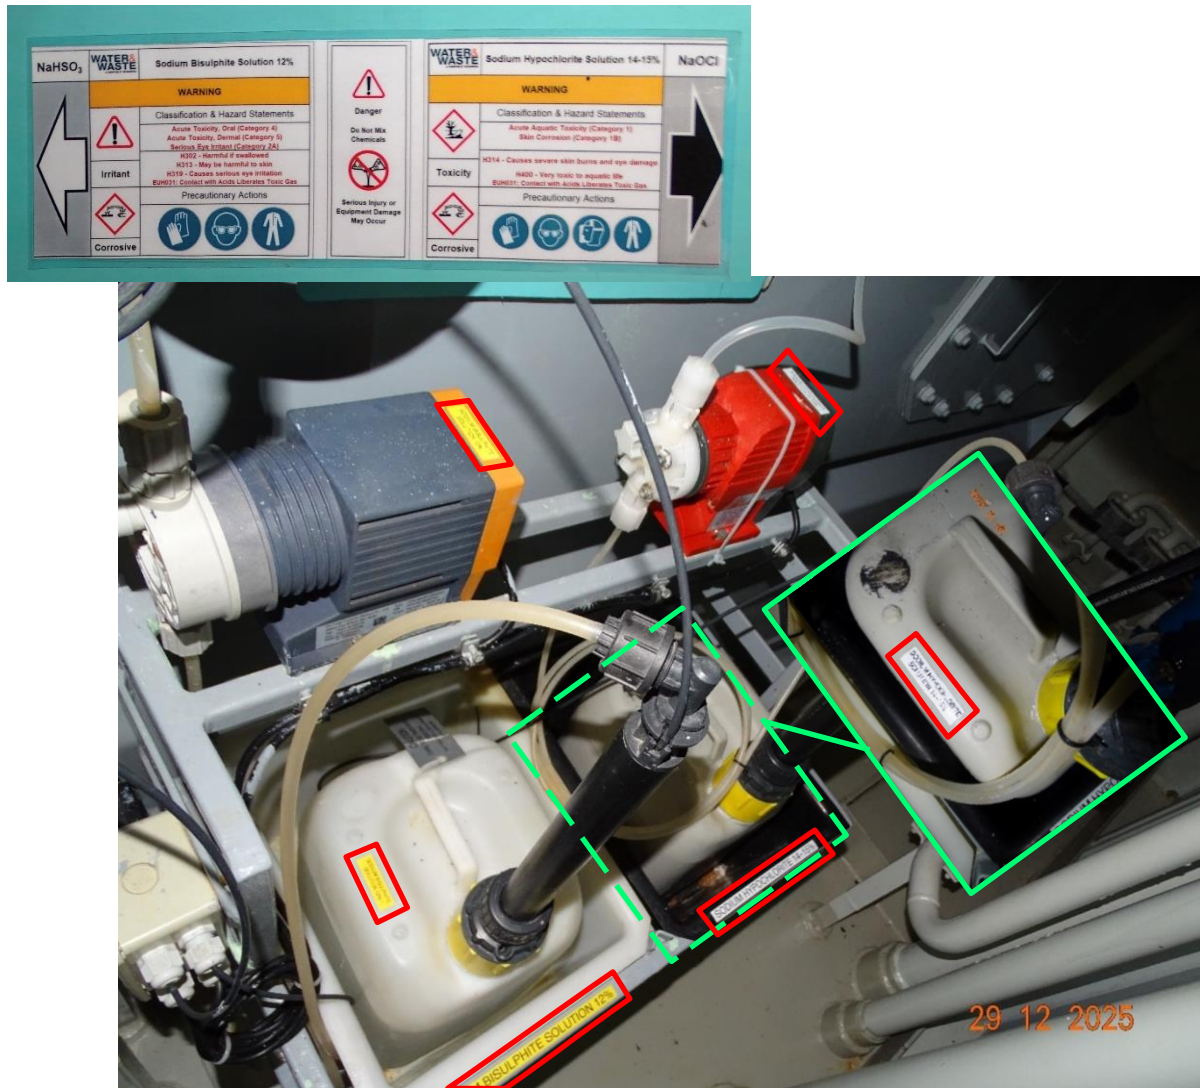
Figure 20: Latest signage and labelling, new dosing tank and bund<sup>61</sup>

As an interim solution, the OEM NaOCl container acted as dosing tank (cf. Figure 18 and Figure 19). Later on, a new white 10 l dosing tank and a new black plastic bund supplied by the manufacturer were installed. Additionally, the labels for all system components related to NaOCl were changed to white with black writing, introducing a clearer differentiation between the components related to each chemical.

After the BSU informed the operator of CORALIUS about the latest signage supplied by the STP's manufacturer (cf. 6.2.3), the signs highlighted in Figure 18 were updated to the latest version in December 2025. Furthermore, additional mandatory action signs were posted on the plant.
