# PRELIMINARY REPORT

## 2026-0091

Lindstrand Hot Air Balloons Ltd. balloon LBL-600; SE-ZIF

16 August 2026, Jarantowiczki

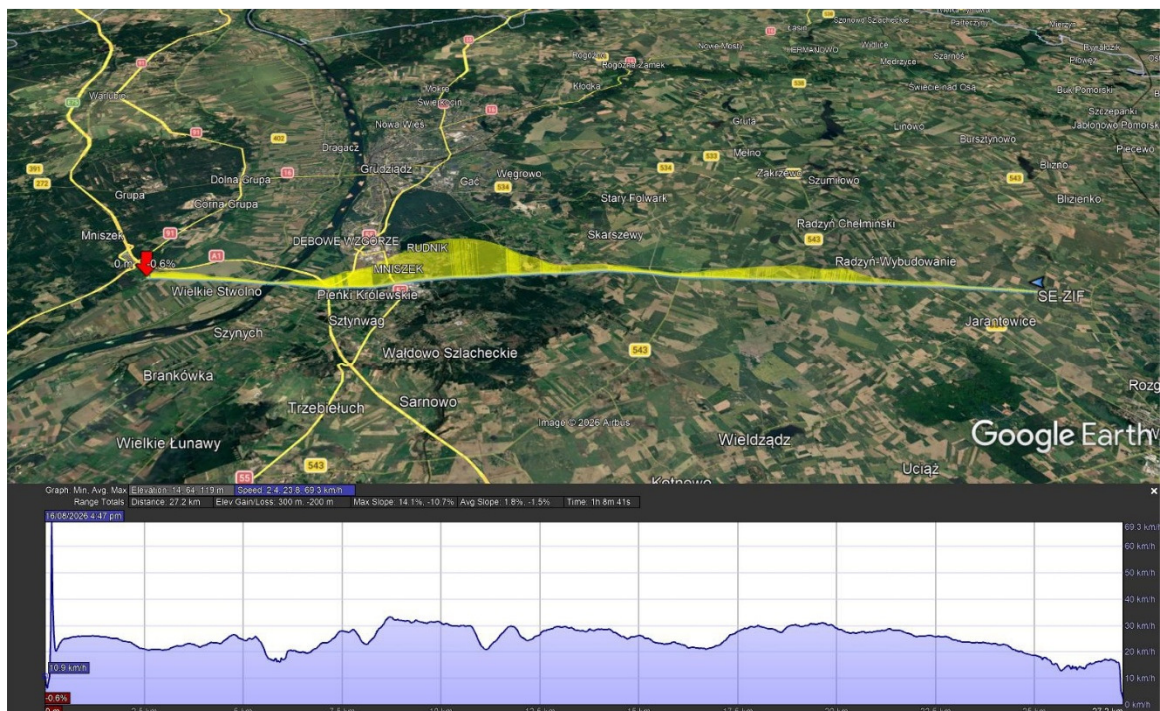
Fig. 1. The flight route of the SE-ZIF balloon on 16 August 2026, together with a speed chart.
