Report on the investigation of  
the fatal man overboard from  
the Isle of Man registered bulk carrier

***World Prize***

3.5 nautical miles east-south-east of  
Rönnskär, Sweden  
on 14 October 2025

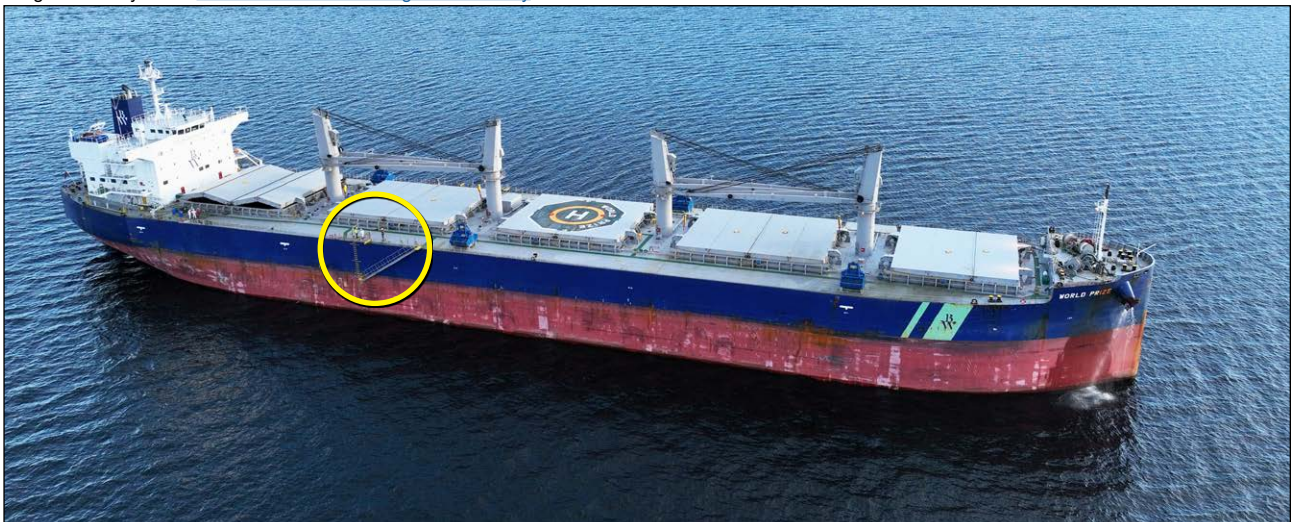
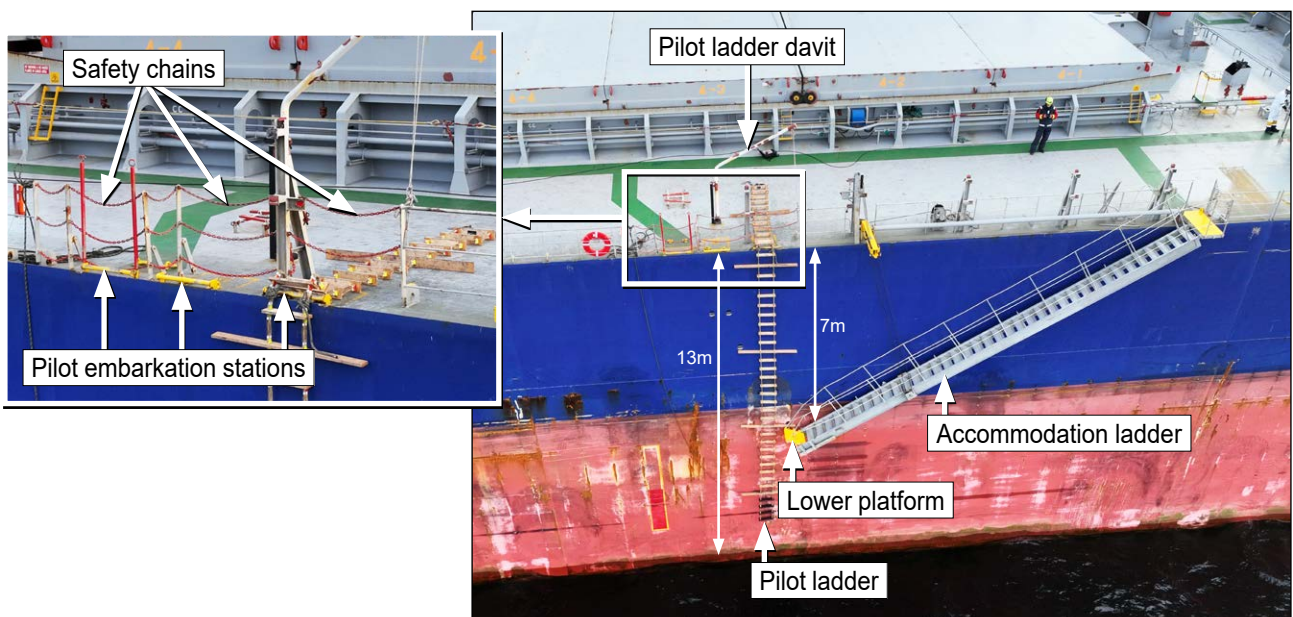
**Figure 2:** *World Prize* deck and combination ladder arrangement

At 0824, the master used their handheld radio to call the team working on deck and told them that the pilots would be departing in 15 minutes. The pilot ladder was rigged through the forwardmost of three pilot embarkation stations on the main deck (**Figure 2**). The safety chains protecting the opening were removed. The bosun then used the remote control for the accommodation ladder winch to deploy the accommodation ladder down the side of *World Prize*. AB1 and AB2 made their way along the accommodation ladder, installing the stanchions on either side of the ladder and threading the guard lines loosely through the loops on the stanchions.

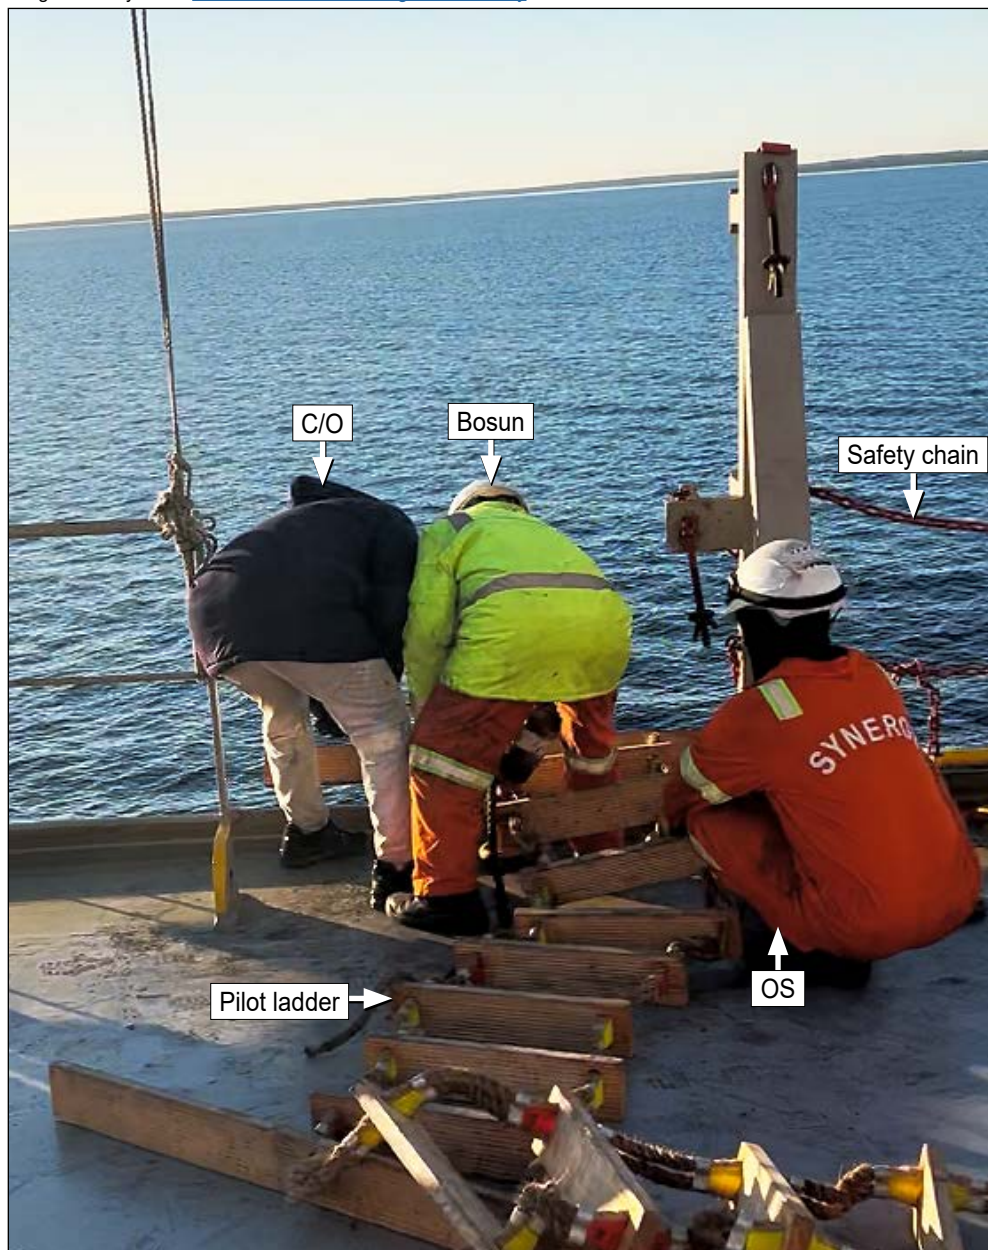
**Figure 3:** Crew positions immediately before the accident

The pilots arrived on the deck to wait for an instruction from the deck crew to disembark the vessel. As the pilot ladder was lowered, one of its spreader bars caught on the accommodation ladder. At the top of the pilot ladder the C/O, bosun and OS lifted and lowered the pilot ladder to free it from the accommodation ladder. The bosun's right leg was positioned between the rungs of the pilot ladder (**Figure 3**). The bosun and C/O leant over the side of the ship, shouting instructions to AB1 who was about 7m below them on the accommodation ladder platform.

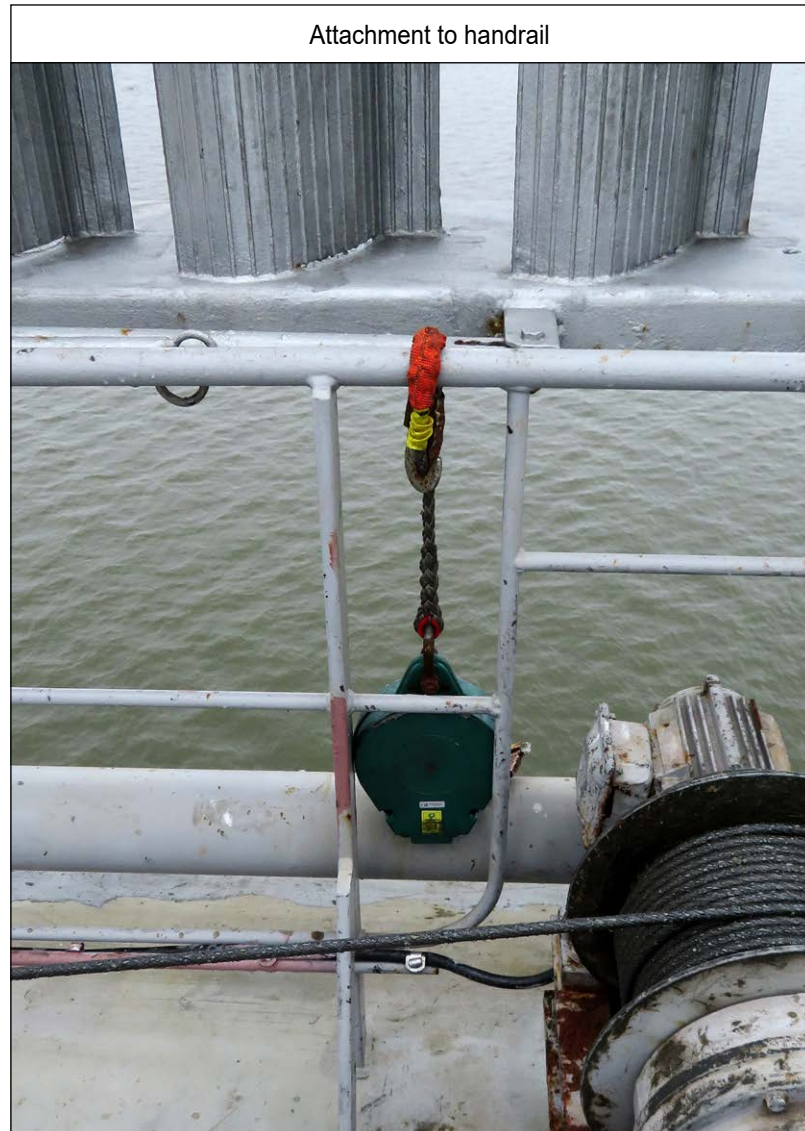
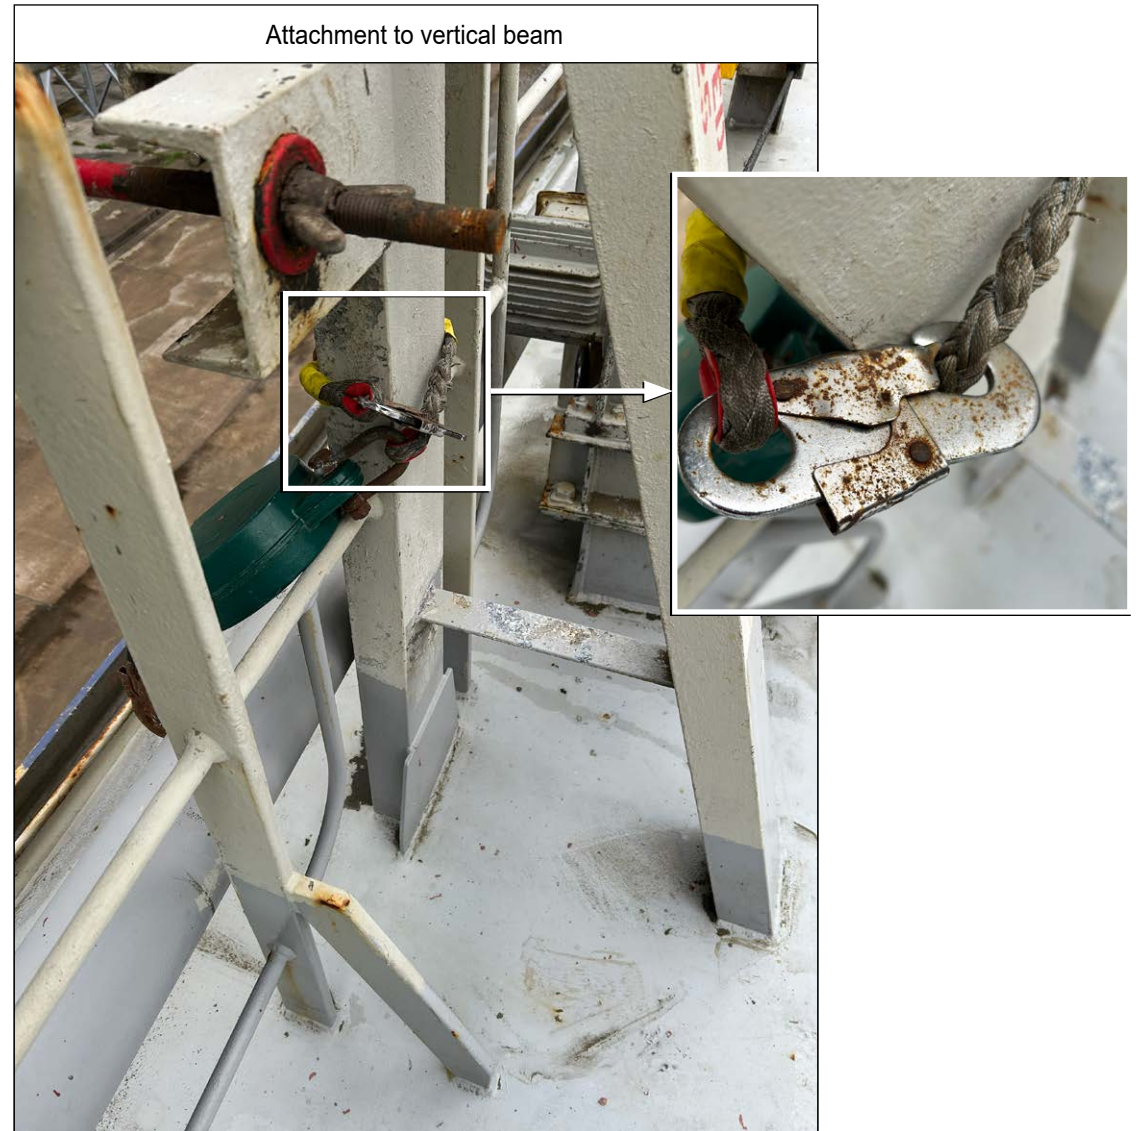
**Figure 5:** Demonstrated anchor points for fall arrest devices

With no attachment points above the accommodation ladders that met the guidance criteria in the vessel's SMS, it is unlikely that fall arrest devices were used when rigging the combination ladders on *World Prize*. The investigation report on the failure of a bosun's fall arrest device when he fell from an accommodation ladder on board *Madinah* also highlighted the need for appropriate anchor points.

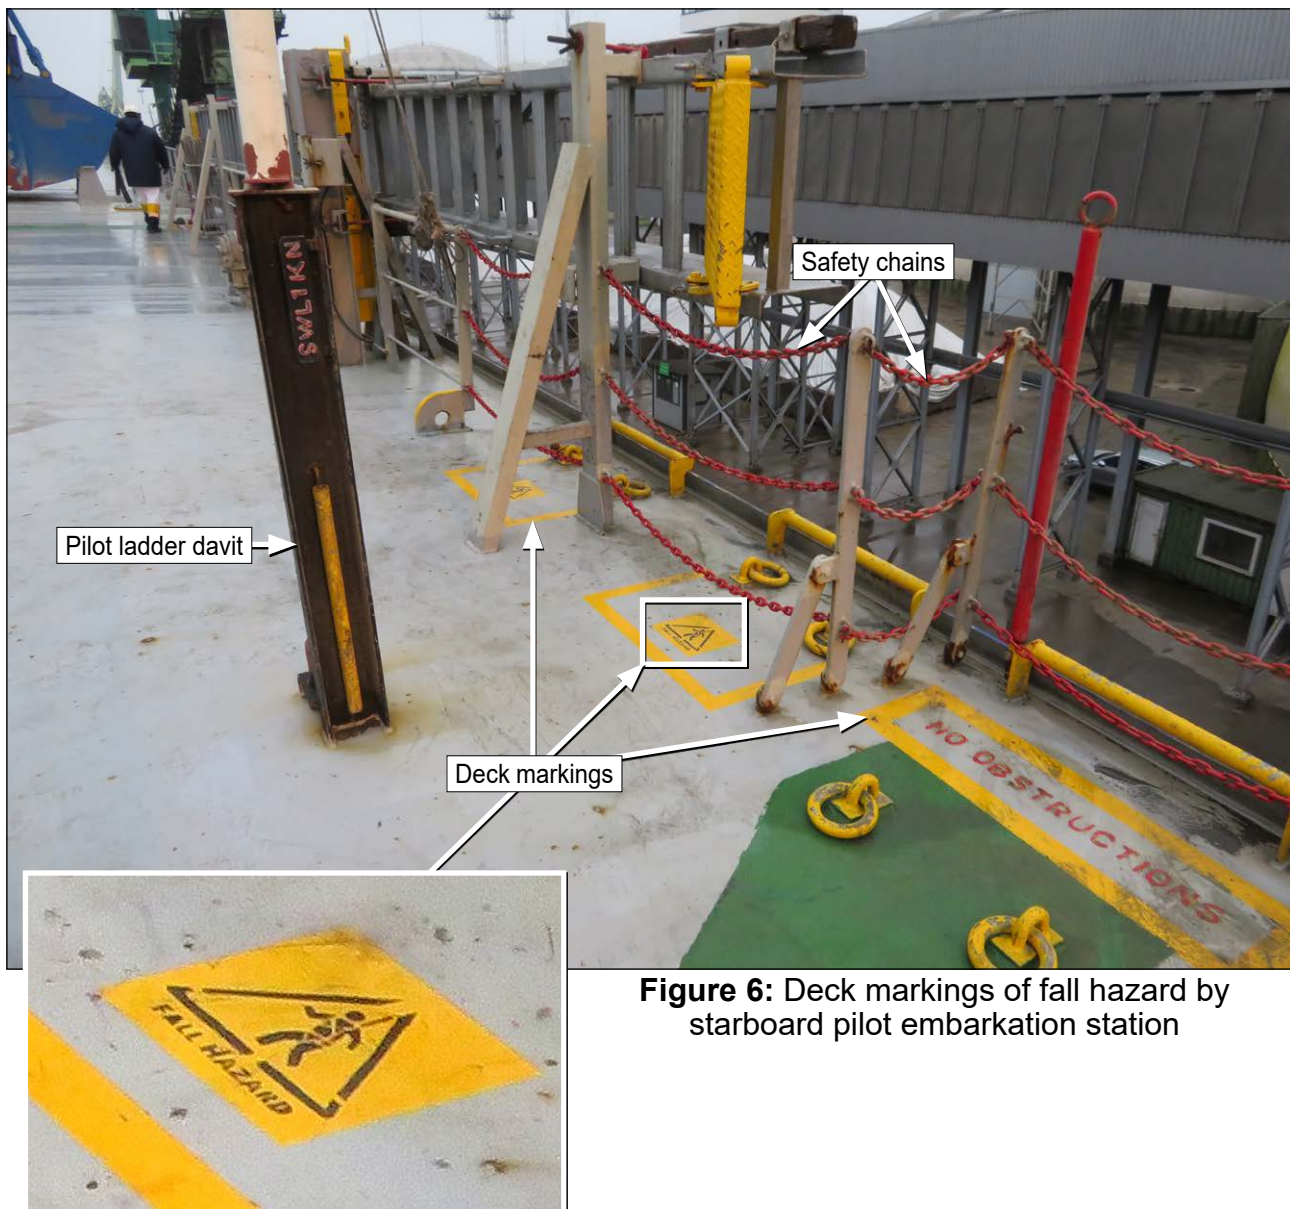
**Figure 6:** Deck markings of fall hazard by starboard pilot embarkation station

The presence of a fall hazard when safety chains at the pilot embarkation stations were removed was partially marked on the deck in way of the pilot ladder access points. The markings did not encompass the extent of the openings in the ship's guardrails, nor the 2m limit of the hazardous area identified in the SMS (**Figure 6**).

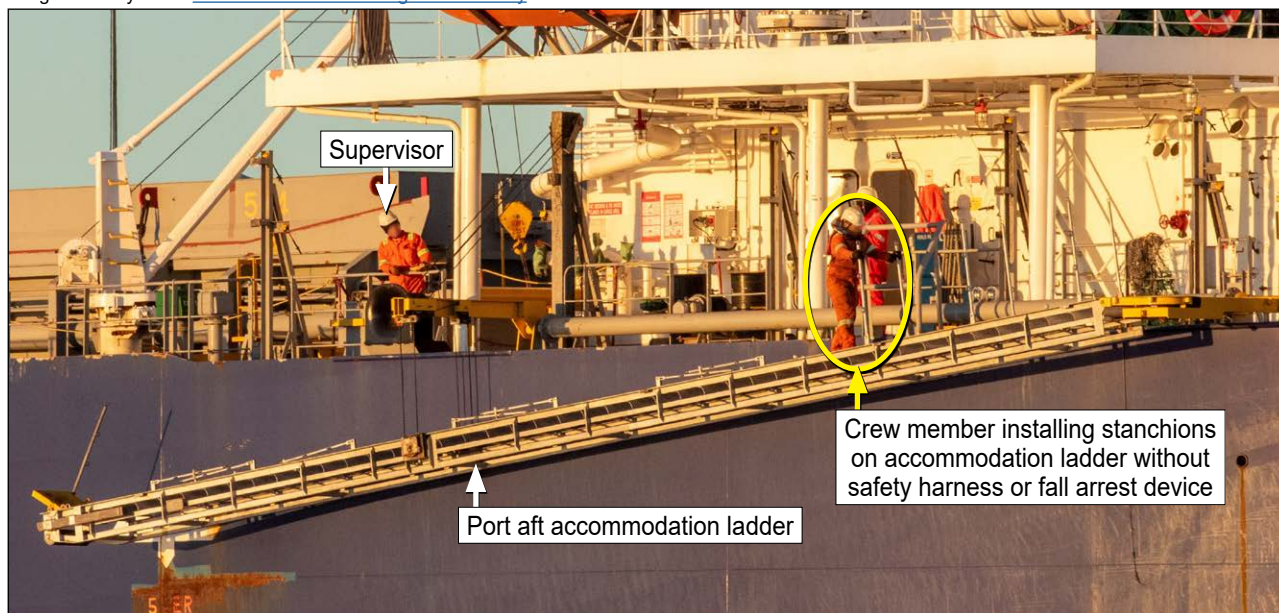
**Figure 7:** *World Prize* crew preparing accommodation ladder for use on arrival at Rönnskär on 11 October 2025

During *World Prize*'s arrival at Rönnskär a photograph captured the crew apparently preparing the accommodation ladder for use. One crew member was standing on the accommodation ladder, with no apparent safety harness or fall arrest device (**Figure 7**).

The evidence that crew working on *World Prize*'s accommodation ladder did not use fall arrest devices during the vessel's arrival at Rönnskär or at the time of the accident supports the likelihood that this equipment was not routinely used when rigging the combination ladder. Similarly, it is likely that crew working on deck near the fall hazard created by the removal of the safety chains at the deck edge did not routinely use the required fall prevention equipment.

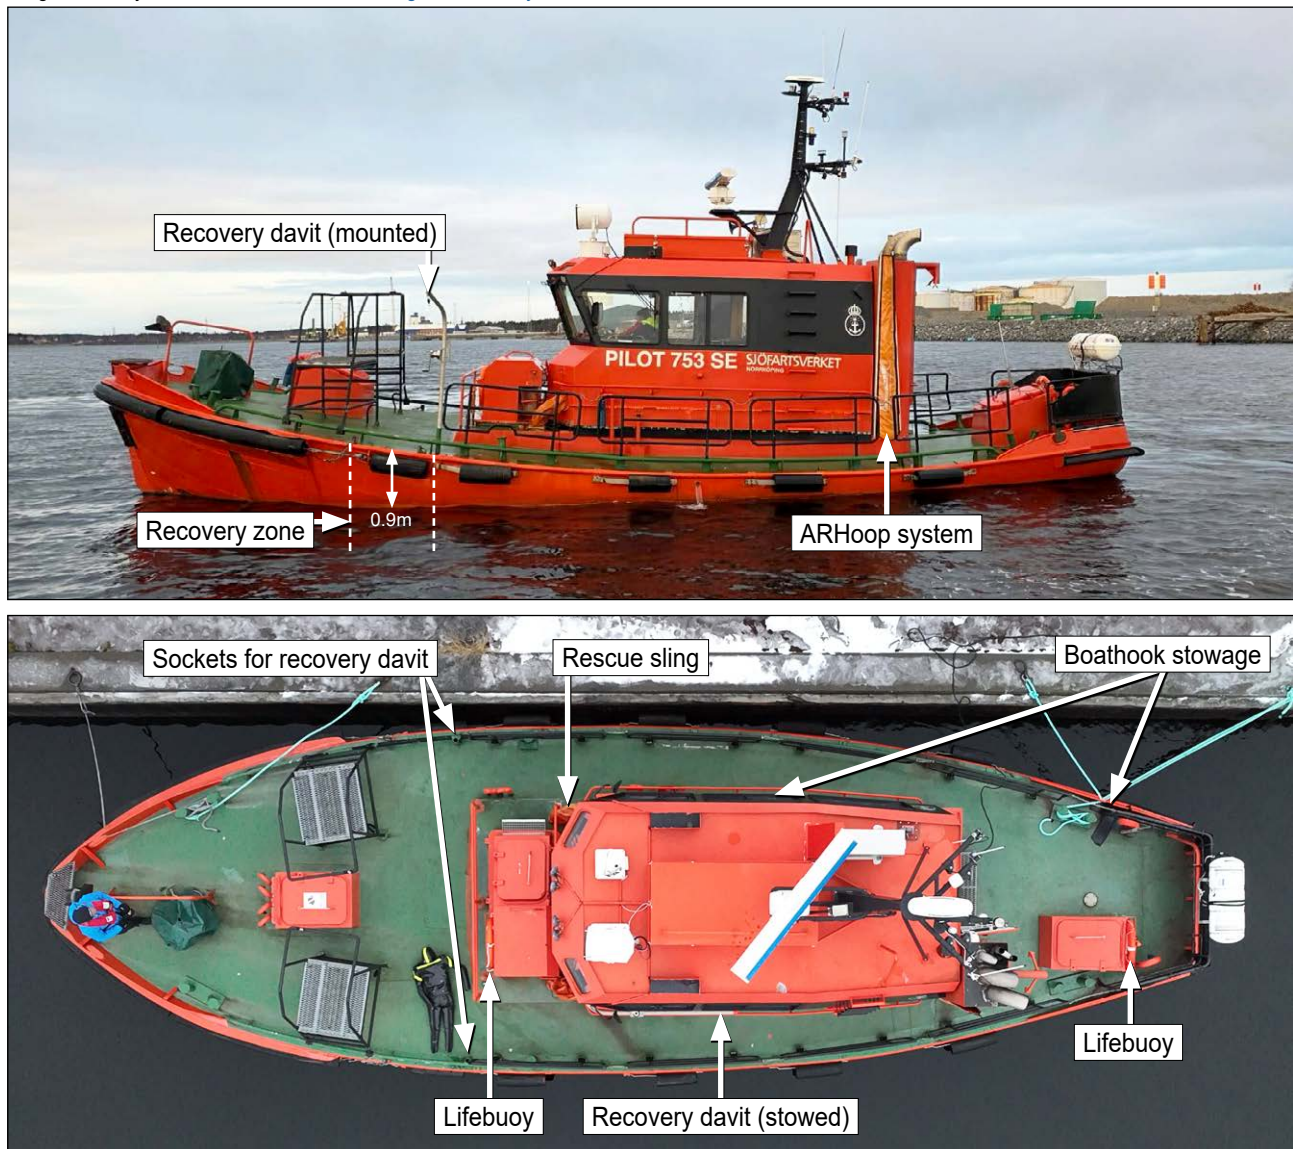
**Figure 8:** *Pilot 753 SE* recovery equipment

Following the accident SHK attended a trial of the ARHoop system on *Pilot 753 SE*, during which two trained crew members used it to recover a mannequin representing an unconscious person from the water. A post-accident inspection by SHK of the rescue sling on board *Pilot 753 SE* found that its pole sections were difficult to assemble.

A later trial of the ARHoop system installed on *Pilot 753 SE* with SHK in attendance demonstrated its capability to recover an unconscious person from the water. However, because the ARHoop system was not used at the outset of the response, the crew had to replan the recovery under conditions in which the bosun was already in danger.
