REPUBLIC OF ESTONIA
SAFETY INVESTIGATION BUREAU

Final Report of Preliminary Assessment of New Findings on MV ESTONIA Accident

Tallinn

2025

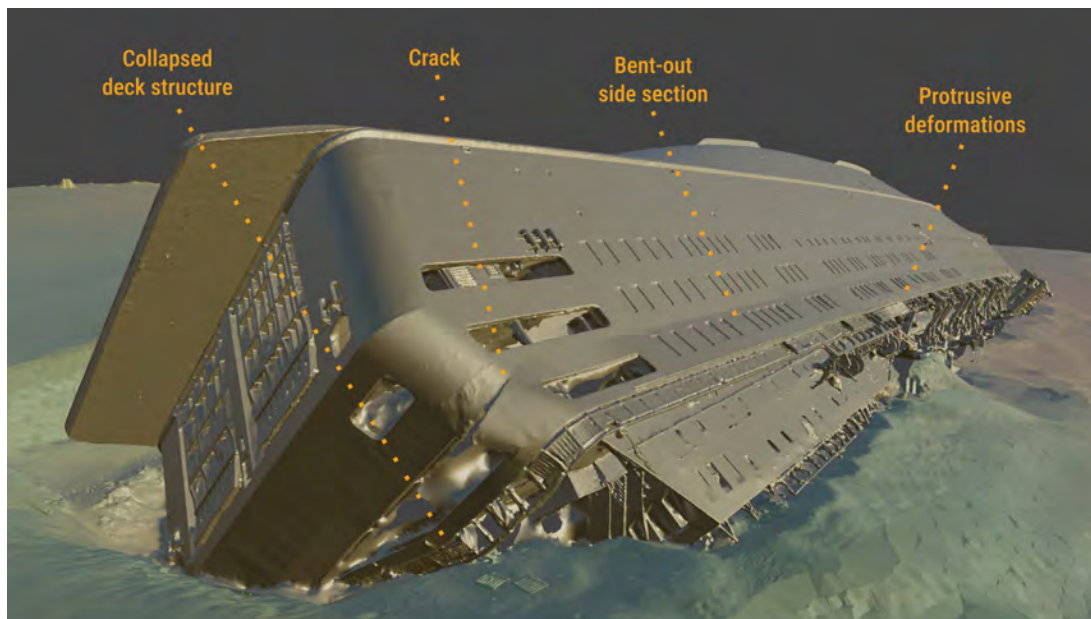
The ROV footage showed that the wreck had extensive damage. The starboard side, previously hidden towards the seabed, now showed an indentation, approx. 25 m of length, which at each end form a breach through the hull into the vessel's interior. The indentation followed the bedrock ridge well. Amongst other damage, the most obvious were a bending, partly a rupture, reaching from the aft part of the vessel's port side towards almost half of the vessel's length; the navigation bridge on port side heavily pushed down to the deck below; and the forward car deck ramp loosened from the remaining two (out of four) hinges and fallen down into the clay at the vessel's side.

FIG. 0.3: Stern view of the photogrammetric model of the wreck illustrating the observed structural damage.

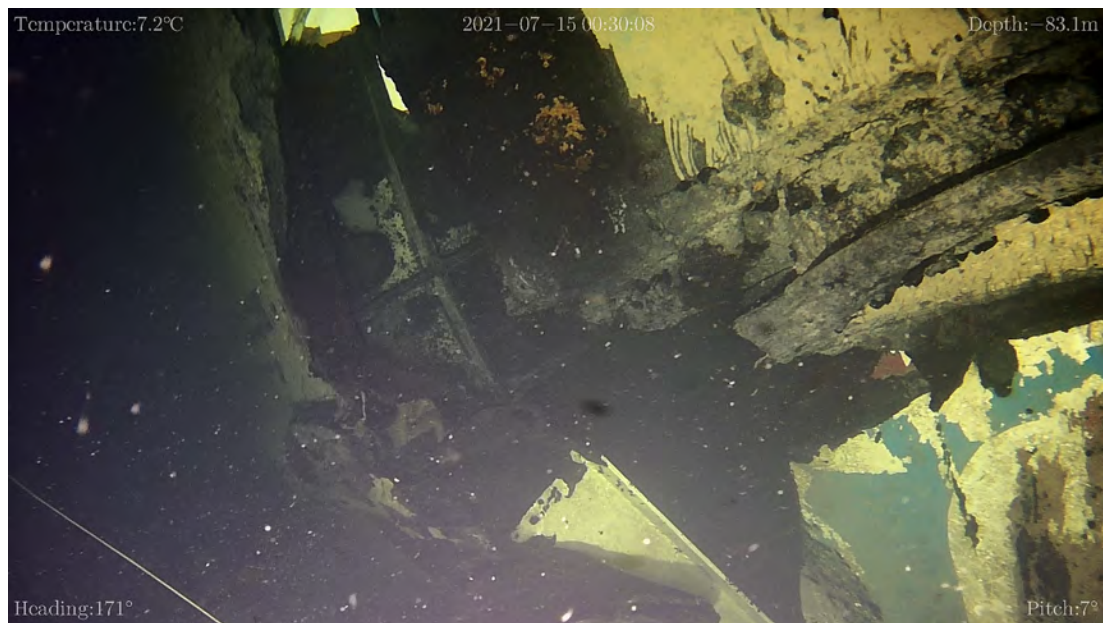
New video footage was published by Monster Media Group Limited in Sep-2020 which revealed a penetrating damage, characterized as a ‘hole’, in the starboard side of the hull (Figure 1.1).

FIG. 1.1: The hole that was displayed in the TV documentary in 2020, as seen in 2021 Remotely Operated Vehicle (ROV) footage.

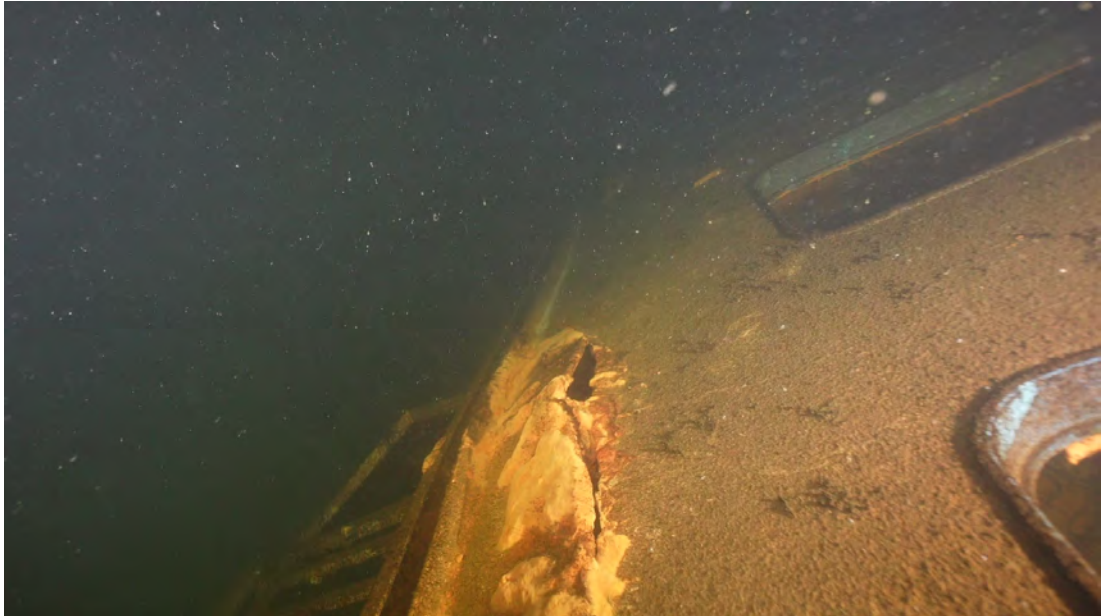
FIG. 3.29: Protrusive deformation on the port side shell plating below Deck 7.

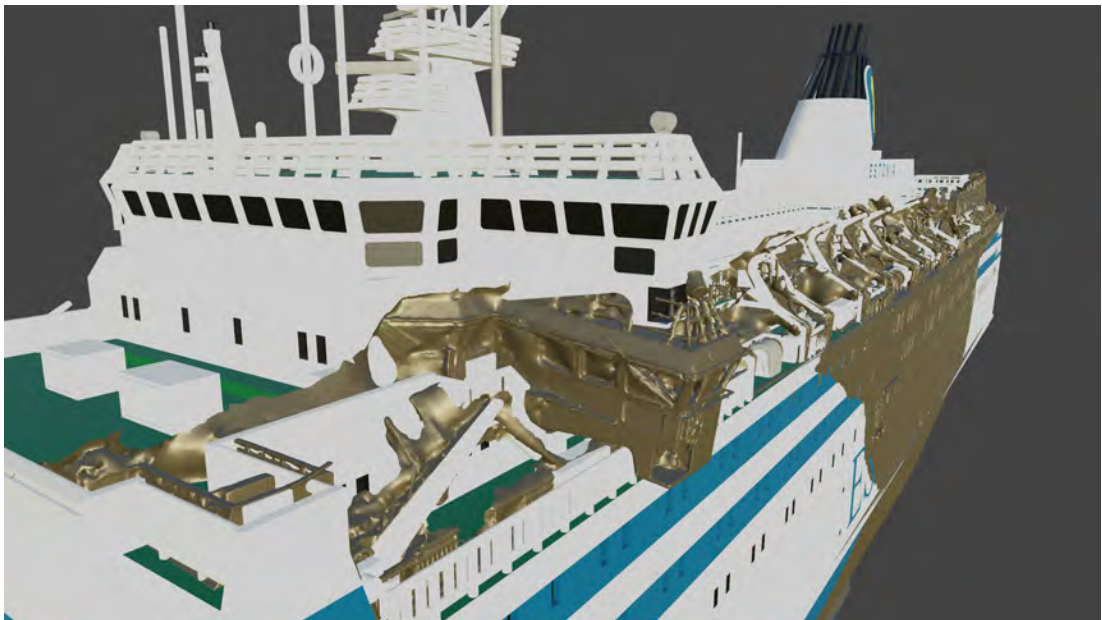
FIG. 3.30: Comparison of the photogrammetric model (metallic) with the theoretical model of the vessel illustrates the collapse of the navigation bridge by 1.5 deck heights because of the wreck movement.

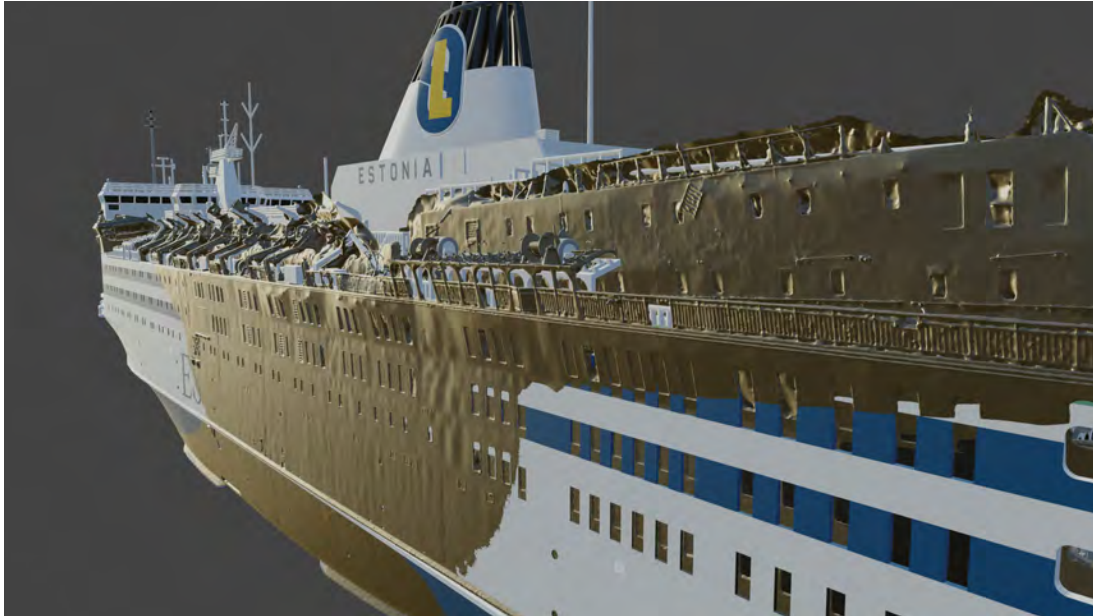
FIG. 3.31: Comparison of the photogrammetric model (metallic) with the theoretical model of the vessel illustrates the hogging of the vessel. Upper decks at midships are pushed out and the stern structure is heavily deformed. Models are aligned by the bilge keels.

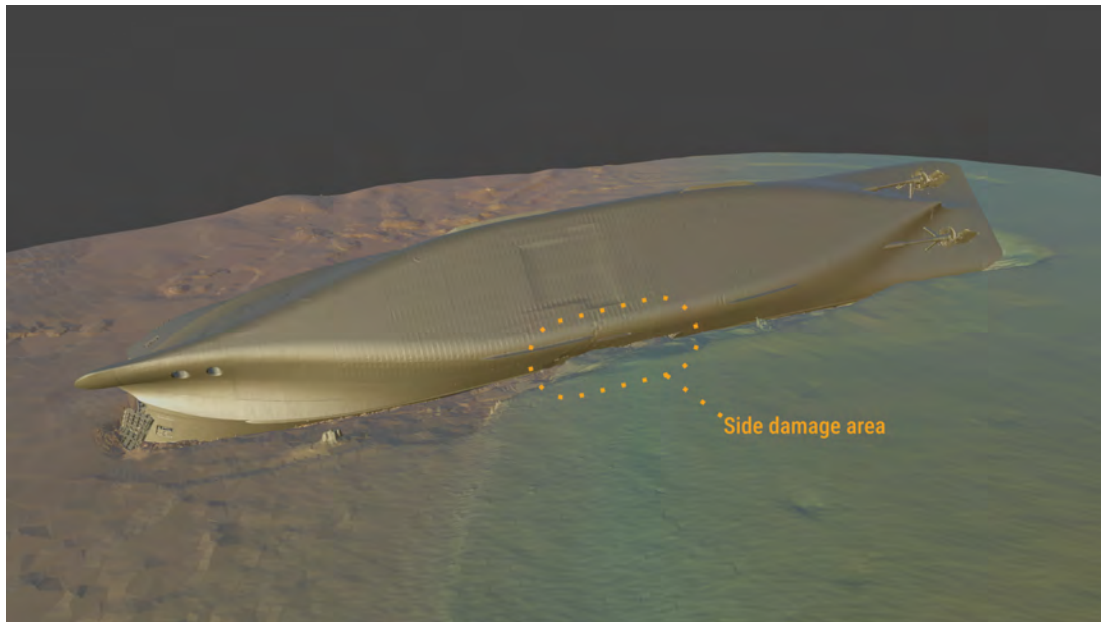
FIG. 3.33: Wreck side damage location on the photogrammetric model of the wreck.

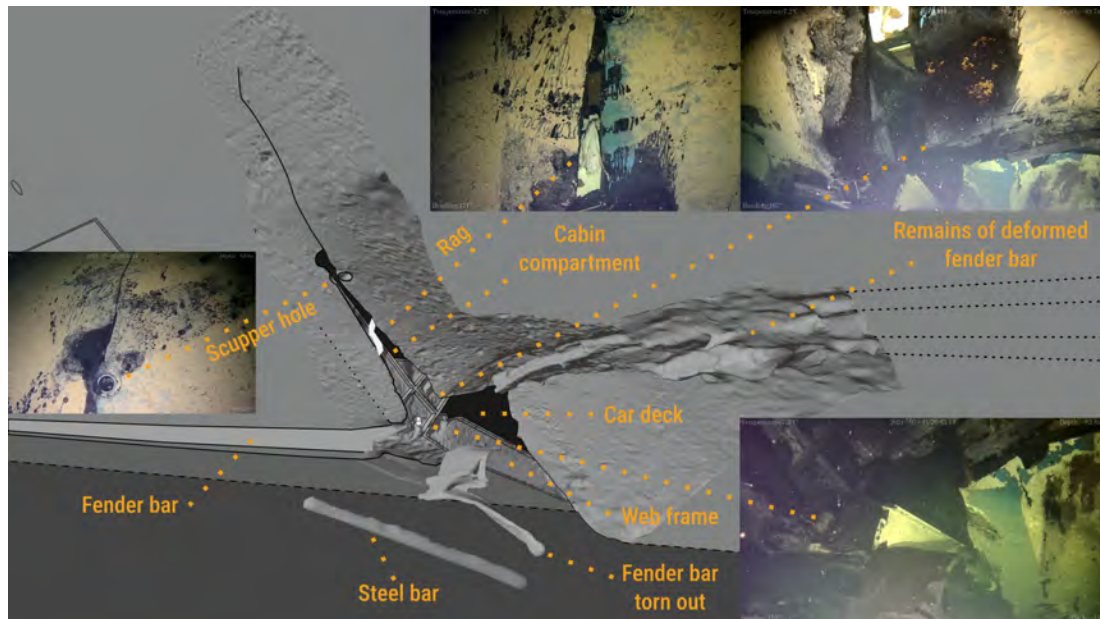
Samples from the vessel's hull at the forward end of the damage on starboard side showed that the damage has not been caused by any collision or explosives. Samples from the vessel's hull itself showed that black or dark shade or colouring was originating from natural growth.

FIG. 3.36: Forward penetrating deformation of the side damage.

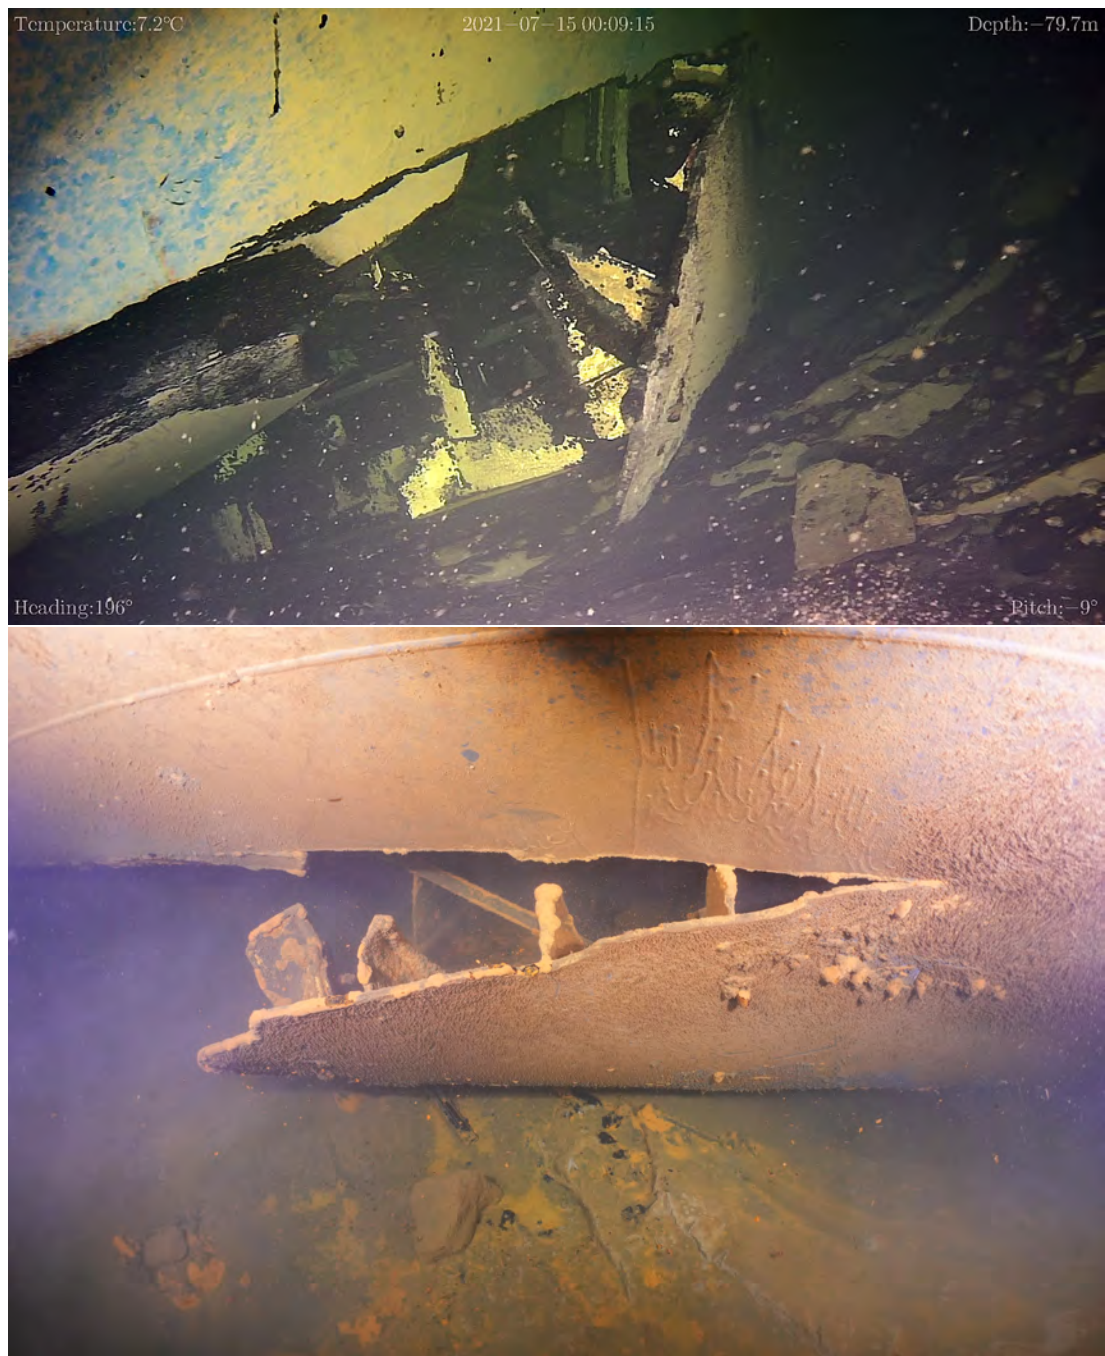
FIG. 3.37: Starboard side aftward penetrating damage close-up. Upper image is from 2021 ([O 2.13](#)), the lower from 2022 ([O 2.20](#)).

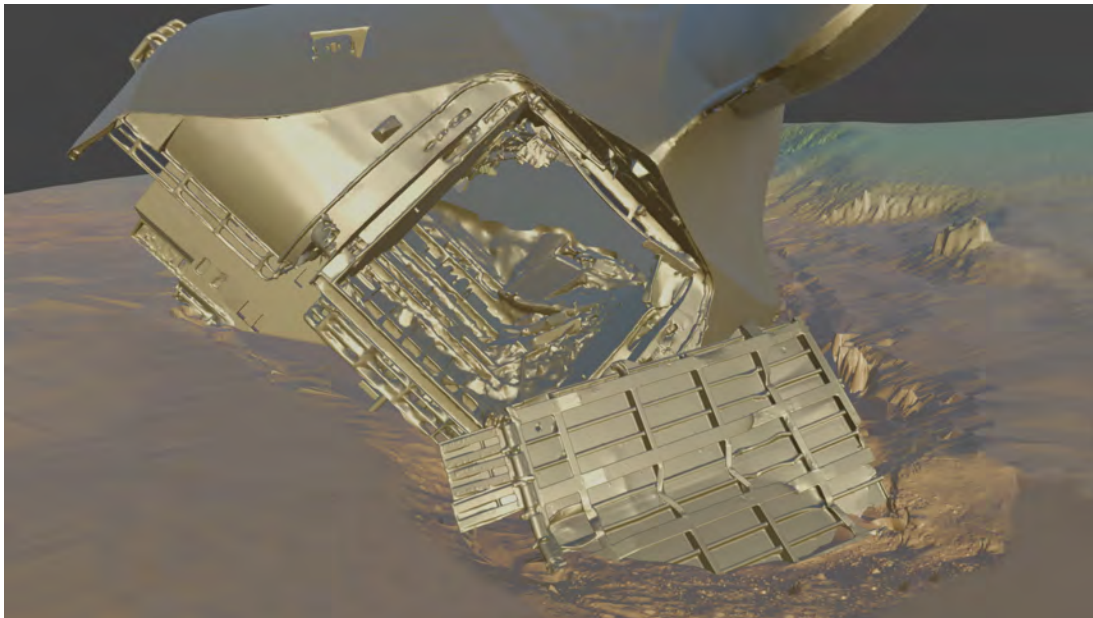
FIG. 3.43: Detached ramp on digital model

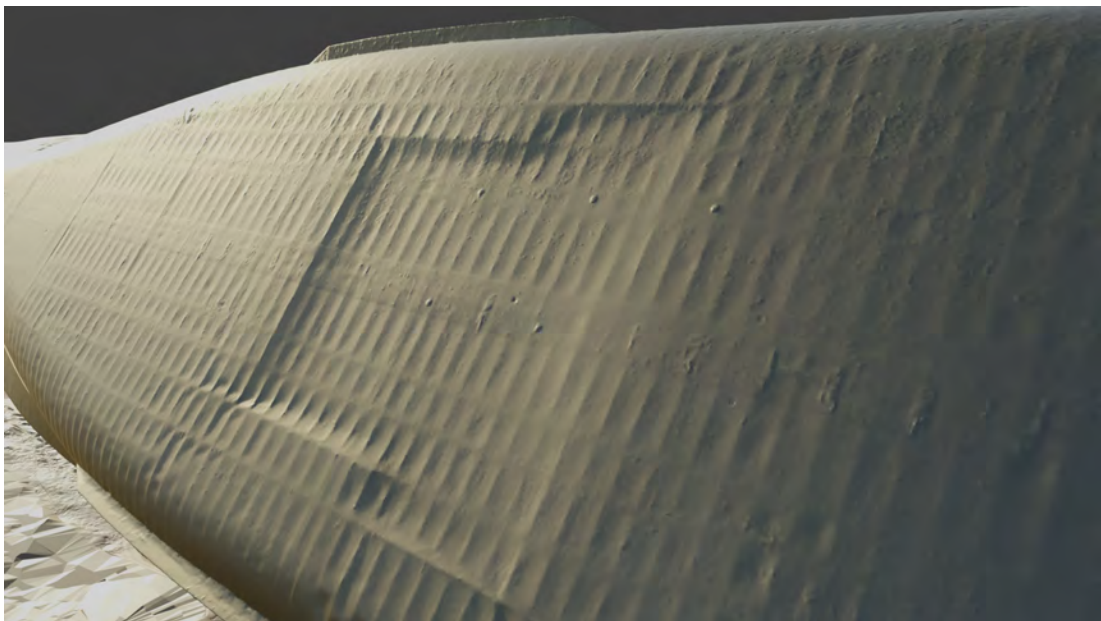
FIG. 3.44: Buckling of the flat bottom

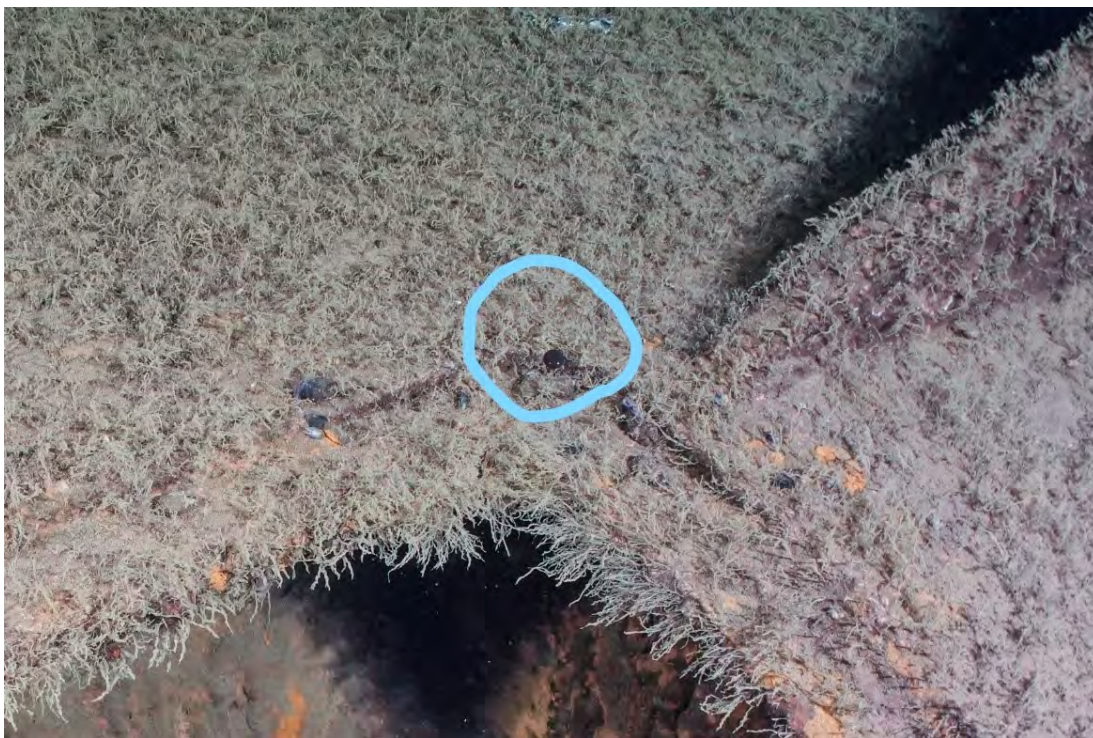
FIG. 3.45: The blue circle shows where a drop of oil is bubbling to the surface. Photo from photogrammetry.

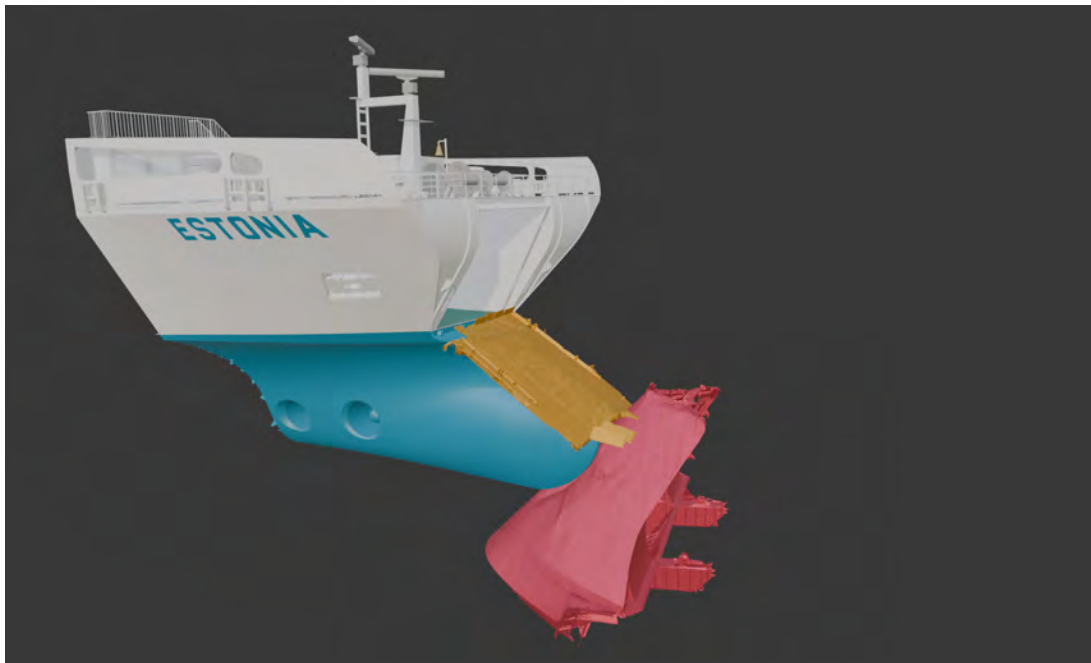
FIG. 4.5: Physical damage of the bow visor and the ramp confirming the full opening of the vessel's bow entrance at the beginning of the accident. The large dent in the front side of the visor (red) is aligned with the bulbous bow and the ramp's (yellow) underside deformations are aligned with the forepeak deck. Visor actuators are not shown.

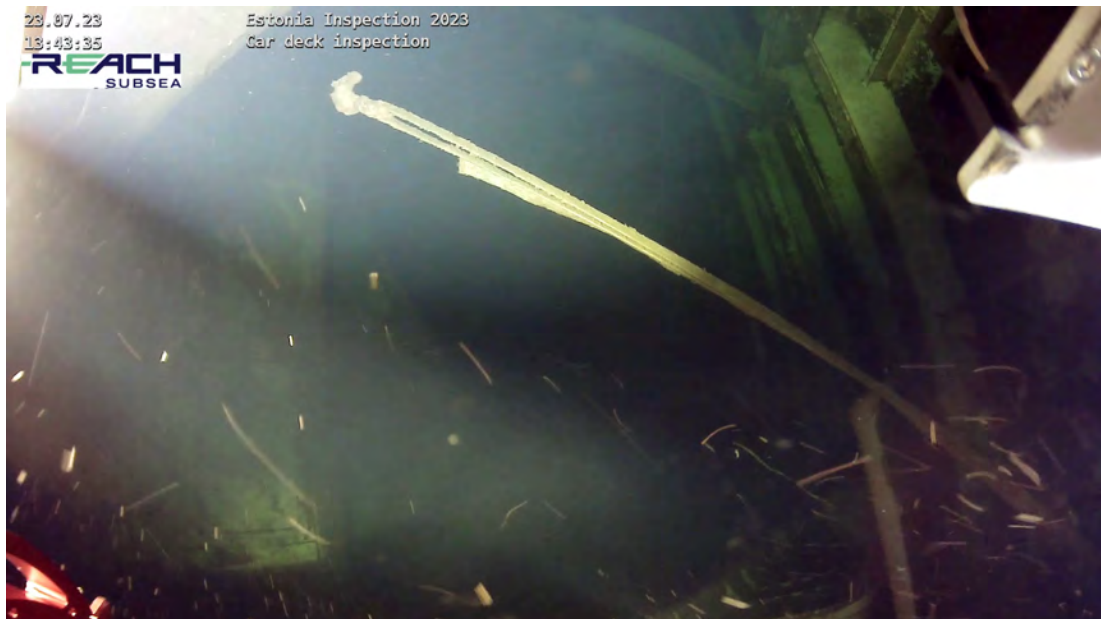
FIG. 5.2: Footage from the car deck shows a disconnected lashing belt from a shifted cargo unit on the car deck of MV ESTONIA during the visual inspection in 2023 (O 2.21).

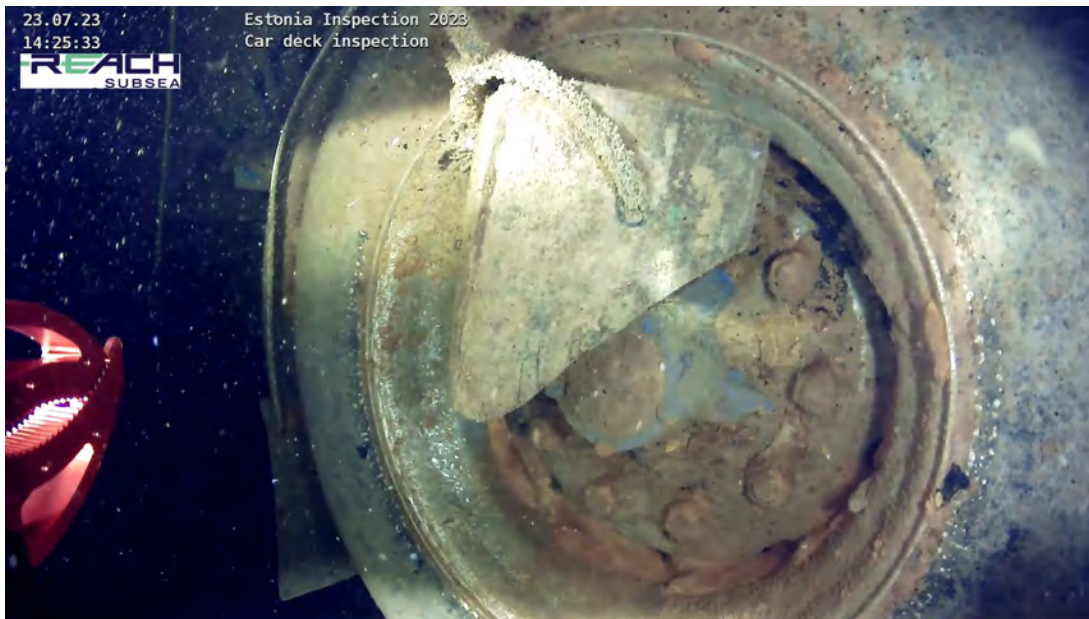
FIG. 5.3: Footage from the car deck shows a cargo securing chock next to the shifted cargo unit on the car deck of MV ESTONIA during the visual inspection in 2023 (O 2.21).

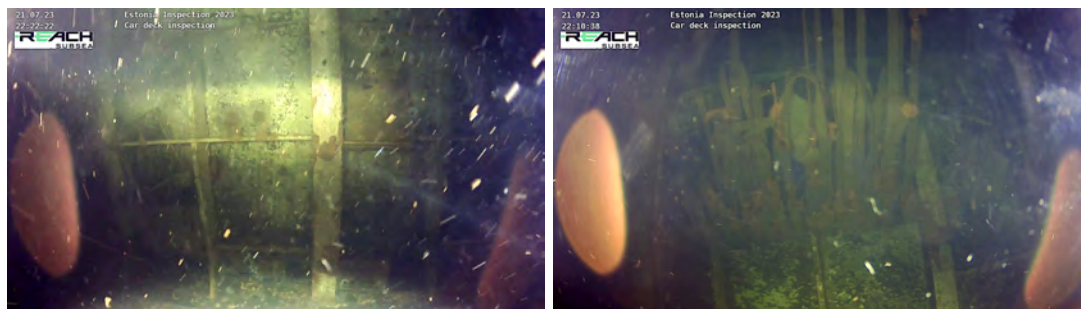
FIG. 5.4: The left image shows an empty space for lashings, while the right shows lashings stored and not being used. Footage from the car deck, made 2023.
