# Avalanche accident in connection with heli- skiing activities near Abisko

The Swedish Accident Investigation Authority has  
investigated an avalanche accident in Kårsavagge,  
Norrbotten County, 20 March 2025

27 May 2026

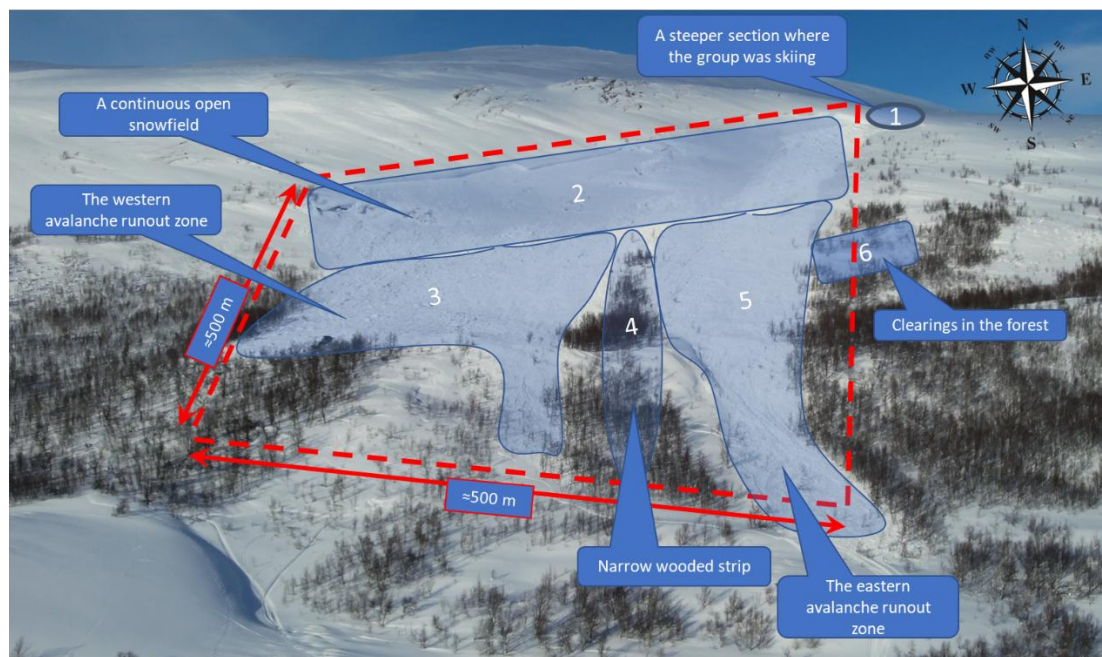
Figure 5. Avalanche area. The red dashed line indicates the approximate extent of the avalanche. Photo: Police Authority (2025-03-21). Markings added by SHK.

In the north-eastern corner at the top, there was a smaller area with a steeper section (area 1). Connected to this there was a larger continuous snowfield that extended westward (area 2). The upper part of this snowfield had an inclination above 30 degrees. Below the tree line, the snowfield split into two parts, separated by a long, narrow wooded strip (area 4). This long, narrow strip of forest extended along the fall line and was located between two larger snowfields (areas 3 and 5). These snowfields are runout zones from previous avalanches, so-called avalanche paths. In the forested area to the east of area 5, the inclination was lower than 30 degrees and there were also two open areas/glades (area 6).

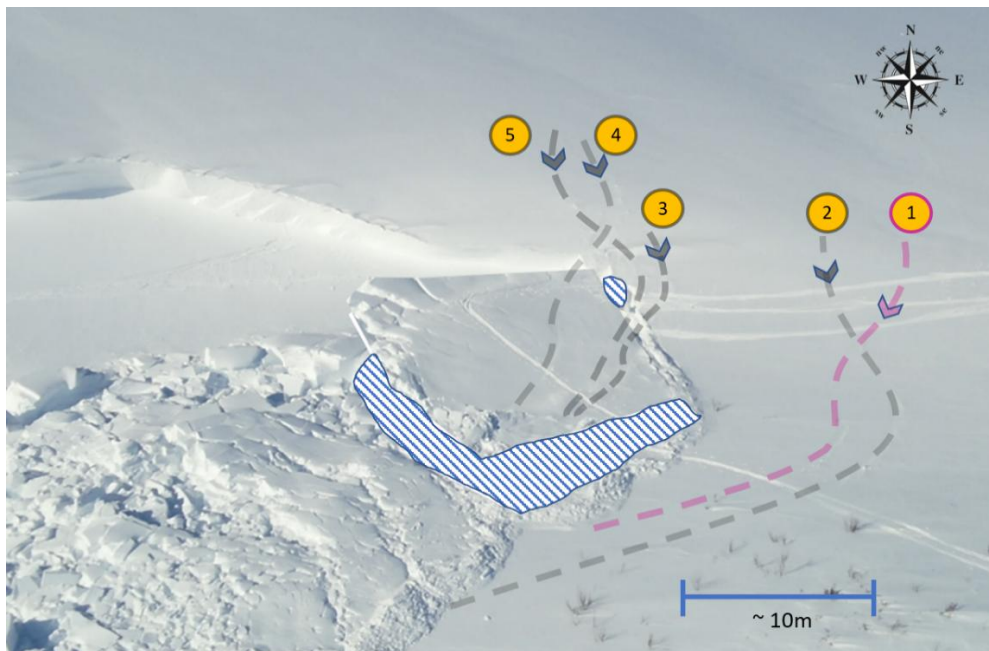
The positions of the skiers at the steep slope have been reconstructed, see Figure 7<sup>4</sup>. The guide's track (marked in pink) is the one that starts furthest to the east.

Figure 7. The skiers' tracks near the steeper section. Note that the skiers were not in these tracks simultaneously; first came the guide – the orange circle numbered 1, thereafter skier 2, etc. The dashed grey lines are the skiers' tracks. The dashed pink line shows the guide's track. The distance between the tracks of skier 2 and skier 3 is approximately 15 metres. The image has been edited; the blue dashed area indicates removed/relocated image data. The editing was done to provide a comprehensive view of the skiers' tracks. Photo: Police Authority (2025-03-21). Markings added by SHK.

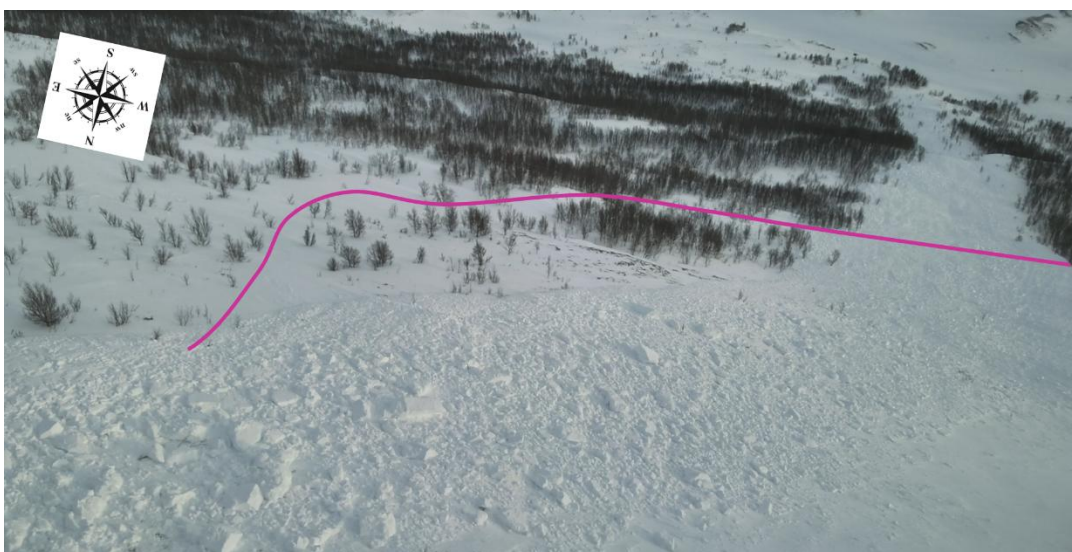
The guide has stated that, before heading out into the steeper section, he stopped and turned around to make sure that the skiers were following his tracks. He then continued and pressed down on a snow drift with his skis to check the snow stability. No snow release was observed. After the steeper section, the guide turned left (east) and followed his scouted and planned line to a larger snowfield (area 5 in figure 5). The left turn was part of the guide's planned route and meant that the descent was directed away from the open avalanche terrain, which was to the west of his tracks. The guide passed the snowfield and continued over to the long, narrow strip of forest. The guide's reconstructed line is shown in figure 8.

Figure 8. The guide's reconstructed line (pink line). The image was taken with a drone two days after the accident.

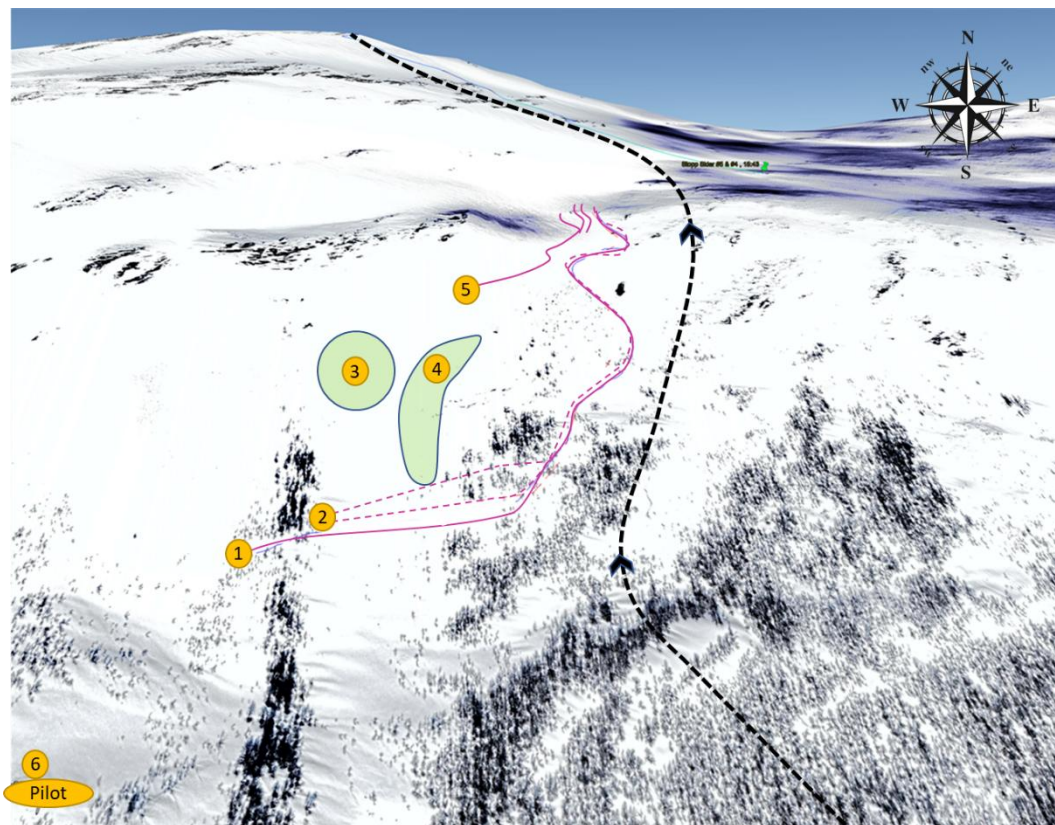
Skier 5 went out over the steeper section and then turned right (west) towards the helicopter. When he had come a bit below the steep slope, he saw the snowpack below and around him break apart. He realised it was an avalanche and immediately turned sharply to the left (east), activated his avalanche backpack and skied as fast as he could to the left. The moment of the sharp left turn and the start of the avalanche has been determined to be at 15:47. Figure 9 shows the skiers' positions and the areas where they were likely located just before the avalanche started.

Figure 9. Reconstructed positions and tracks of those involved just before the avalanche started. On the right side of the image, the last scouting flight (i.e., the helicopter flight) to the summit is shown with a black dashed line. For skier 2, two possible route choices through the forest are shown. The probable line of descent of skier 2 is marked with a pink dashed line. Source: Google Earth, image date 2020-04-28. Markings added by SHK.

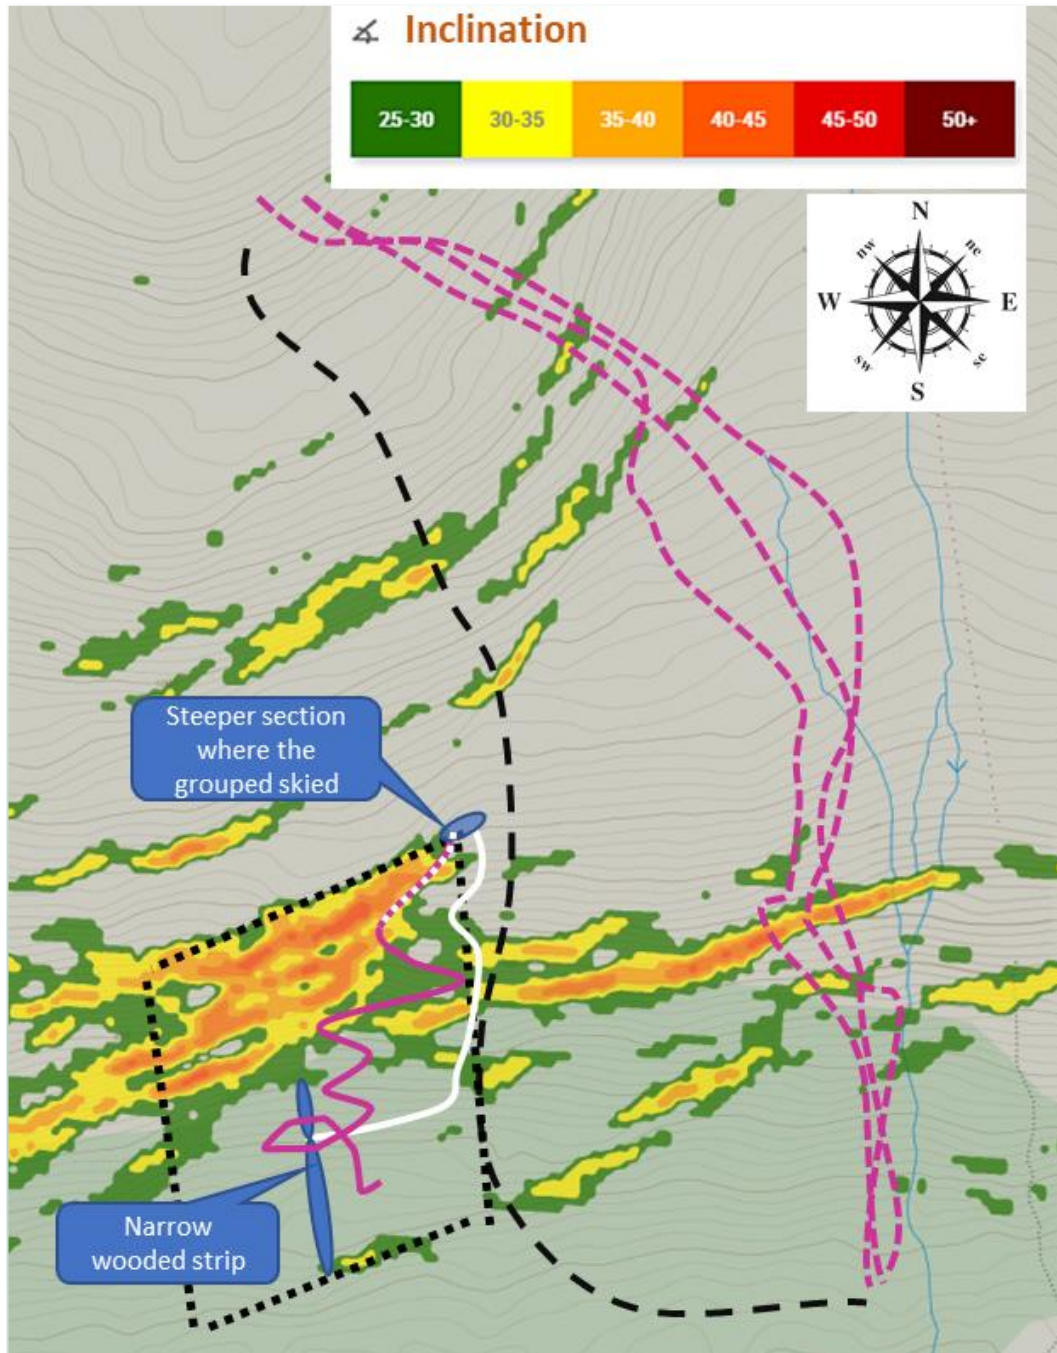
The inclinations in the area are shown in figure 10. Here it can be seen that to the left of the helicopter's reconnaissance flight, there is a large, continuous area with an inclination of up to 40 degrees. The figure also shows the inclinations at the locations where previous runs had been carried out.

Figure 10. Inclinations map with GNSS tracks from skier 5's descent. Pink dashed line: the three runs before the final run. White-pink dashed line: the final run up to the position at the moment the avalanche was triggered. Solid pink line: the track after the avalanche was triggered. Solid white line: the guide's track. Black dashed line: the helicopter flight and scouting before the final run. Source: Swedish Environmental Protection Agency (Naturvårdsverket). Markings added by SHK.

The guide's reconstructed track initially runs mainly outside avalanche terrain. During the traverse towards the helicopter, the reconstructed track passes through a runout zone.

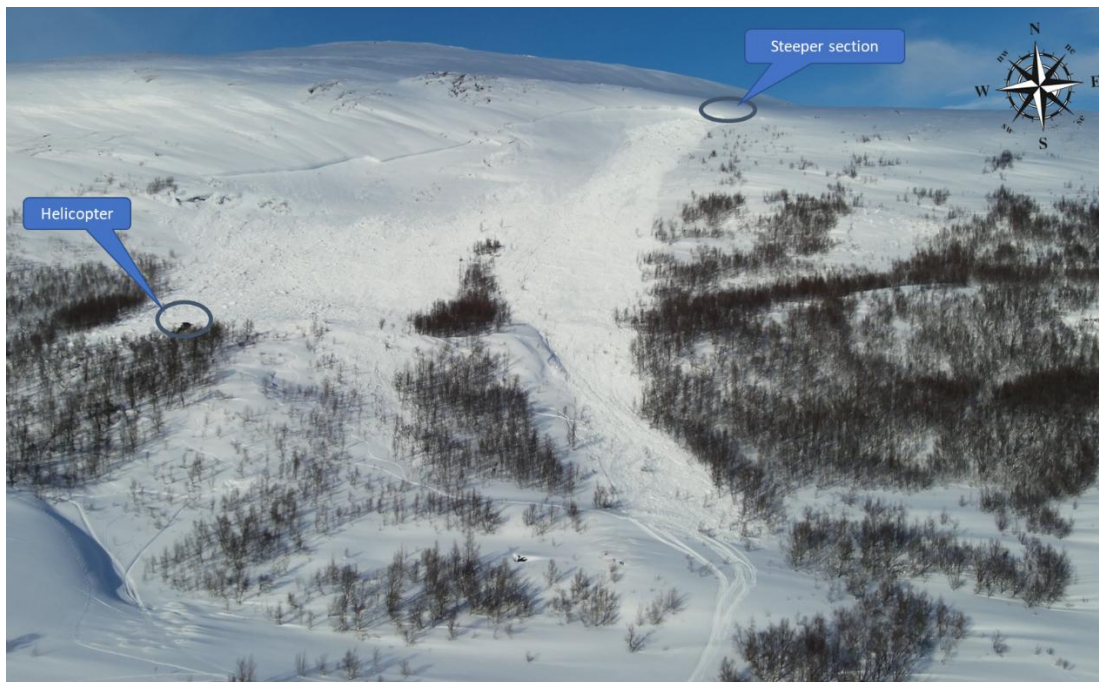
Figure 11. The area as it appeared the day after the avalanche. Photo: Swedish Police Authority. Markings added by SHK.

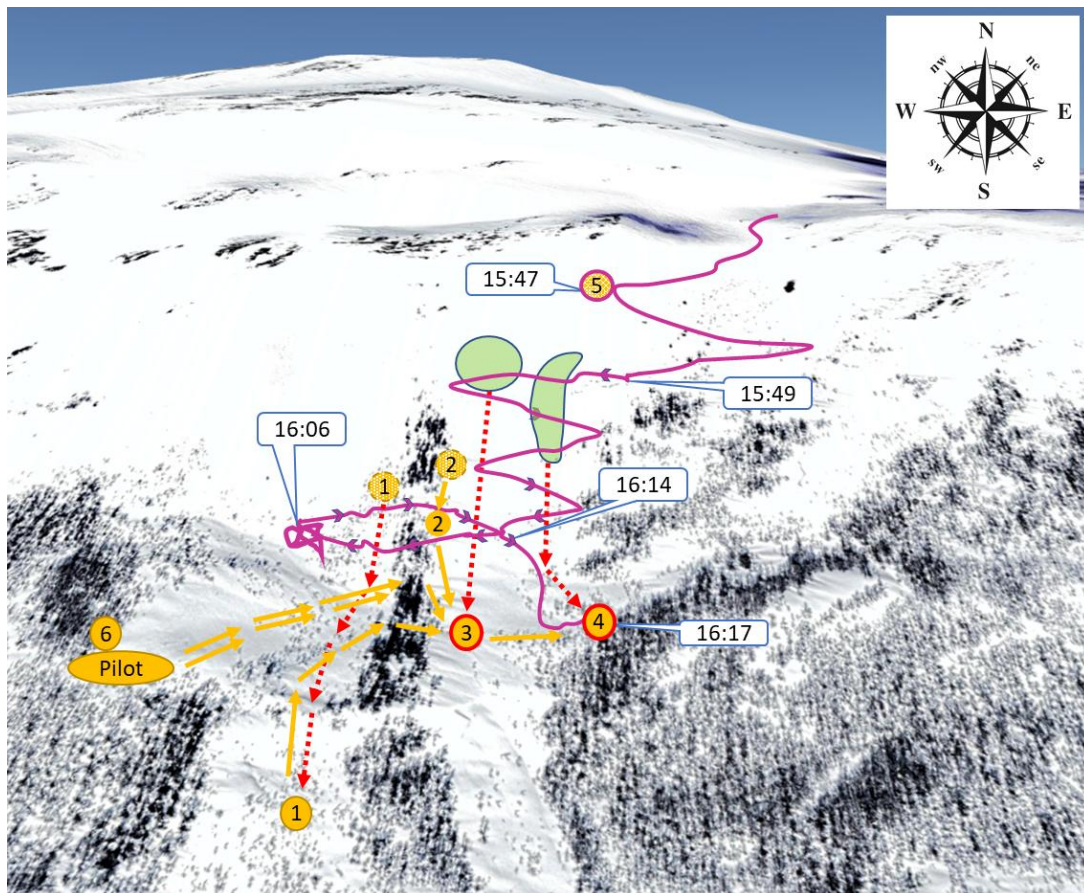
Figure 12. Satellite image showing the positions of those involved. The track for skier 5 is based on GNSS data and is shown in purple. The start and end positions (orange circles) during the avalanche event for the guide and skier 3 (green circle) are connected by red dotted arrows indicating a probable path in the avalanche. Orange arrows indicate the approximate search paths. Source: Google Earth, image date 2020-04-28. Markings added by SHK.

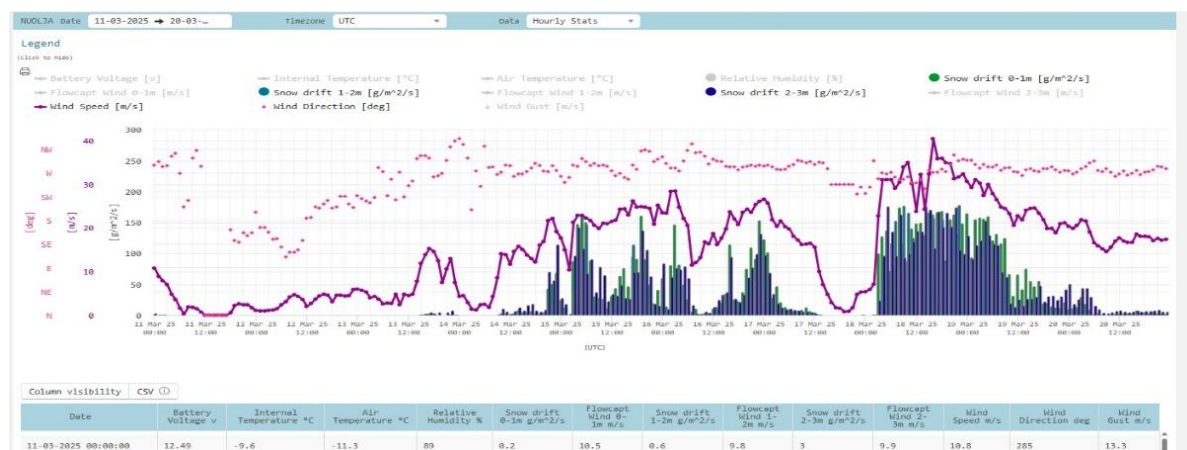
Weather data from the days preceding the accident were collected from a measuring station at the summit of Mount Nuolja, which is situated directly adjacent to Kårsavagge. The data indicate westerly winds of around 30 m/s, resulting in drifting snow; see figure 14. The weather conditions on 20 March are also shown; there were westerly winds of approximately 17 m/s.

Figure 14. Weather data from the measuring station located on Mount Nuolja. Source: Swedish Environmental Protection Agency (Naturvårdsverket).

Overall, the weather developments during the period 14–20 March resulted in significant amounts of wind-transported snow accumulating on leeward slopes with north, east and south exposure, on top of previous snow layers. The newly deposited snow accumulated and formed a thick and cohesive slab above the underlying weak layers. The uneven snow distribution meant that the slab became very thick in certain areas, which contributed to the large extent of the avalanche.
