# Main landing gear wheel separation involving Saab 340, VH-VEZ

Canberra Airport, Australian Capital Territory, on 29 January 2026

## ATSB Transport Safety Report

AO-2026-008

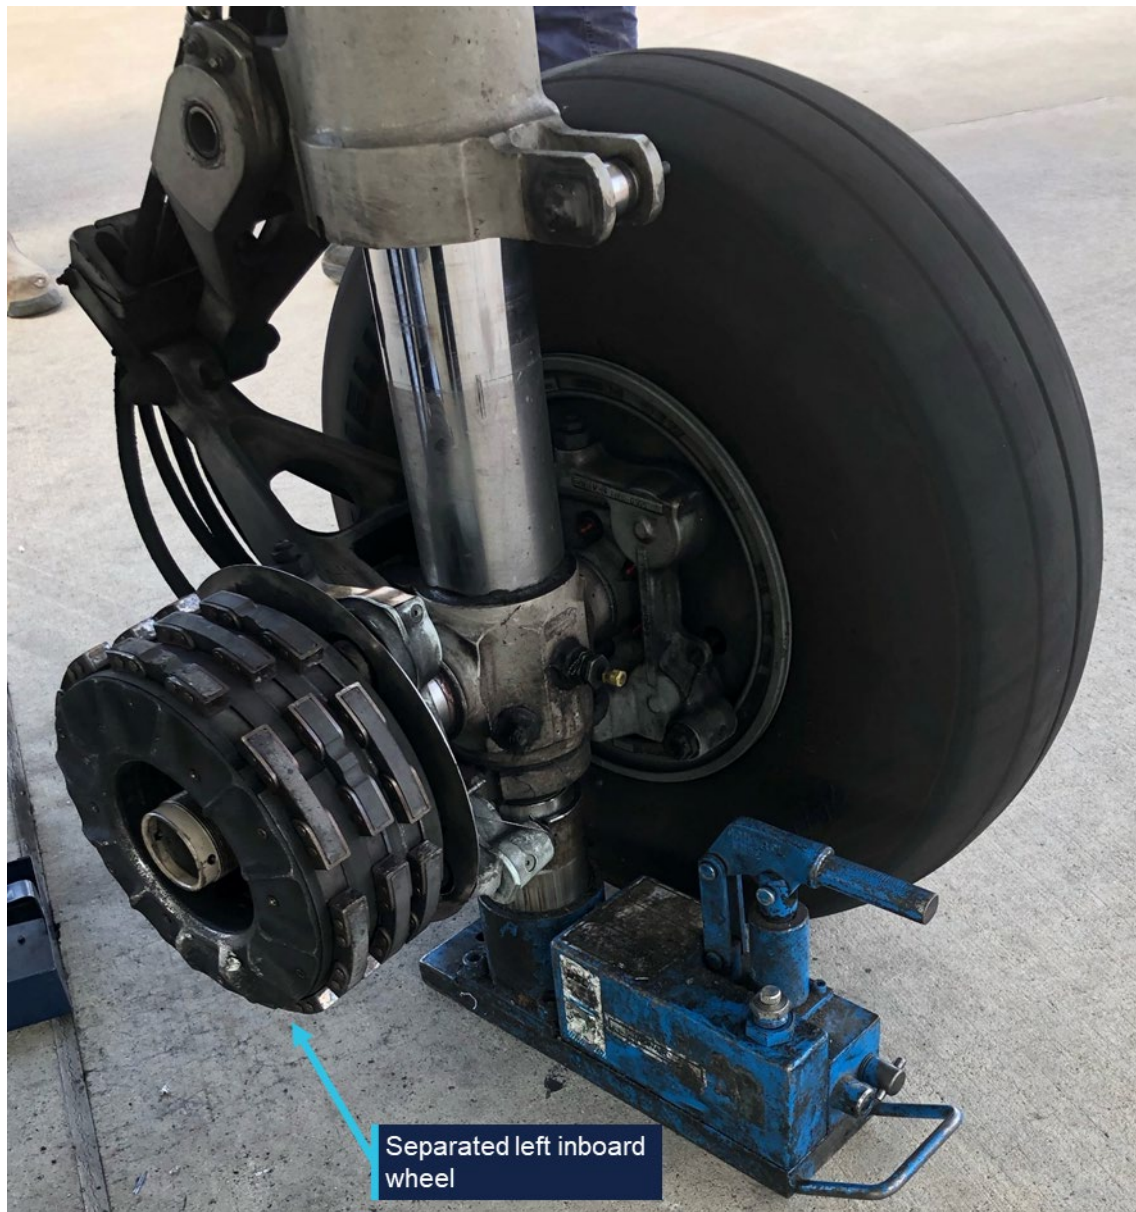
At 1611, the aircraft landed safely and was brought to a stop at the end of the runway (Figure 1). Airport emergency services reported no fire, smoke, or fluid leaks from the landing gear. The crew shut down both engines on the runway, and the aircraft was towed to the apron, where passengers were disembarked. Canberra Airport safety personnel located the main wheel against an internal airport fence on the eastern side of runway 35.

**Figure 1: VH-VEZ left main landing gear with separated inboard wheel**

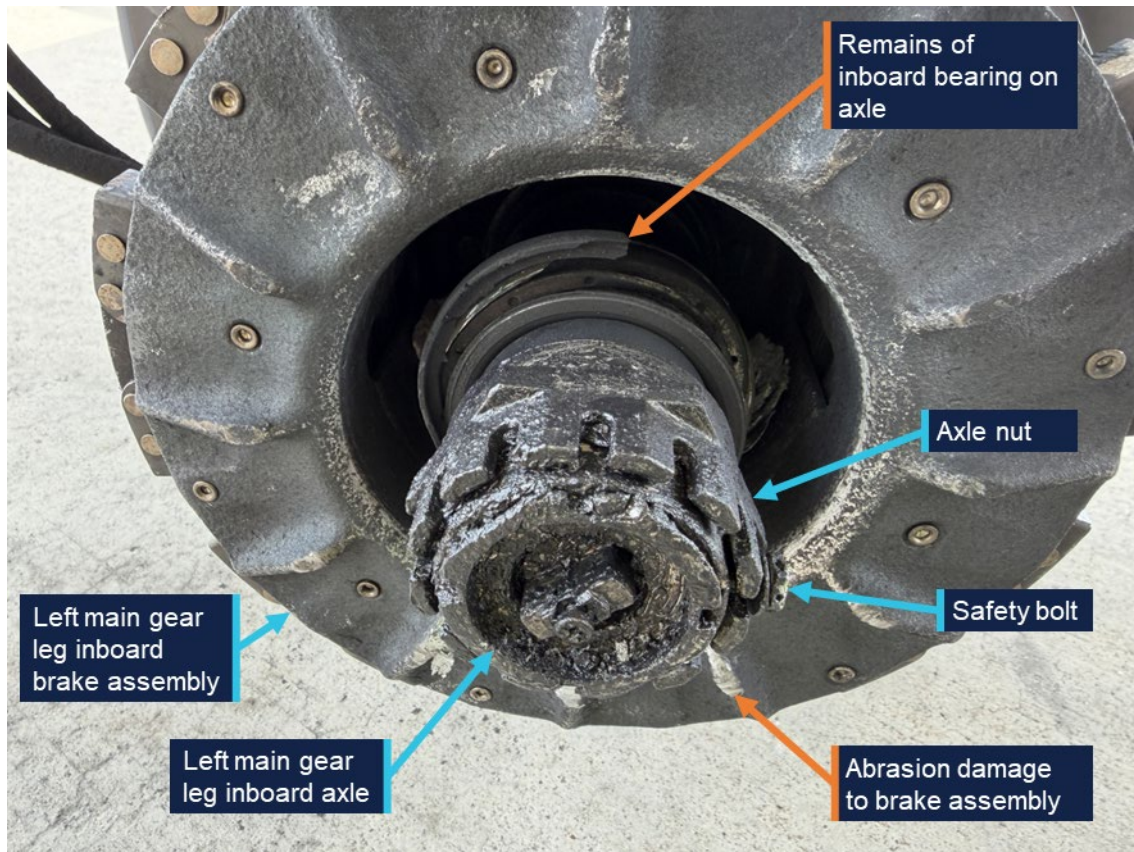
A post-incident inspection of the left main landing gear wheel and the main landing gear axle identified significant damage to both components. The axle nut and safety bolt remained in place on the axle (Figure 5). Remains of the inboard bearing were also identified on the axle, and there was visible abrasion to the brake assembly.

**Figure 5: Left main gear leg inboard axle**

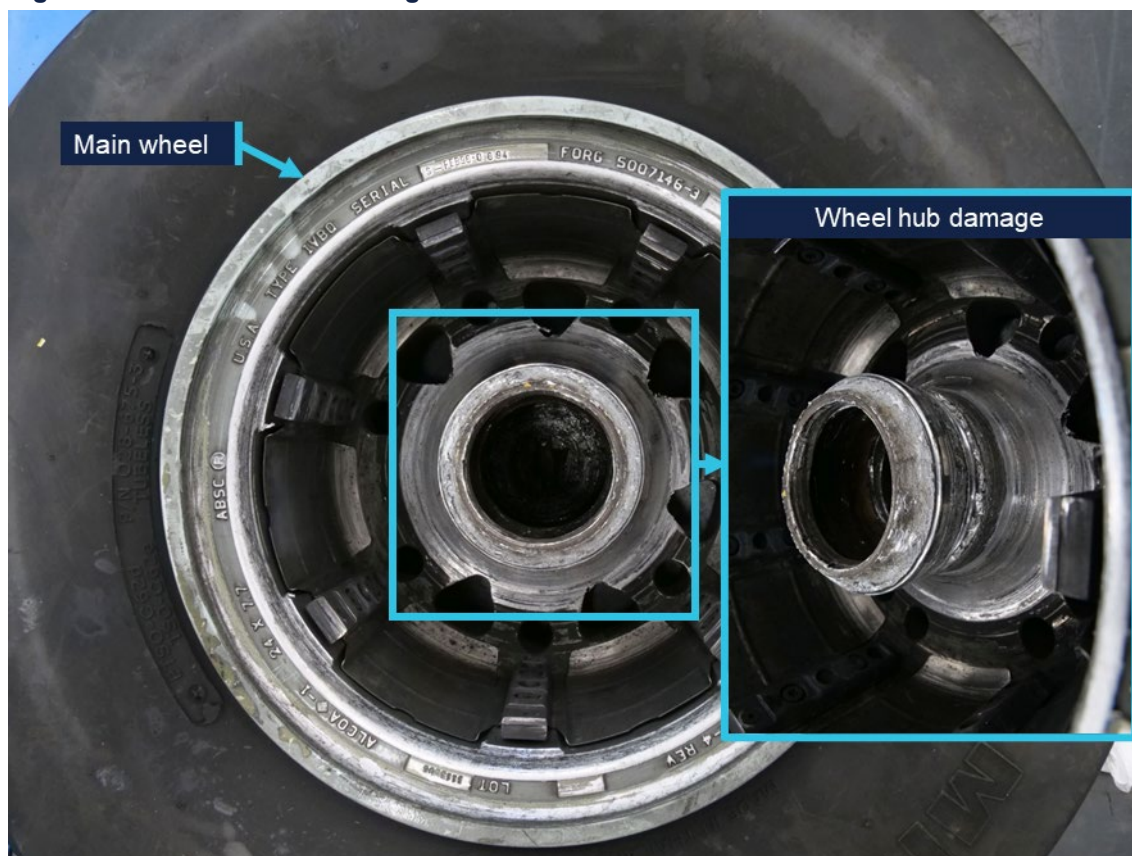
The inboard side of the wheel sustained significant damage (Figure 6). A circumferential fracture surface was visible on the inboard region of the hub encompassing the inboard bearing cone seat. The hub surfaces in proximity to the brake assembly when the wheel is installed exhibited deep rotational gouging and scoring.

**Figure 6: Main wheel hub damage**

Pieces of bearing material were found with the wheel, including 13 roller elements, fragments of the roller cages and bearing seals. The outboard cup remained installed in the wheel. All of the bearing races exhibited significant damage and smearing,<sup>4</sup> including deformation from impact with loose rollers. Both cones had heat colouration as evidence of exposure to high temperatures.

The fractured sections of wheel hub also had evidence of heat damage. To the extent that could be established,<sup>5</sup> the ATSB did not identify any evidence of progressive cracking or pre-existing defect that might have contributed to the fracture.

The level of damage to both bearings, and the absence of any identified pre-existing cracking or defect on the fractured hub pieces supported failure of the bearings as the initiating event. The hub fracture was assessed as secondary, the result of abnormal loading during continued wheel rotation with collapsed bearings.

In response to the occurrence, the operator conducted a fleet-wide inspection of main wheel assemblies and nose wheel assemblies for any defects. No faults were found on any aircraft at the time of inspection.

In addition, the operator has elected to replace wheel bearings on-condition or at every second wheel overhaul, whichever occurs first.
