# Serious incident south of Örebro Airport on 11 December 2024

The Swedish Accident Investigation Authority has investigated a serious incident involving aircraft SE-LGL, a Cessna 172R, in which a loss of control occurred in connection with the use of the autopilot.

16 September 2026

File number: L-132/24

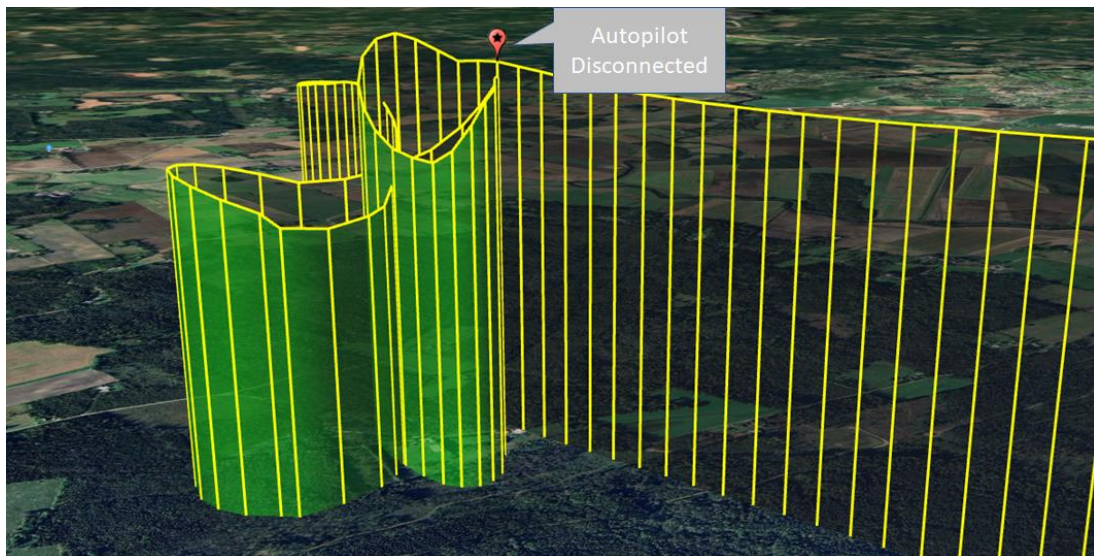
Figure 2. Flight path after the autopilot was disconnected. Image: Google Earth © Lantmäteriet. Markings added by SHK.

Once the autopilot system was disconnected, the pitch attitude increased rapidly at a rate of 26 degrees per second. The maximum pitch attitude reached 56 degrees and the airspeed decreased to 26 knots. The flight was then uncontrolled for 48 seconds, see Figure 2. During this period, repeated variations in pitch attitude between -51 degrees nose-down and 49 degrees nose-up occurred, as well as roll angles between -9 and -121 degrees to the left.

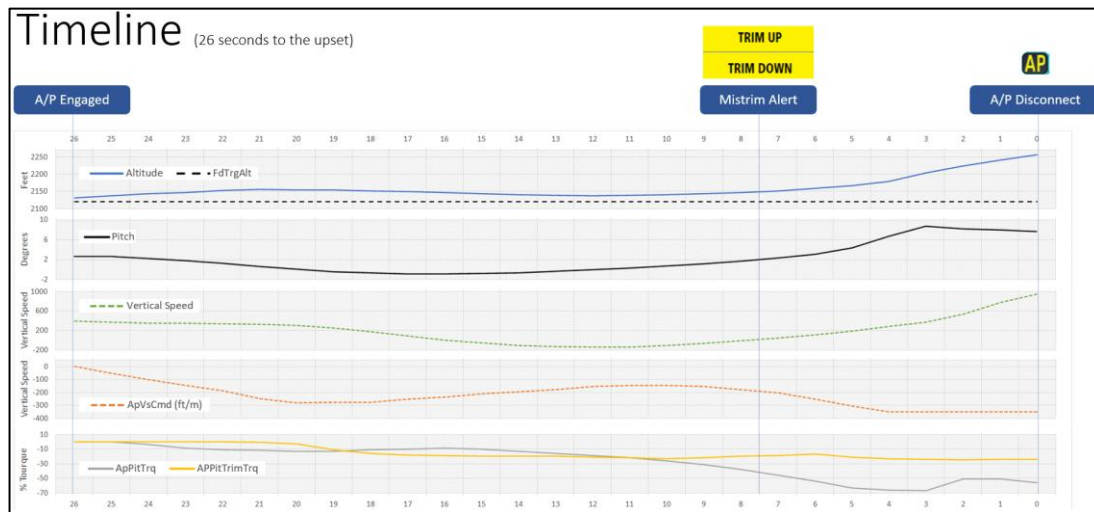
Figure 16. Summary of flight data and GoPro video from when the autopilot was engaged until it was deactivated, 26 seconds later.

The video recording shows that, sixteen seconds after the autopilot was engaged, an amber mistrim alert illuminated on the pilot's flight instrument. This alert indicates that the pitch servo did not have sufficient authority to provide the desired outcome of the autopilot input. At the same time, the recorded data shows that the aircraft's pitch attitude gradually increased and the aircraft began to climb slowly, while the pitch servo increased the applied torque. The pitch trim servo remained active, and the autopilot system continuously commanded nose-down trim.

Furthermore, the video recording shows that the control yoke moved rapidly forward six seconds after the mistrim alert illuminated, at the same time as the pitch servo, according to the autopilot data, reached its maximum torque in the nose-down direction. Despite this, the rate of climb continued to increase. The video also shows that, during this period, the pilot grasped the control yoke first with his right hand and then with his left hand, and that shortly thereafter, according to the data, he disconnected the autopilot system using the switch on the control yoke, see Figure 1.

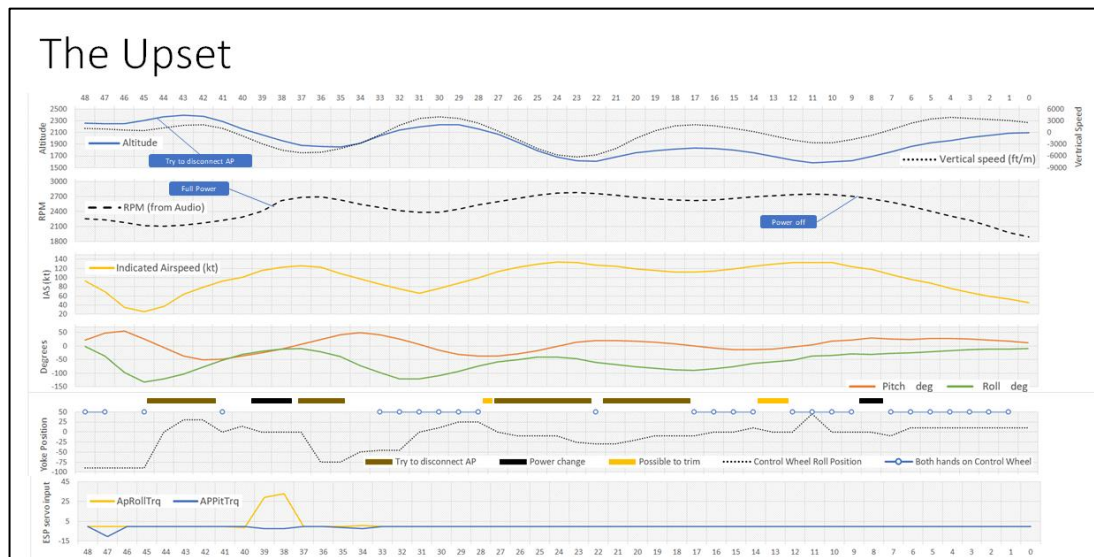
Figure 18. Summary of flight data and information from the GoPro video during upset.

The timeline in Figure 18 covers the period during which the aircraft was uncontrolled, from the moment the autopilot was disengaged until the pilot regained control of the aircraft. The graph showing engine power (RPM) is based on the audio recording from the GoPro video, where the propeller speed has been calculated from the frequency of the propeller noise. The graph of the control wheel position shows the estimated control wheel position derived from the GoPro video. Negative values represent control wheel deflection to the left and positive values represent control wheel deflection to the right.

In addition, information that can be interpreted from the video is presented, including the points in time when the pilot is holding the control wheel with one or both hands, when the pilot attempts to disengage the autopilot, changes in engine power setting, and the period during which it was possible to retrim the aircraft manually with the right hand.

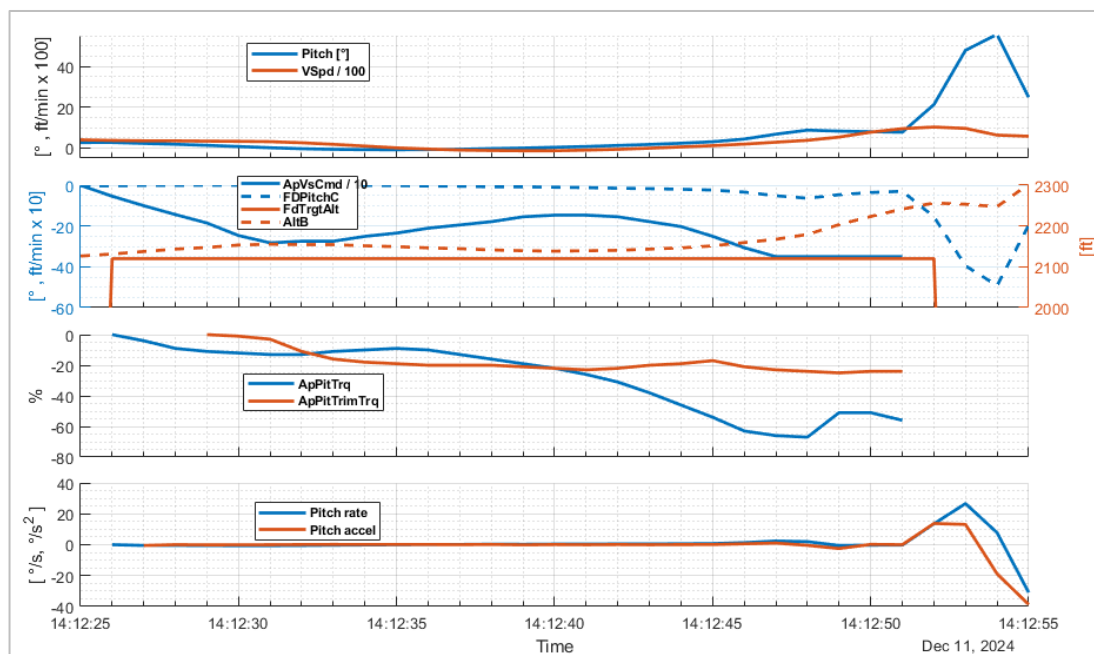
Figure 19. Data for a 30-second sequence, starting 26 seconds before the rapid change in pitch angle, while the autopilot was engaged.

The data in Figure 19 represent a number of characteristic variables relating to the altitude-hold function of the autopilot. The variables in the bottom graph are derived values based on pitch-angle data. The autopilot was engaged to maintain an altitude of 2,100 feet at 14:12:26, at which time the aircraft was above 2,120 feet and climbing. Almost immediately, the elevator servo began to apply a nose-down elevator torque and the autopilot integrated the vertical speed in order to reduce the altitude. Four seconds later, the elevator trim servo was activated to offload the elevator servo (negative values). At around 14:12:32, the altitude began to decrease, before increasing again eight seconds later. The elevator servo continuously applied a nose-down torque which, from 14:12:40, became more negative and reached the maximum negative torque (-67 % of -70 % possible). The elevator servo torque was then reduced to -51 % and finally -56 % at 14:12:51. At 14:12:48, the pitch rate can be seen to decrease slightly.

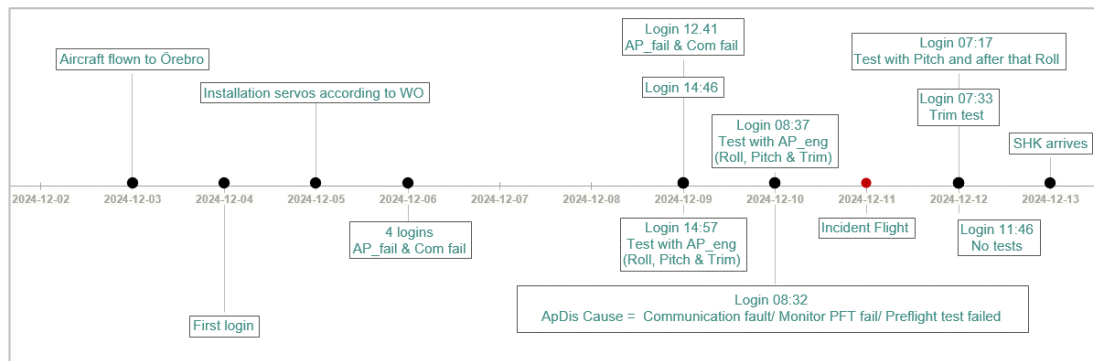
Figure 20. The timeline shows the period from when the aircraft arrived at Örebro for maintenance until SHK was able to examine it. Logins indicate that the maintenance organisation started the GI 275 flight instrument, which then stored data.

On 9 December, the servo-software was updated via the GI 275 instrument from version 2.41 to version 3.10. The first attempt at updating was not accepted by the system and the action had to be repeated. However, fault messages recurred during a number of subsequent tests, including AP fail, Communication fault and Preflight test failed, before a successful test was finally completed, see Figure 20.

SHK has not been able to identify the particular actions that led to the successful completion of the installation.

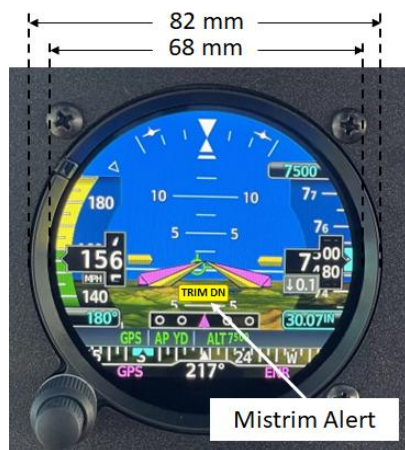
Figure 21. Amber mistrim alert on the PFD indicated by a white arrow. Source: Supercub.org. Annotation and mistrim alert (TRIM DN) added by SHK.

mistrim alert was not noticed by the pilot, which contributed to the subsequent loss of control. There is therefore reason to examine whether the mistrim alert in the system clearly draws the pilot's attention, enabling the pilot to recognise that control forces are present in the system.

The mistrim alert is indicated on the GI 275 instrument by TRIM UP or TRIM DN. It shares a limited display area with a considerable amount of other information. One challenge for the pilot is that Garmin's manuals do not provide an overview of where on the display the mistrim alert is presented. This makes it more difficult for the pilot to prepare and, ultimately, to notice and interpret the alert from the system. The mistrim alert is presented only visually and as a static indication on the instrument. There is no associated aural alert, which further increases the risk of it being overlooked. This is particularly the case when the pilot is operating under VFR<sup>23</sup> and is not continuously monitoring the flight instruments, see Figure 21.
