Fall accident

The Swedish Accident Investigation Authority has investigated a fall accident involving ROERBORG in the Port of Oxelösund, Södermanland county, 15 October 2023

19 November 2024

Final report SHK 2024:16e

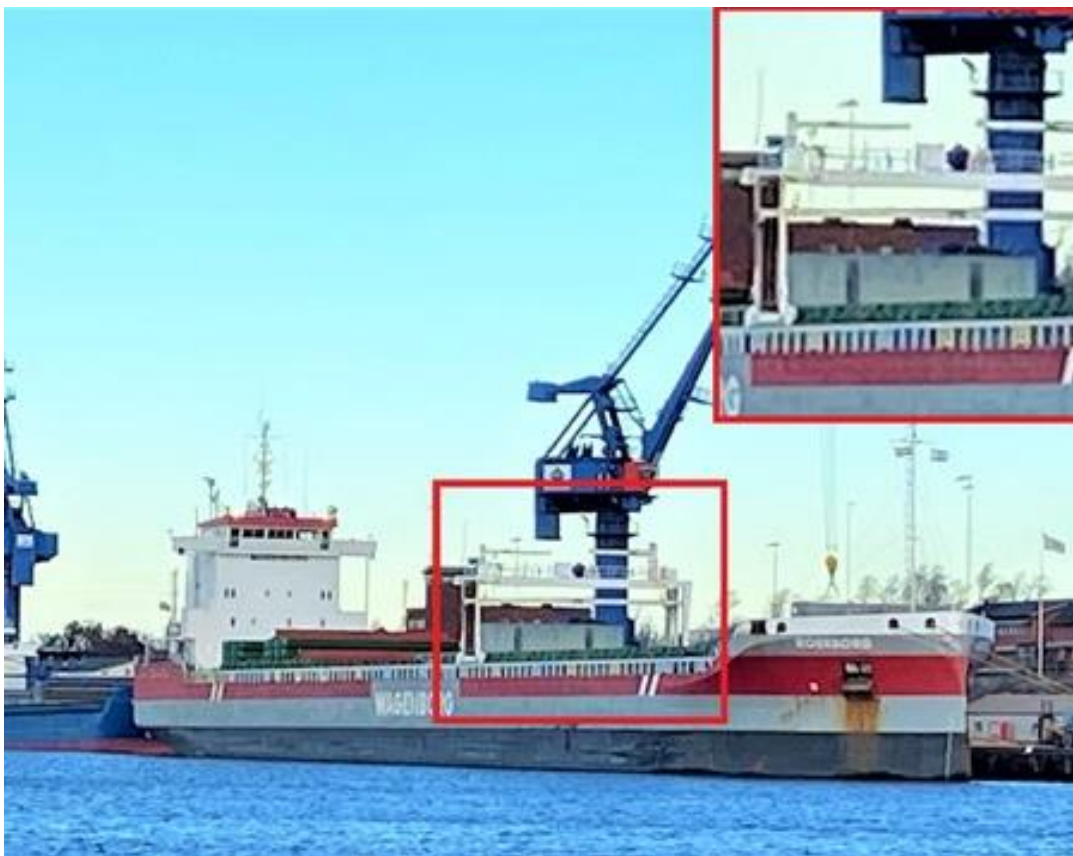
Figure 1. ROERBORG berthed in Oxelösund, but not at the quay where the accident took place. The gantry crane is the white structure visible in the red markings. The blue crane in the background belongs to the port.

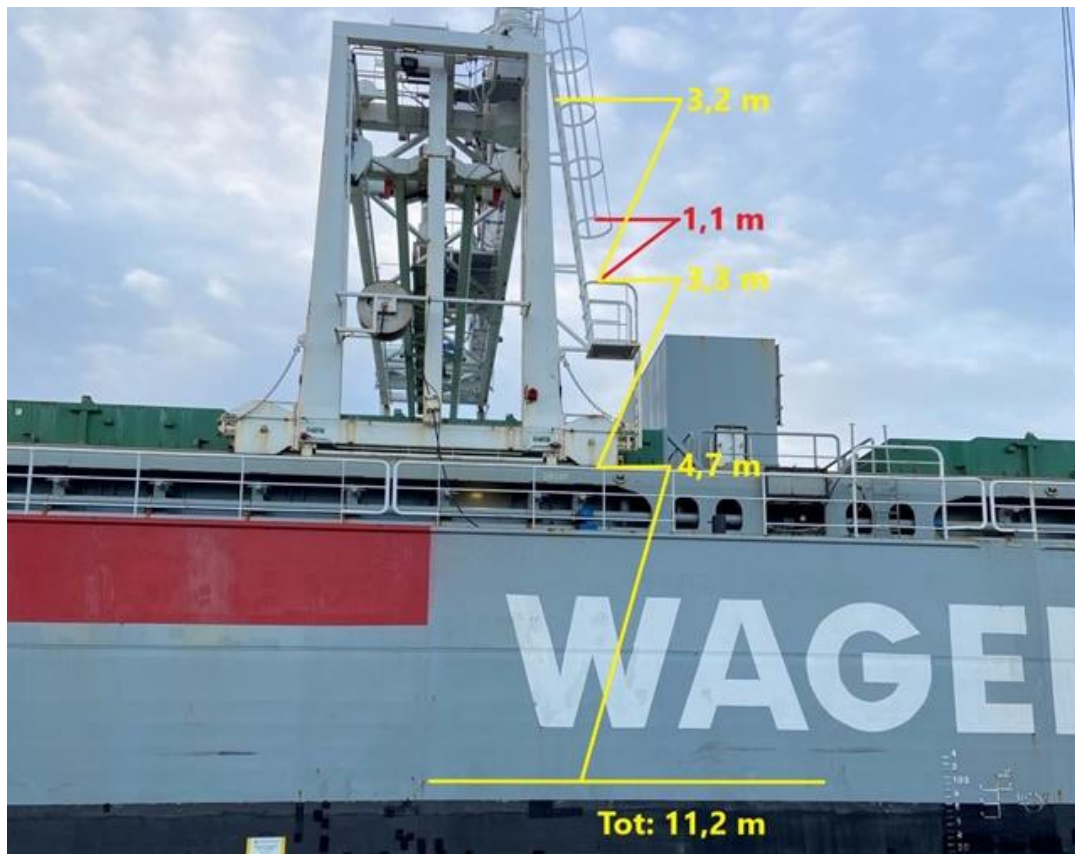
The ladder that the crew member was climbing on was equipped with a protective cage and the platform under the ladder was equipped with a railing. Between the platform railing and the ladder's protective cage there was an unprotected space measuring just over 1 metre, which the crew member fell through, see Figure 2.

Figure 2. The picture shows how the person fell down onto the quay. Yellow lines and figures mark the heights of the various stages of the fall. Red figures and lines mark the opening that was present between the ladder's protective cage and the railing on the narrow platform. The picture has been taken on another occasion when the vessel had a different draught. The bottom yellow horizontal line marks the height of the quay at the time of the accident.

The ladder from the top of the crane, the upper ladder, had a protective basket, but between the platform railing and the ladder protective basket there was a space of 1.1 meters open on all sides. Through that opening the crew member fell out. Had the platform been larger or had additional protection on the sides, the person would have landed on the platform floor instead of falling further.

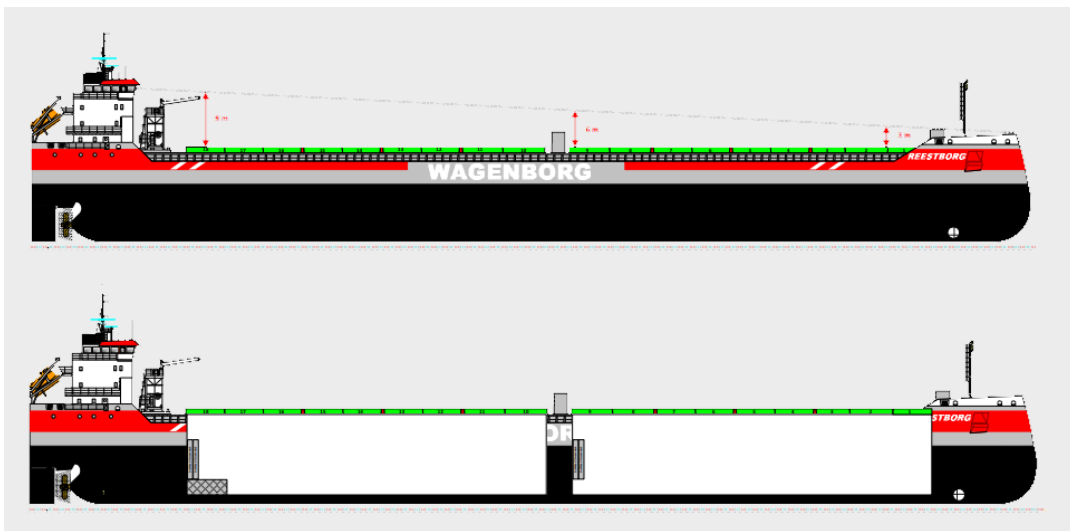
Figure 1. Side view showing the vessel. The lower picture shows a cross-section of the cargo holds.
Illustration: Wagenborg Shipping B.V.

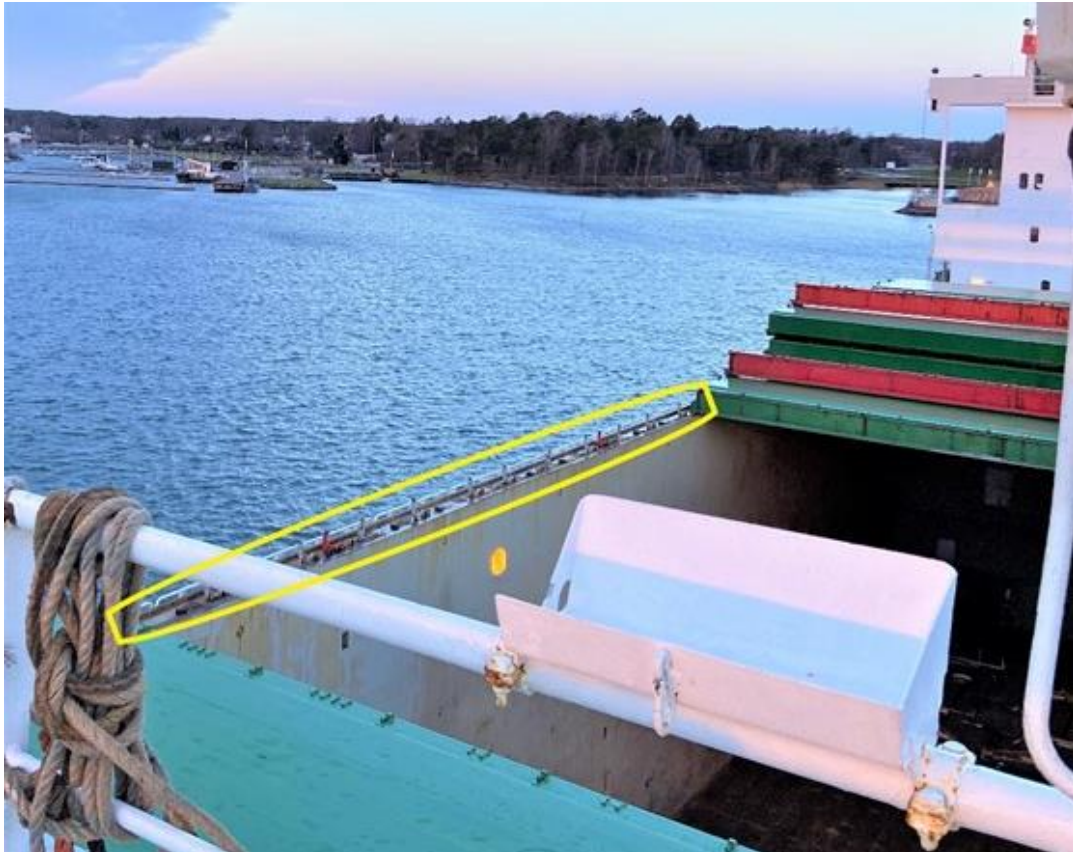
Figure 2. View from the top of the gantry crane. The cargo hold is open and the cargo hold hatches are lying in the background stacked on top of one another. The cargo hold frame is visible within the circled area.

To get to the crane, it was necessary to walk on the cargo hold coaming, which was around 1.3 metres above the level of the deck. The cargo hold coaming was not equipped with railings. Below the coaming was the bulwark, which was about 1 metre wide and had a 110 cm-high railing towards the sea. The cargo hold was on the inside of the coaming. When the cargo hold hatches were removed there was nothing to prevent a person from falling from the coaming down into the open cargo hold.

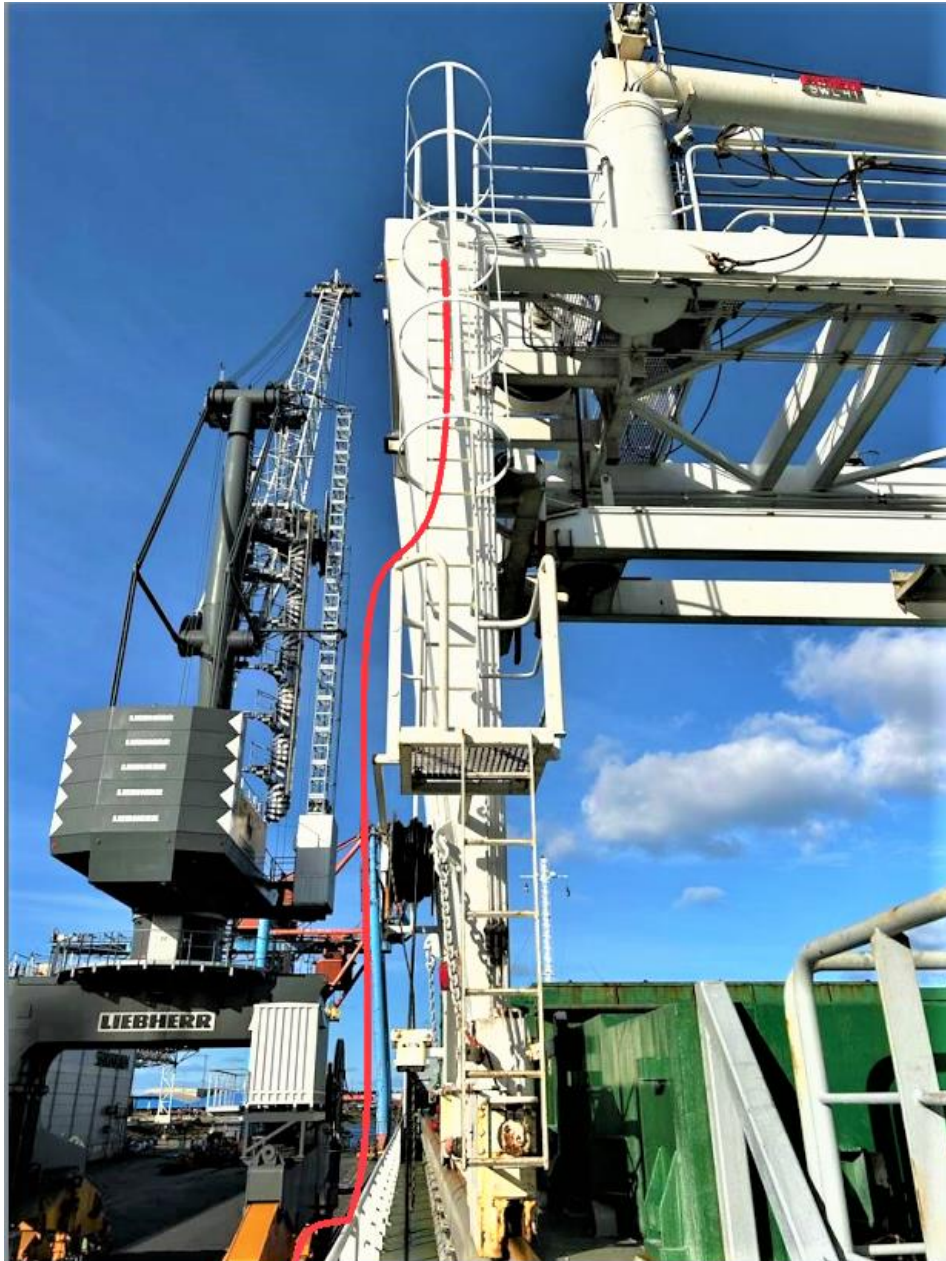
To get up on the gantry crane from the cargo hold frame it was necessary to first climb on a 2.2 metre-high and 30 cm-wide ladder to a small platform. The platform was just over 1 square metre in size and was equipped with a 110-cm-high railing. From the platform there was a 4-metre-high and 30-cm-wide ladder up to the top of the gantry crane. The upper ladder was equipped with a protective cage that began 2.2 metres above the floor of the platform and extended to just over one metre above the upper part of the gantry crane. The protective cage consisted of five horizontal hoops that were welded in place, with three vertical bars between the hoops. The diameter of the hoops was just under 70 cm. There was an unprotected space between the railing on the platform and the ladder's protective cage, see Figures 2 and 5.

Figure 3. The picture shows the ladder and platform of the gantry crane. The red line marks the approximate route of the crew member's fall.

The railing around the platform was 1.1 metres high and protected three of the four sides. The aft side, where the ladder between the cargo holds coaming and the platform was located, was open. The platform was probably not made larger because there would be a risk of this hitting removed cargo hold hatches and other things alongside the leg of the crane.

The open gap between the platform railing and the ladder's protective cage meant that the crew member was not caught as intended when falling down from the ladder. The platform itself only had railings on three sides and was open aft. If a person who is standing on the platform loses their balance, there is a risk of them falling down onto the cargo hold coaming and, in the worst case, also down into the cargo hold or overboard. The shorter lower ladder between the platform and the cargo hold coaming had no protection at all against falling down into the cargo hold, and there was also a risk of falling overboard.

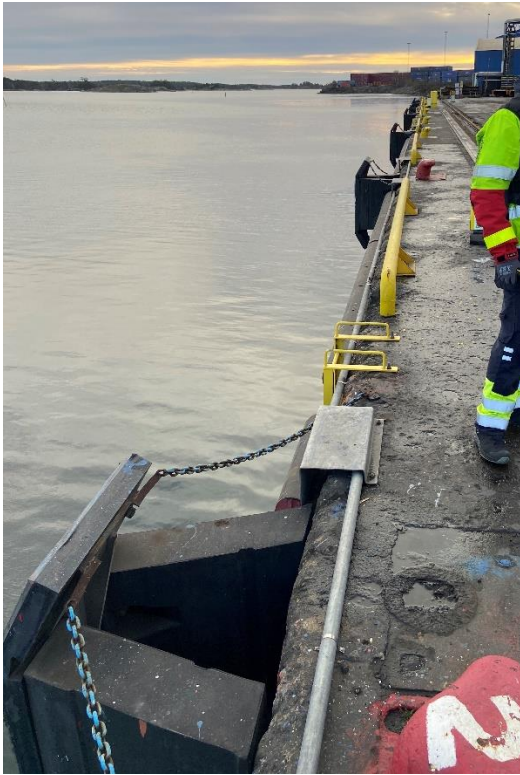
The quay at which ROERBORG was berthed was, approximately 2.5 metres above the sea surface. Impact-absorbent fenders were mounted alongside the quay. These fenders made a gap of approximately 70 cm between the edge of the quay and the side of the vessel when it was berthed, see Figure 6. On the quay there were also bollards, pipe structures, rails and other things that were sticking up.

Figure 4. The quay at the steel port in Oxelösund where the accident took place.
