Accident with a helicopter at Enköping/Långtora Air- port

The Swedish Accident Investigation Authority has investigated an accident with a helicopter of the model 369E with registration SE-JVM at Enköping/Långtora Airport, Uppsala County, on November 18, 2024.

13 November 2025

Final report SHK 2025:18e

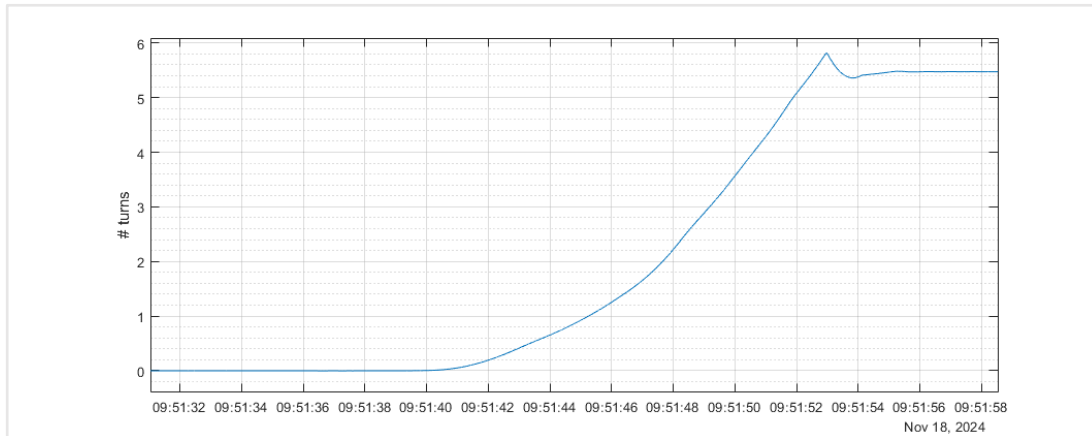
The Visimind system, used for the inspection of power lines, employs several sensors. Data from these sensors have been analysed by SHK to assess movements and accelerations. This analysis determined, among other findings, that the helicopter completed six full rotations after take-off, with the angular velocity gradually increasing and the rotation occurring in the same direction throughout, see Figure 5.

Figure 5. Number of rotations of the helicopter as a function of time.

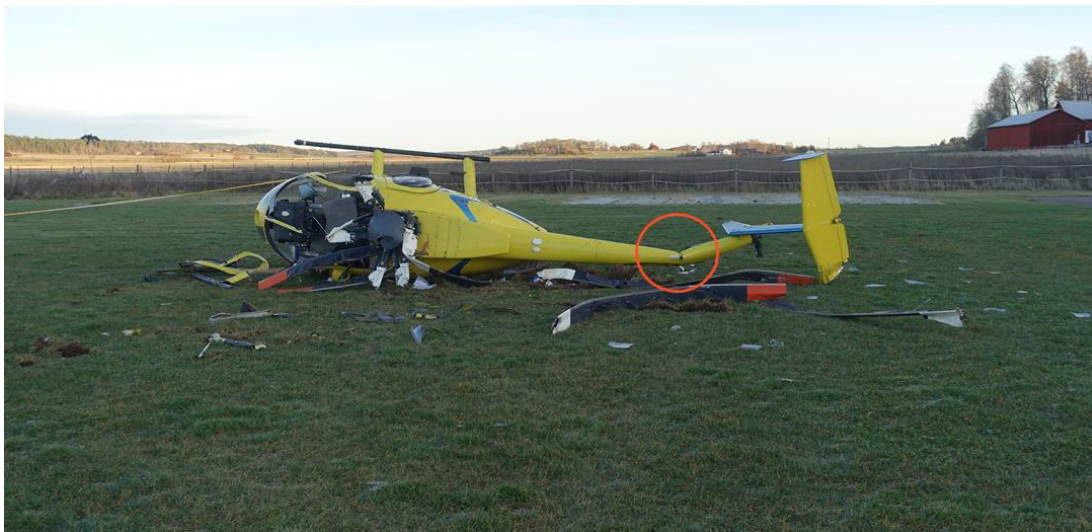
The marks in the ground indicated where the main rotor blades, left main landing gear and stabiliser struck the ground. Sequential impacts with the ground brought the rotation of the main rotor to a stop. The tail boom sustained significant damage. The damage to the helicopter is shown in Figure 8.

Figure 8. The aircraft wreckage, the damage to the tail boom marked with a circle.

The technical investigations conducted have not identified any faults that could have contributed to the accident. The damage to the helicopter, including the broken drive shaft and other damaged components of the yaw control system, is assessed to have occurred upon impact.

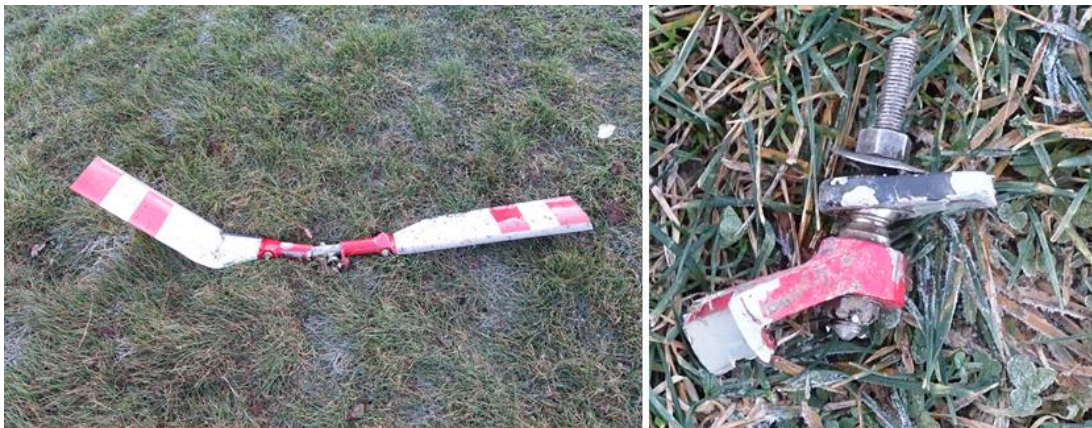
The tail rotor was found five metres northeast of the helicopter, see Figure 9. A pitch arm was found five metres southwest of the helicopter, see Figure 9. Other parts scattered in connection with the accident consisted mainly of parts from the helicopter's window panes. The fuel tank had been damaged in several places and fuel had leaked onto the ground underneath the helicopter. No oil leaks were observed.

Figure 9. The left image shows the tail rotor where it was found. The right image shows one of the tail rotors blades pitch arms, along with a section of a pitch link.

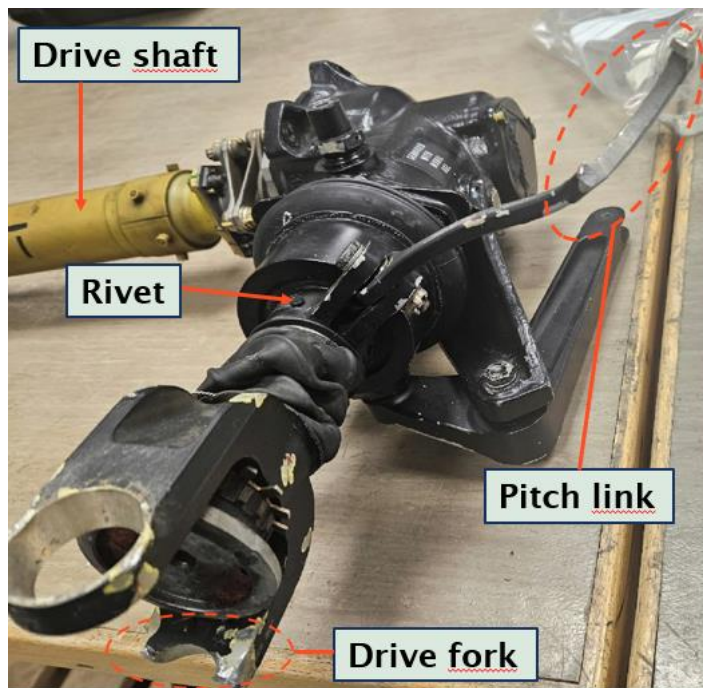
Figure 10. Tail rotor gearbox with damaged parts marked.

The drive fork, pitch links, rivets and tail rotor (including the pitch arm, the blade at the blade pitch attachment and the hub) have failed as a result of instantaneous ductile overload fracture.

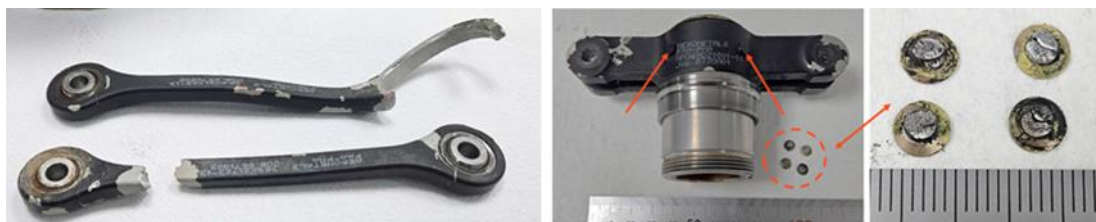
Figure 11. The picture on the left shows the damaged pitch links. The pictures on the right shows the damaged rivets. The rivet heads are coming from the inside of the housing.

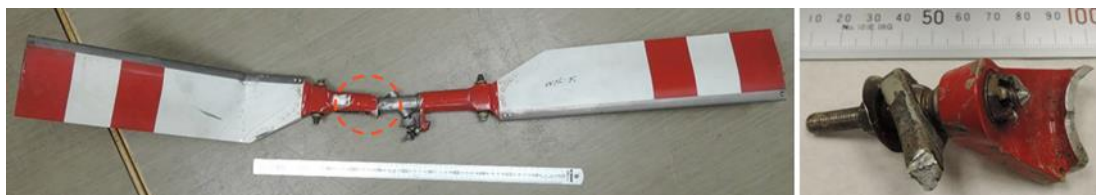
Figure 12. The picture on the left shows the tail rotor, with the marked area indicating the focus of the examination. The picture on the right shows the broken pitch arm along with a section of the pitch link.

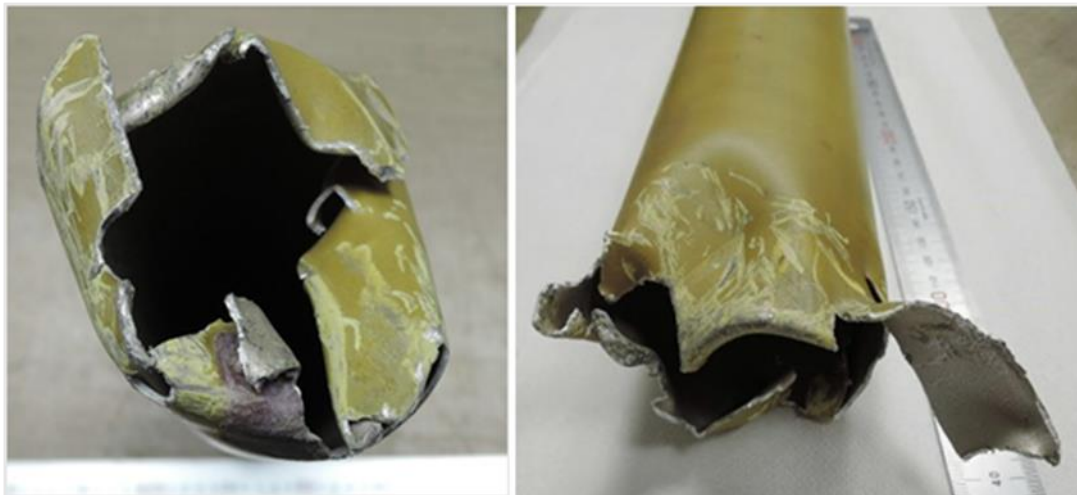
Figure 13. The picture on the left shows the fracture on the section of the drive shaft leading towards the engine. The picture on the right shows the fracture on the section of the drive shaft leading towards the tail rotor gearbox.

It is not possible to determine failure mode for the tail rotor drive shaft due to damaged fracture surfaces. As the drive shaft has not deformed along its long axis, it is assessed that the tail rotor drive shaft has not failed due to torsion, but to due to bending or buckling.

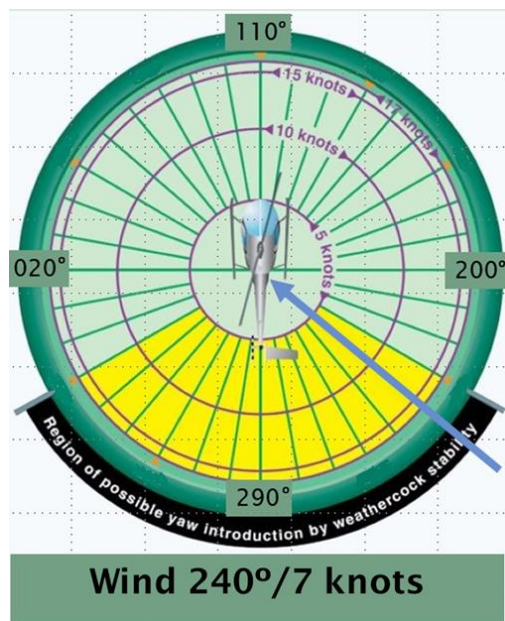
The wind, coming obliquely from behind on the right side, within the range and wind strength capable of causing an unanticipated yaw, likely caused the helicopter to yaw unexpectedly to the right, turning up to the wind due to weathercock stability, see Figure 16. The helicopter's relatively high take-off mass, combined with high power output during the hover, may also have contributed to the tail rotor's insufficient thrust capacity.

The pilot's perception that the wind was coming from the front during take-off and hover likely contributed to the yaw being unexpected and to a delayed corrective response. As the rotation continued, full pedal movements may have been insufficient to counteract the yaw moment and stop the rotation. This likely explains why the pilot felt that the rudder inputs were ineffective.

Figure 16. Weathercock stability, wind from behind, 120° to 240°. Prevailing wind at the time was 240°/7 knots. The blue wind arrow shows the approximate wind direction relative to the helicopter. Markings added by SHK.
