# MARCO POLO – Grounding in Northern Hanö Bay

The Swedish Accident Investigation Authority has investigated a shipping accident that took place in the northern part of Hanö Bay, Blekinge County, on 22 October 2023.

17 February 2025

File number: S-199/23

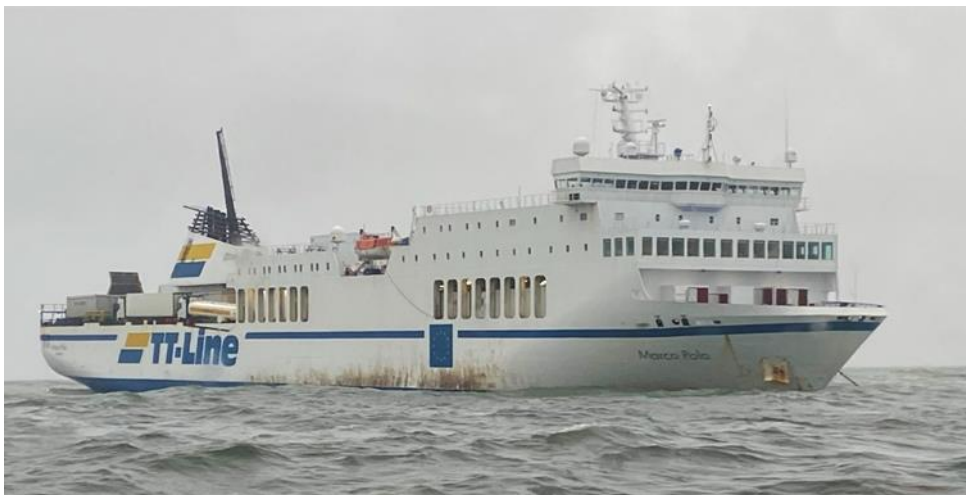
Figure 2. Picture of the vessel following the grounding. Picture: Swedish Maritime Administration.

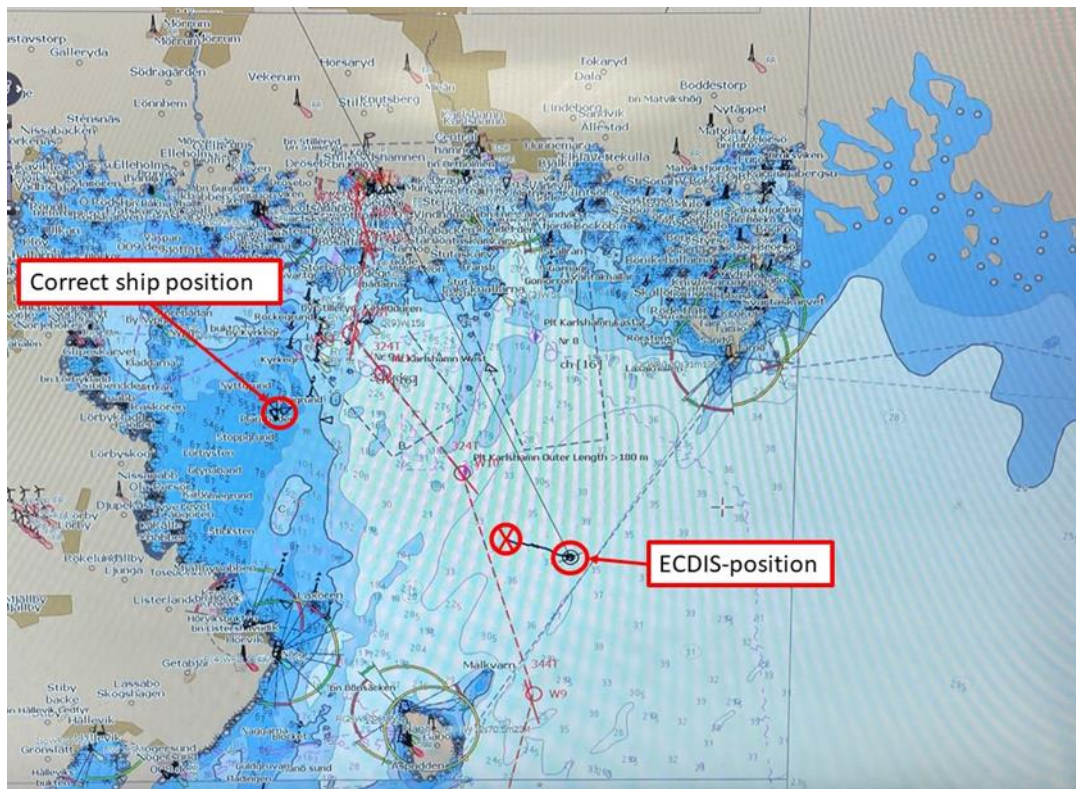
On the vessel's bridge there was confusion about what had happened. The ECDIS showed that the vessel was out in 30-metre-deep water and drifting at half a knot in an easterly direction, see figure 6. The crew was still unaware that the vessel had run aground.

Figure 5. Photograph of the display of the vessel's ECDIS after the second grounding. The mark to the right in the picture (ECDIS position) shows the vessels position and drift calculated from the dead reckoning. The vessel's actual position is marked left in the picture. Text and markings inserted by SHK. Picture: The Swedish Maritime Administration.

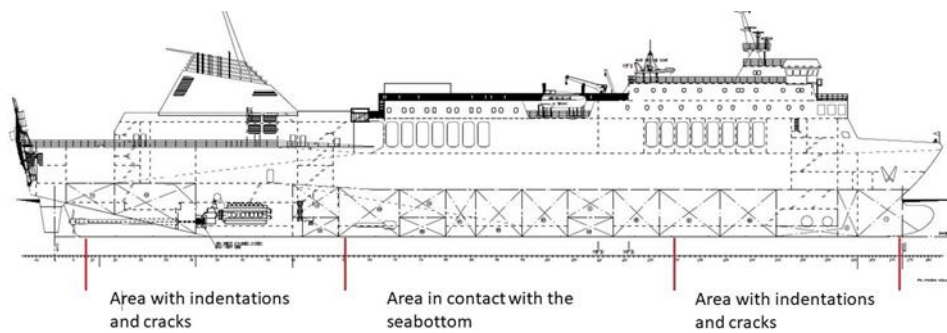
Dives took place in order to inspect the damage to the hull. It was found that the vessel had bottom contact with the shoal at a point just forward of the engine room, and stretching 50 metres forward (see figure 7). Large indentations in the hull with holes and cracks into the vessel's tanks were observed in several places, but the propulsion machinery and rudder appeared to be undamaged.

Figure 6. Side view of the vessel. The picture shows the damage to the vessel following the second grounding.

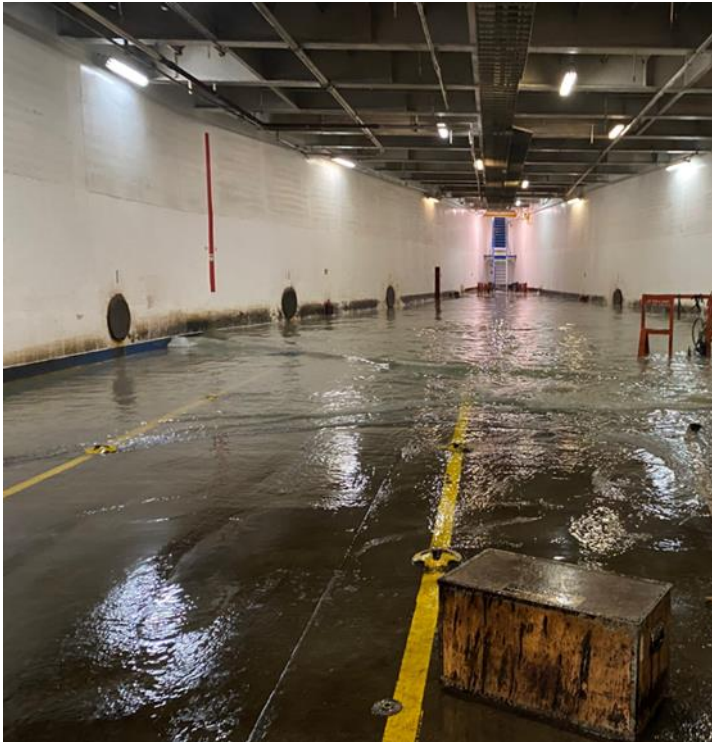
After 25 minutes, the vessel had turned towards the waves, and the movement of the vessel decreased. Through leaking manholes and a broken sounding pipe, the vessel was taking in water in her lower hold and in the bow thruster compartment.

At the time, the bilge pump system on board could not pump out the flooding water, see figure 9. Preparations were therefore made for a second evacuation of the vessel.

Figure 8. The picture shows water ingress in the lower cargo hold after the third grounding. Picture used with permission of the Swedish Maritime Administration.

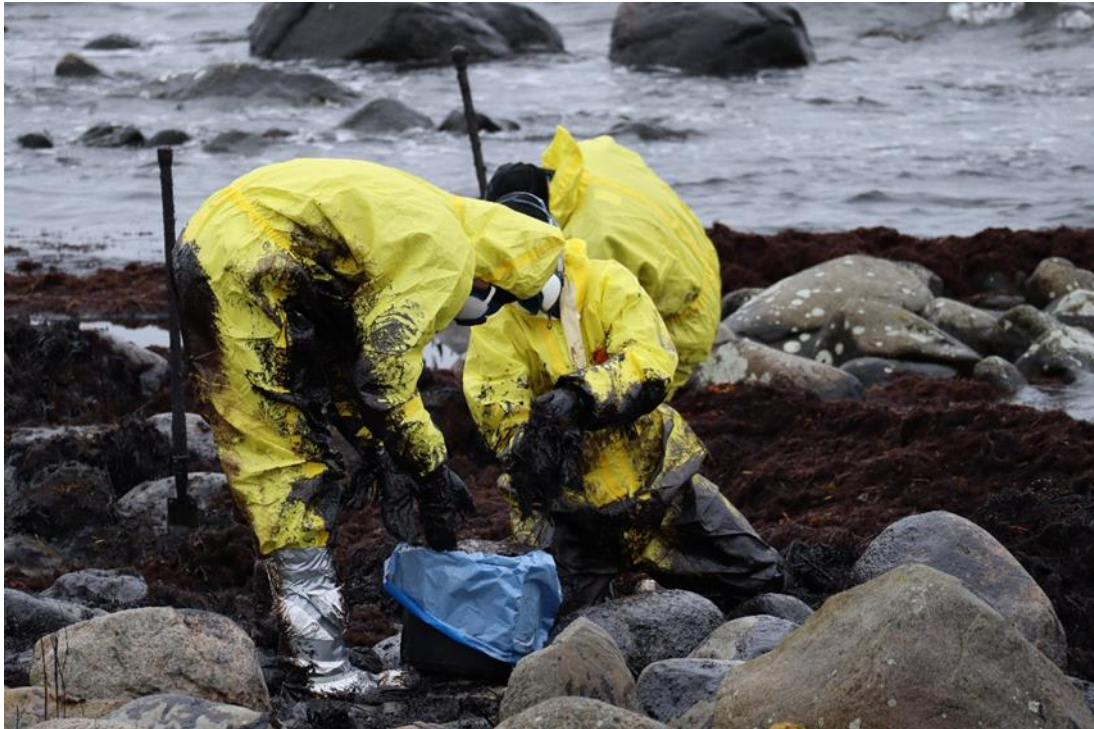
When the vessel drifted off the shoal, new oil spills were observed. The oil booms that had been set out around the vessel were released in order to allow access for the vessels engaged in the evacuation. At sea, the Coast Guard worked to encircle oil with booms and recover it. Ashore, the municipal rescue service decided to deploy municipal rescue operation measures in bays that had not already been affected by the oil. Together with the municipality and the SSRS, booms and beach protection fabrics were set out at Sternö-Sandvik. The conditions

Figure 9. Picture of the oil clean-up work at Spragehall. The picture is from Sölvesborg Municipality.

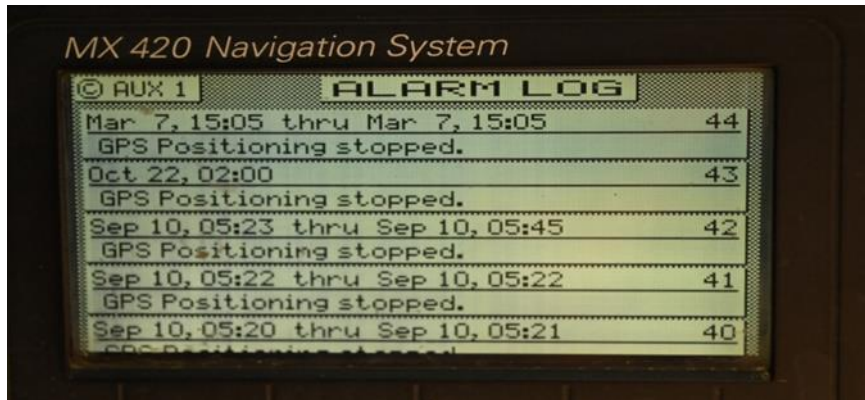
radar systems. The receiver's alarm log shows that a GPS rollover error (date fault) occurred at 01:59:59 hrs. The error occurred when the GPS receiver's built-in clock passed 23:59:59 UTC<sup>15</sup> on 21 October 2023, at which time the date in the GPS receiver changed to 5 March 2004. The image displays the date rollover error, see figure 11.

Figure 11. Image from the alarm log on the Leica MX 420 GPS receiver. The picture was taken on board, two days after the grounding.

The fault resulted in the ECDIS and the radar systems rejecting the positioning signal from the receiver, thus losing the incoming positioning signal.

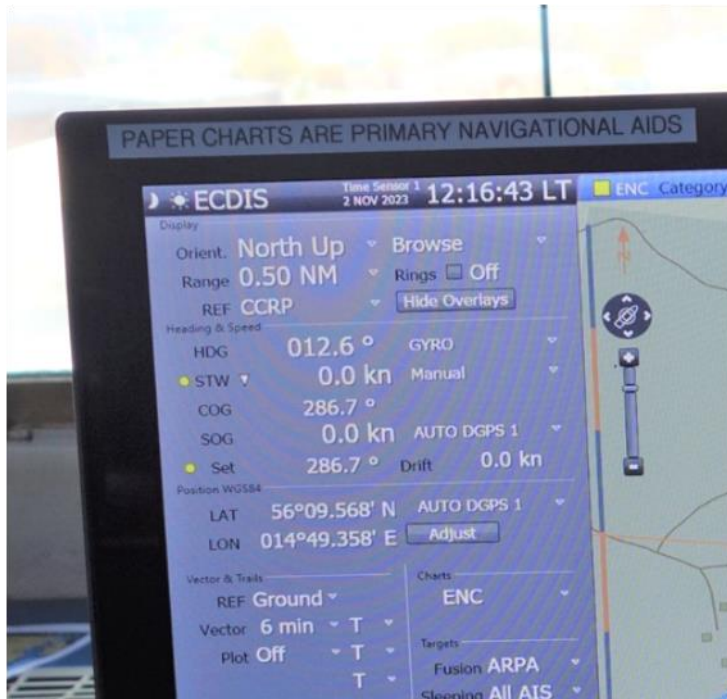
Figure 12. Picture of the ECDIS screen. Photographed during one of SHK's on-board visits after the accident. Note the text on the screen frame on top.

The ECDIS lacked a radar overlay function, i.e. the potential to add the radar image from either of the two radar systems. This function is an aid that facilitates the comparison of radar information with chart data. However, this function is an aid and not a requirement for an approved ECDIS.

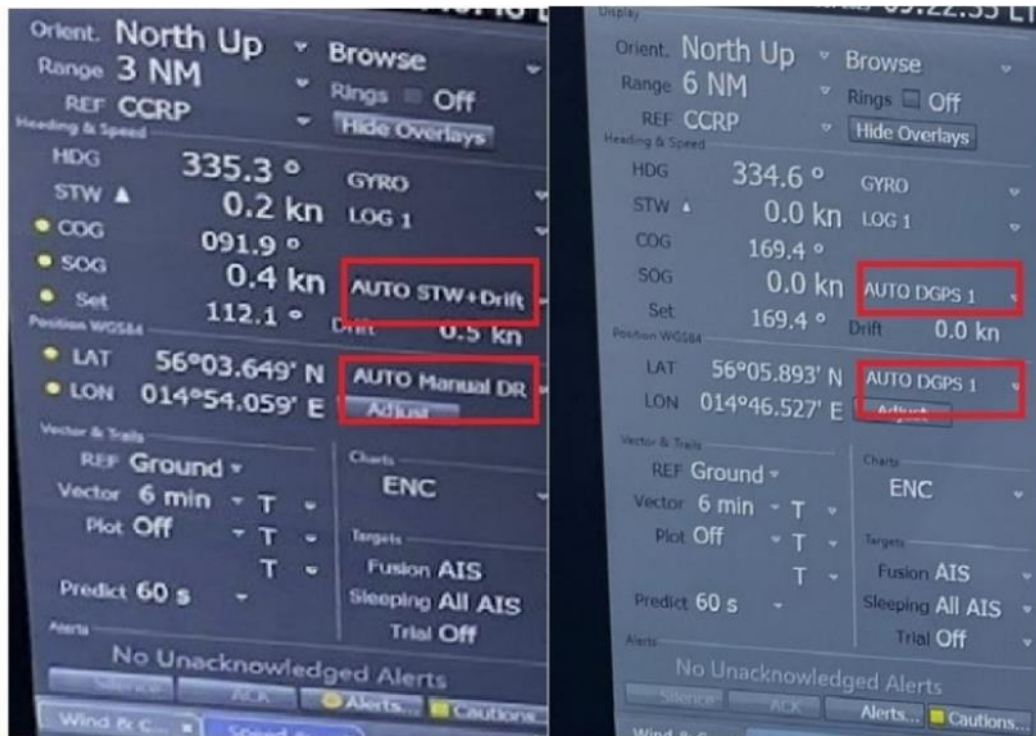
When the alarm was activated, a yellow marking was also shown on the navigation parameters that were dependent on GPS data. In the position field in the sidebar menu the marking "DGPS 1" was replaced with "Auto Manual DR", which indicated that the ECDIS had switched over to dead reckoning. These indications were there even after the acknowledgement of the alarm for loss of position in the ECDIS. In other words, after acknowledgement, there was still information about dead reckoning on the ECDIS display, albeit only as a small marking in the sidebar, see the red marking in figure 13.

Figure 13. The image on the left shows the navigation panel on the ECDIS when the systems does not have an incoming GPS signal (dead reckoning). Note yellow spots as 'Alerts'. The image on the right shows the navigation panel on the ECDIS when the system has incoming GPS signal. The red squares have been added by SHK.

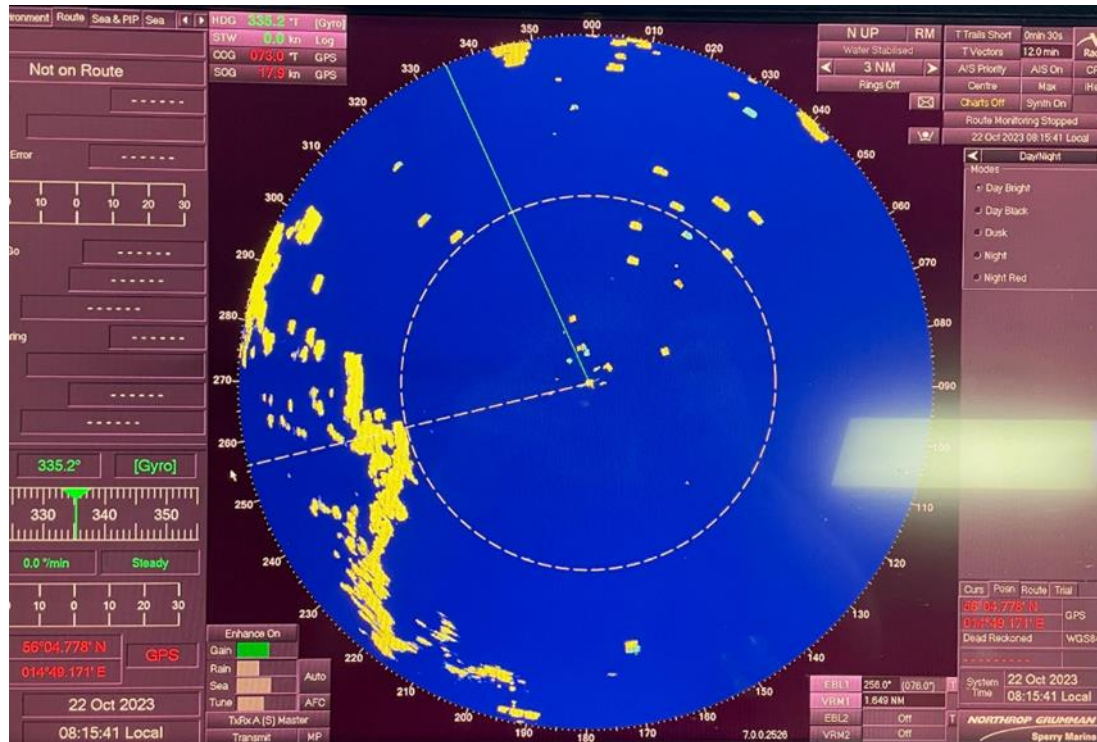
in the same manner as the ECDIS. The fact that the system had switched to dead reckoning to determine its position was signalled in the ECDIS by the colour of the digits of the GPS position changing from white to red, and by the white text beneath the positioning data in the right part of the radar screen that stated, “Dead Reckoned”, see figure 14.

Figure 14. The S-band radar shows the position of the vessel at the time of the second grounding. The position is shown in red both at the lower right and the lower left. Below the right position, the white text "Dead Reckoned" can be seen. The photo, which has been cropped slightly, is from the shipping company.

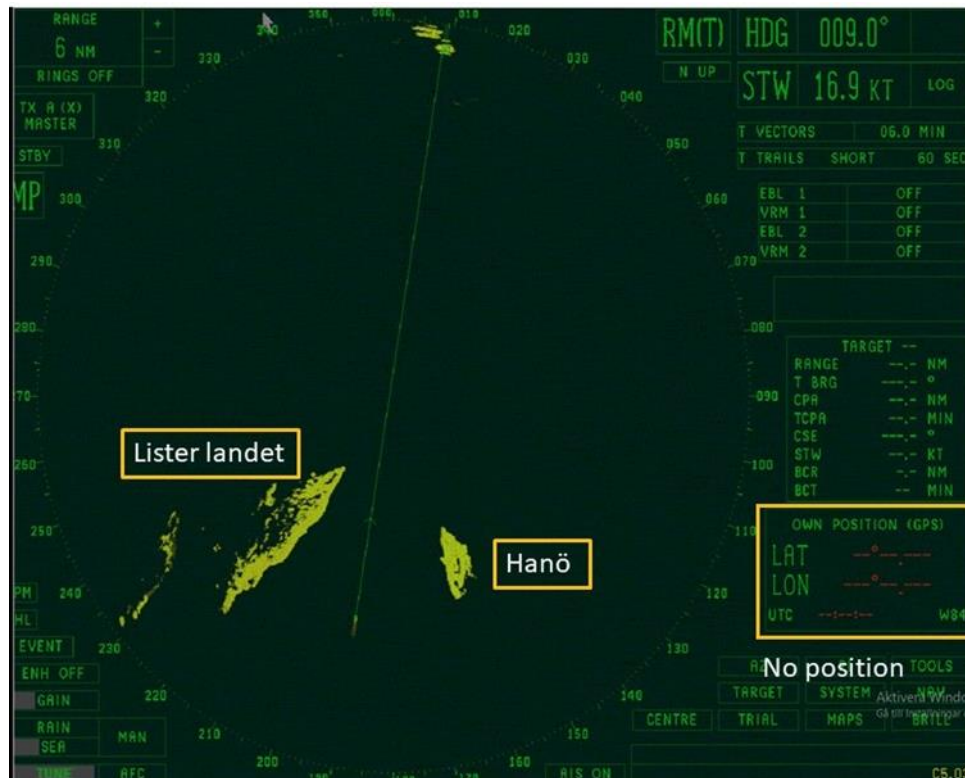
The VDR system, which recorded the radar image from the X-band radar, shows the actual passage of the vessel between the mainland and the island, see figure 15.

Figure 15. VDR recording of the X-band radar from 05:02 hrs. The yellow fields on either side of the green line showing the course consist of land bodies. Note that no GPS position is presented in the lower right corner (LAT, LON). Boxes and white text inserted by SHK.
