SUMMARY OF UNDERWATER ROBOT SURVEY OF PASSENGER FERRY ESTONIA 14-15.07.2021

20.07.2021

TUUKRITÖÖDE OÜ
Graniidi 20-9
10413 Tallinn
+372 501 6663
tuuker@tuuker.ee

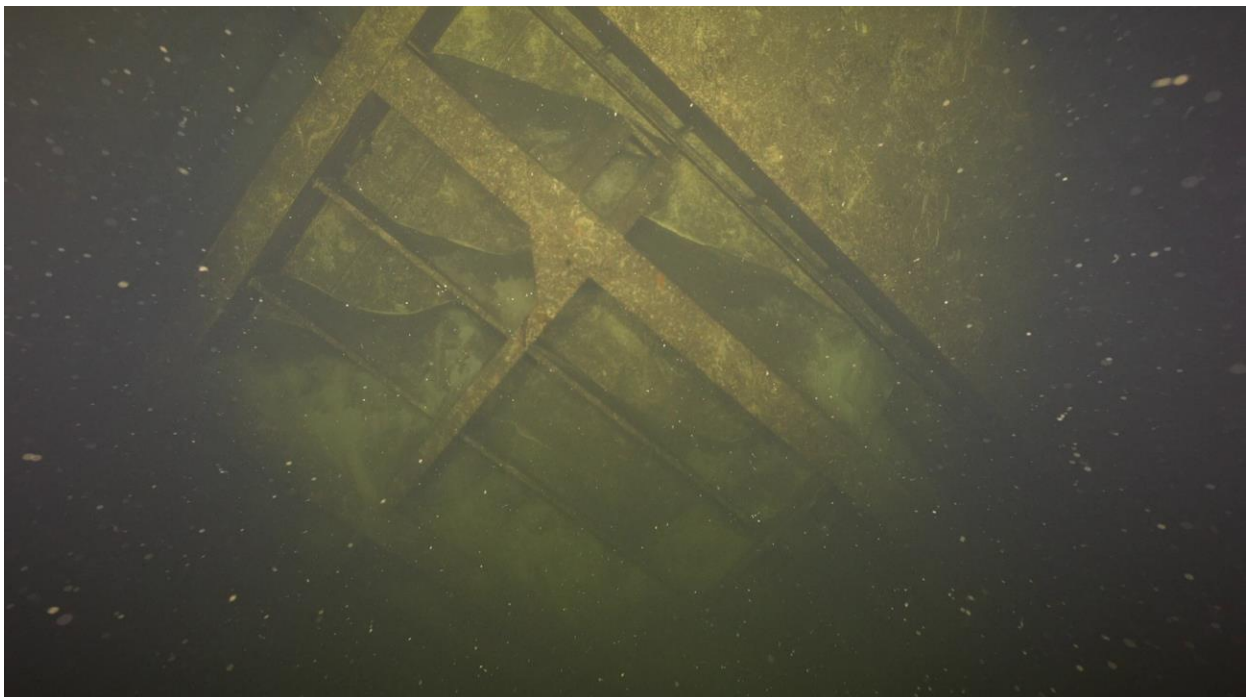
Work was performed in the stern part of the wreck to determine the position and condition of the stern ramps, the condition of the rudder blades and propellers, and the mudline in the stern part. During the works it became clear that the stern ramps are in the closed position: 15.55

No damages were discovered on the outer sides of the stern ramps. The lower right stern corner of the hull is partly inside the ground.

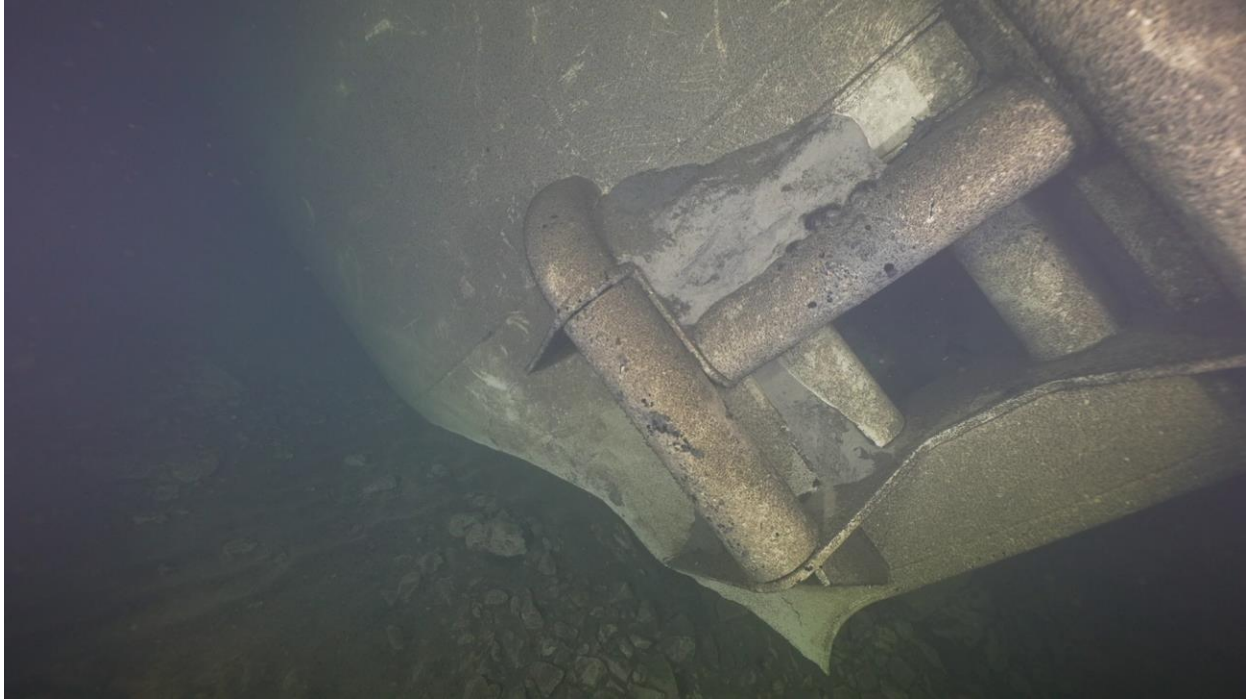
One can see a fairlead with rollers and gravel used for wreck covering works:
21.13

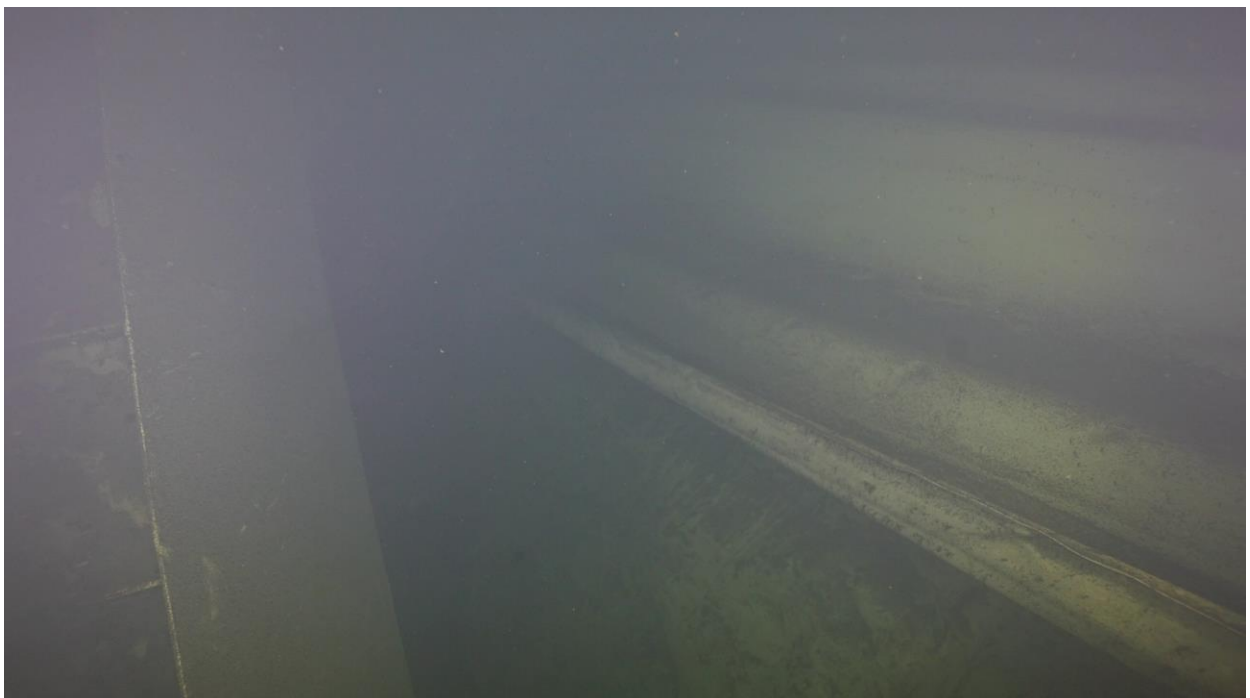
One can see a geotextile or a detail of the superstructure lying on the seabed behind the stern (pictured on the right): 22.23

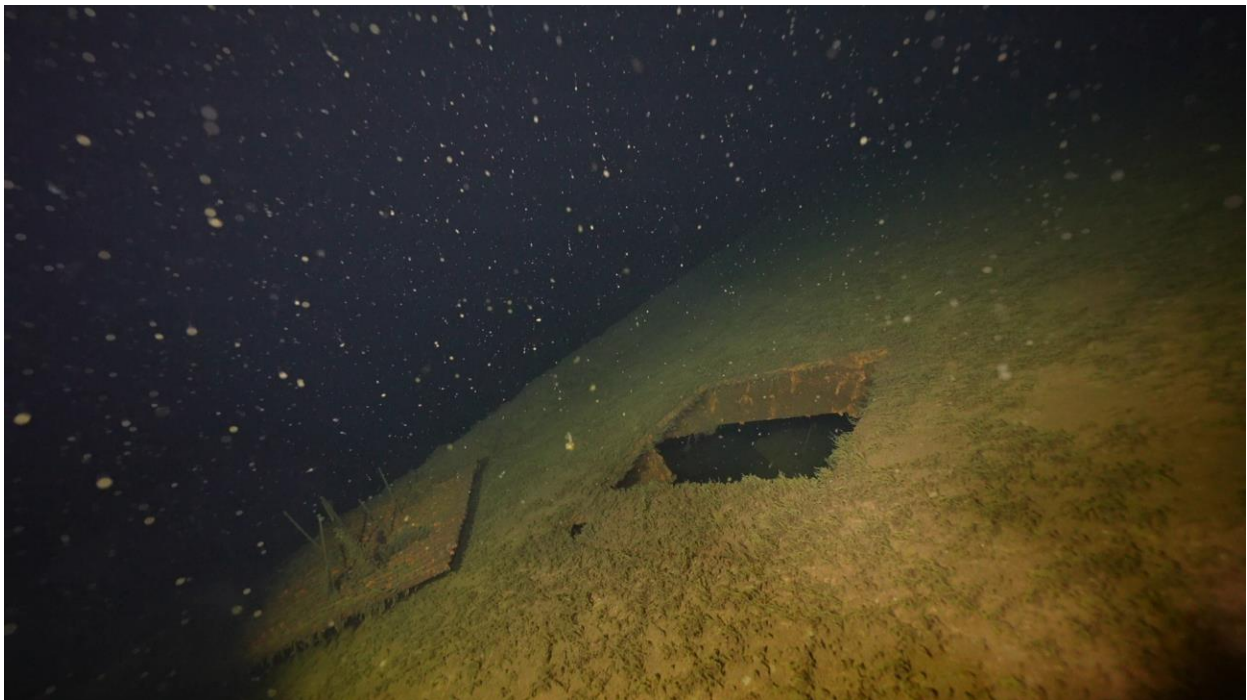
Next it was headed upwards to the port side (1.25.00), where the condition of the centre part of the flat bottom of the vessel and an inlet on the port side cut into the hull (1.35.34) during the diving survey in 1994 was observed, and the metal truss that was used to close it with a cut-out piece of the hull.

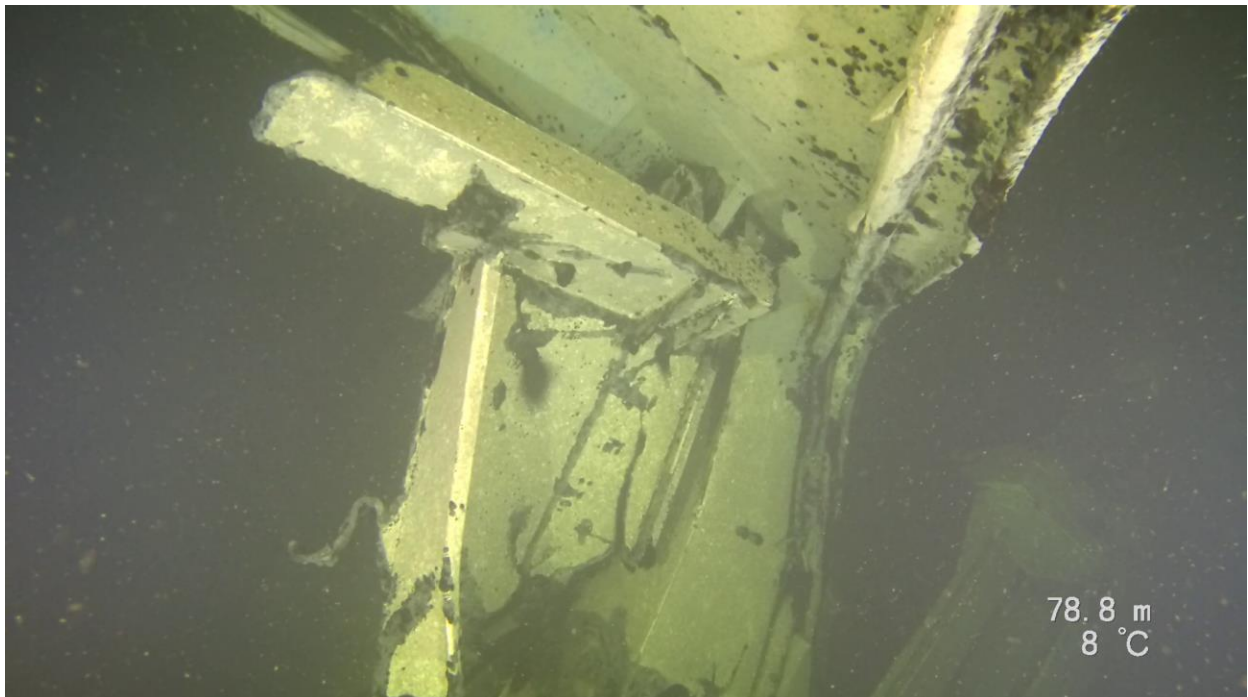
55.06 A closer look shows how the stiffeners, plating and welds are torn on the fragment. Next to the longitudinally hanging longitudinal stiffener, one can see a strip of torn and rolled steel plate.

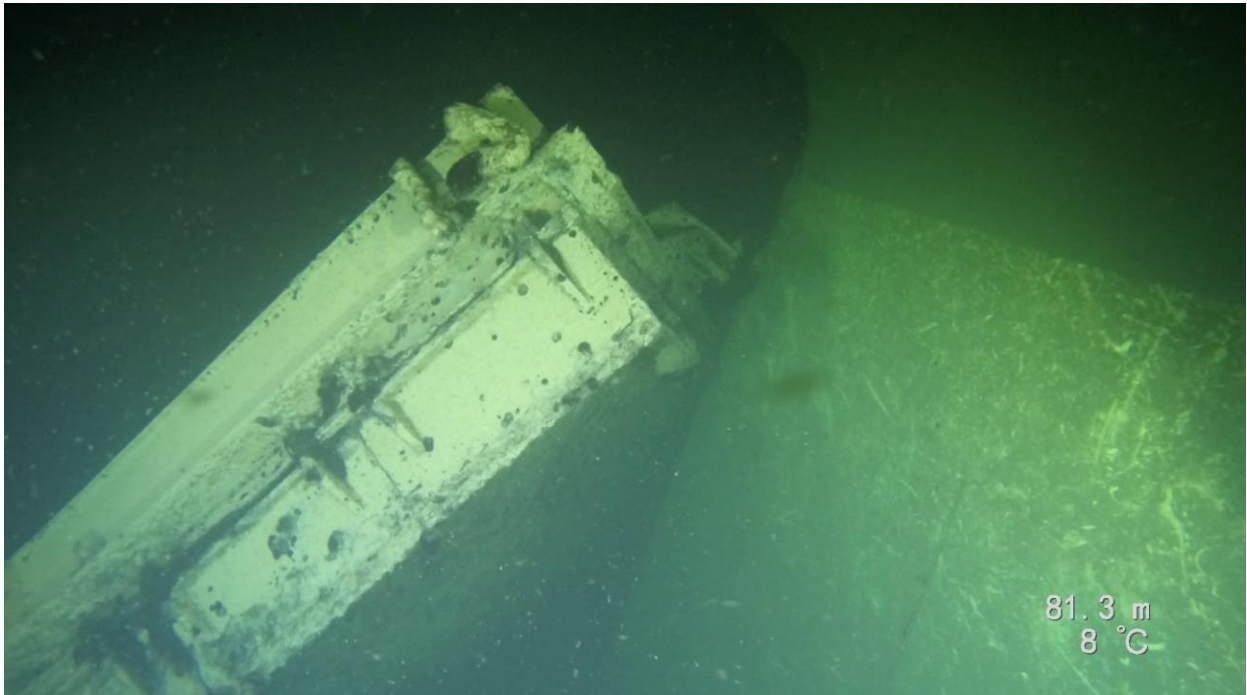
1.03.30 Back again next to the draught marks on the starboard side of the bow and descending to the bow ramp: 1.06.32

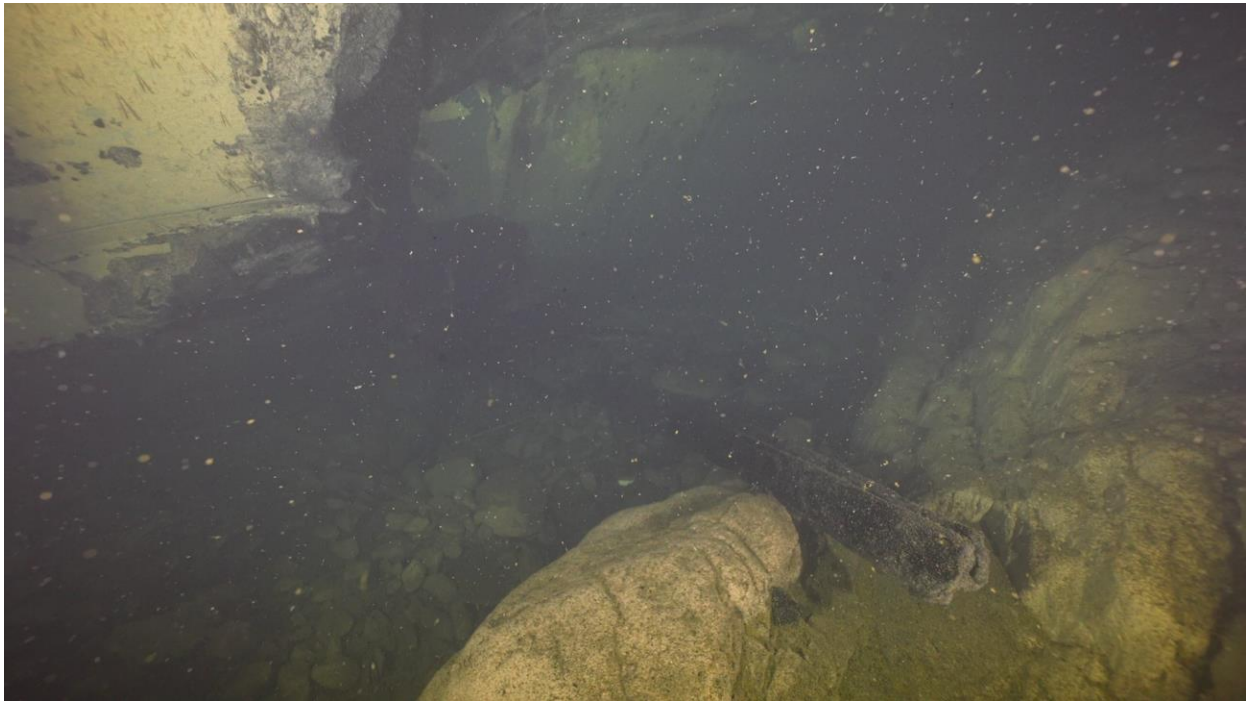
25.03 Even steeper ascent and rupture in bow side. One can see a stronger base and the slope of the moraine layer on it.

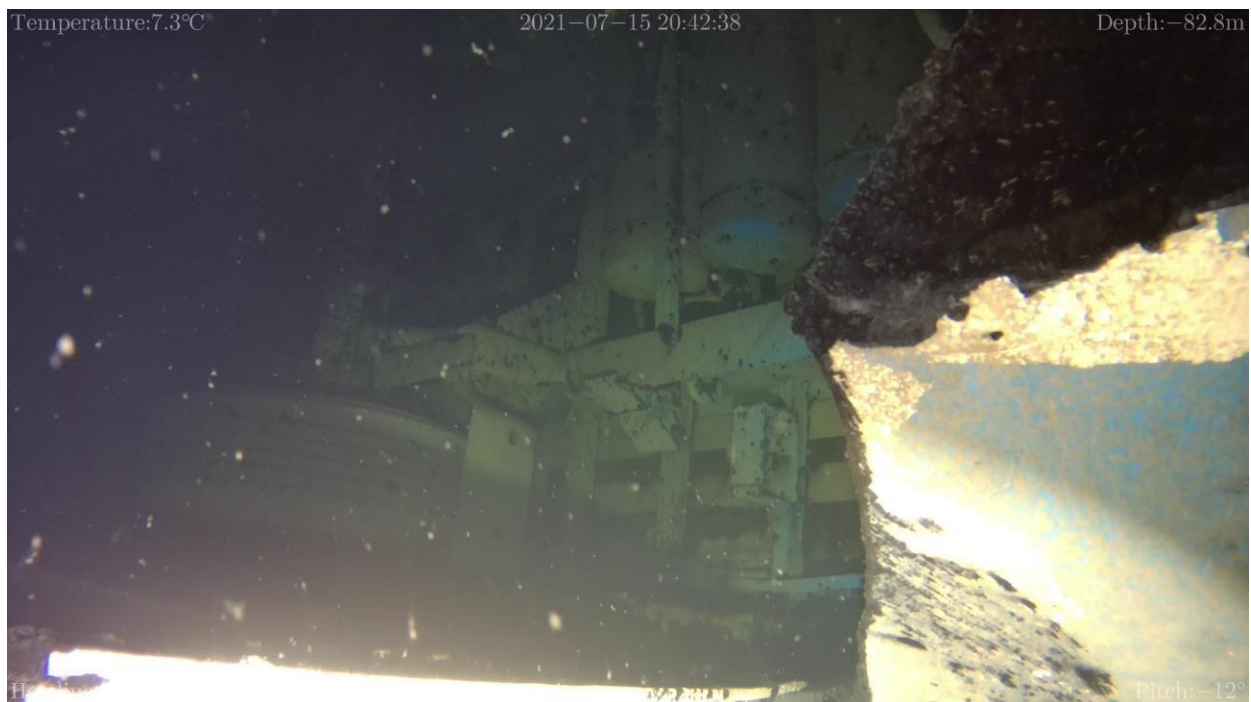
The rupture runs through the hull at a depth of 82.2 m from the 50 mm outlet.
The central part of the rupture and the torn beam at a depth of 83.1 m.
We push the drone into the opening and see the frame and axle of a truck turned upside down on the car deck 27.43

The rupture opening has been formed exactly at the level of the car deck.
