INVESTIGATION REPORT No 23U-AR0075

10 August 2023

Investigation applicant	Director of the Estonian Safety Investigation Bureau Märt Ots
Circumstances	During the preliminary assessment of M/S Estonia in the period from 19 July to 25 July 2023, a piece of metal was cut out of the edge of a hole in the starboard side of the wreck of the vessel.
Letter No	27-2/2023/3775-1
Letter	Compiled on: 27 July 2023 Arrived on: 27 July 2023
Presented for the investigation	<p>Investigation object A piece of metal cut from the edge of a hole in the hull of the wrecked ship</p> <p>Information material Submitted by the Estonian Safety Investigation Bureau: 1. video screenshots and photogrammetric drawings (27 digital files) of the wreck of M/S Estonia; 2. 3D photogrammetric model of the wreck (online).</p>
Investigation type	Metals survey
Assignment	Does the submitted metal piece show any signs of contact or collision with a metal item/object?
Experts	Forensic Expert Meelis Toomet phone 663 6718, email meelis.toomet@ekei.ee

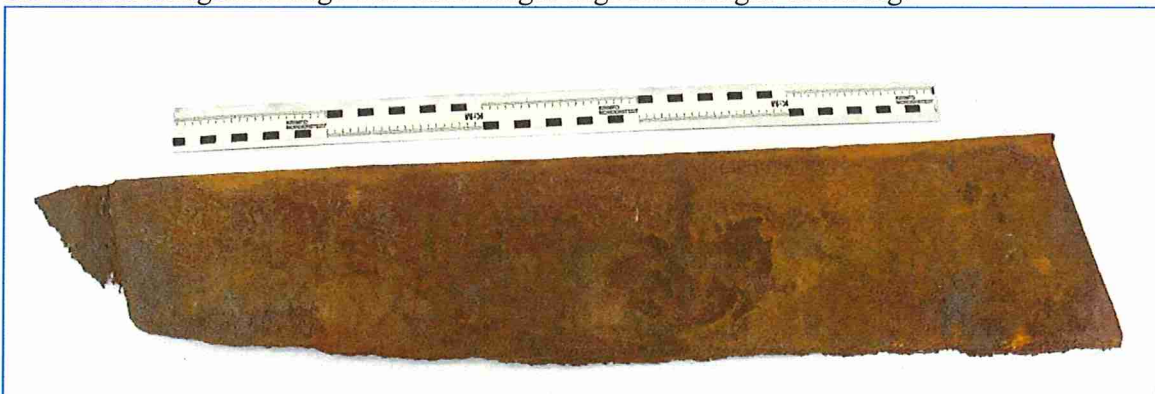
An elongated strip-shaped piece of a metal plate was submitted for examination (Figure 1). The thickness of the plate is between 13–13.5 mm, the approximate length is 66.5 cm and the width at the widest point is 14.5 cm. The strip is rectangular in shape, with one longer straight cut edge and one shorter straight cut edge. The other longer edge shows signs of tearing.

Photo 1. Piece of metal submitted for examination, view from the curved side

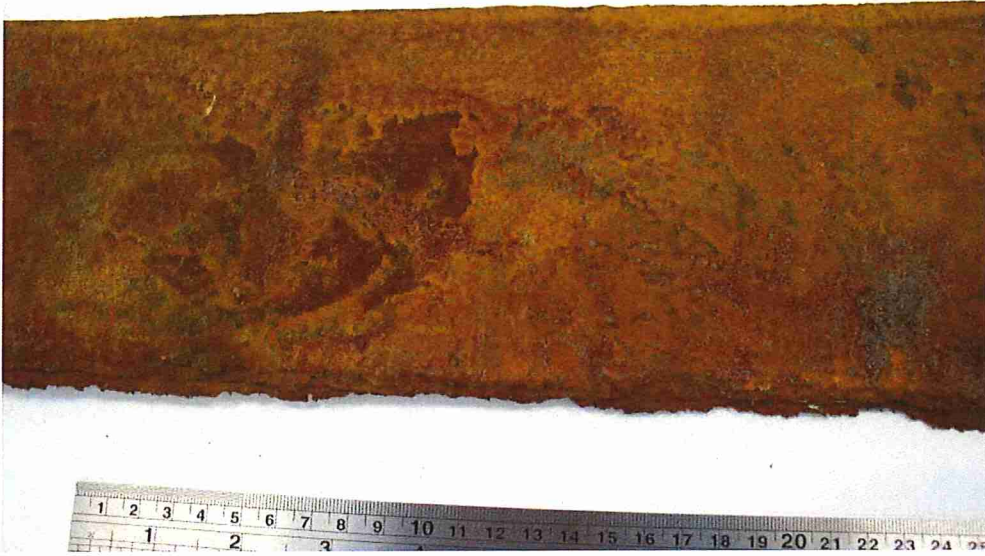
Photo 4. Torn edge of metal strip, view of hull exterior.

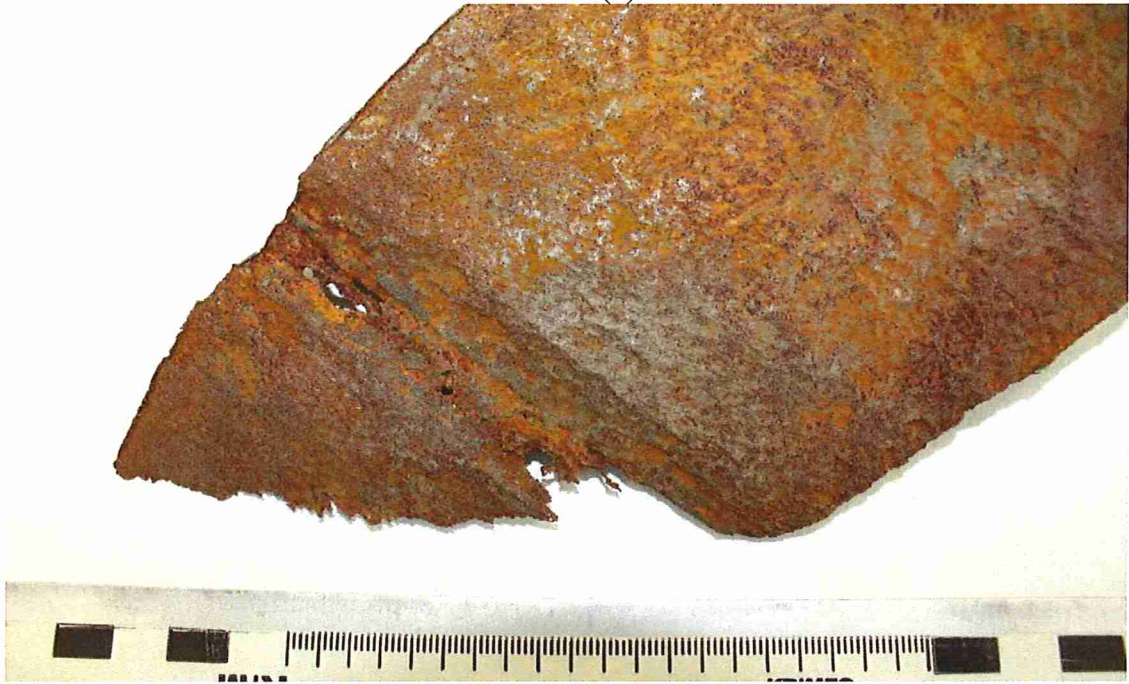
Photo 7. Torn edge of metal strip, view of hull exterior, possible joint.

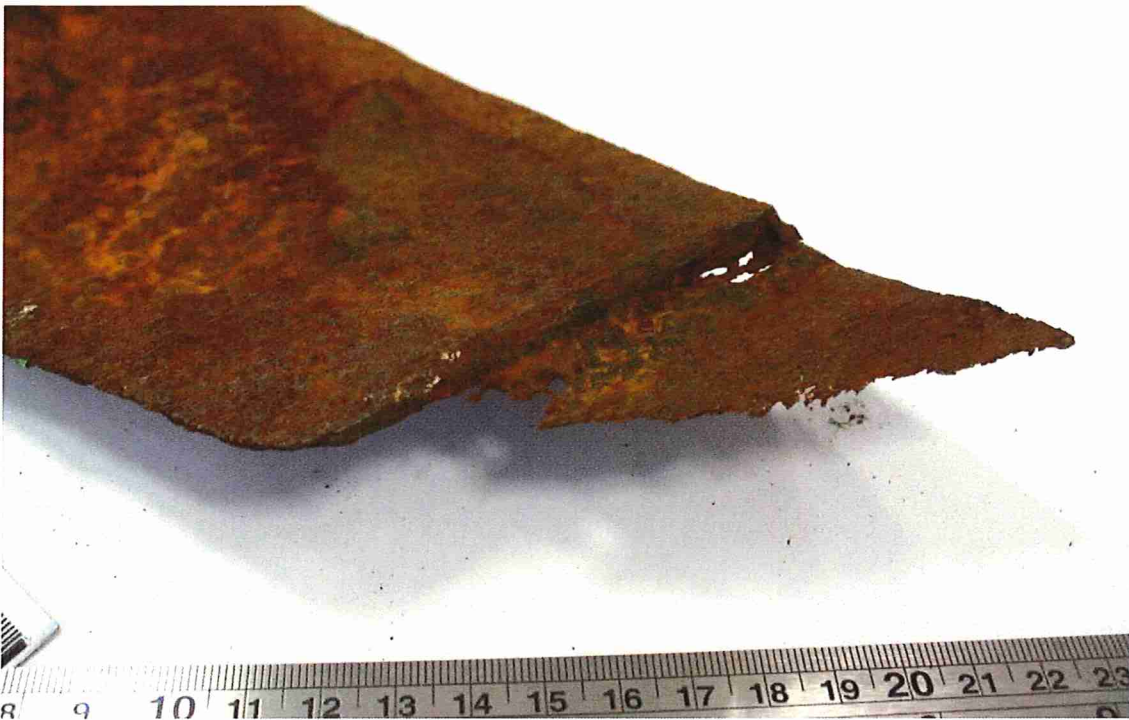
Photo 8. Torn edge of metal strip, view of hull interior, possible joint.
