TECHNICAL REPORT

Examination of Salvaged Bow Ramp, m/s Estonia *Translation to English of TEK23-0101*

ELEMENT MATERIALS TECHNOLOGY AB

TEK24-0010

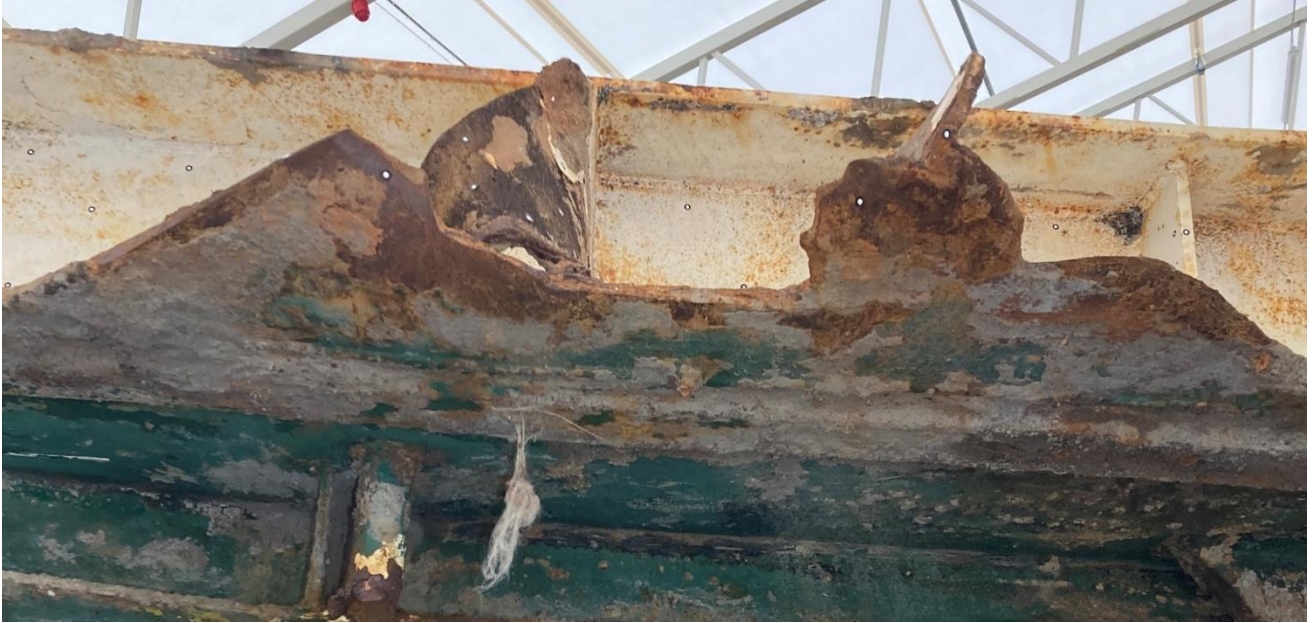
It is concluded that the locking hooks have been latched at the time of the accident as the bracket on the starboard side has separated from the bow ramp (missing), see Figure 1 and on the port side the bracket is very severely deformed, see Figure 2.

Figure 1. Missing bracket for the ramp locking hook on starboard side.

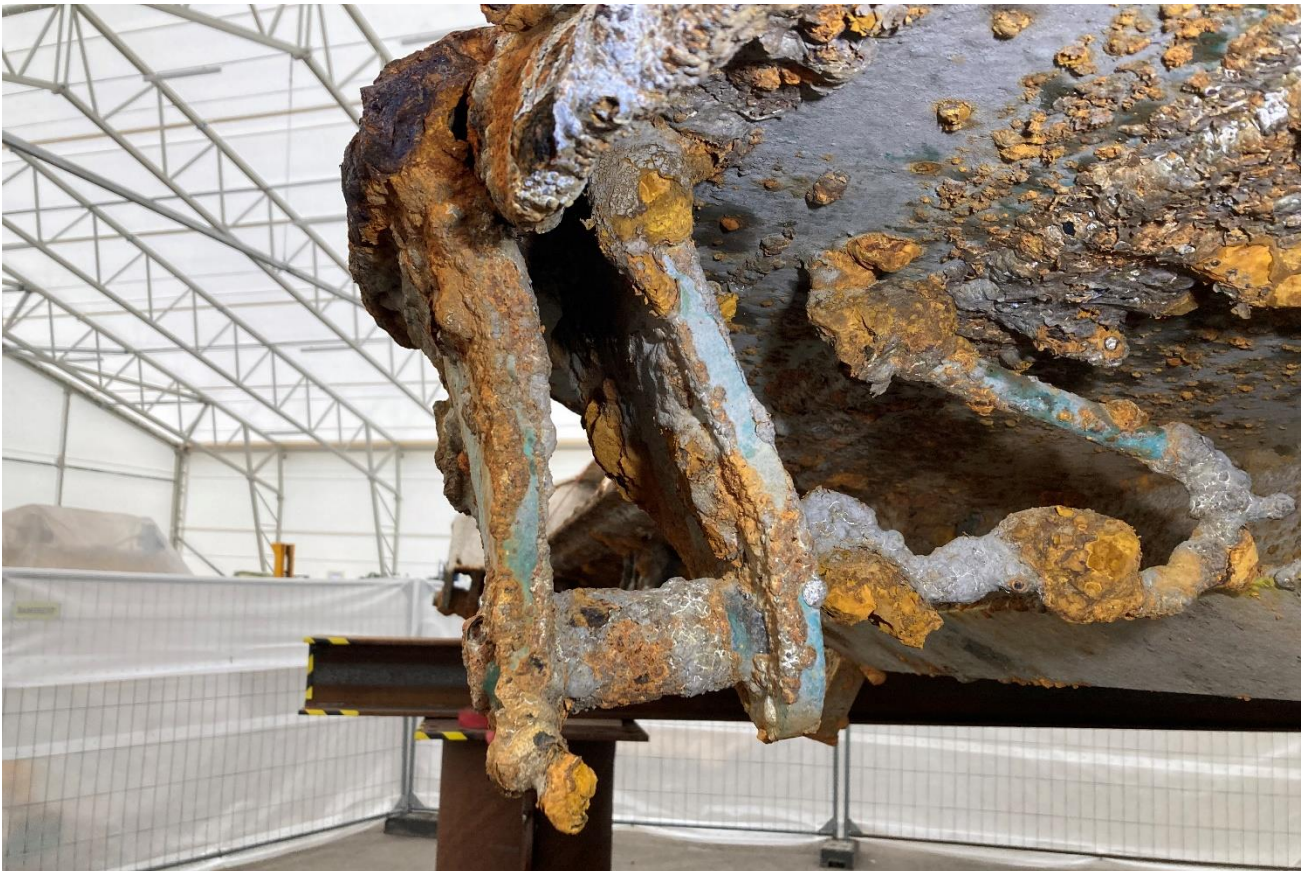
Figure 2. Bracket for the ramp locking hook on port side.

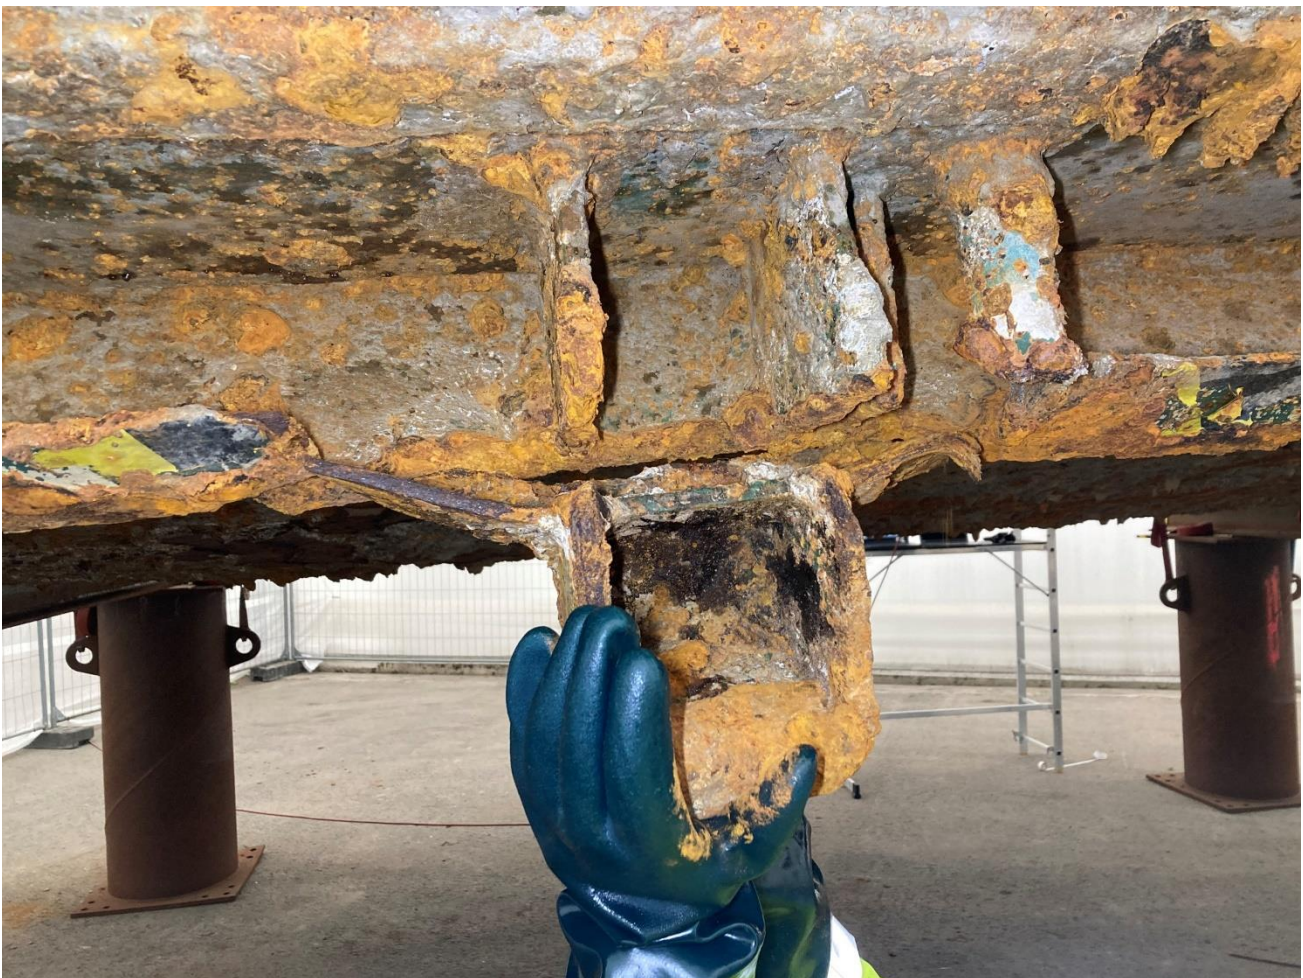
The lock boxes on the port side have failed with more bending than on the starboard side. Figure 3 and Figure 4 show the port side lock boxes and Figure 5 and Figure 6 show the starboard side lock boxes. On the starboard side, it looks like the lock boxes has had a evenly distributed pressure against the inside of the lock boxes and pulled the boxes off in a straight direction. This may be because, as stated in the documentation, that the lower lock piston on the port side has not been fully extended.

It may also be a consequence of the sequence in which they fracture which is as follows. First, the locks on the port side breaks because of the bow visor not hitting the upper edge of the ramp quite evenly.

Figure 3. Port side upper ramp side lock box.

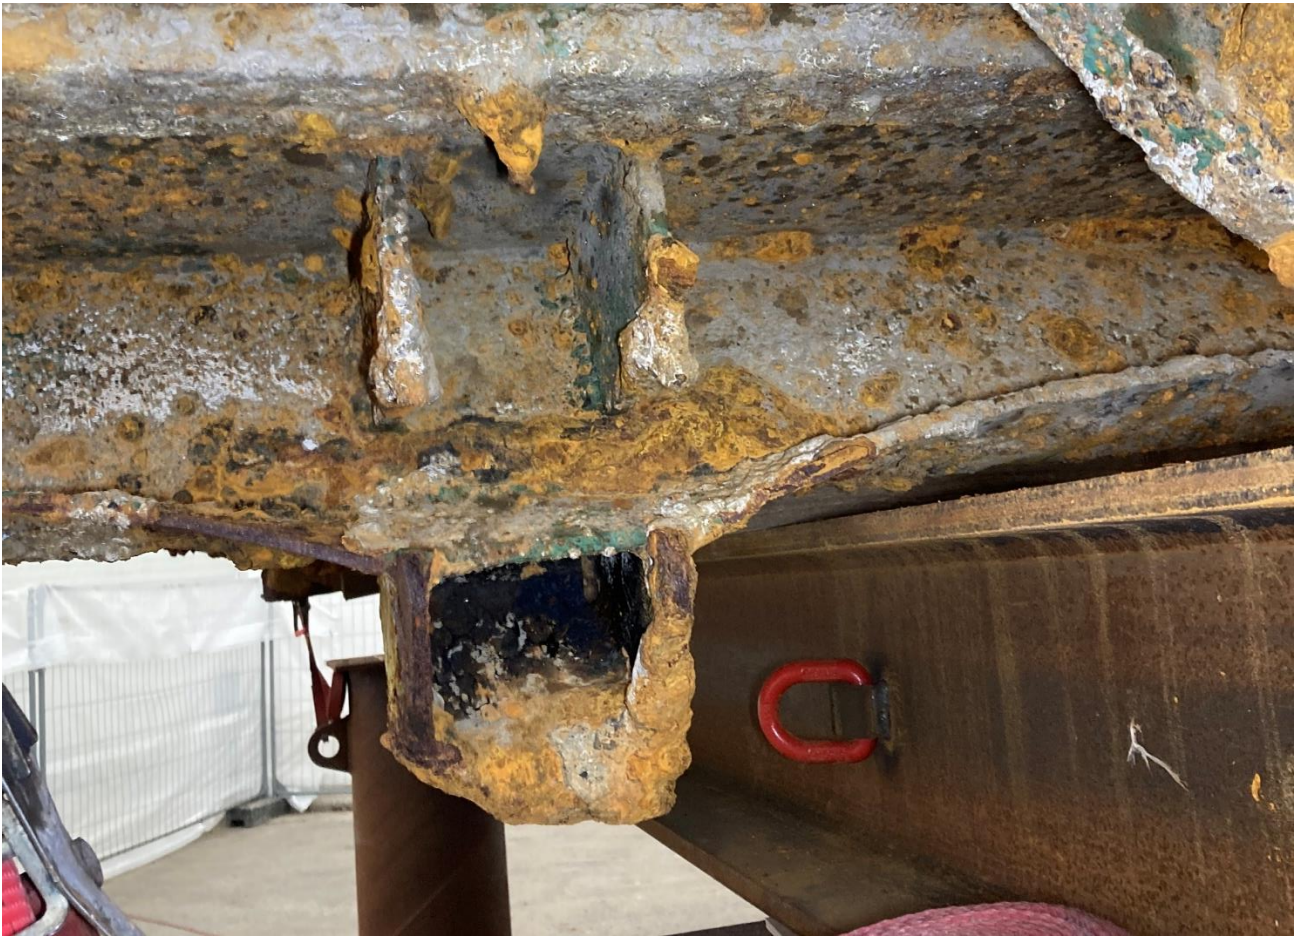
Figure 4. Port side lower ramp side lock box.

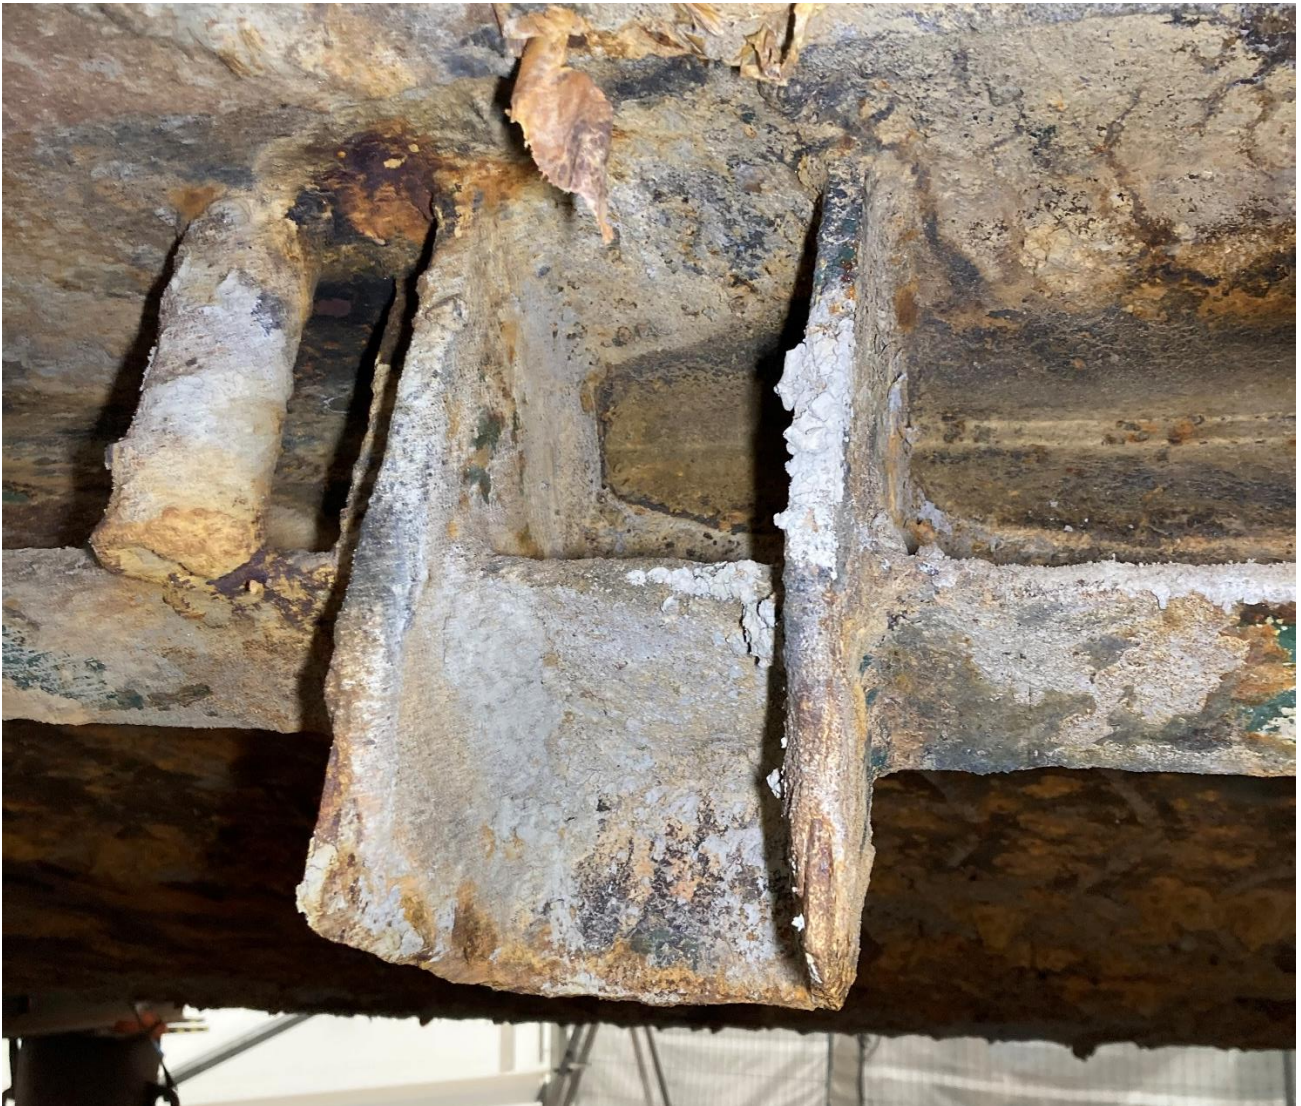
When the port side locks are broken, lateral movement/tilting of the ramp is permitted. This movement causes the starboard side lock pistons to slide out of the lock box slightly before they fracture due to overloading. As a result the force against the lock box also gives rise to a torque that bends the lock housing down before the fracture occurs.

Figure 5. Starboard side upper ramp side lock box.

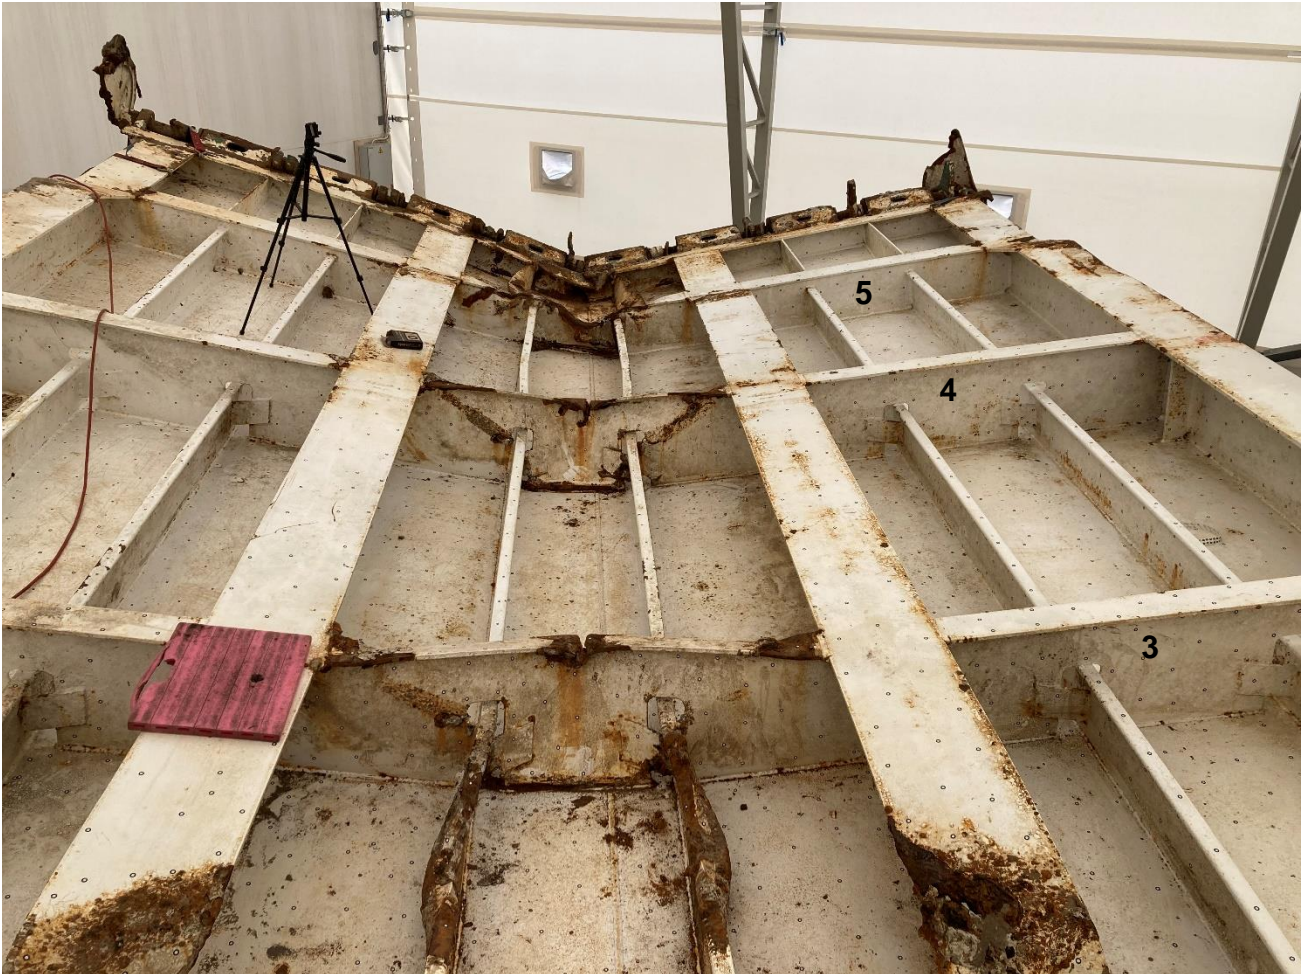
Damage on the sea side of the bow ramp is consistent with the description given in the document with damage both from impacts into the bow visor and bulb stem. Damage from when the bow visor falls back to its closed position also matches the description in the document, Figure 7 shows an overview of the damage to the upper part after hitting the ship's bulb.

Figure 7. The sea side of the bow ramp seen from the hinge side, transverse beams 3, 4 and 5 marked.

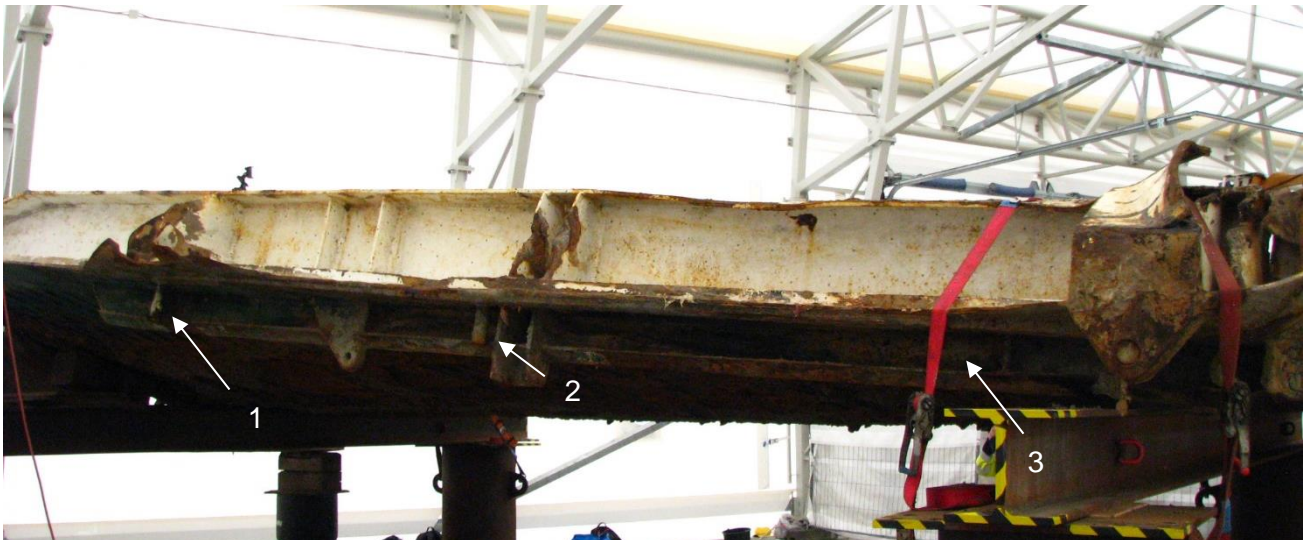
The railing on the bow ramp is assessed to have separated from the bow ramp in the accident and not cut or dismantled in any other way before/after the accident. This assessment is based on the deformation (occurrence of bending and shearing of the remaining parts) that does not occur when cutting with machine tools or thermal cutting. The damage is consistent with the protruding locking bolts holding the railing in place when the bow ramp is fully opened as described in the documentation. The surrounding structure also has severe deformation in several of the positions from being hit with great force by other parts and the railing may also have been broken off during these hits.

It is also an indication that they ruptured in relatively different ways, two of the examples below have, for example, ruptured in the weld against the bow ramp where it would not be natural to cut the railing for access reasons. Seven of the attachments are seen in Figure 8 to Figure 16.

Figure 8. Three attachment positions for railing on the starboard side.

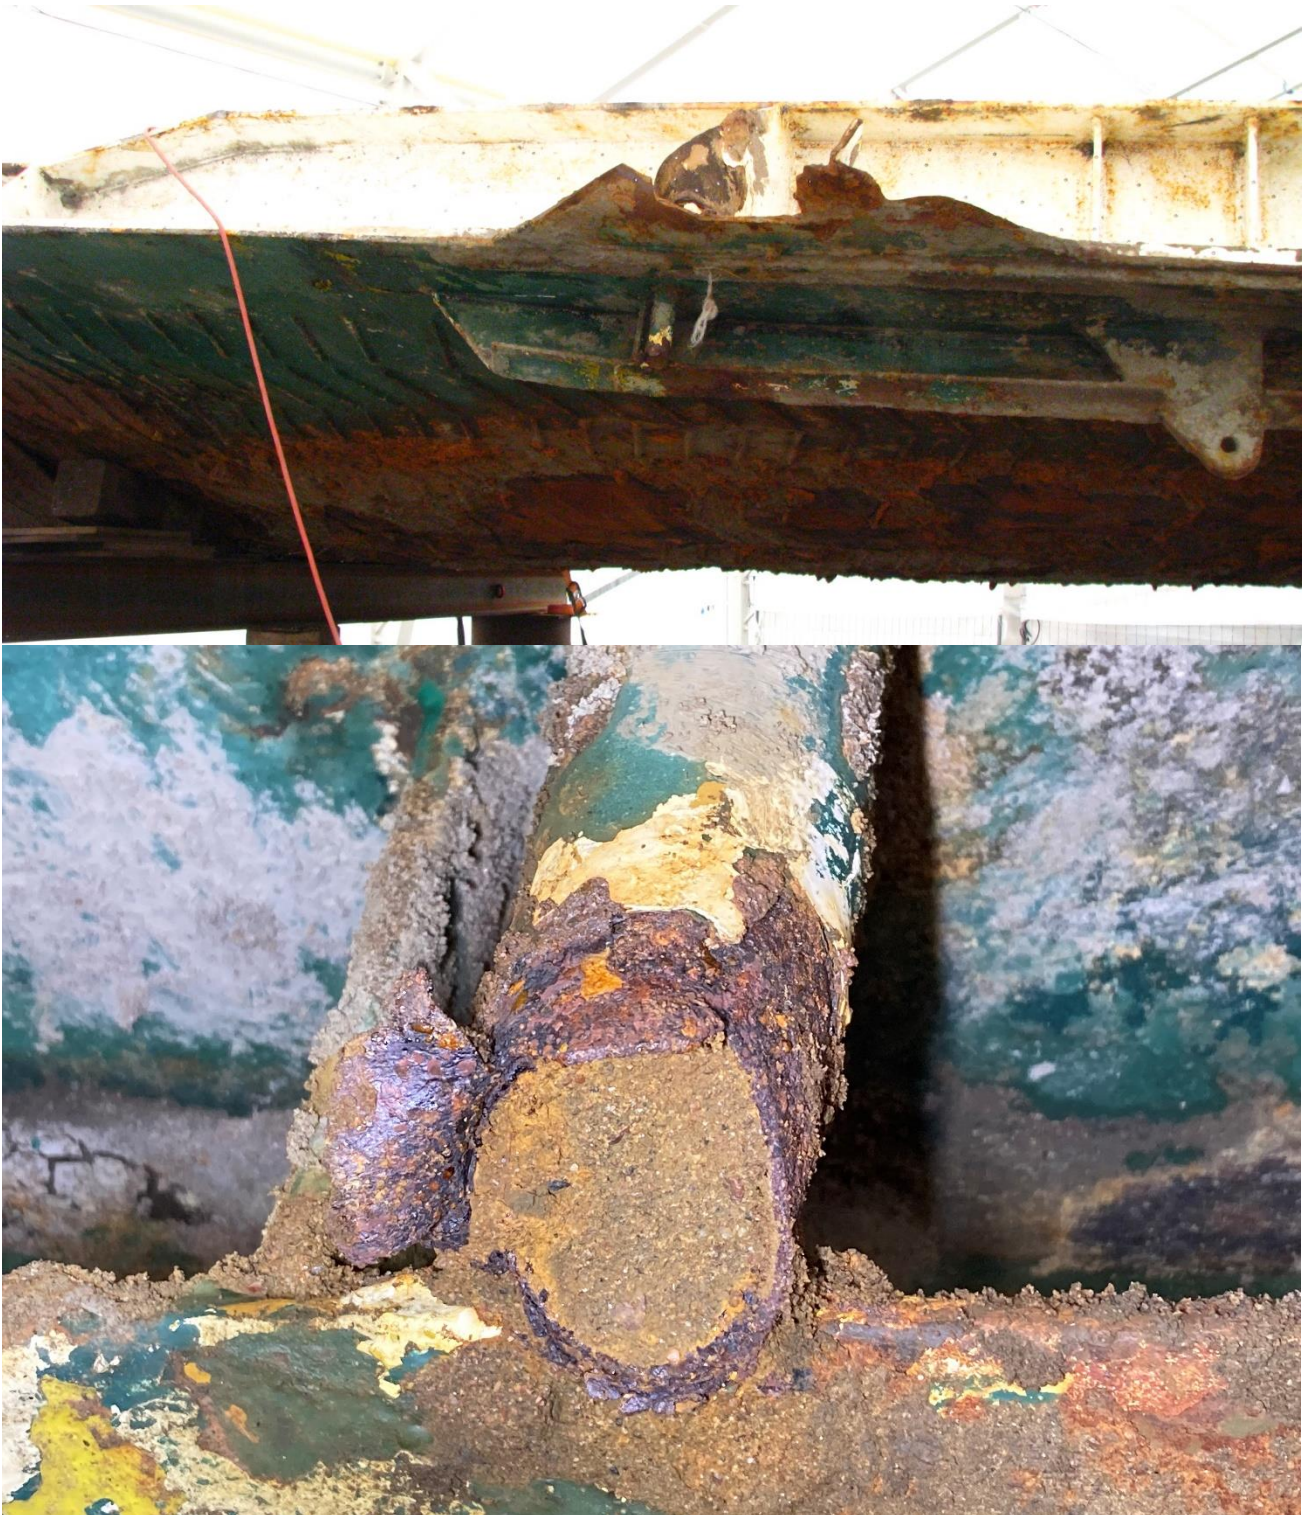
Figure 9. Starboard uppermost attaching position for railing (1 in Figure 8).

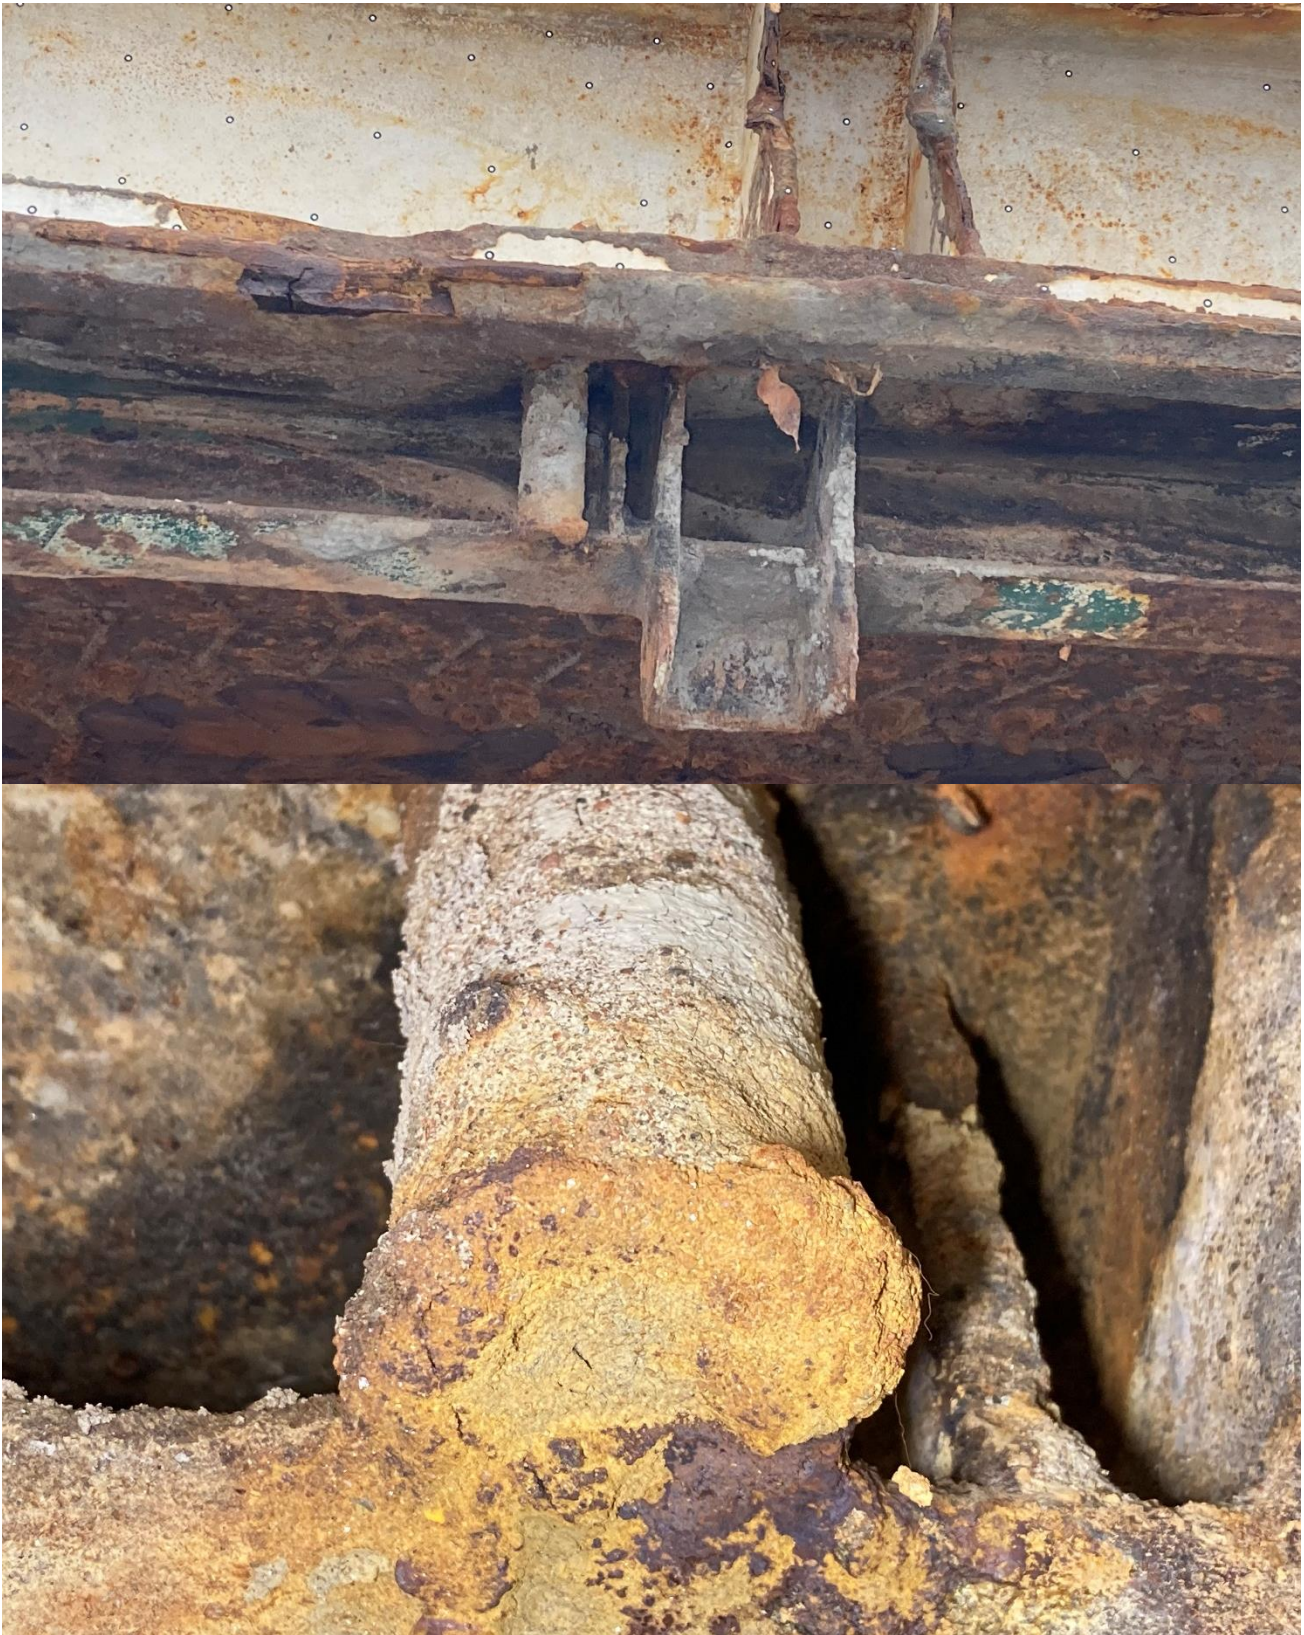
Figure 10. Starboard attaching position for railing (2 in Figure 8).

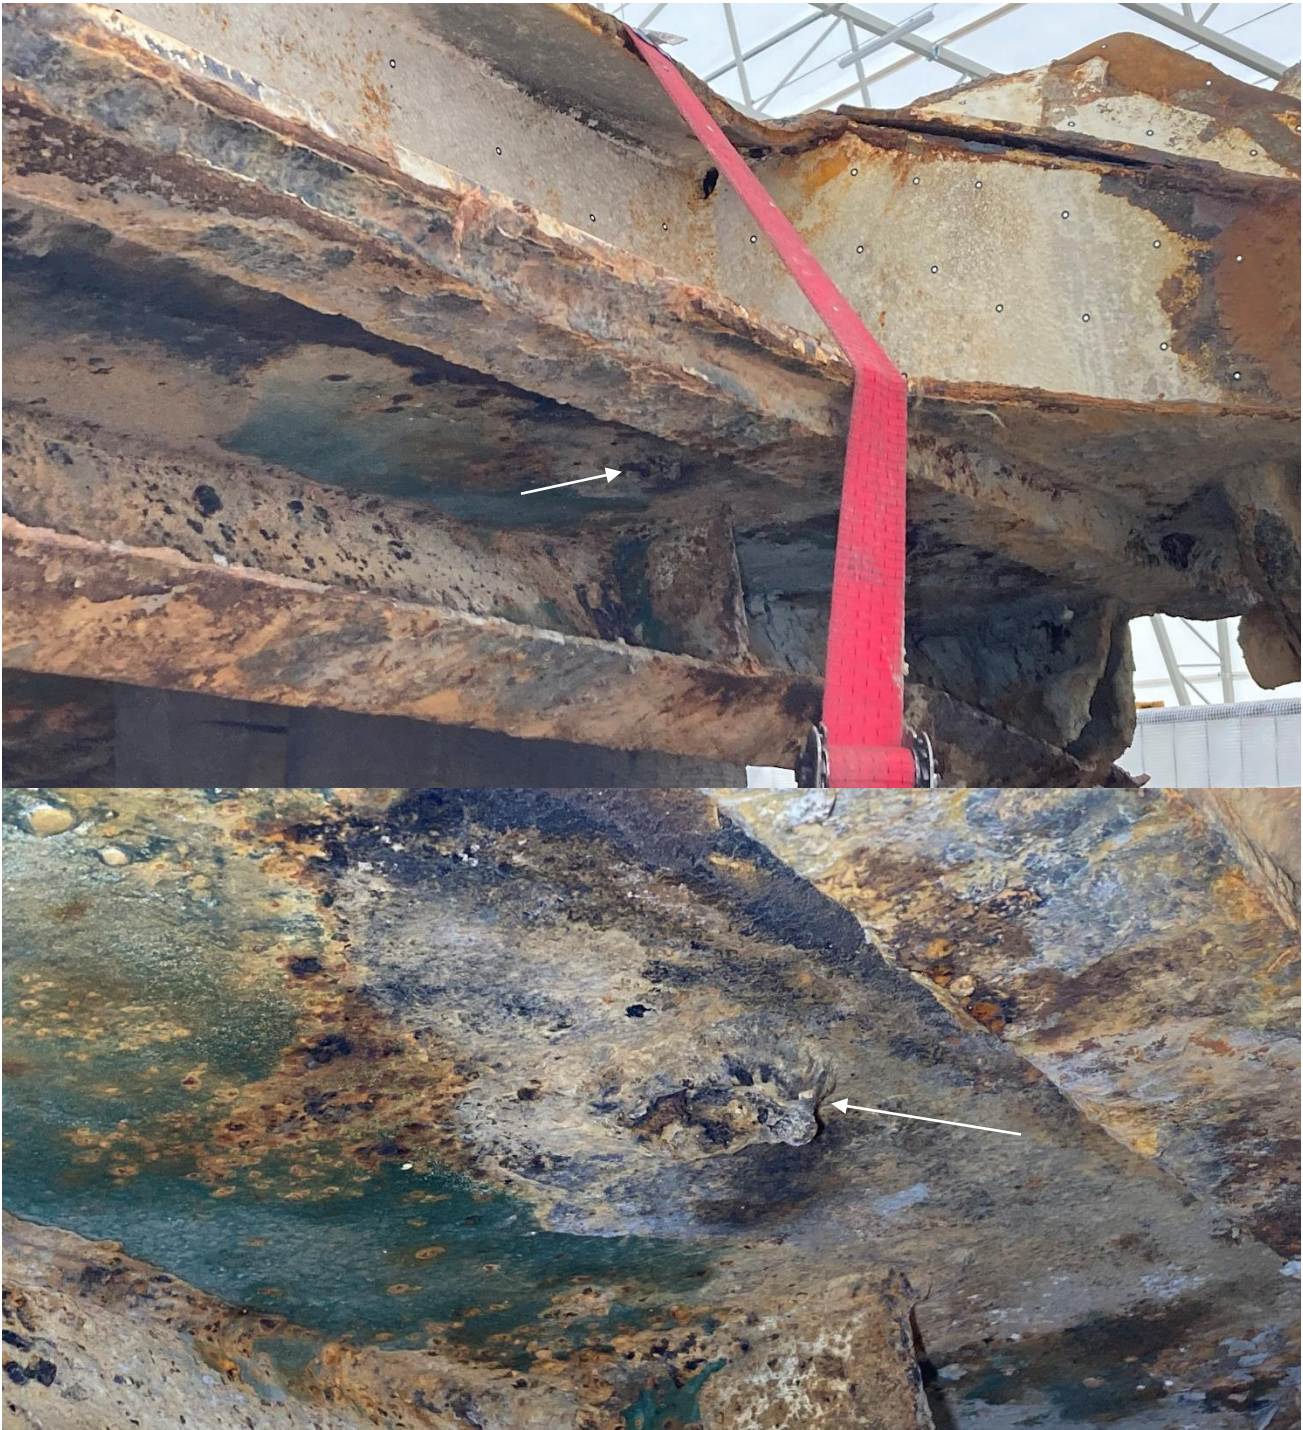
Figure 11. Starboard attaching position for railing, only the weld fillet remains on the bow ramp (3 in Figure 8).

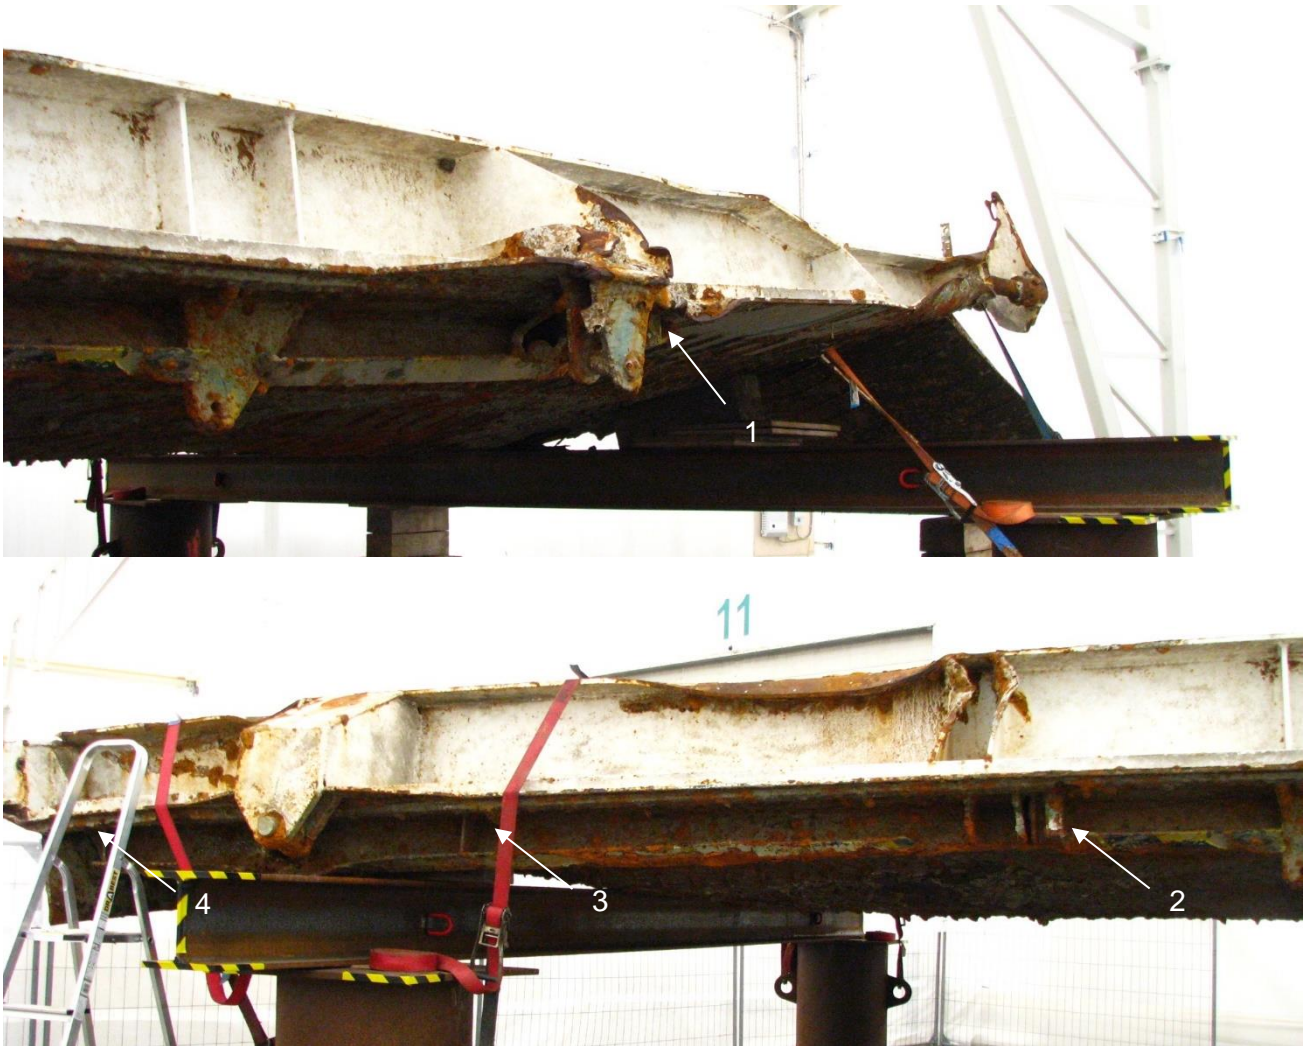
Figure 12. Four attachment positions for railing on the port side.

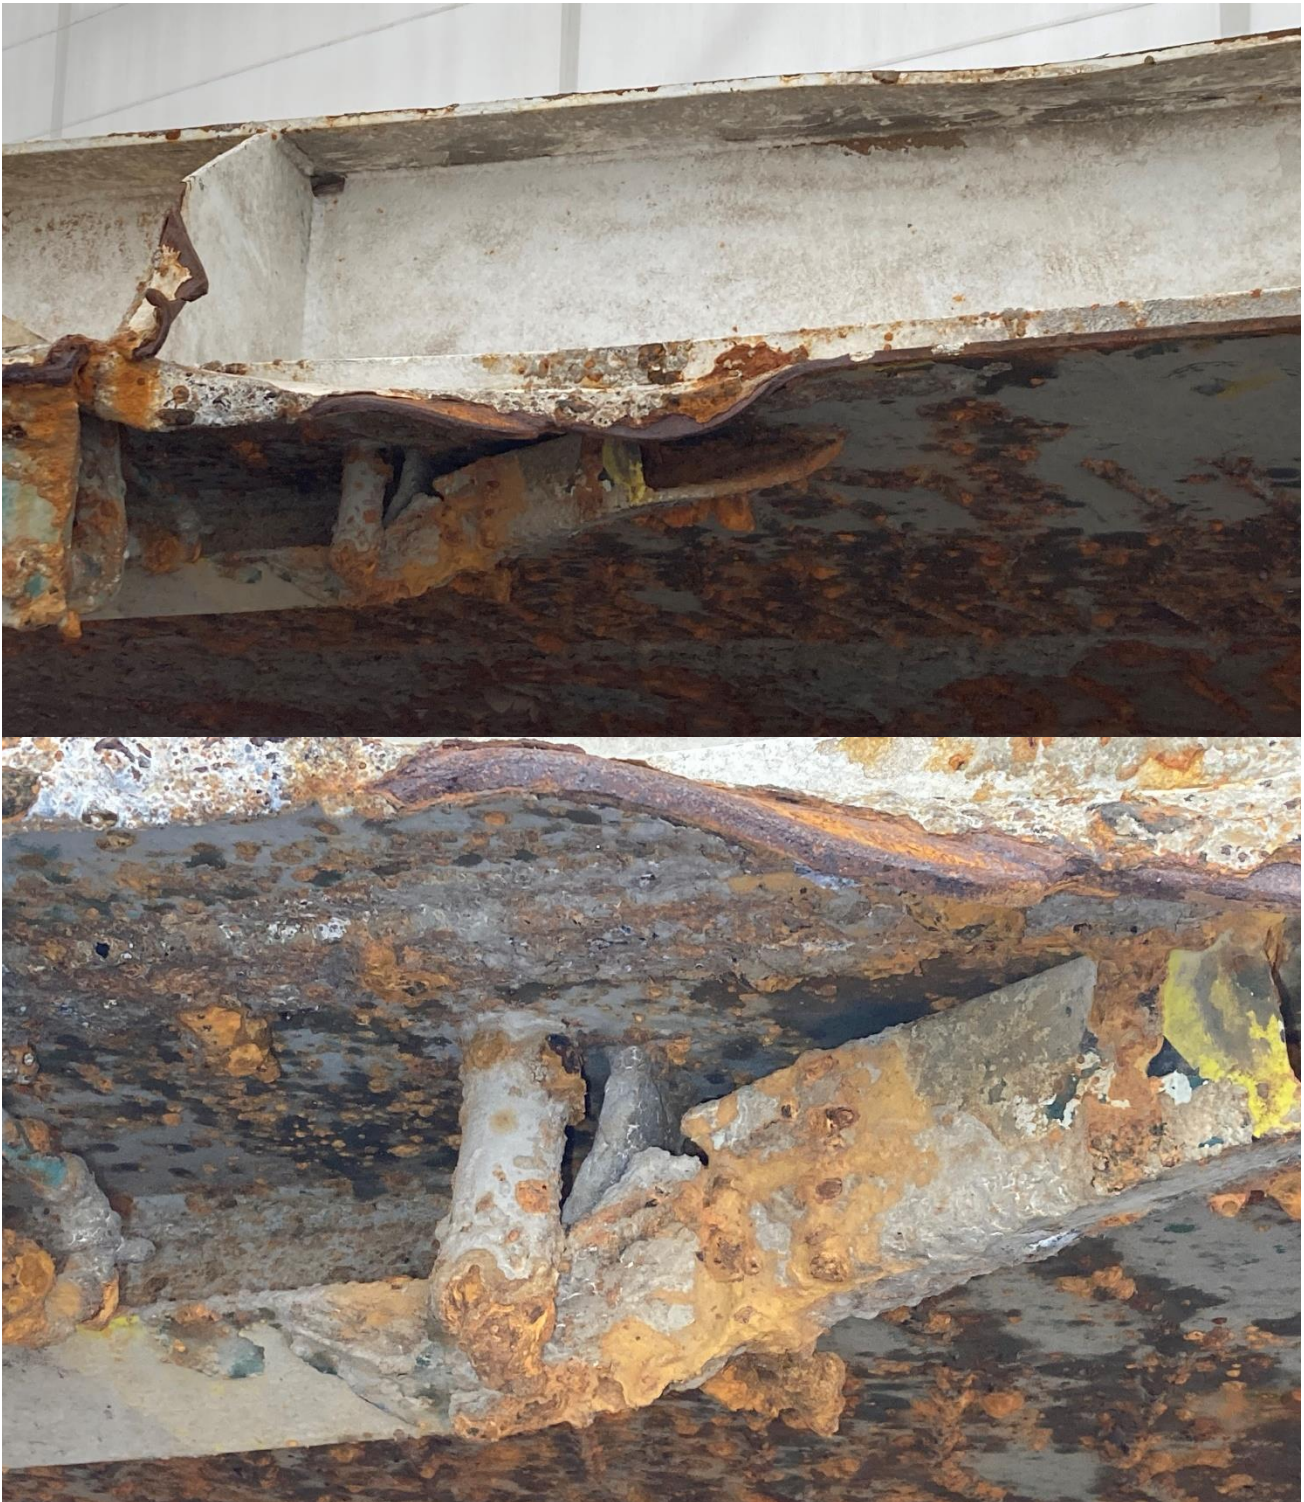
Figure 13. Port side attaching position for railing (1 in Figure 12).

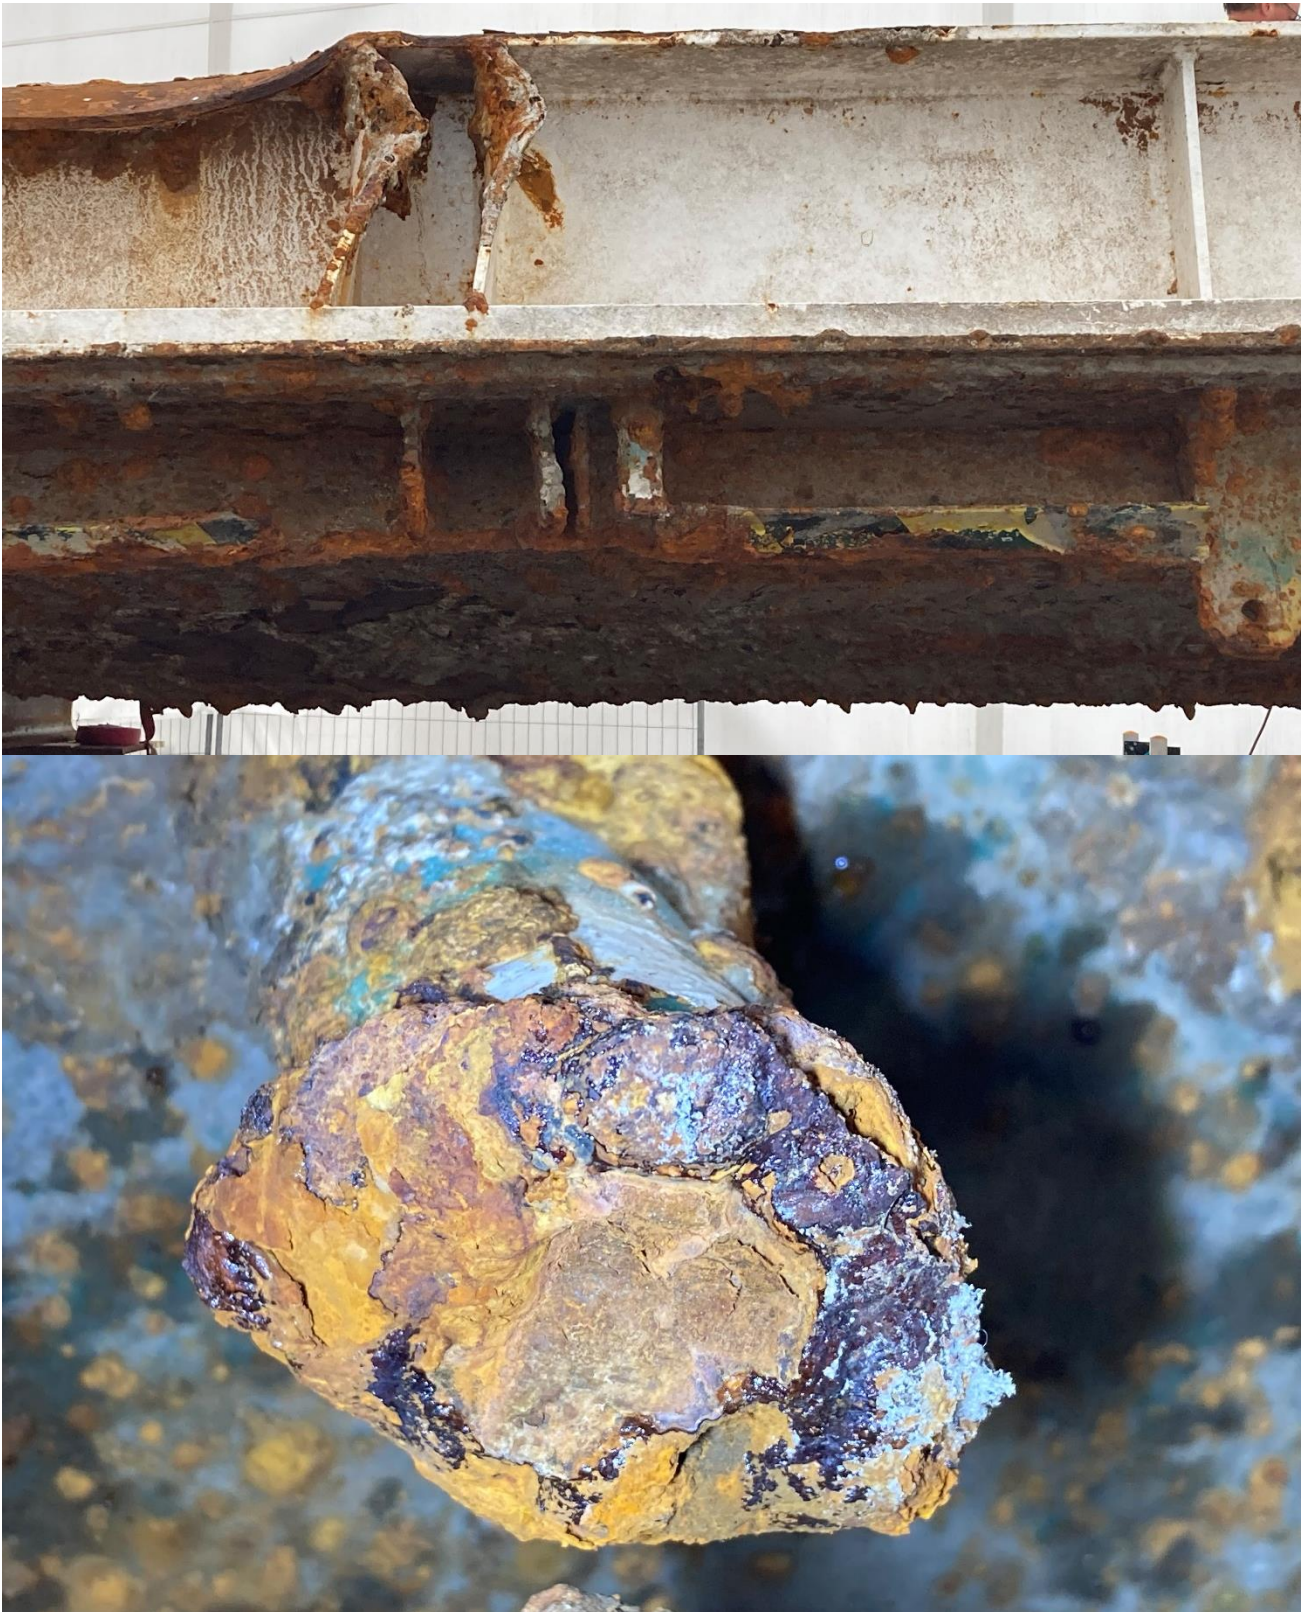
Figure 14. Port side attaching position for railing (2 in Figure 12).

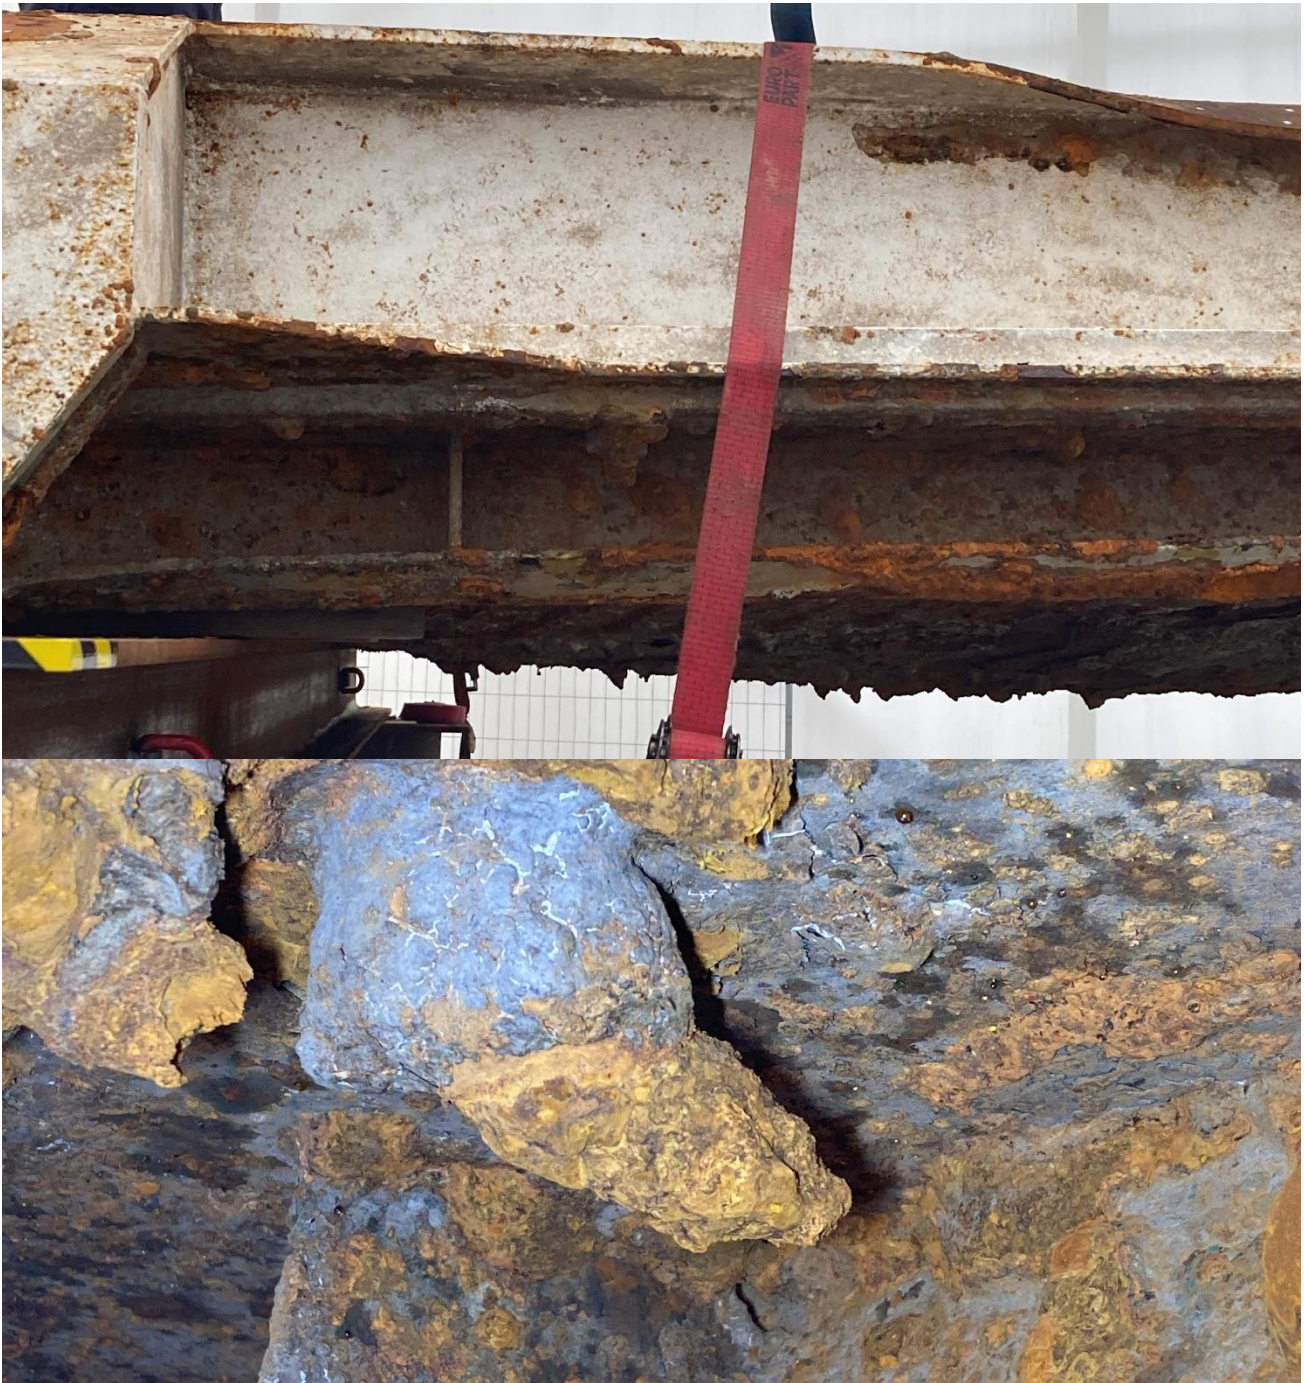
Figure 15. Port side attaching position for railing (3 in Figure 12).
