TECHNICAL REPORT

Examination of Salvaged Bow Ramp, m/s Estonia *Translation to English of TEK23-0101*

ELEMENT MATERIALS TECHNOLOGY AB

TEK24-0010

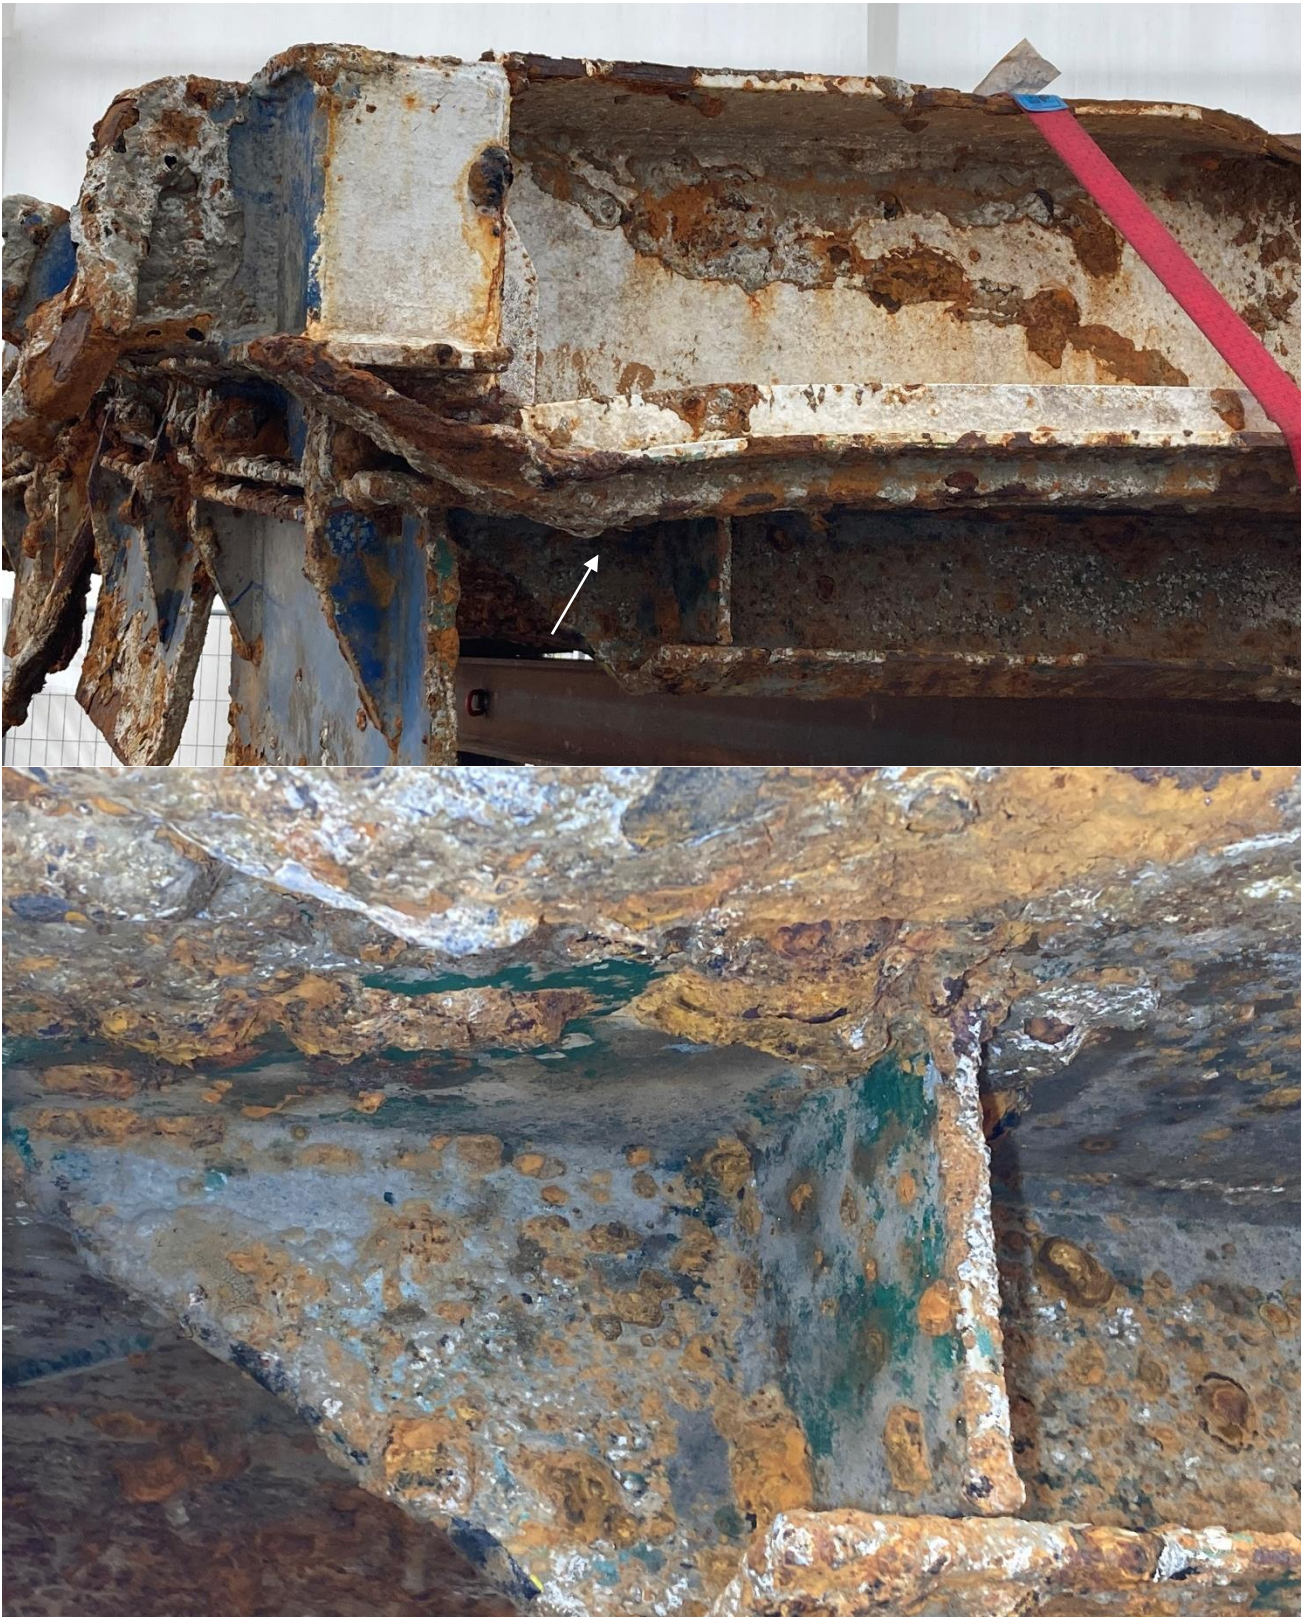
Figure 16. Port side attaching position for railing, no part of the railing remains, the weld has been somewhere below the heavily corroded area (4 in Figure 12).
