Engine failure involving Saab 340B, VH-RXE

140 km south of Perth, Western Australia on 21 December 2022

Aviation Occurrence Investigation (Short)

AO-2022-066

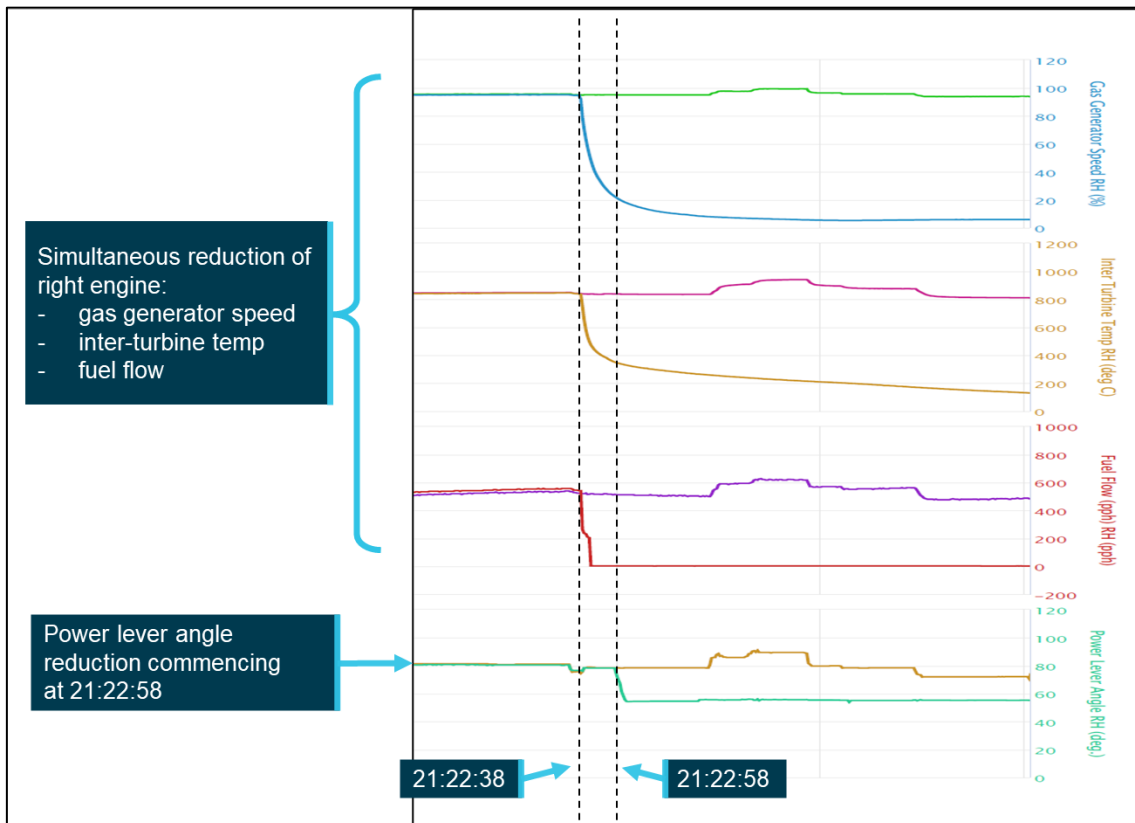
Figure 1: Recorded flight data for the occurrence showing selected parameters

A plot of these parameters is displayed at Figure 1 with the following occurrence events identified on the right engine:

- 21:22:38
 - gas generator speed began reducing from 92% to 5%
 - inter-turbine temperature began reducing from 820°C to 180°C
 - fuel flow reduced abruptly to 250 pounds per hour, stabilised with a gradual reduction for approximately 4 seconds, followed by another immediate reduction from 200 to 0 pounds per hour.
- 21:22:58
 - power lever angle started to reduce to 55°.

Flight data analysis also identified that the reduction in gas generator speed, inter-turbine temperature, and fuel flow preceded the power lever reduction by 20 seconds.

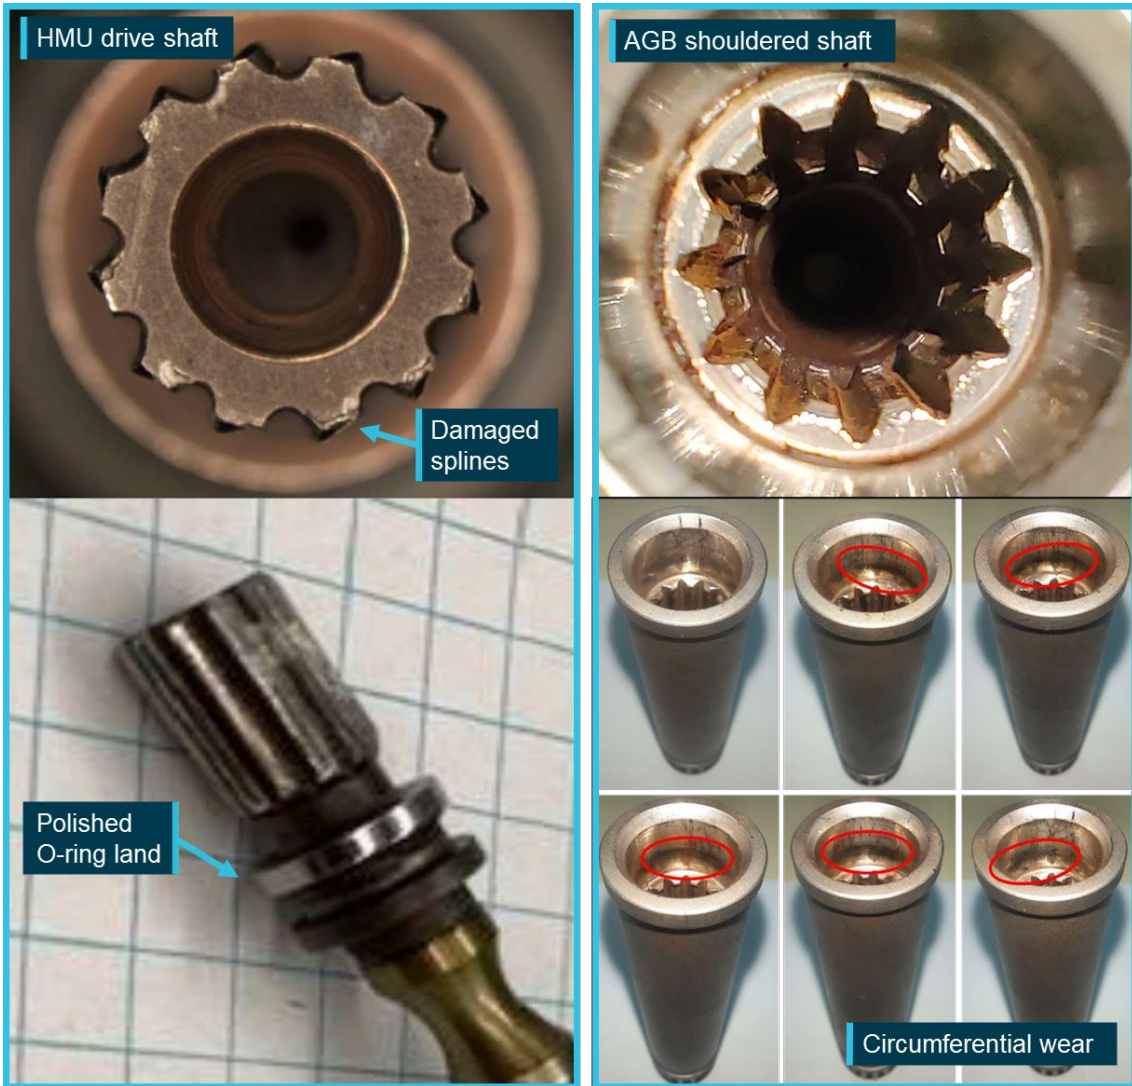
Figure 5: HMU drive shaft spline and AGB shouldered shaft damage

The HMU was removed from the AGB and functionally tested on a test bench with no fault detected. The HMU drive shaft was inspected and was observed to not be bent, however, damage and wear was identified on the spline teeth (Figure 5). An O-ring seal retaining land, located on the HMU drive shaft was observed to be highly polished due to rotational wear.

Post-occurrence troubleshooting, component testing, examination and analysis were conducted on the right engine. Wear and deformation were identified on the splines of the HMU drive shaft and the internal splines of the AGB shouldered shaft.

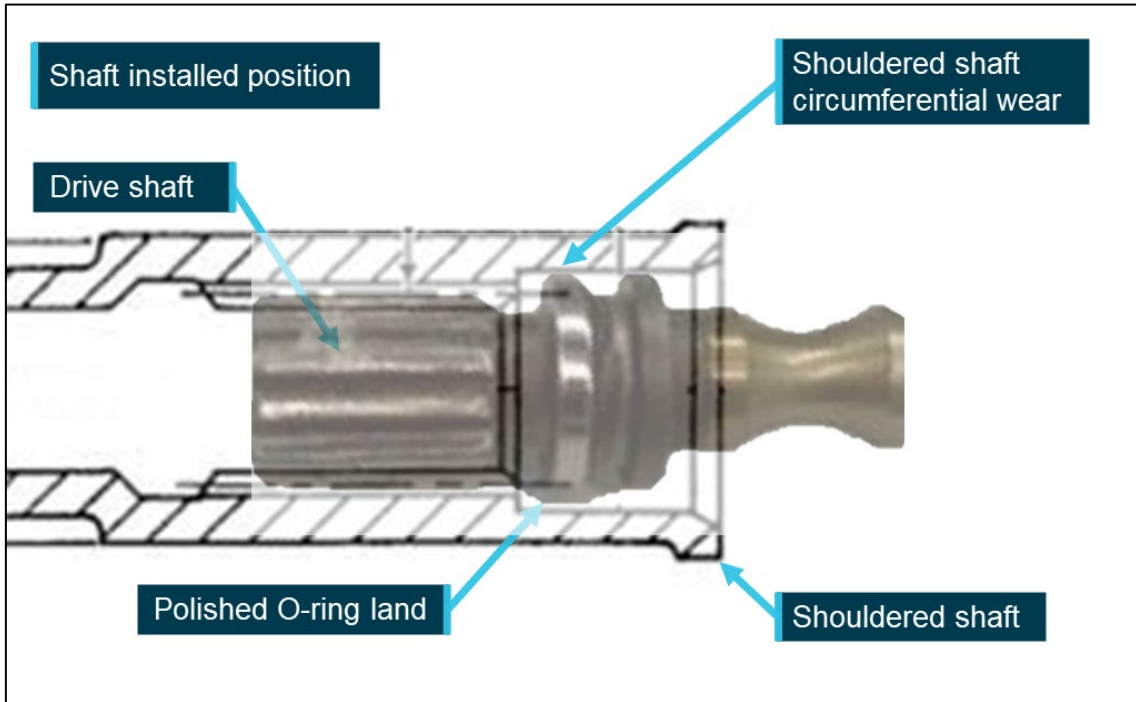
Figure 6: HMU to AGB drive shaft connection

An inspection of the AGB internal shouldered shaft identified deformation wear on the drive shaft spline receptacle along with a circumferential wear mark corresponding with the polished O-ring retaining land position on the HMU drive shaft when assembled (Figure 6). GE Aerospace reported that this was evidence of the drive shaft rotating within the shouldered shaft receptacle as a result of a decoupling.

Measurements were taken of the AGB shouldered shaft inner spline diameter and also of the diameter of the HMU drive shaft spline. These measurements identified that the HMU drive shaft spline's maximum diameter was less than the minimum diameter for the receptacle splines, indicating a physical inability to be coupled.

Significantly, the polished O-ring land on the HMU drive shaft and the corresponding circumferential wear marks within the AGB shouldered shaft indicated that the drive shaft had decoupled and was spinning within the shouldered shaft during operation. Damage identified on the HMU drive shaft splines, along with corresponding wear and damage to the AGB shouldered shaft receptacle also indicated that rotation had occurred between the 2 shafts. Additionally, the measured minimum internal diameter between the splines of the AGB shouldered shaft receptacle was larger than the maximum HMU spline diameter, indicating a physical impossibility of the AGB to drive the HMU.

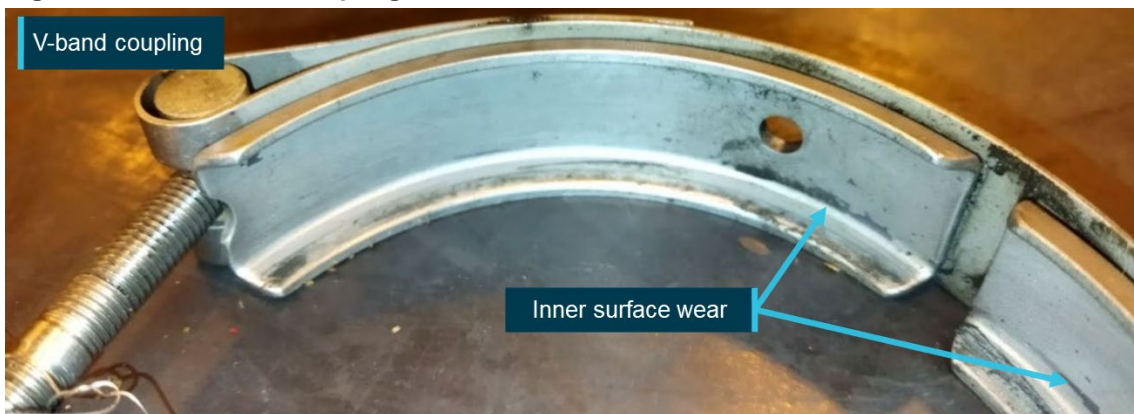
Figure 7: HMU V-band coupling wear location

The V-band coupling securing the HMU to AGB flanges together was observed to have wear on its inner surface from contact with the AGB flange. This wear was present in an area where, if the HMU and AGB flanges were correctly aligned and seated, the apex gap would be present. Interference wear in this area was evidence of a misalignment and non-seating of the HMU onto the AGB.

HMU V-band coupling with wear from the AGB flange located on inner surface clearance (apex gap) area
 Source: GE Aerospace, annotated by the ATSB

Wear marks from the AGB flange were observed on the inner surface of the V-band coupling. These wear marks were located on an area of the coupling that, when the flanges of the HMU and AGB are correctly aligned and the coupling is aligned correctly prior to and during torquing, an apex gap is maintained between the flanges and the inner surface of the V-band coupling. The presence of interference wear marks on the inner surface of the V-band coupling demonstrated that the flanges, or the V-band coupling, were misaligned during installation.

This misalignment of the HMU, taking into consideration that the HMU drive shaft was not bent, likely translated to an uneven loading of the splines of the HMU drive shaft and the AGB shouldered shaft receptacle during operation. This in turn probably caused wear, damage, and subsequent decoupling of the HMU drive shaft during operation.

GE Aerospace advised that it intended to share the learnings of this occurrence with its customers and maintenance facilities and to remind them of the correct installation and maintenance of the hydro-mechanical unit to prevent a reoccurrence and premature wear of the drive shaft and accessory gearbox internal shouldered shaft.

Regional Express reported a number of safety actions taken as a result of this occurrence. These include the dissemination of a technical notice to their engineers highlighting the importance of correct hydro-mechanical unit installation and the addition of V-band coupling installation to the list of critical control system maintenance items. The operator has also commenced a fleetwide inspection of their aircraft to confirm correct V-band coupling installation. As of 24 July 2024, 50% of the fleet had been inspected with no incorrect installations identified.

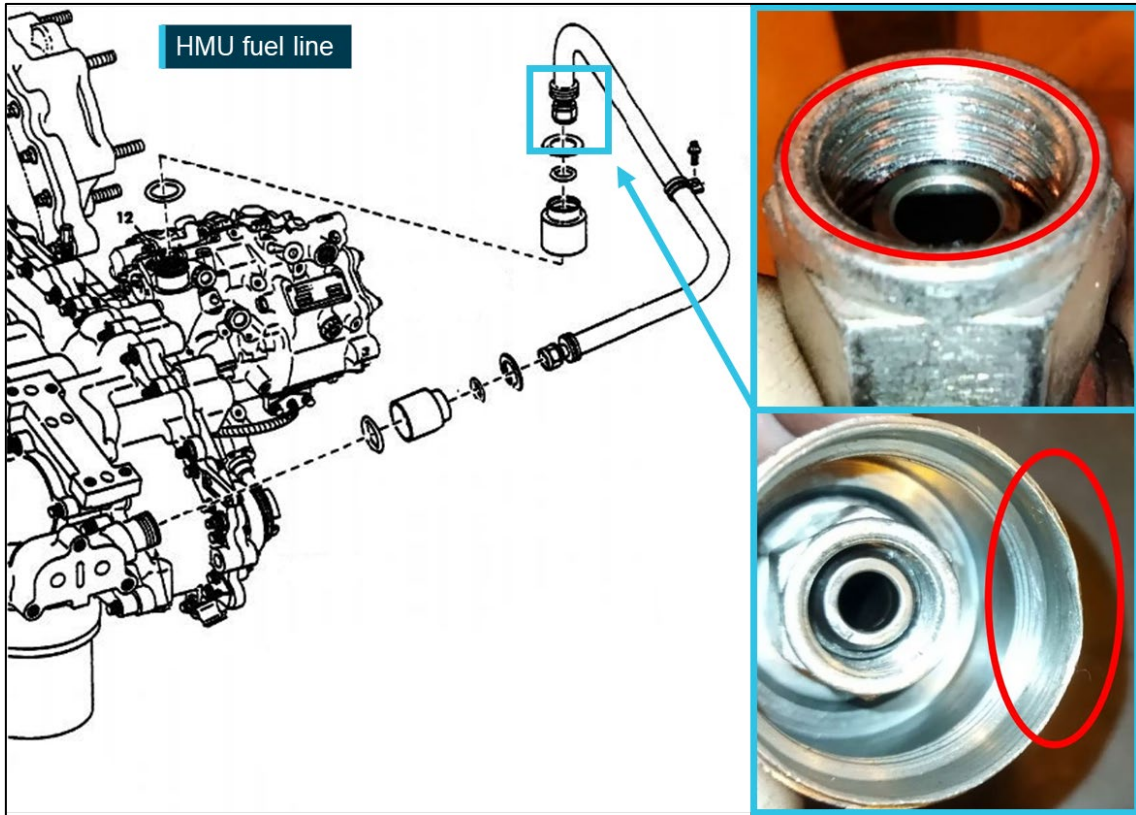
Figure 8: HMU fuel line

Damage to the nut and threads was observed on the fuel line that connects the HMU and the fuel filter. A minor dent was also observed on the fuel line sleeve (Figure 8).

HMU fuel line with wear on thread and dent on sleeve
 Source: GE Aerospace, annotated by GE Aerospace and the ATSB

Also noted during the post-occurrence inspections was damage to the threads on the fuel line that connected to the HMU. This line was connected as part of the HMU installation and the presence of damage to the threads was a possible further sign of the fuel line being connected to a misaligned HMU.
