Accident involving an aircraft of the model Antonov AN-2

The Swedish Accident Investigation Authority has investigated an accident at Vårgårda, Västra Götaland county, on 08 July 2023

19 June 2024

Final report SHK 2024:10e

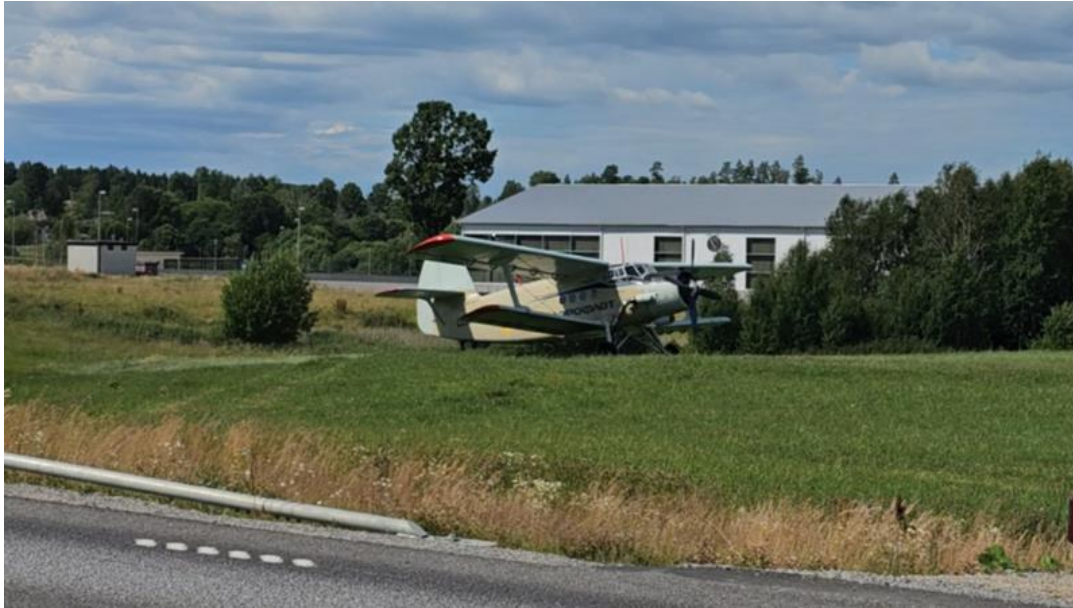
The films show the aircraft taxiing towards the position for take-off and car traffic passing on the road directly adjacent to the field. The aircraft is seen to initiate the take-off in an easterly direction. Evidence observed from the wind on trees, branches, grass and flagpoles, indicates that the wind is westerly, i.e. tailwind in the aircraft's take-off direction. At lift-off, the aircraft is seen to roll to the right and an upward deflection can be seen on the right aileron, (see Figure 2).

Figure 1. The aircraft at take-off position. Photo: Private.

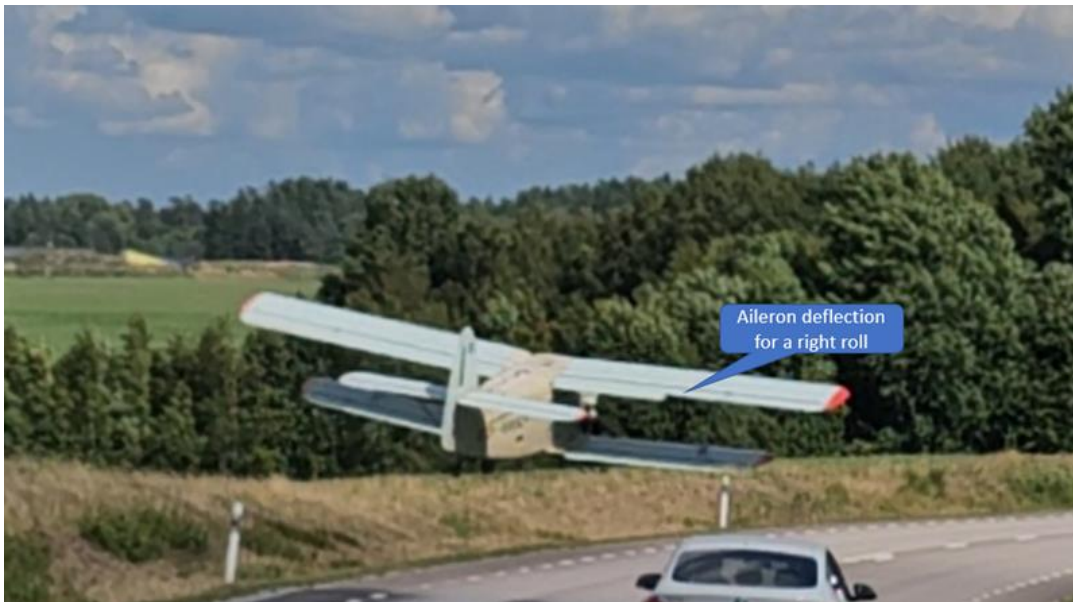
Figure 2. Roll to the right in connection with the lift-off. Markings inserted by SHK. Photo: Private.

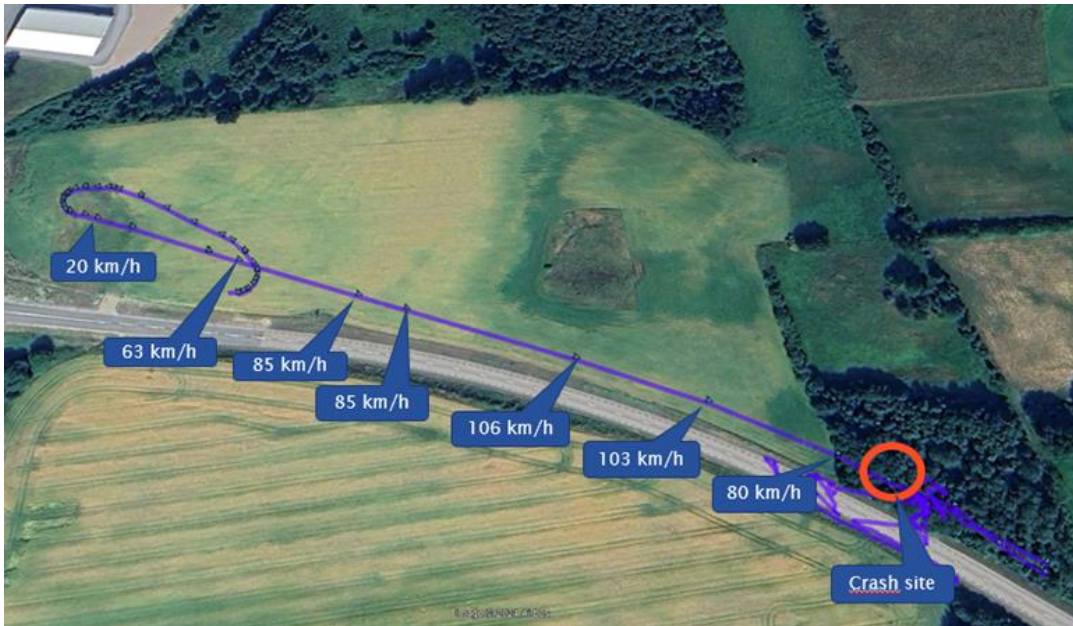
Recorded data shows the flight track and ground speed. The data shows that the take-off direction was 110 degrees. The highest recorded speed was 106 km/hour and was reached around the position at which the aircraft, according to the films, lifted off. Thereafter, the speed decreased until the position where the collision with the trees occurred, (see Figure 5).

Figure 5. Recorded data from one of the navigation applications with the ground speed. Markings inserted by SHK. Image: Google Earth.

Read-out GPS data shows that the aircraft's maximum ground speed was 106 km/hour. As the tailwind was estimated to be 15 km/h, this meant that the maximum airspeed was around 90 km/h, which corresponds to a normal lift-off speed according to the AFM. Thereafter the speed decreased until the collision. The AFM describes that the initial climb should be done while increasing speed.

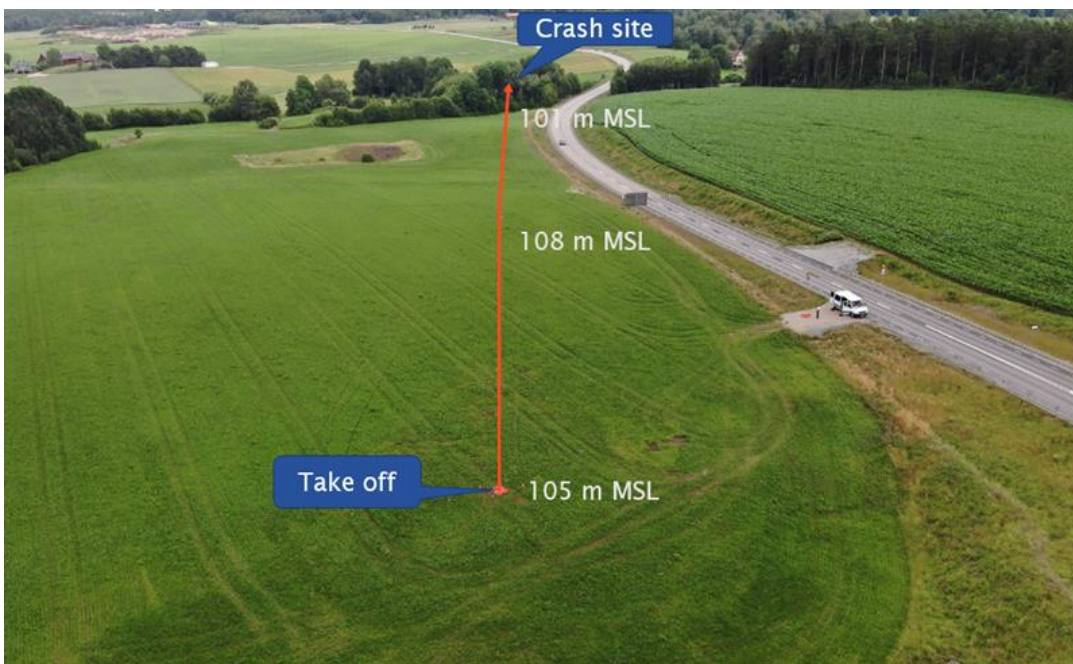
The field was about 400 metres long. In the western part, the ground was marshy and sloped towards a ditch, making part of the field unsuitable for a take-off. The ground consisted of soil and was covered with grass 20–30 cm high. The western part of the field was close to buildings, poles and roads. The southern part was directly adjacent to road 181. In the direction of take-off at the eastern part of the field there was a patch of forest with trees rising to a height of about 20 metres.

The field had a varying slope. The take-off position height was 105 MSL (mean sea level). The highest point along the take-off run was 108 MSL and the height at the end of the field was 101 MSL. The average slope ratio was $0.011 = 0.63$ degrees downhill, (see Figure 6).

Figure 6. The image shows the take-off and accident site and the field elevation above MSL. The red arrow shows the take-off direction. Markings inserted by SHK. Photo: The Police Authority.

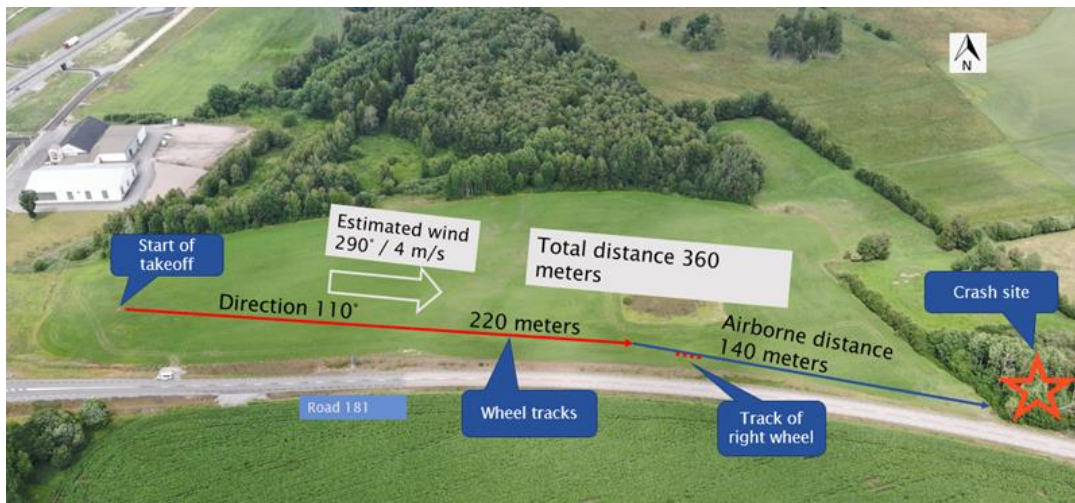
There were clear tracks in the grass from both the main wheels for a distance of 220 metres. After 250 metres there was a short track which was probably from the right main wheel. The total distance from the take-off position to the trees at the end of the field was 360 metres, (see Figure 7).

Figure 7. Tracks in the terrain. Markings inserted by SHK. Photo: The Police Authority.

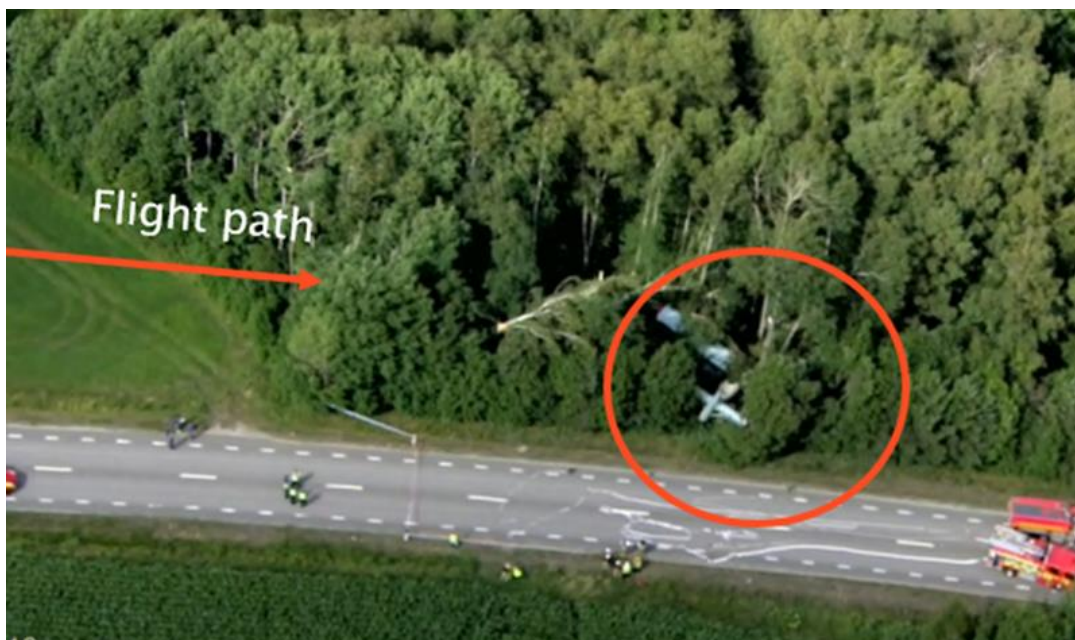
The crash site was in a patch of forest at the eastern end of the field. Large tree trunks were broken off as a result of the collision, (see Figure 8).

Figure 8. The crash site. Markings inserted by SHK. Photo: The Police Authority.

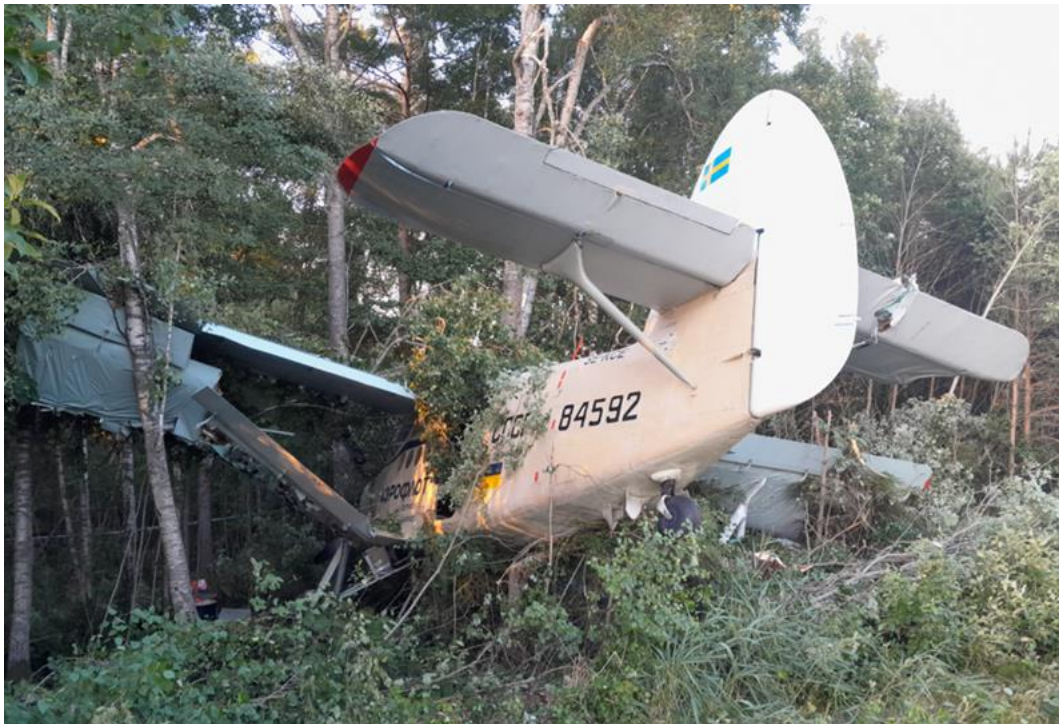
The aircraft sustained substantial damage, mainly to the wings. The cabin received relatively minor damage, (see Figure 9).

Figur 9. The aircraft at the crash site. Photo: Alingsås and Vårgårda rescue services association.
