MESHKA – grounding in Öresund

The Swedish Accident Investigation Authority has investigated a marine accident that occurred in Öresund, Skåne County, on 31 May 2025

01 June 2026

File number: S-128/25

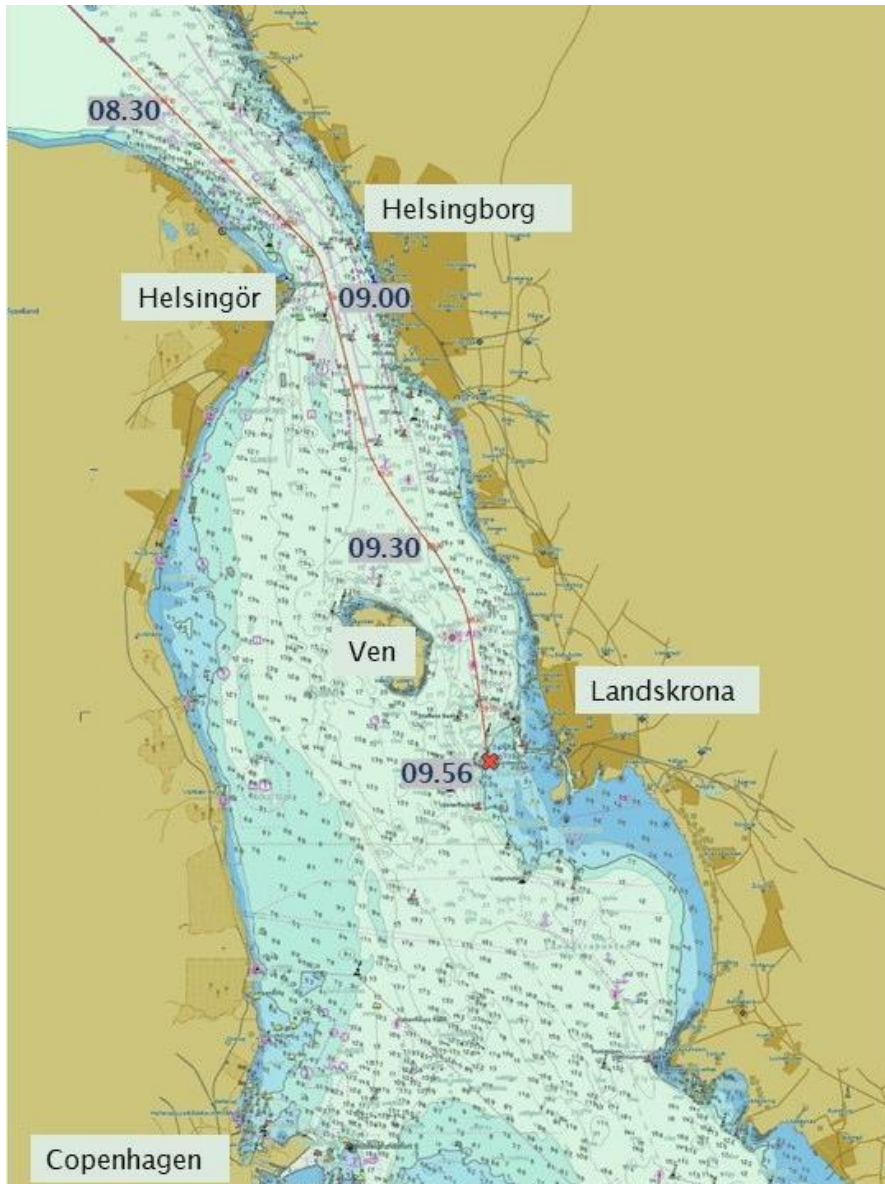
The bulk carrier MESHKA was on a voyage from Tarragona in Spain to Vysotsk in Russia. It was in ballast condition, i.e. without cargo. On the evening of 30 May 2025, the vessel anchored east of Skagen and bunkered fuel. The voyage towards the Sound was resumed at around half past nine that evening. The following morning, the vessel had reached the traffic separation scheme between Helsingör and Helsingborg. The vessel's route was planned to follow the traffic separation scheme, then continue east of the island of Ven, proceed into the Flint channel under the Öresund Bridge, and finally out into the Baltic Sea. The route up to the grounding site is shown in figure 1.

Figure 1. Chart of the Sound with MESHKA's track indicated. © Swedish Maritime Administration No. 26-00511. Annotations added by the Swedish Accident Investigation Authority (SHK).

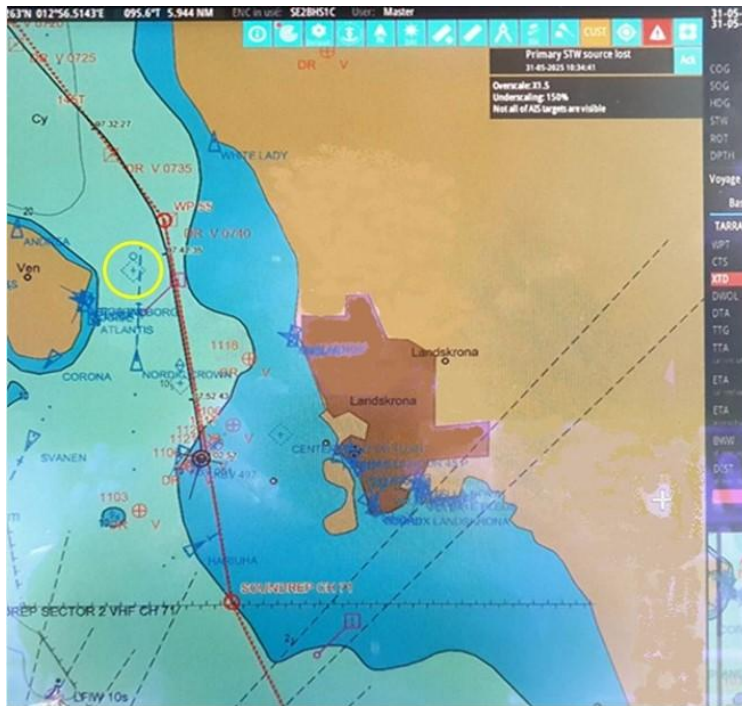
For the passage through the Sound, detailed electronic navigational charts (ENC) were missing in the vessel's ECDIS¹. As a result, navigational marks and detailed depth information were not displayed in the chart image presented by the ECDIS.

Figure 2. The image shows the chart in MESHKA's ECDIS after the grounding. The ENC is SE2BHS1C, which was the ENC active in the ECDIS system at the time of the grounding. The yellow circle marks the virtual AIS buoy. The image from MESHKA's ECDIS was taken by the Swedish Transport Agency's on-call ship inspector 31 May 2025. The image has been edited by SHK.

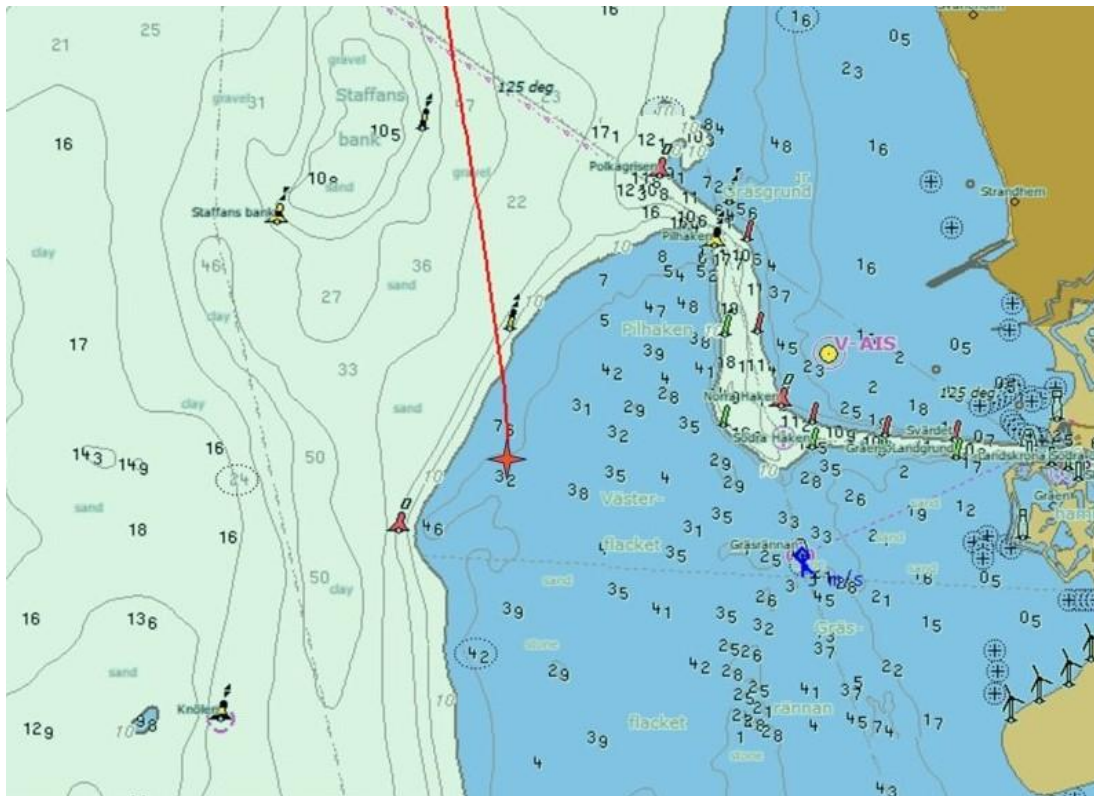
The master realised that the vessel was heading towards a shoal area and ordered the able seaman to apply 20 degrees of starboard rudder while at the same time reducing the propulsion engine revolutions. Shortly thereafter, the vessel ran aground at a depth of 3.2 metres. The vessel's track up to the grounding position is shown in figure 3.

Figure 3. The image shows the grounding position with the plotted track. © Swedish Maritime Administration 26-00511. Annotations added by SHK.

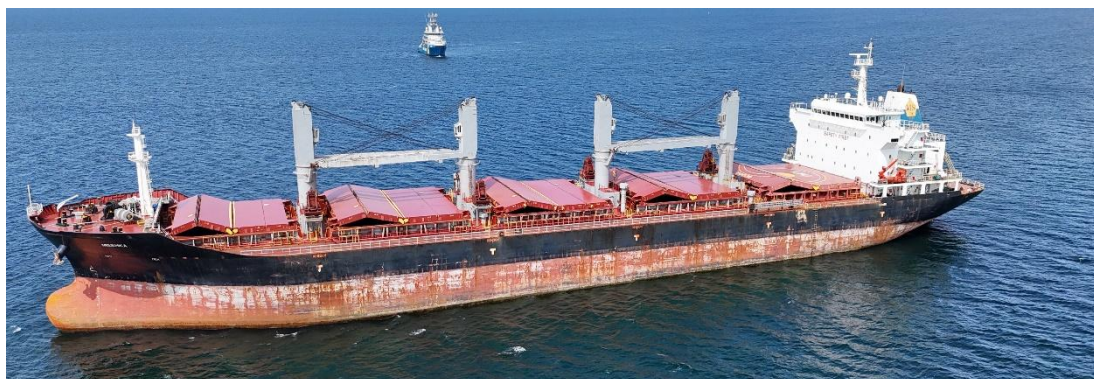
At 09:56 hrs, an operator at the ship reporting service, SOUNDREP⁴, called up MESHKA and warned that the vessel was heading towards shallow water. SOUNDREP instructed the master to alter course to starboard. At the time of the call, however, the vessel had already entered shallow water and the first bottom contact occurred while the conversation with SOUNDREP was ongoing. Shortly afterwards, the vessel came to a complete stop and remained aground, see figure 4.

Figure 4. The image shows MESHKA after the grounding.

Minor damage occurred to the hull (amidships) during the grounding. In addition to long scrape marks in the paintwork, a localised dent of up to 3 mm occurred in the bottom plating. There were also small cracks at the outer edges of the propeller blades and the rudder, which most likely arose during the grounding. The damage to the propeller blades was repaired by divers while the vessel was berthed in Landskrona.

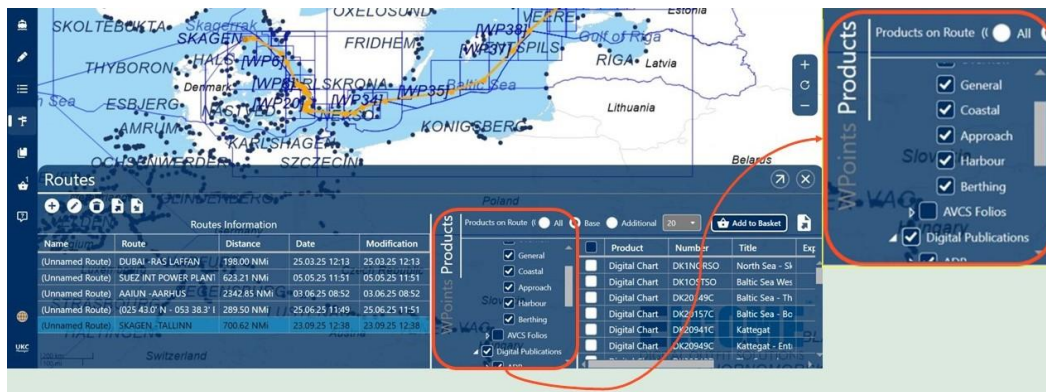
Figure 6. The image shows a section of the chart-ordering program. In the red circle, options for chart scales that can be ordered are listed. The planned route is shown in the chart display of the chart-ordering program. Elcome© Annotations added by SHK.

In the advanced system settings, the user could also choose to completely hide detailed ENC in the software. According to the chart providing company, this feature was introduced after users had requested the ability to avoid accidentally ordering large scale charts for, for example, a port, simply because the planned voyage passed close to the port.

In its review of the chart order, SHK has found that for other areas along the vessel's route, chart cells had been ordered which included large-scale (detailed) chart cells. It is therefore considered unlikely that large-scale ENCs were deliberately excluded. Instead, it is likely that an error occurred during the ordering process which the officers failed to detect.

If the chart ordering software had featured a function that listed the chart cells that had been actively excluded along a proposed route and which were also missing from the ECDIS internal database, the officers would have been better equipped to identify that the chart data in the system was inadequate. This is a function that is available from other providers of similar chart services. The chart provider Elcome should therefore take measures to clarify when available chart cells (ENC) have been deselected along a planned route.

- ensure that it is clearly indicated in the chart ordering software when electronic chart cells (ENC) are missing or have been deselected along a planned route (see section 3.1.1). *(SHK 2026:10: R1)*

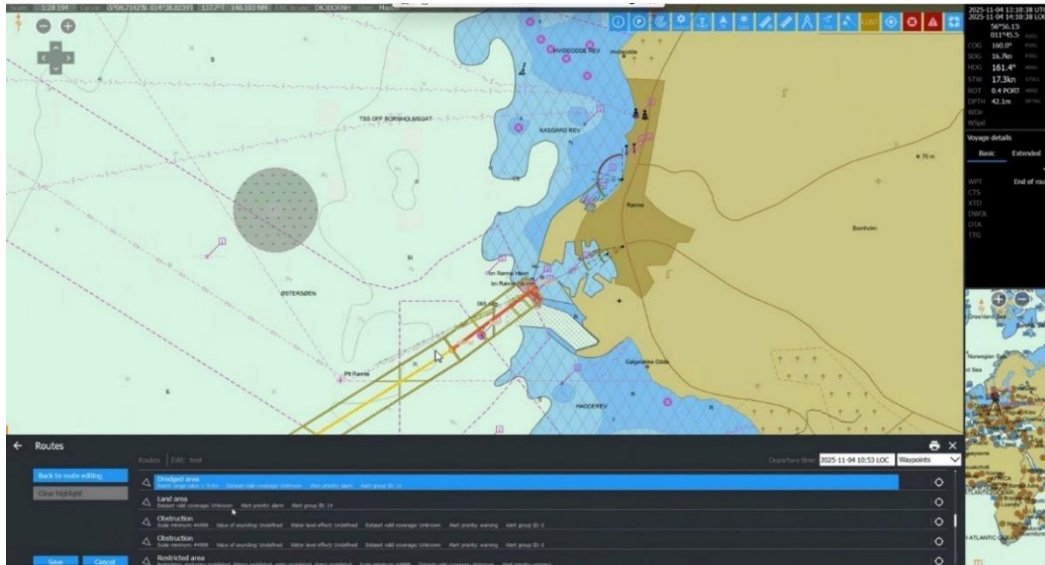
If there were warnings along the route leg, the section was highlighted in yellow. Warnings referred to lower-priority risks, such as the route approaching a high-traffic area or a traffic separation scheme. If the route leg was uncoloured, there were neither hazards nor warnings along the section up to the next waypoint, see figure 7.

Figure 7. Example image showing the “grounding check” function in the ECDIS. The risk level for each leg is indicated by a red or yellow line. In this image, the shallow pattern function is activated, displaying a grid over areas with depths of less than 10 metres. Photo: Danelec.

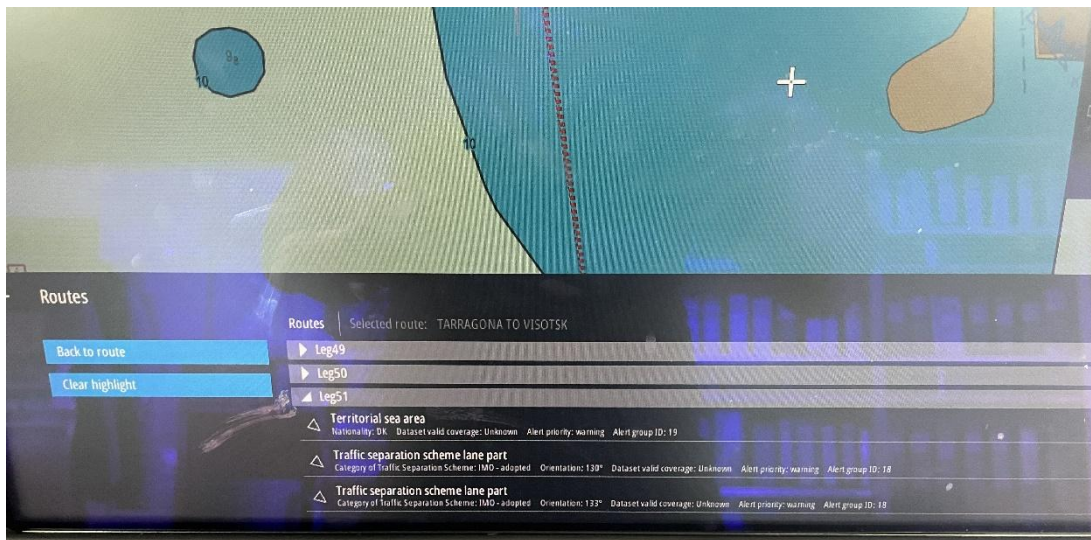
After the grounding check, a table was also presented in which each leg of the route was listed. The bridge officers could use a drop-down menu to review the risks along a selected leg, see figure 8. When reviewing the current route validation, the second officer based the assessment on the information in the table.

Figure 8. Validation list in ECDIS. The picture was taken on board MESHKA. For each leg, it is possible to expand rows containing information about the risks associated with the respective leg.

A review of ECDIS revealed that the grounding check function had a limitation: it could only list up to 51 route legs in tabular form. MESHKA's voyage plan contained 92 route legs. Validation continued for routes with more than 51 legs, but in order for the system to display hazards along each leg, the bridge officers themselves had to pan along the route. With this method, there was no limitation on the number of legs that could be reviewed. The limitation to 51 route legs was not mentioned in the ECDIS instruction manual and was not known to the bridge officers on board.

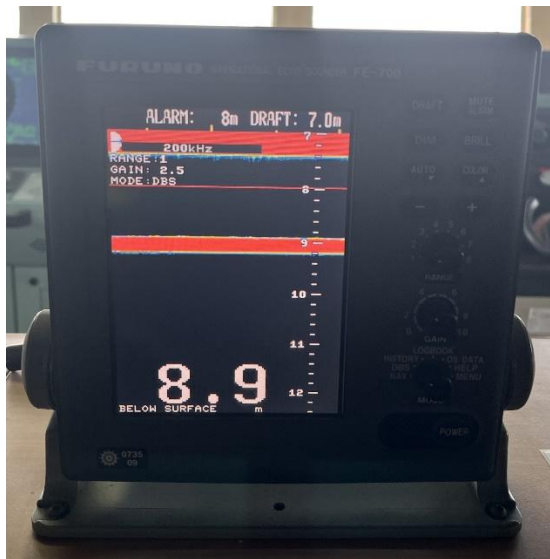
During the vessel inspection of MESHKA, SHK observed that the ship's echo sounder was set to display water depth measured from the water surface. The vessel's draught was set to 7 metres on the echo sounder. The echo sounder indicated a water depth of 8.9 metres when, in fact, the vessel was aground, see figure 9. According to the safety parameter checklist, the echo sounder should trigger an alarm when the *under keel clearance* (UKC) was 1 metre in port and 10 metres at sea. At the time of the vessel inspection, the echo sounder alarm was set to activate when the water depth was less than 8 metres. The echo sounder's transducer was mounted in the bow of the vessel, where the draught was significantly less than at the stern. The echo sounder did not alarm as the vessel approached shallow water because the vessel had a substantial trim by the stern (2.2 metres) and the settings for the echo sounder transducer had not been adjusted accordingly.

Figure 9. Image of MESHKA's echo sounder. The picture was taken during SHK's onboard visit.

In the checklist "ECDIS voyage safety parameters", which formed part of the company's safety management system, it was stated that the echo sounder should always display the depth under the keel in order to avoid misunderstandings.
