Accident with the aircraft D-EDVJ of the model Piper PA-28-140

The Swedish Accident Investigation Authority has investigated an accident at Fagerhult, Skåne County 24 August 2025

File number: L-68/25

Final report SHK 2026:08e

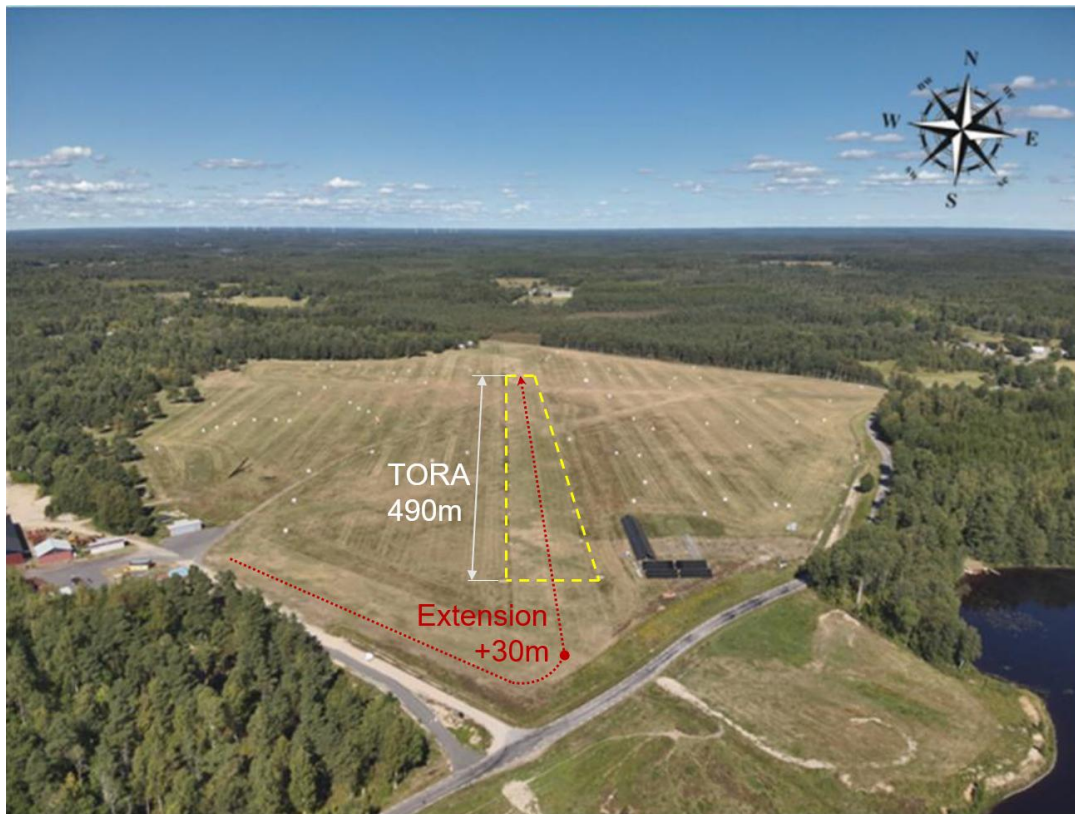
Beyond the runway end, the terrain rise, and on this elevation, there was first a stretch of approximately 100 metres of young forest, followed by about 230 metres of birch forest where the tree height was around 20 metres (65 feet). Thereafter, the terrain opened up into a field which was approximately 100 metres long.

Figure 1. Overview image taken in a northerly direction over the aerodrome with marked available runway length (see 1.10 Aerodrome information). Markings added by SHK. Lantmäteriet dissemination permit no: LM2025/133392.

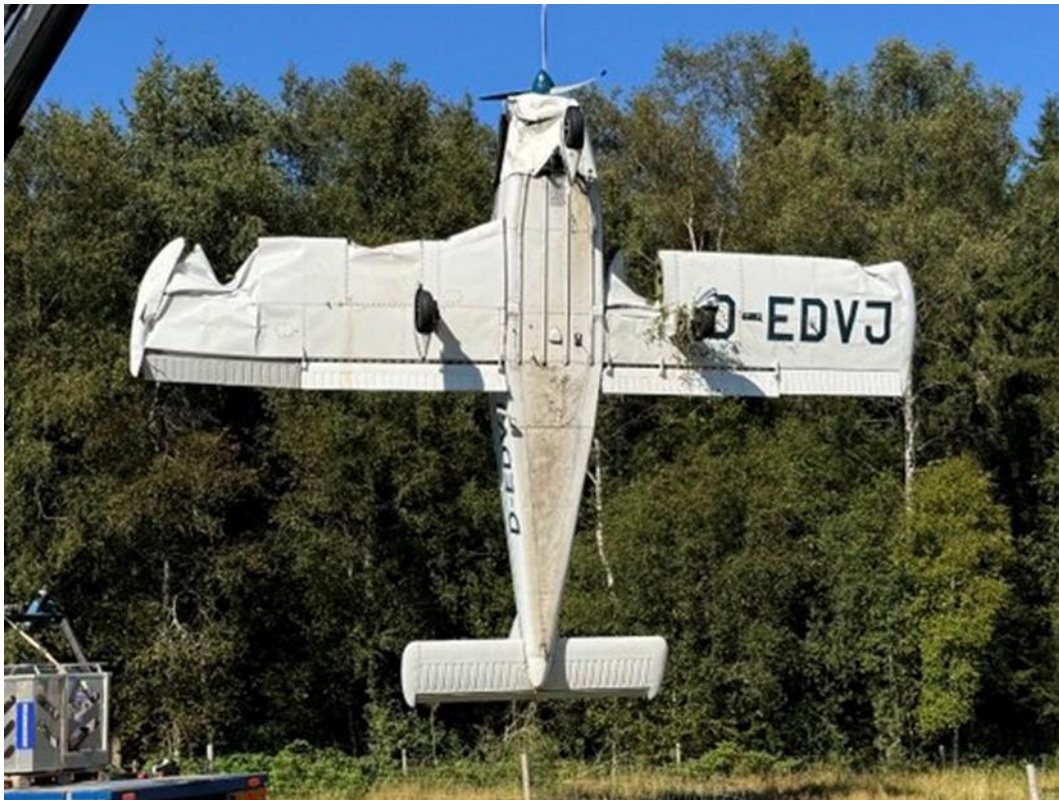
Substantially damaged.

Figure 2. The pictures show the damaged wings and forward part of the fuselage.

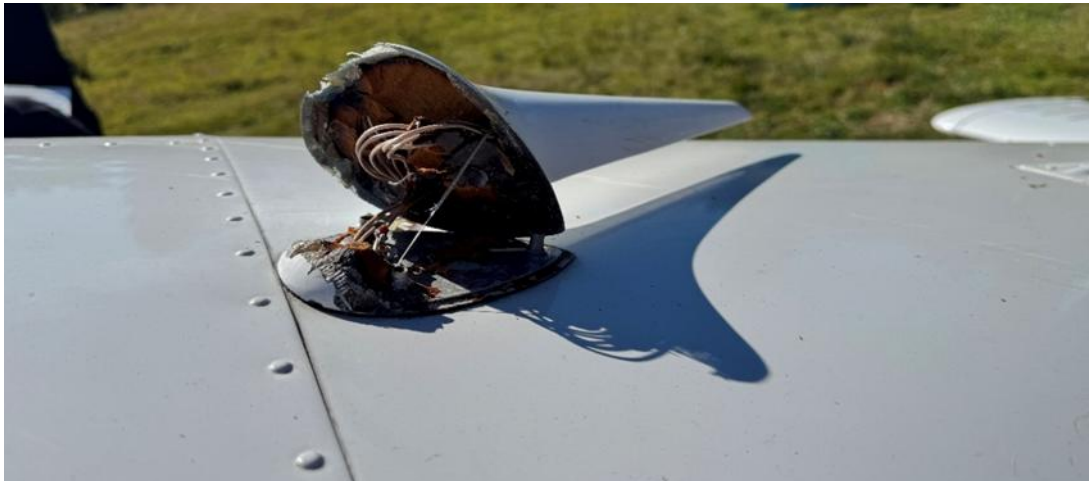
After the accident, the pilot attempted to send a distress message to Sweden Control without receiving any response. The reason was that the communication antenna had been broken.

Figure 4. Picture of the damaged communication antenna.

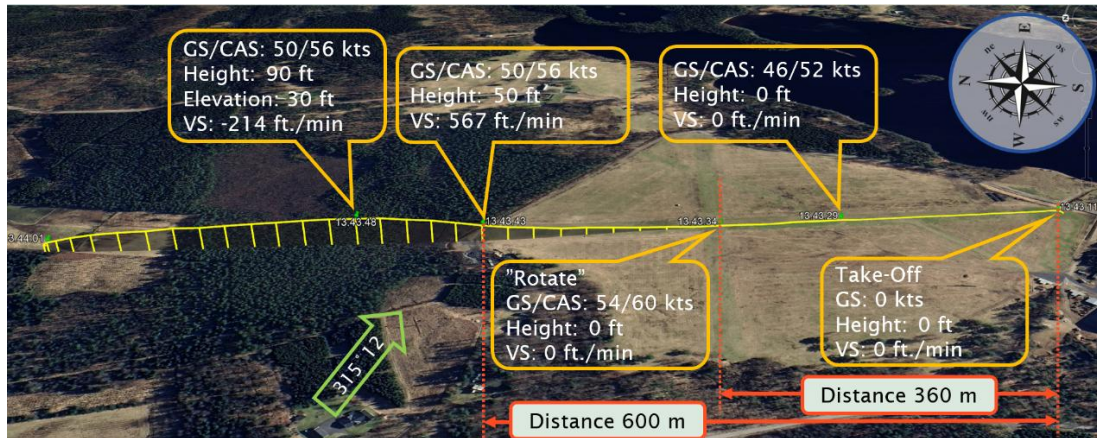
Figure 6 shows the recorded flight, from take-off to the accident site. The image is oriented in an easterly direction. The ground roll distance was 360 metres, and the distance to 50 feet height above the runway was 600 metres from the start of the runway. The speech bubbles in the figure indicate the aircraft's ground speed (GS), calibrated airspeed (CAS) corrected with the mean wind based on SMHI's analysis for the area, as well as height above ground and vertical speed (VS) at different points after the aircraft had lifted off.

Figure 6. The flight path is shown in Google Earth from take-off to the accident site. Markings added by SHK.

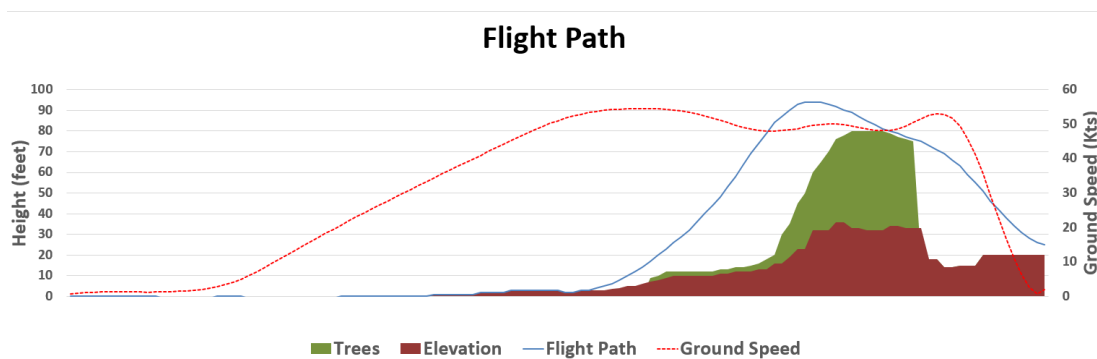
Figure 7. The flight path with groundspeed. The image is not to scale in height and distance.

The data shows that the groundspeed at the moment of rotation was 54 knots and the groundroll distance was 360 metres. SMHI's analysis indicated that the mean wind speed, converted to calibrated airspeed, corresponded to about 60 knots. During the subsequent phase of flight, the speed did not increase as expected, but instead decreased slightly, and then dropped rapidly just before the collision.

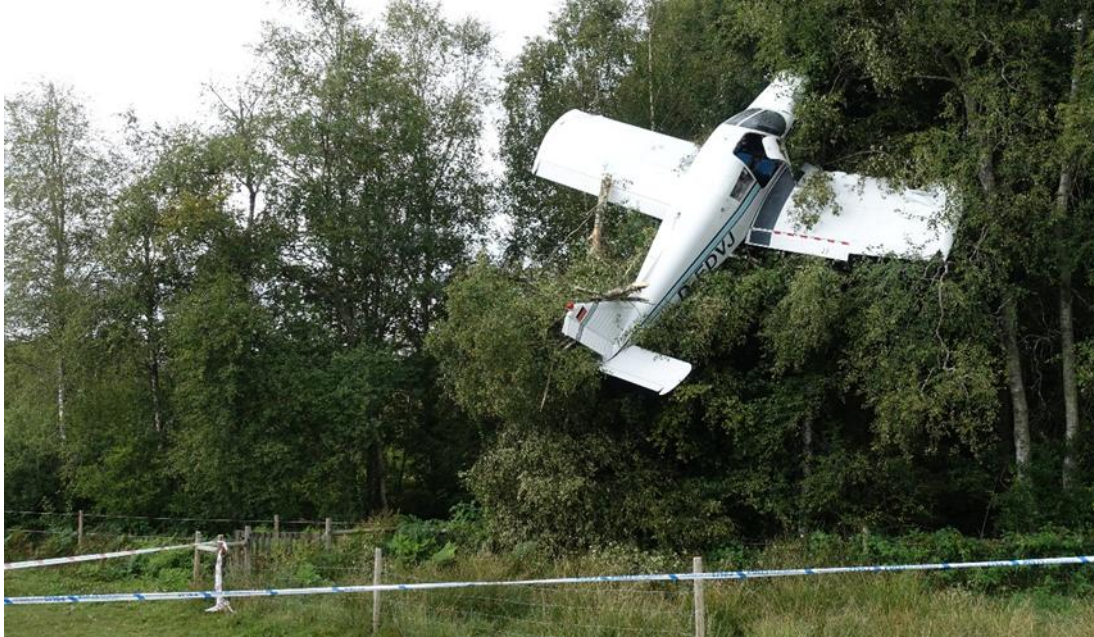
The aircraft collided with a birch forest and finally came to rest 450 metres north of the runway end at Skånes-Fagerhult Airport. The aircraft's final position was approximately eight metres above the ground, measured from the cabin door.

Figure 8. The final position of the aircraft.

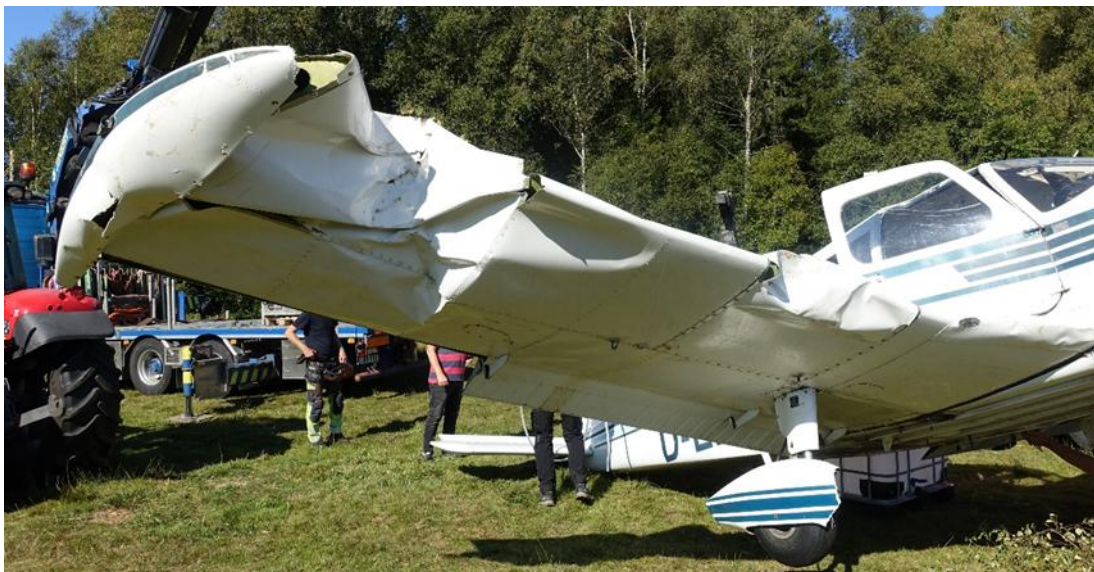
Both wings had sustained damage to the leading edge and wing spar. The fuel line on the left side had broken off in front of the wing spar and was leaking fuel. The engine cowlings were damaged, and the tip of one propeller blade was bent forward from the propeller hub on one side.

Figure 9. Damages on the right wing.

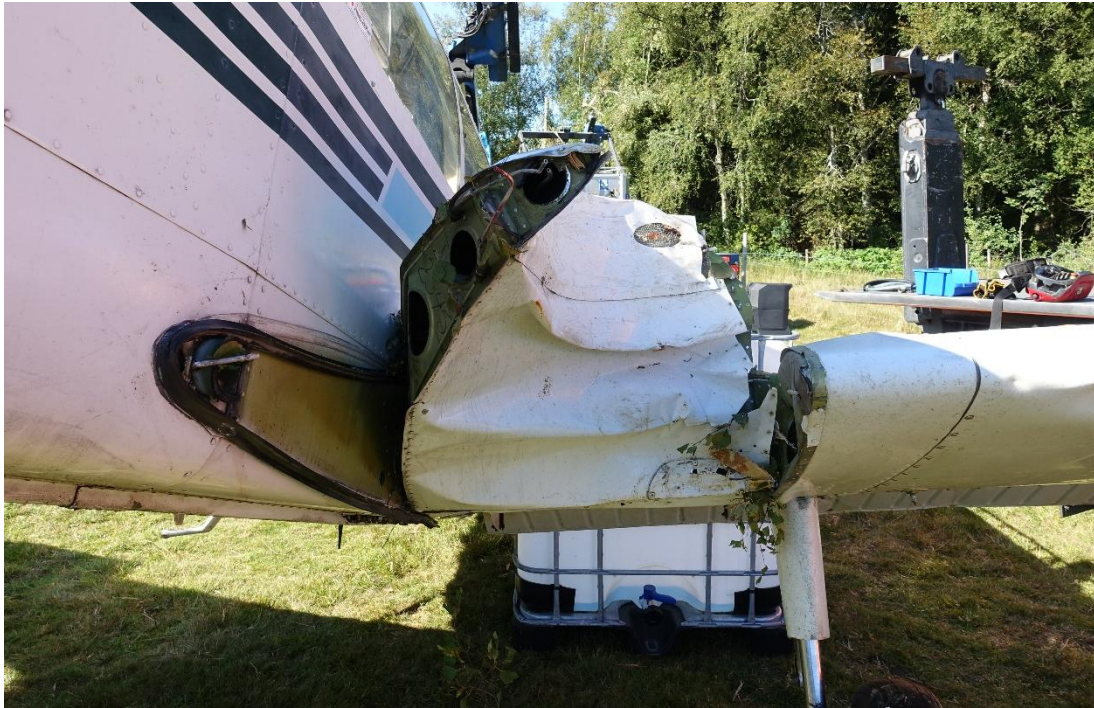
A certain amount of fuel leaked out at the accident site. The leak was caused by damage to the wing tanks' fuel lines from the collision with the trees. The fuel lines that ruptured were located in the leading edges of the wings. Since the aircraft remained hanging in the tree branches, most of the fuel stayed in the tanks.

Figure 10. Damages on the left-wing root.

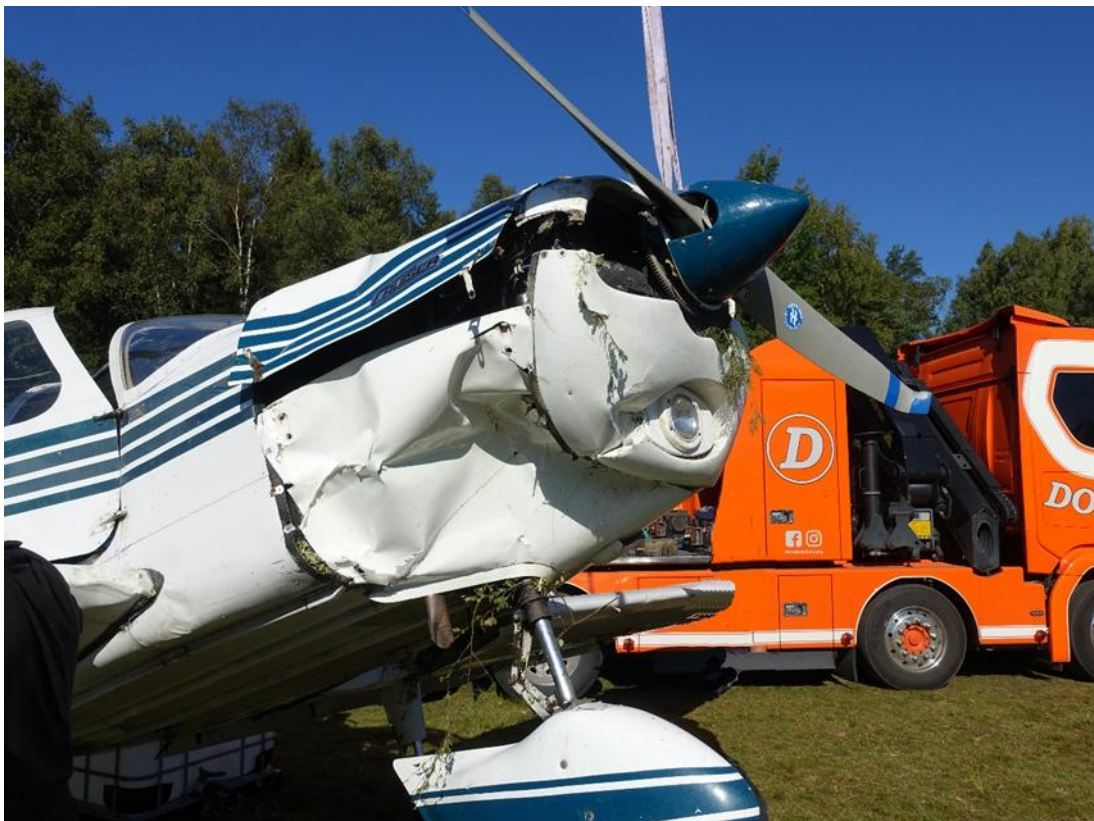
Figure 11. Damages in front of the fire wall.
