Interrupted engine start and evacuation involving Saab 340B, VH-ZRK

Melbourne Airport, Victoria, on 5 April 2022

ATSB Transport Safety Report

AO-2022-019

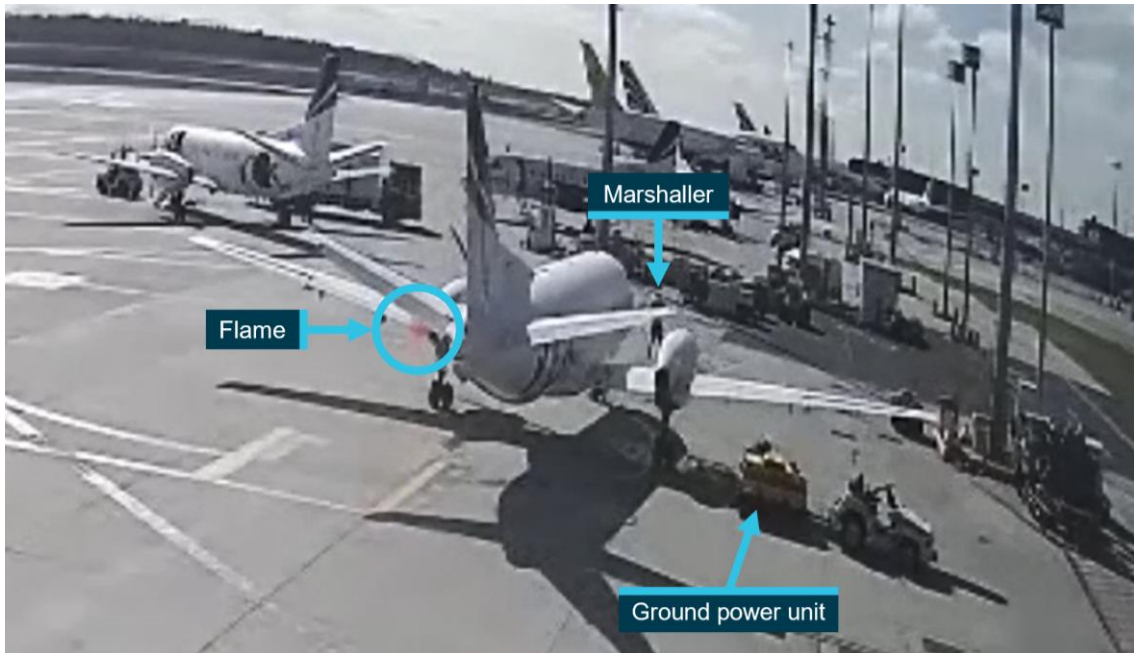
At 1445:28, as the left engine propeller began to rotate again as part of the engine motoring procedure, a tailpipe fire had developed as indicated by flame and smoke coming from the rear of the engine. The marshaller, who was still positioned at the front of the aircraft, saw a 'burst of flame' from the back of the engine (Figure 1) and began to signal to the flight crew to stop what they believed to be an additional engine start (as they were unaware of the motoring procedure). As the marshaller and flight crew were not able to communicate verbally (there was no radio and no communications headset for the Saab 340), the marshaller reported they tried to signal to the captain to shut the engine down using a 'cut-throat' hand signal. They also tried to indicate that there was a fire coming from the back of the engine, however, the marshaller could not recall the hand signal for fire and instead attempted to communicate it by mouthing the word 'fire' and gesturing to the left engine. CCTV recorded the marshaller waving their hands at this time. The captain was responding to the marshaller verbally (noting the marshaller could not hear) advising that they had to continue, however the marshaller continued to try to advise that they had seen fire from the left engine. As a result of the marshaller indicating they observed flames from the engine, the captain ceased motoring the engine and the left propeller stopped rotating.

Figure 1: Still image of CCTV showing flame during first motoring attempt

However, during this process burning fuel was blown through the tailpipe, appearing as a plume of flame and smoke behind the engine. As the left propeller began to rotate during this motoring attempt, the marshaller (unaware of the motoring required by the procedure) mistakenly thought that the flight crew were attempting to restart the engine. Having observed the flame and smoke, the marshaller signalled to the flight crew, which prompted the captain to stop motoring the engine. Residual fuel would have continued to burn inside the engine.

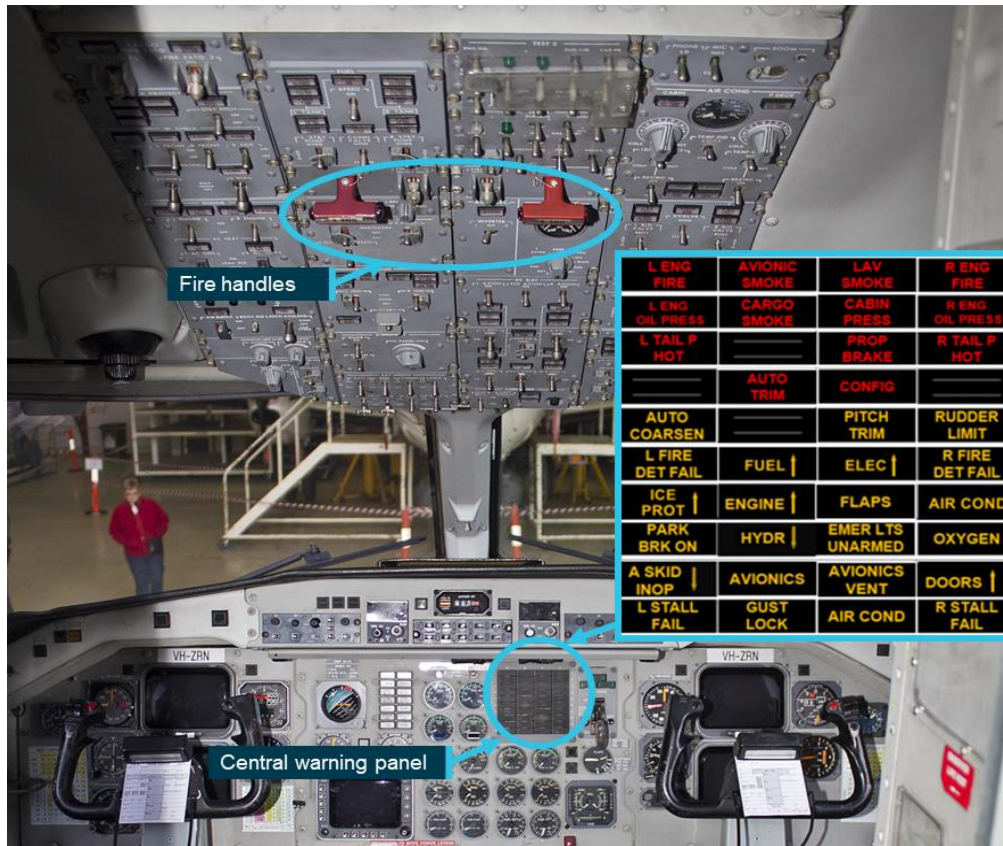
Engine fire detection was provided by a continuous loop detection circuit mounted under each engine, outside of the casing when the temperature reaches approximately 300 °C. Proximity of fire to this loop would change its characteristics and trigger multiple types of warnings in the flight deck. These warnings consisted of a fire bell, master warning lights, a caption for each engine on the central warning panel, and lights in the fire handle for the relevant engine (Figure 2).

Each engine also had tailpipe overtemperature sensors that triggered the master warning lights and a caption for each engine on the central warning panel (CWP) in the flight deck if the temperature in the tailpipe reached approximately 235 °C. The lights would extinguish after the temperature had reduced.

Figure 2: Saab 340B flight deck

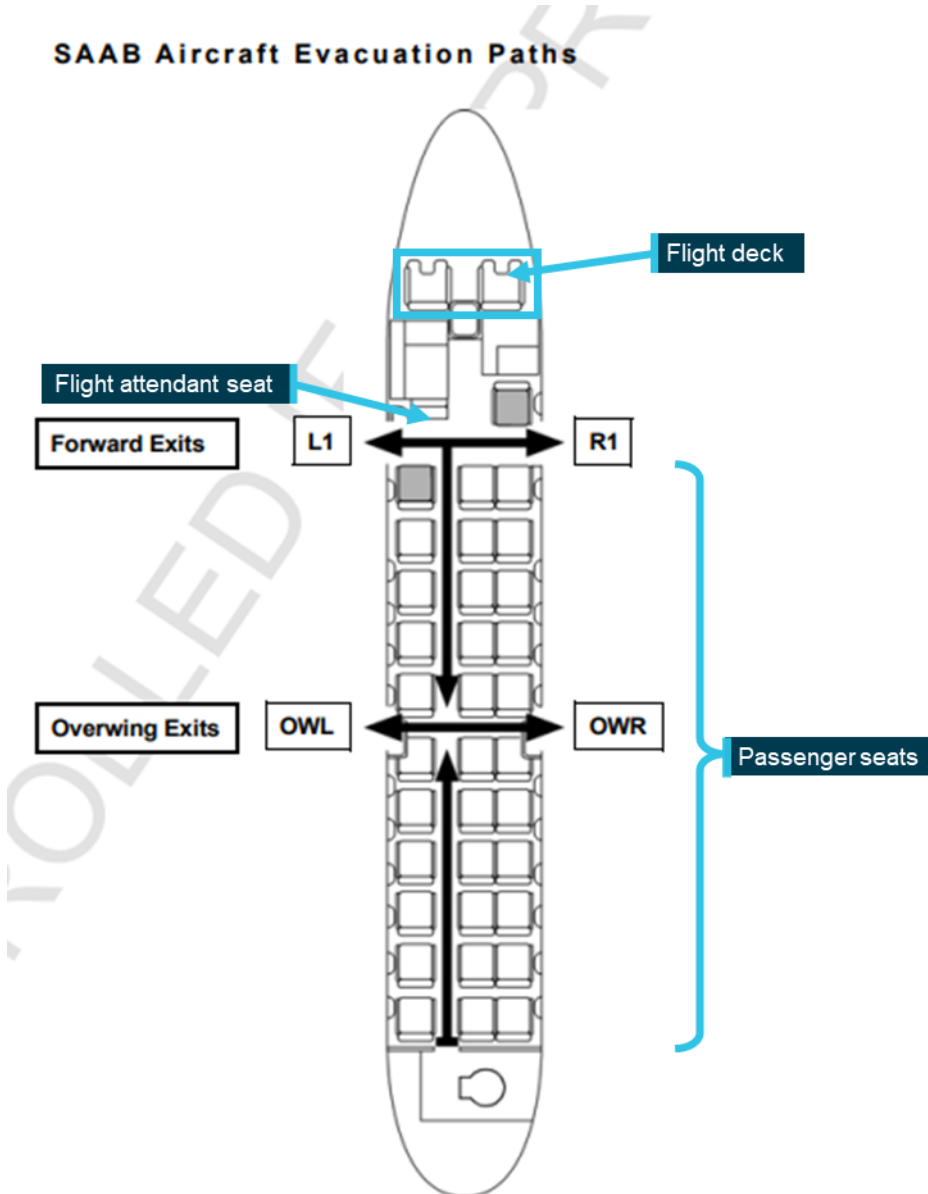
There are 4 emergency exits on the Saab 340 type aircraft. There are 2 exits at the front of the cabin in row 1, and 2 overwing exits in row 6. The sill height of the 2 forward exits is 1.68 m, with no emergency escape slides fitted (Figure 3).

Figure 3: Emergency exit locations

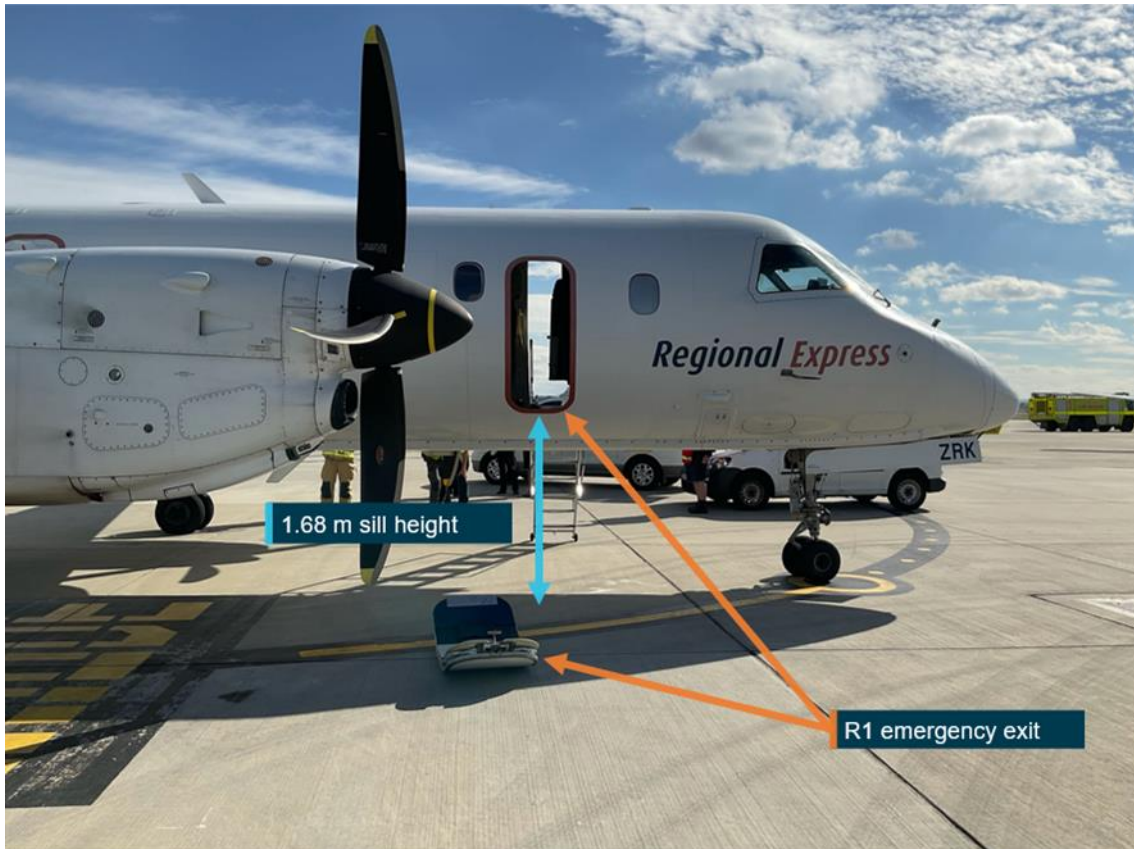
The first passenger at the R1 exit hesitated due to the height of the door sill (1.68 m without steps or escape slide) but was encouraged by the flight attendant to exit. This passenger received a minor injury. The FO exited the aircraft after the first passenger, and a refueller and ground staff assisted the remainder of passengers to evacuate. The flight attendant continued to instruct passengers to evacuate and to 'sit and jump'. Some passengers attempted to bring their bags during the evacuation and the flight attendant and the captain (after exiting the flight deck) instructed them to leave everything behind. After receiving these instructions, a small number of passengers still exited the aircraft with their bags.

For this occurrence, the evacuation, from when the evacuation announcement was made until all passengers and crew had evacuated, was completed in about 4 minutes utilising one of the 4 exits.

Figure 4: R1 emergency exit on the Saab 340B

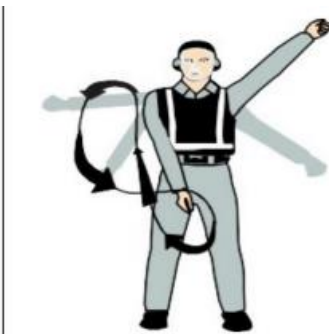
Fire

The Rex airport services manual included ground crew hand signals for fire (**Error! Reference source not found.**). The hand signals were derived from the International Civil Aviation Organization's Annex 2: Rules of the Air. The airport services manual was provided to Rex ground staff, but not to flight crew. These signals were taught to ground crew during their initial training only.

Move right hand in a fanning motion from shoulder to knee, while at the same time pointing with left hand to area of fire.
