# In-flight fire and cabin smoke involving Saab 340A, VH-KDK

114 km east-north-east of Cobar, New South Wales, on 23 April 2023

## **ATSB Transport Safety Report**

AO-2023-020

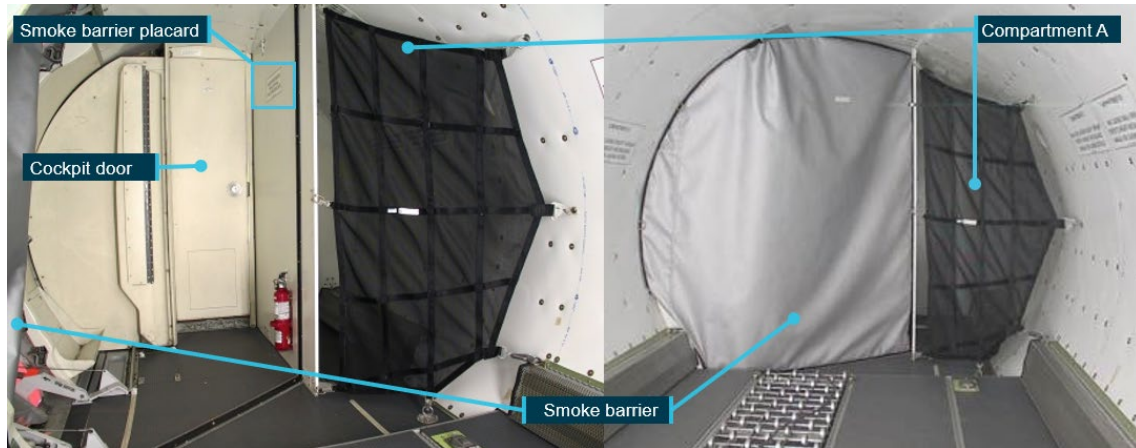
**Figure 3: Smoke barrier curtain location in exemplar aircraft**

During interview, the flight crew stated that they were not aware of the use of the smoke barrier, and that it had been located after the incident in compartment A of the cargo area, and that it was not in place on the left of the cabin. The ATSB did not determine why the engineers who loaded the engine into VH-KDK had not secured the smoke curtain.

Saab has revised their preparatory and walk-around pre-flight checklists to include the fitting of the smoke barrier curtain when carrying cargo in the cargo-configured aircraft.

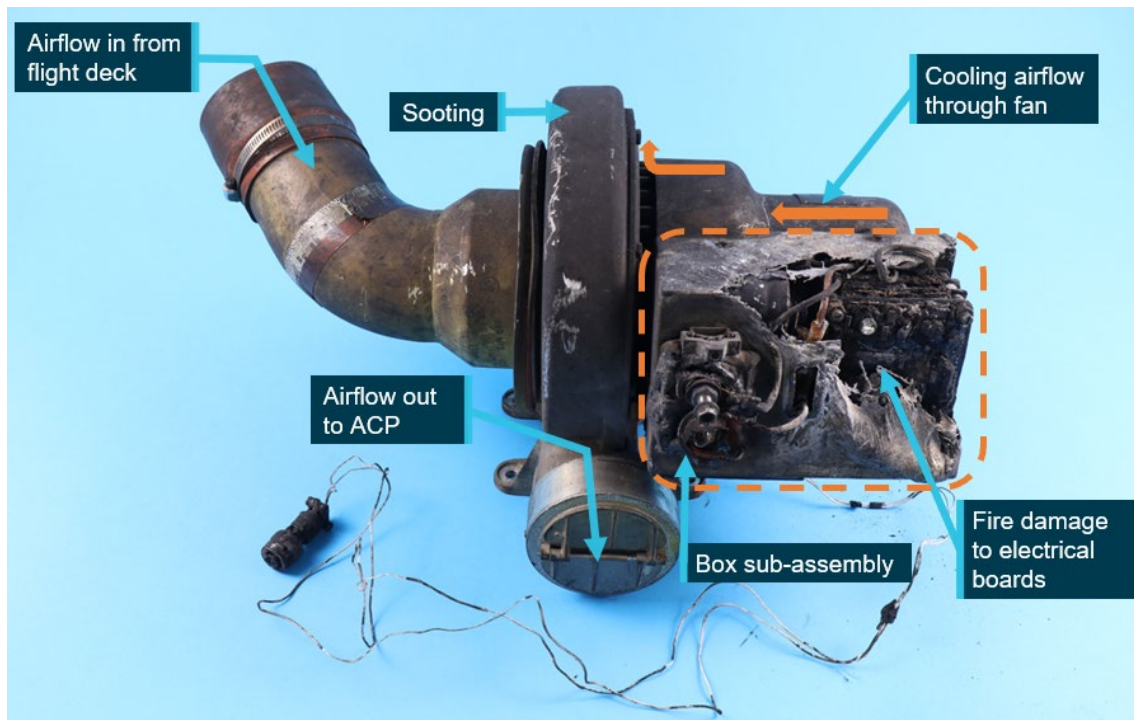
**Figure 5: Damaged recirculating fan**

Fire damage was found in the area around the right recirculating fan and on the fan itself (Figure 5). There were no other components in the vicinity of the fan with significant fire damage. As such, it is likely the right recirculating fan was the source of the fire.

An examination of the recirculating fan was conducted at the ATSB's technical facilities in Canberra. The examination found that the fire damage was most significant at the external box sub-assembly which housed the EMI filter, the resistor support plates and electronic card sub-assembly. The aluminium cover of the box sub-assembly had melted, the electrical wiring was damaged, and some terminals had disconnected as a result of the fire damage. There was heavy soot and melting of solder in the cooler assembly.

The electronic card sub-assembly was made up 3 circuit boards, mounted to the resistor support plate. The function of the circuit boards was for motor speed detection, timer control, and a logic card. The damage exhibited on the circuit boards showed significant burning, consistent with the other components within the aluminium cover.

The electromagnetic interference (EMI) filter sub-assembly had considerable damage to the filter itself and to the mounting plate with signs of melting and heat tinting of the steel plate structure, indicating a significant heat source. The heat tint was indicative of temperatures of approximately 310° to 330°C.

Of note, the fire did not appear to be associated with the motor and there was no indication of damage to the internal components of the fan and was able to rotate freely. There was carbon and soot observed on the external surface on the motor. The crew stated that there had been no circuit breakers tripped that would be associated with the failure of the electronic card sub-assembly.

The ATSB examination of the recirculating fan could not determine the cause of the failure of the electronic components attached to the assembly.

The source of the in-flight fire was traced to the right recirculating fan assembly. Although the fan was not damaged internally, the fire damage was most significant at the box sub-assembly, which was mounted external to the fan and housed the electrical control circuit boards. It is likely that an electrical component or components within the box sub-assembly failed, resulting in the underfloor fire. The fire damaged underfloor insulation and plastic air conditioning ducting components, which led to thick smoke filling the cabin and cockpit and aircraft structural damage.

Rex advised that it is implementing a fleet-wide inspection of the flight deck and passenger compartment recirculation fans at the next aircraft heavy maintenance visit. The inspection will be focused on the electronic sub-assembly module of the recirculation fan due to this component being identified to have the most significant fire damage on the fan assembly removed from VH-KDK.

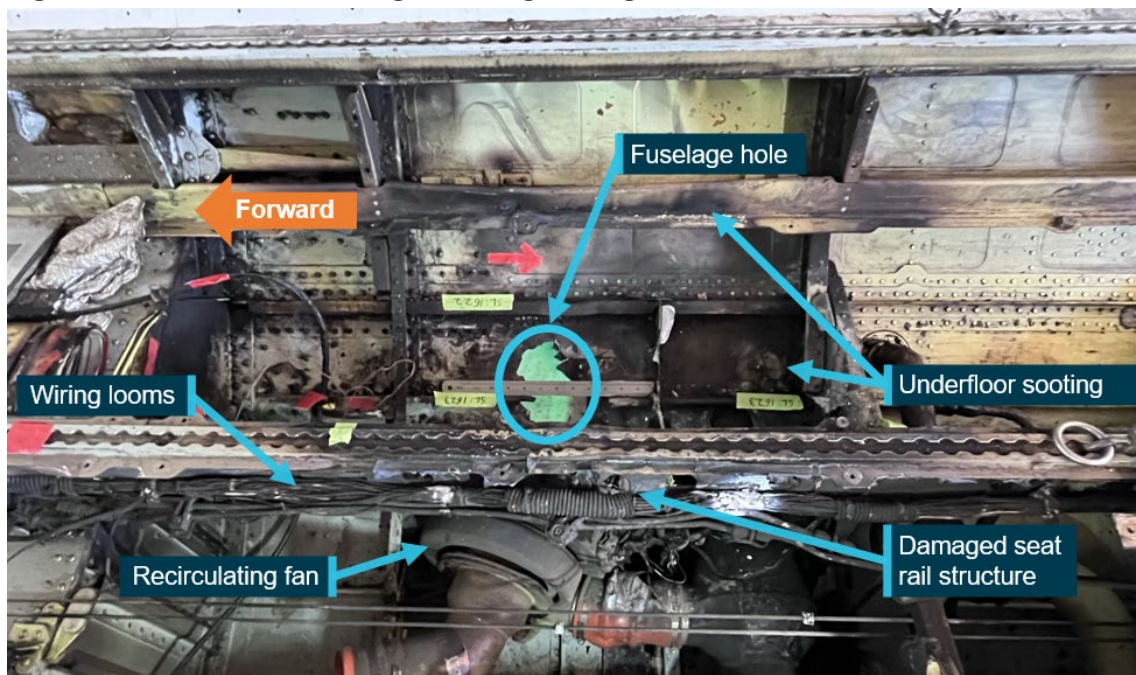
**Figure 6: Underfloor fire damage showing fuselage hole**

The severity of the fire resulted in significant damage to the surrounding underfloor furnishings, ducting and airframe structure. The damage was then sufficient to rupture the skin (Figure 6) and caused a subsequent depressurisation of the aircraft.

- The underfloor fire caused weakening of the fuselage structure, which led to a subsequent depressurisation of the aircraft during the descent. However, the depressurisation aided in the removal of enough smoke from the flight deck on approach to allow an unhindered visual approach at Cobar.

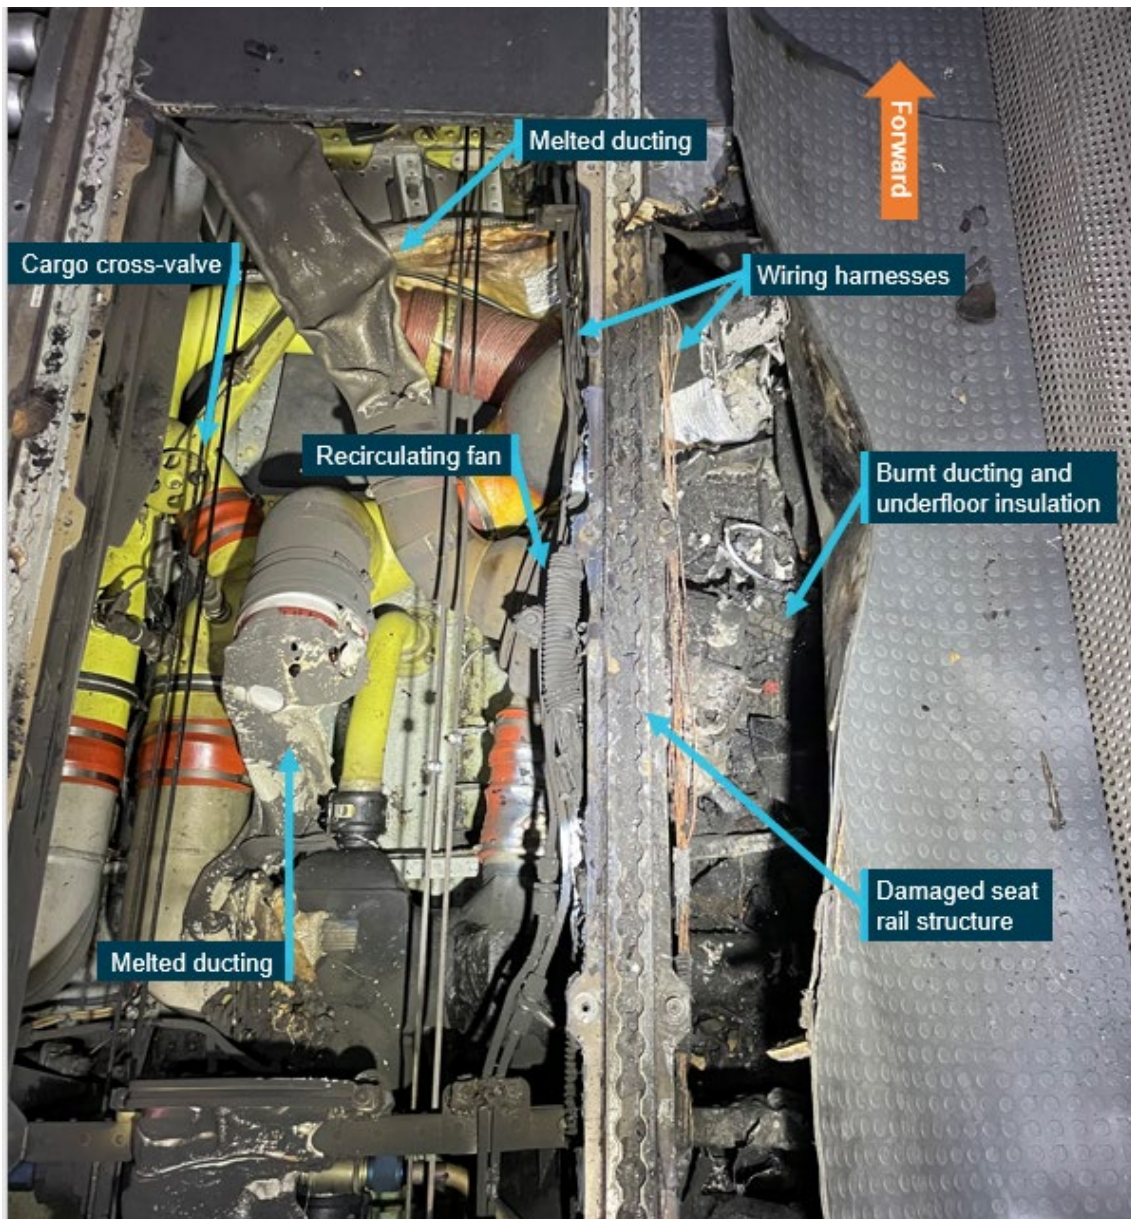
Figure 8: Underfloor fire damage

The damage caused by the underfloor fire was substantial. The fire had damaged underfloor air conditioning ducting and electrical wiring (Figure 8).

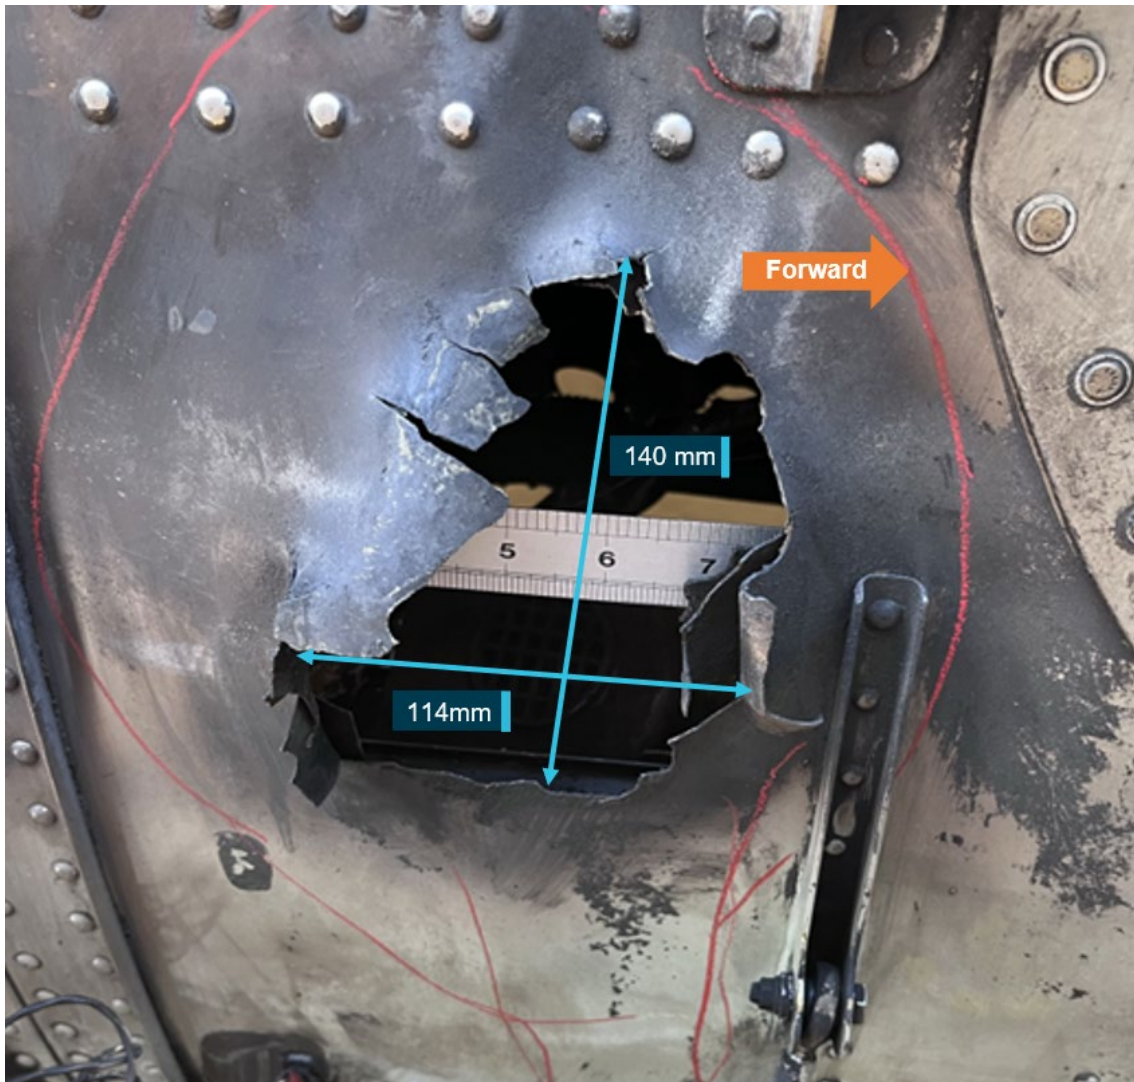
**Figure 9: Fuselage skin breach**

Structural components in the surrounding area had been distorted by the extreme heat, including the floor panels, which had collapsed when fire crews entered the aircraft and inadvertently walked over the affected area. The seat track support structure had distorted, and the fuselage

was weakened by the fire which breached the outer skin, preventing the aircraft from remaining pressurised (Figure 9).

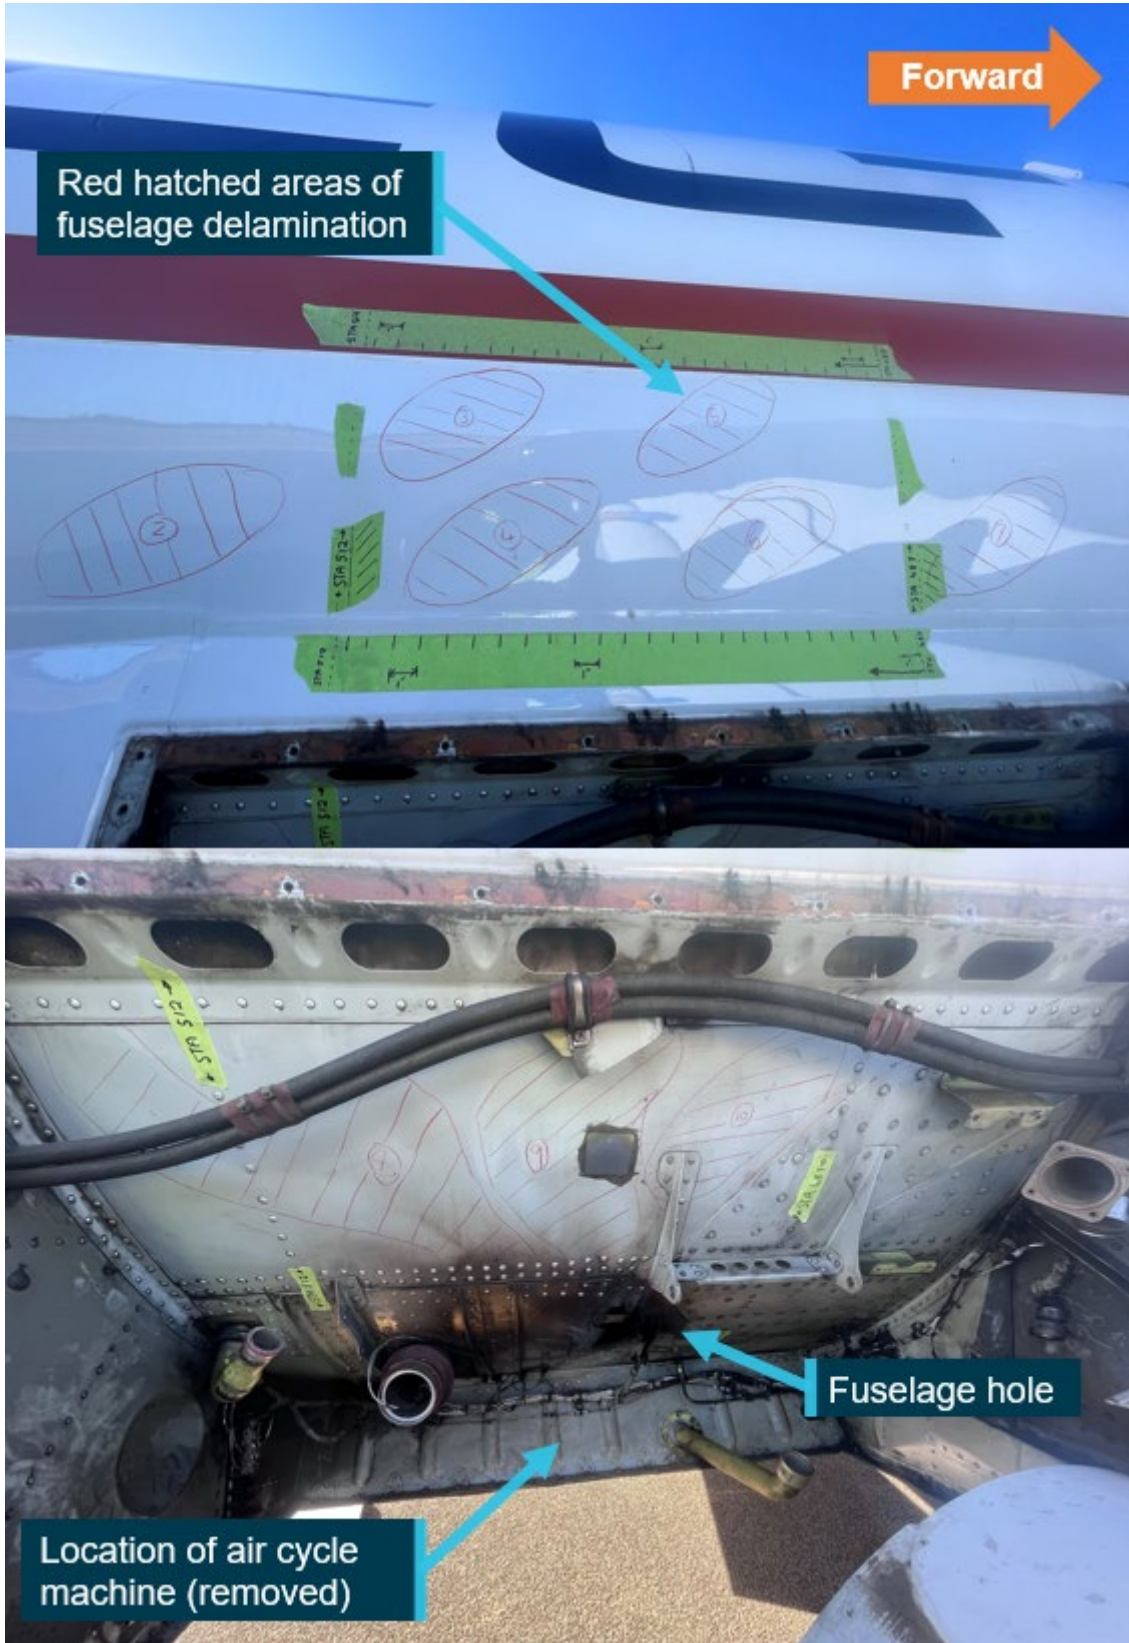
Figure 10: Right side delamination on fuselage

The fuselage in the immediate area above and below the cabin floor was buckled and delaminated. The heat from the fire most likely travelled between the interior panels and freight lining, leading to the damage observed (Figure 10). Following an engineering inspection of the fire damage, the aircraft was withdrawn from service and not repaired.
