ROV VIDEO SURVEY OF THE SELECTED SONAR TARGETS ON THE SINKING TRACK OF MV ESTONIA ON THE BALTIC SEA JULY 1 TO JULY 4, 2024

PRELIMINARY ASSESSMENT
FACTUAL REPORT
OCCURENCE ID: M280994

Document ID: OJK-M280994-FaR-240704-R00-EN
Document version: Revision 0
Document date: 2024-09-03

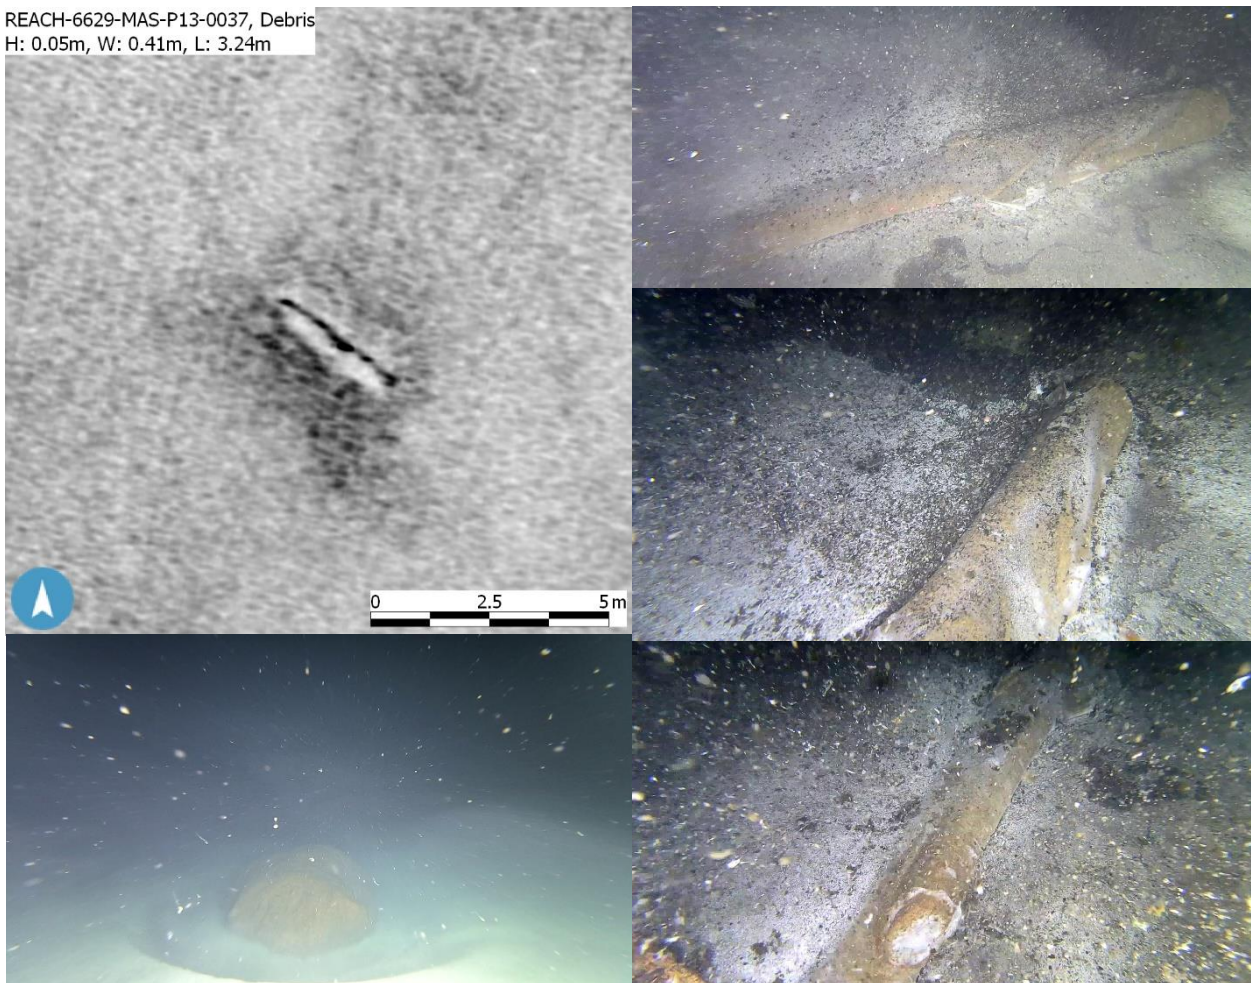
REACH-6629-MAS-P13-0037, Debris
H: 0.05m, W: 0.41m, L: 3.24m

Some smaller boulders and one larger isolated boulder were in the area. Selected target turned out to be a brown colour wood log with remains of branches.

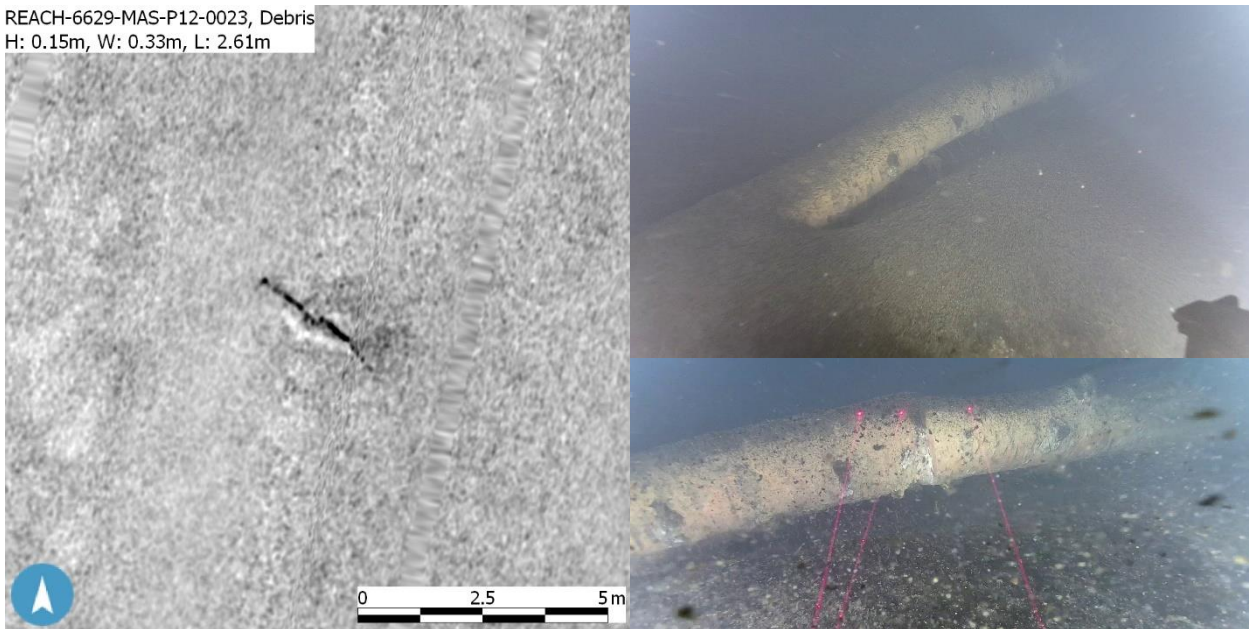
REACH-6629-MAS-P12-0023, Debris
H: 0.15m, W: 0.33m, L: 2.61m

Some isolated boulders and a boulder field were visible in the area. Selected target turned out to be a light colour wood log with remains of branches.

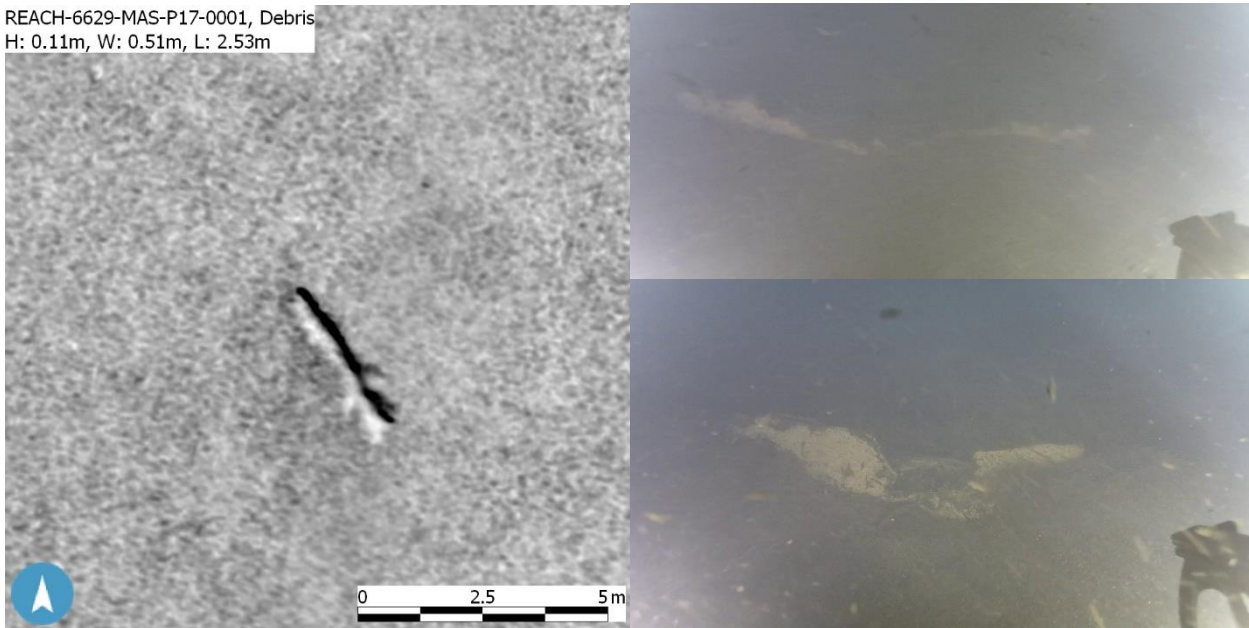
REACH-6629-MAS-P17-0001, Debris
H: 0.11m, W: 0.51m, L: 2.53m

Selected target turned out to be a light colour wood log with remains of branches. A lot of suspended sediment.

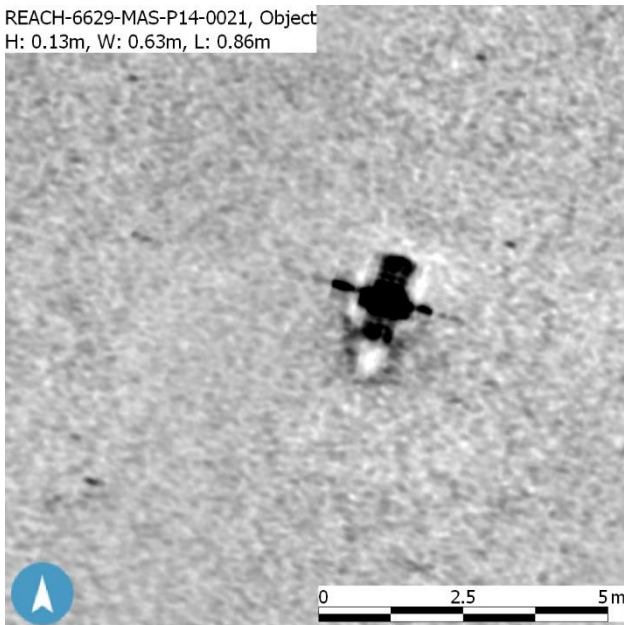
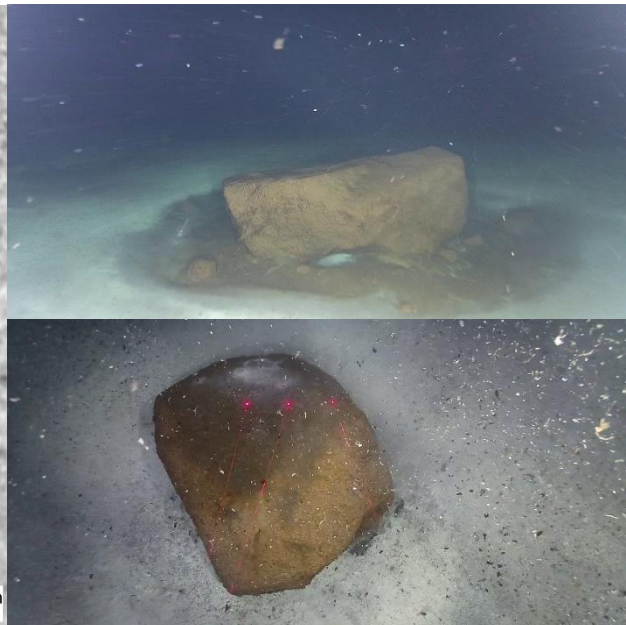
REACH-6629-MAS-P14-0021, Object
H: 0.13m, W: 0.63m, L: 0.86m

Selected target turned out to be a rectangular boulder, one isolated larger boulder was also visible.

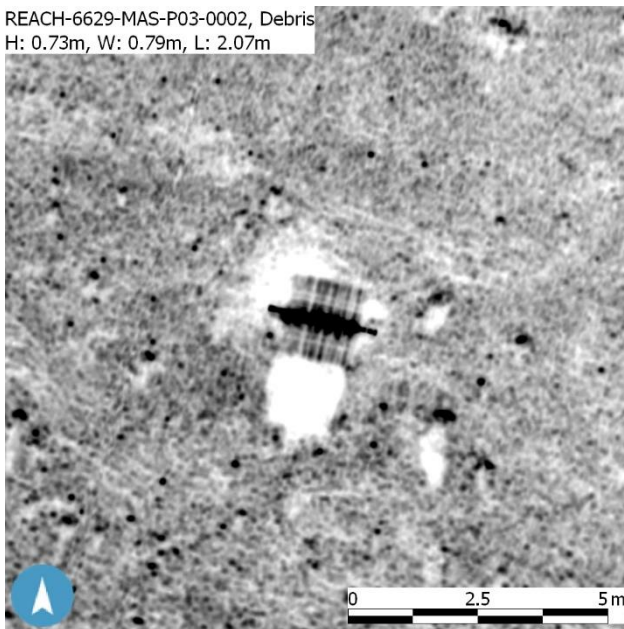
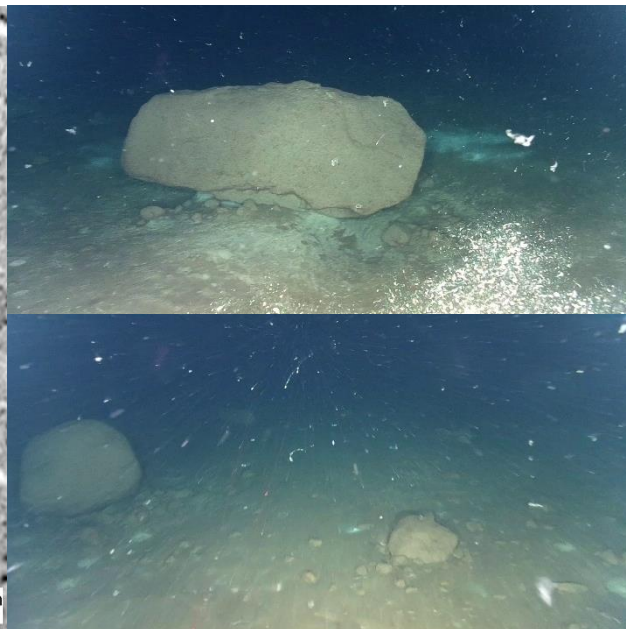
REACH-6629-MAS-P03-0002, Debris
H: 0.73m, W: 0.79m, L: 2.07m

Selected target turned out to be a rectangular boulder, boulder field was also visible in the vicinity.

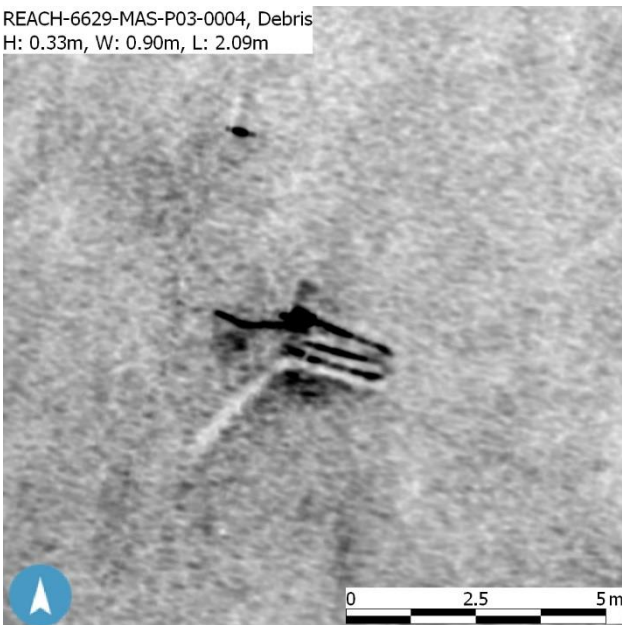
REACH-6629-MAS-P03-0004, Debris
H: 0.33m, W: 0.90m, L: 2.09m

Selected target (P03-0004) turned out to be rotatable part of the starboard side ramp railing and second object (P01-0002) in vicinity possible metallic wire. The railing was recovered (the only object recovered from the seabed during the survey).

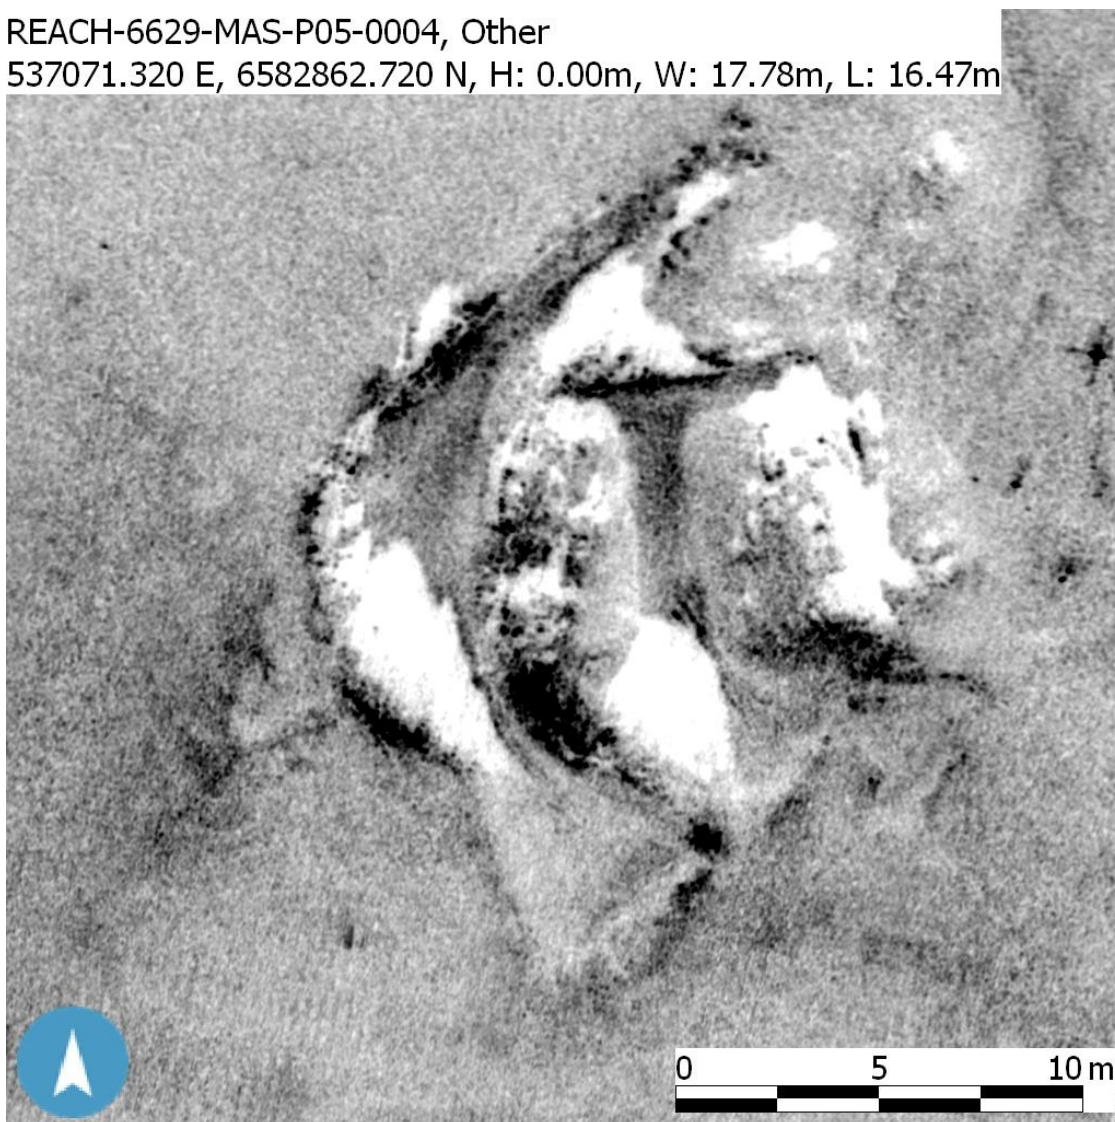
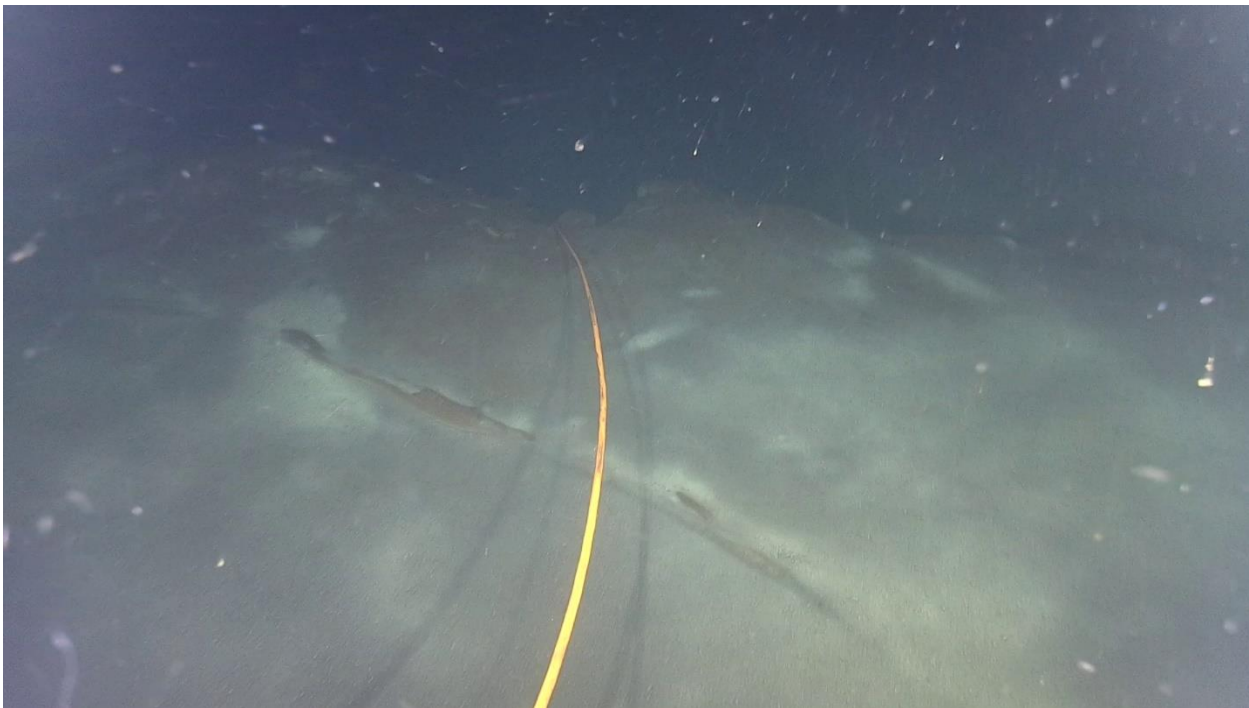
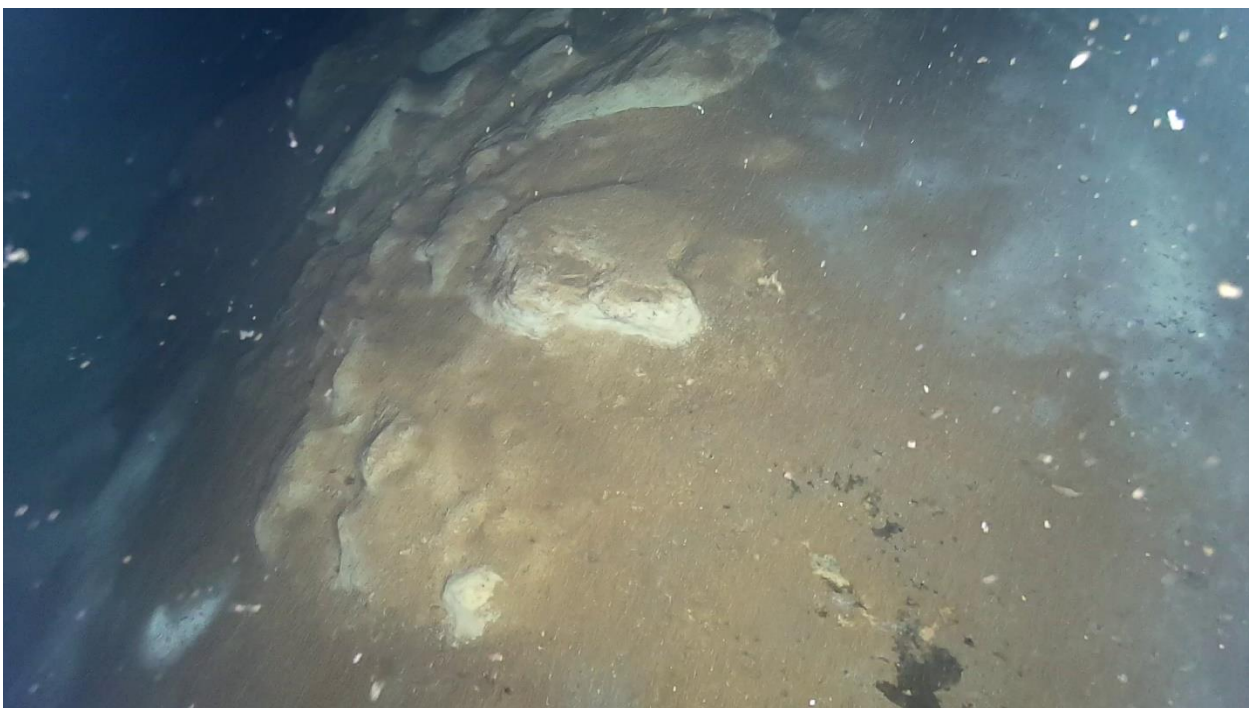
REACH-6629-MAS-P05-0004, Other
537071.320 E, 6582862.720 N, H: 0.00m, W: 17.78m, L: 16.47m

Sediment depression from bow visor was filmed, only one thin elongated object was detected.

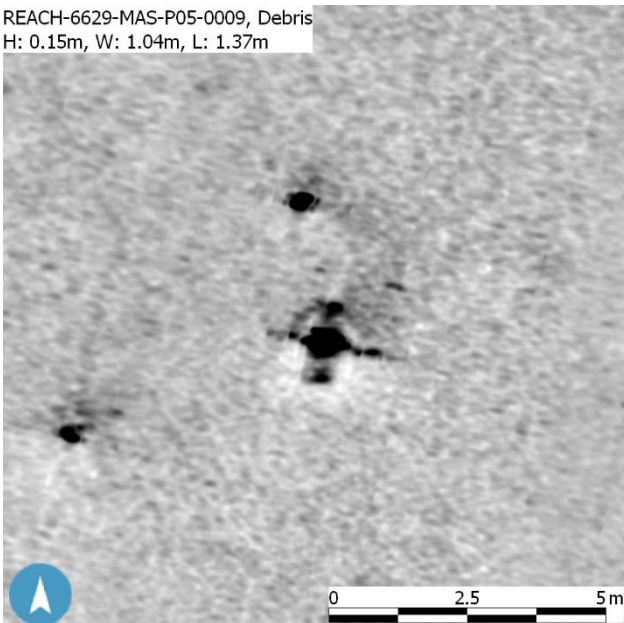
REACH-6629-MAS-P05-0009, Debris
H: 0.15m, W: 1.04m, L: 1.37m

Selected target (P05-0009) turned out to be a boulder and another target (P09-0009) in the vicinity a brown colour wood log.

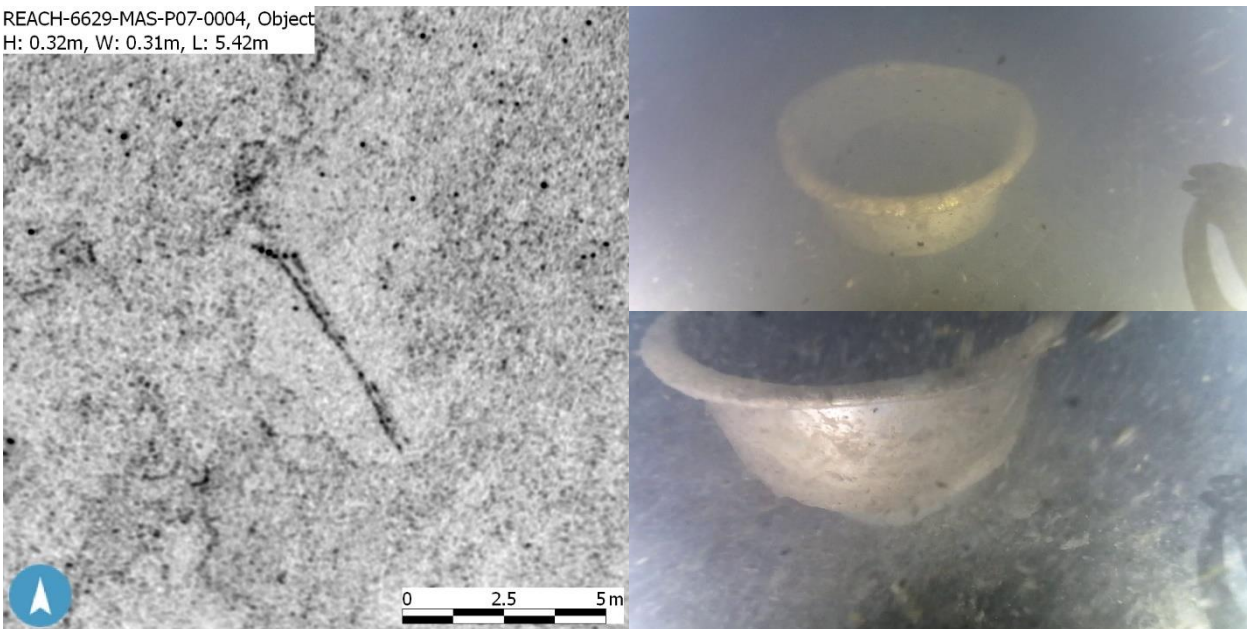
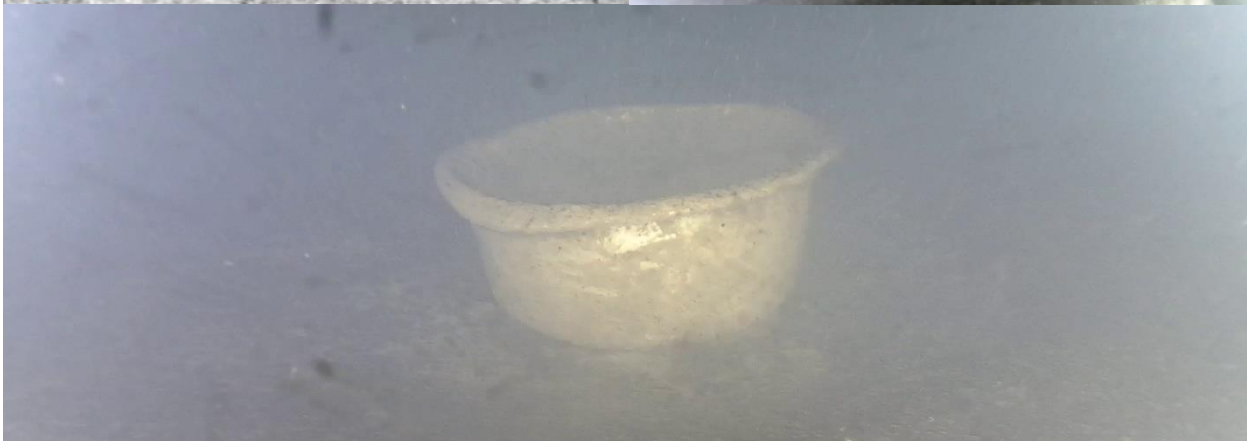
REACH-6629-MAS-P07-0004, Object
H: 0.32m, W: 0.31m, L: 5.42m

No object was found from the dive for the selected target, interpreted as possible debris or scar. Only a metallic bowl was found during the search.

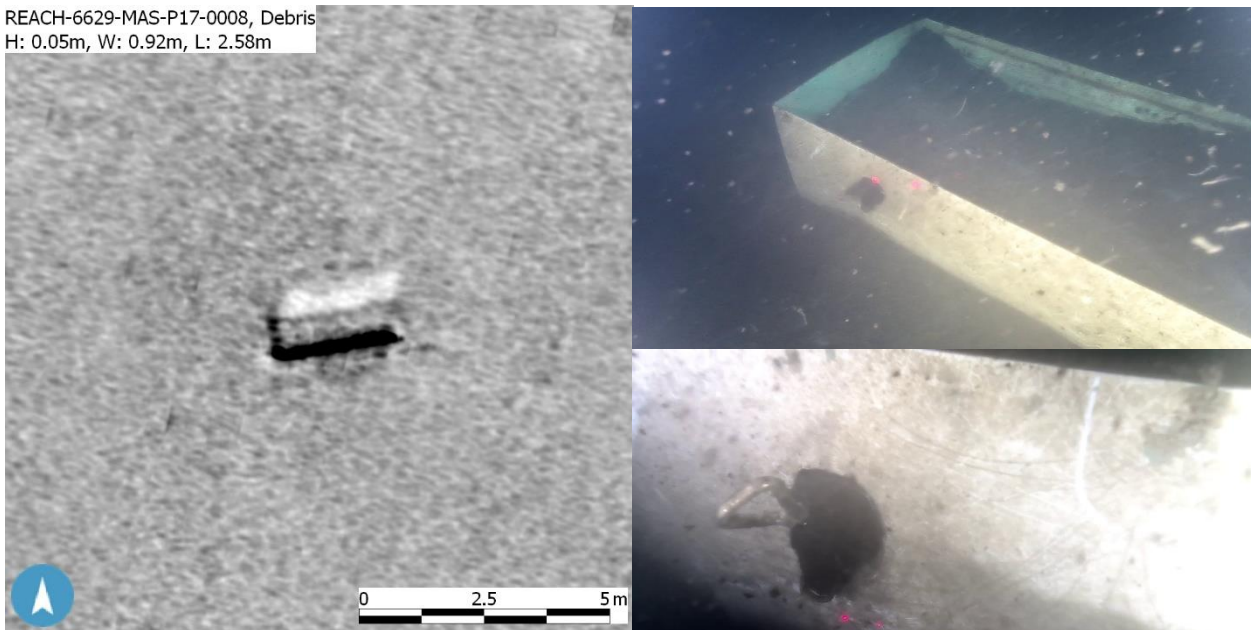
REACH-6629-MAS-P17-0008, Debris
H: 0.05m, W: 0.92m, L: 2.58m

Selected target turned out to be a possible life-saving appliance box.

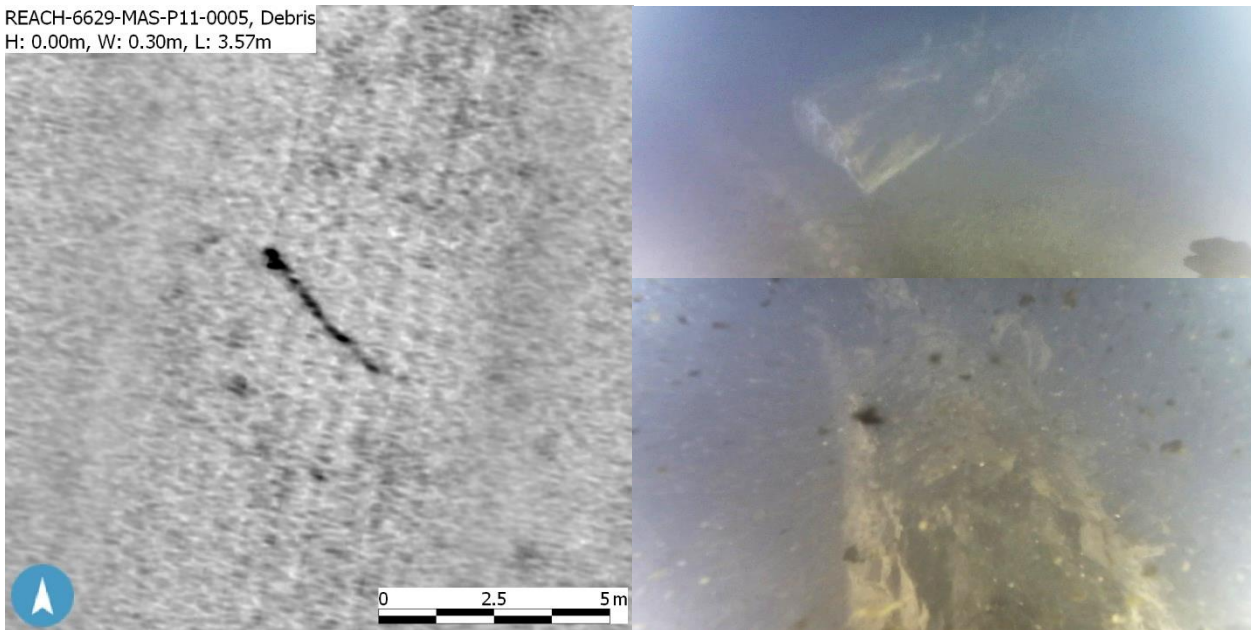
REACH-6629-MAS-P11-0005, Debris
H: 0.00m, W: 0.30m, L: 3.57m

Selected target turned out to be a light colour thick wood log, poor visibility.

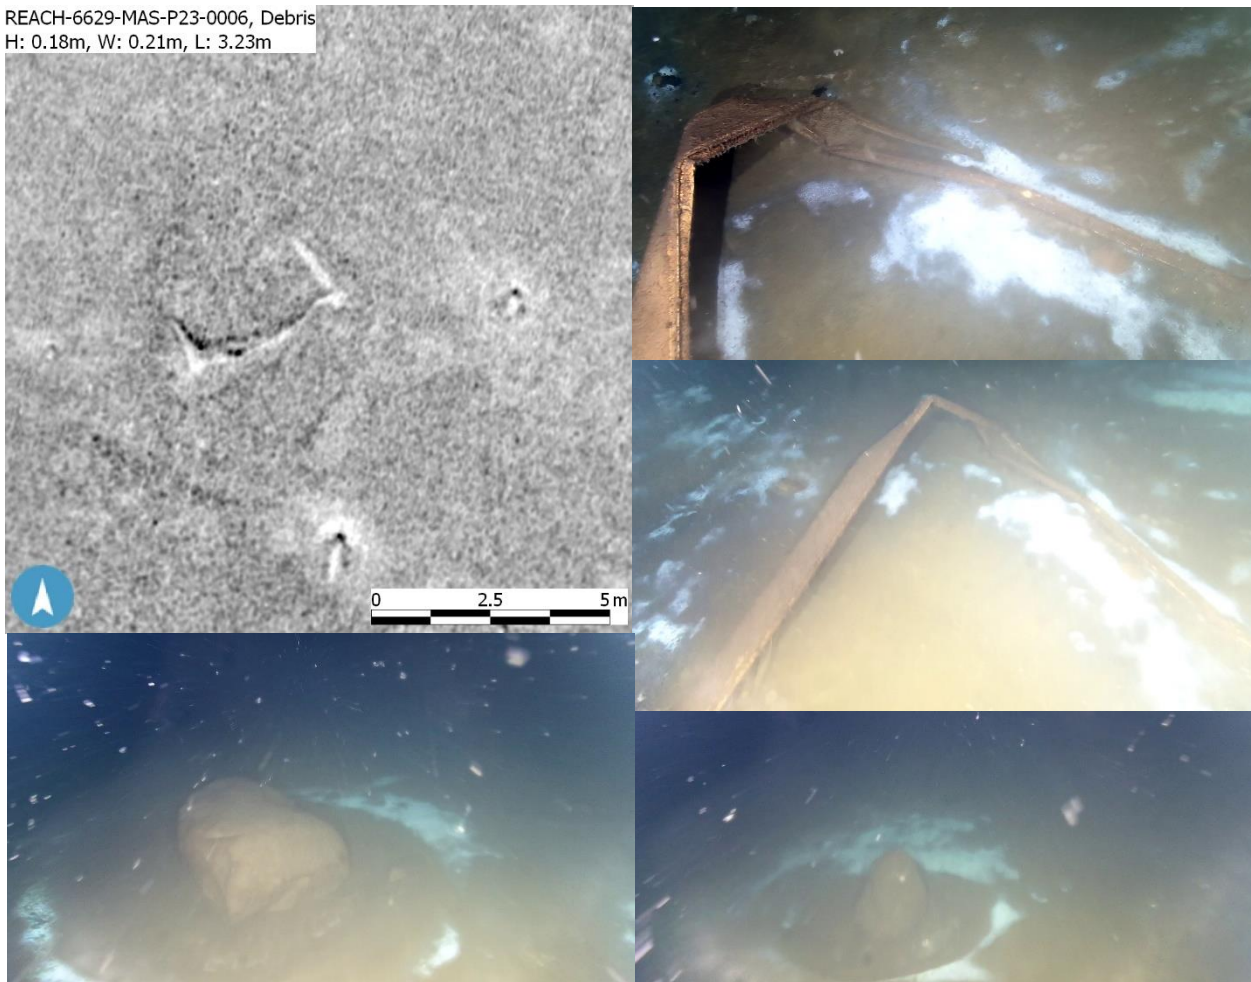
REACH-6629-MAS-P23-0006, Debris
H: 0.18m, W: 0.21m, L: 3.23m

Selected target turned out to be a bent and twisted panel. Two isolated boulders were also visible in the area.

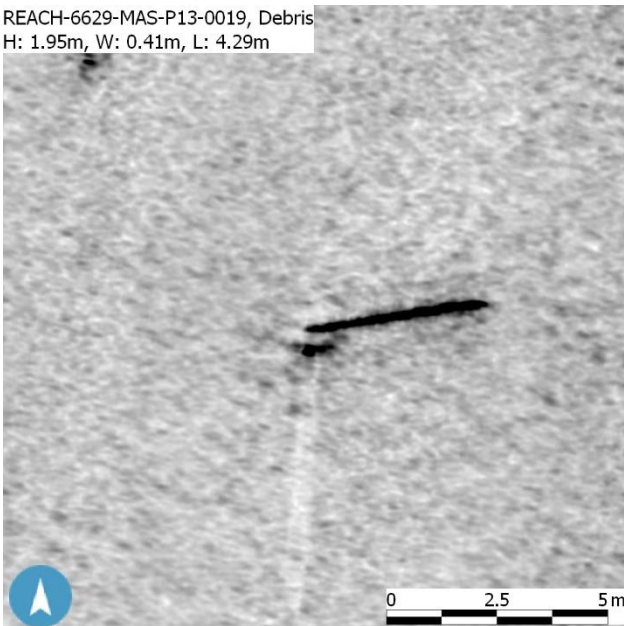
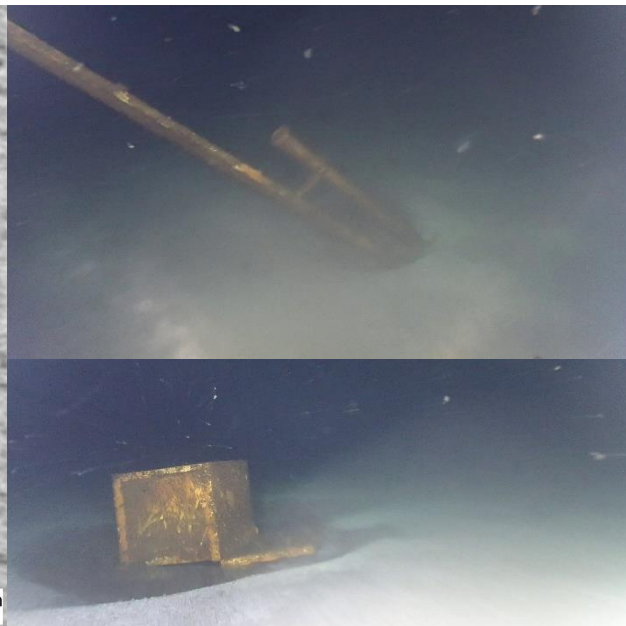
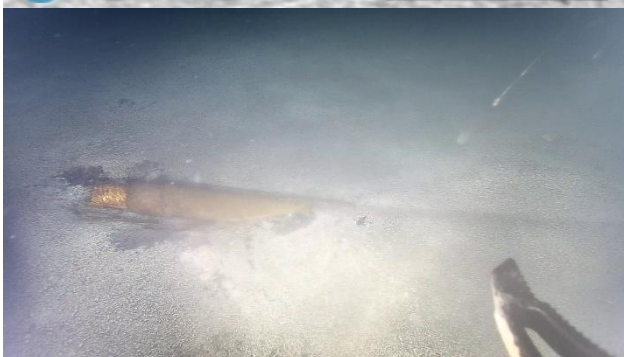
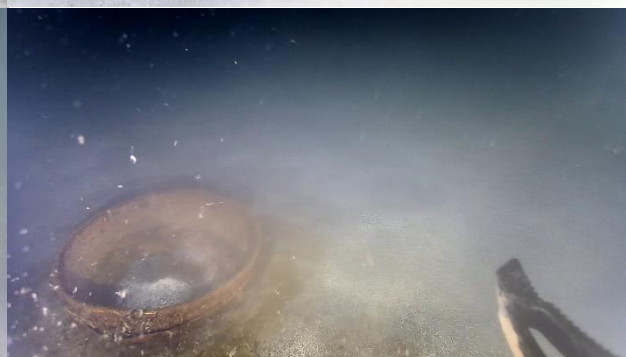
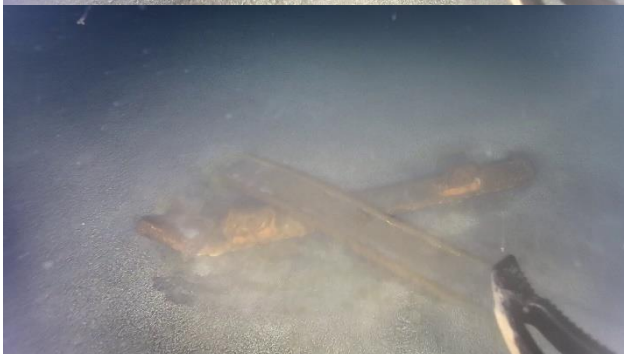
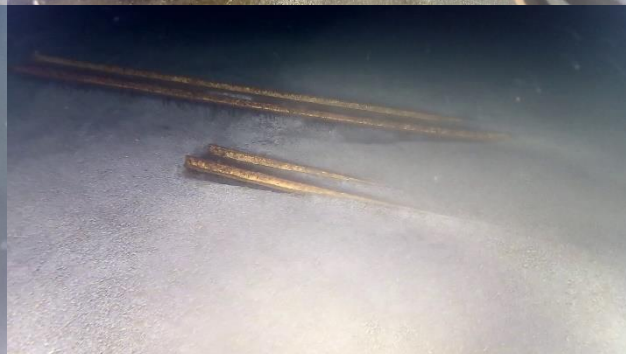
REACH-6629-MAS-P13-0019, Debris
H: 1.95m, W: 0.41m, L: 4.29m

Selected target turned out to be a metallic beam with a capsule. In addition, many objects were seen in the vicinity, e.g., a box-shaped object (possibly ventilation housing from Deck 9), a cylindrical object, a metallic bowl, panels, a metallic object, a floodlight, and a part of a weather deck bench.

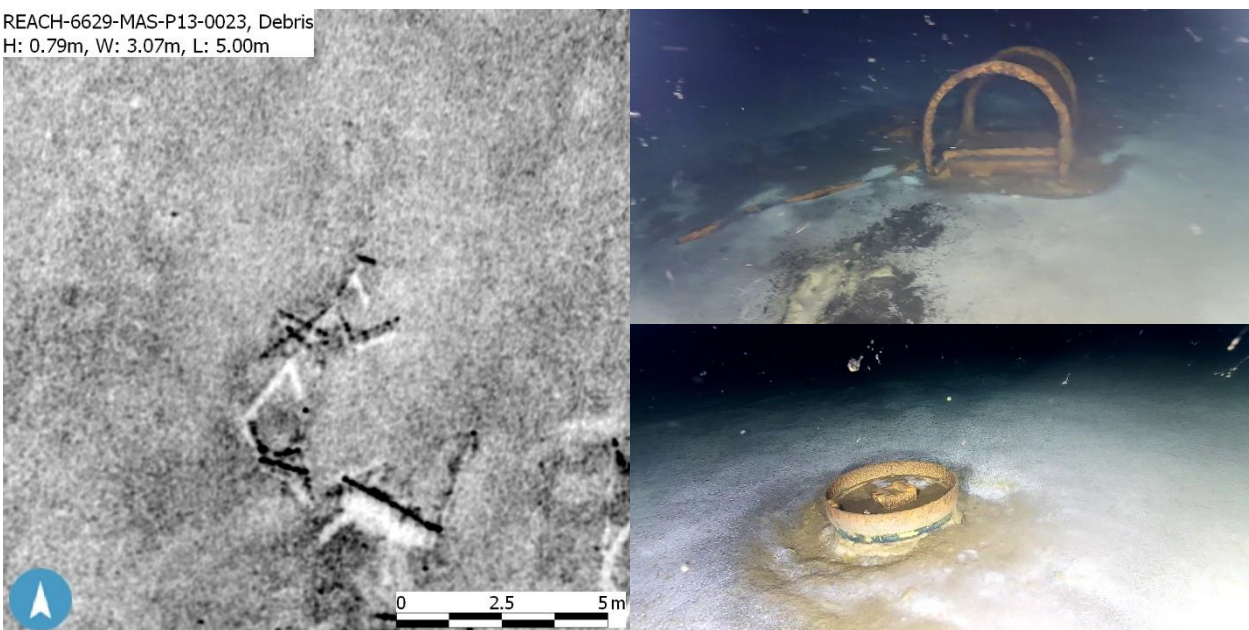
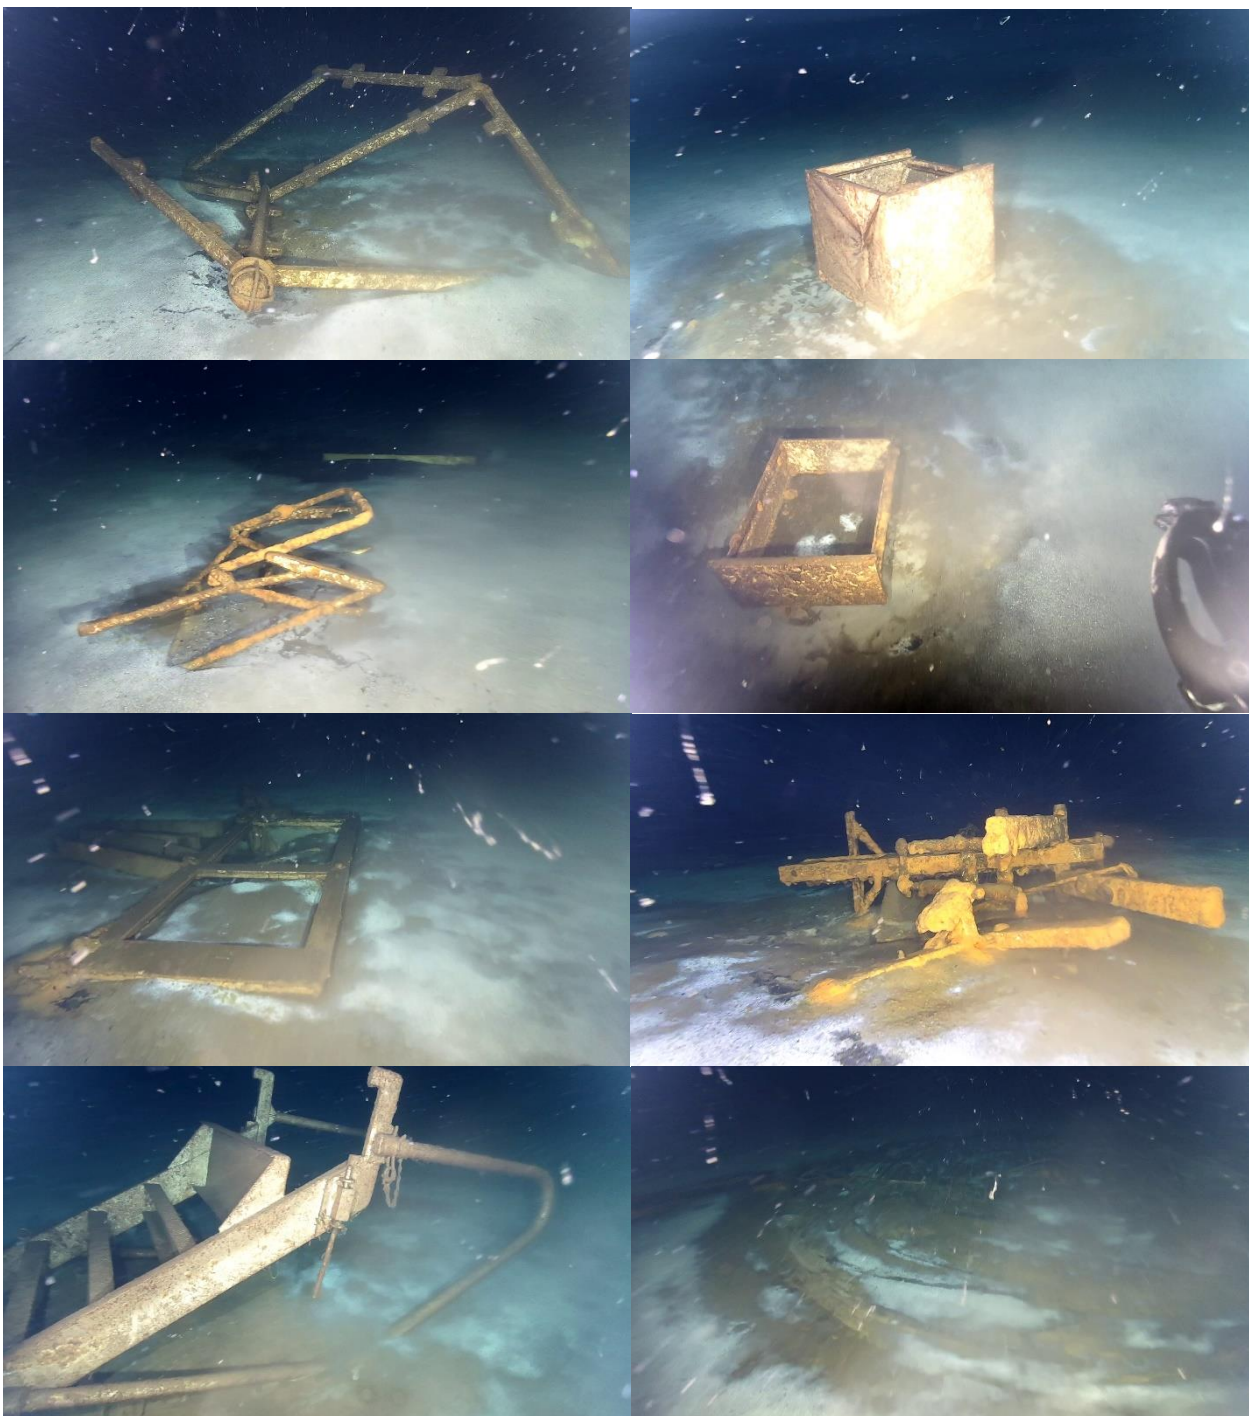
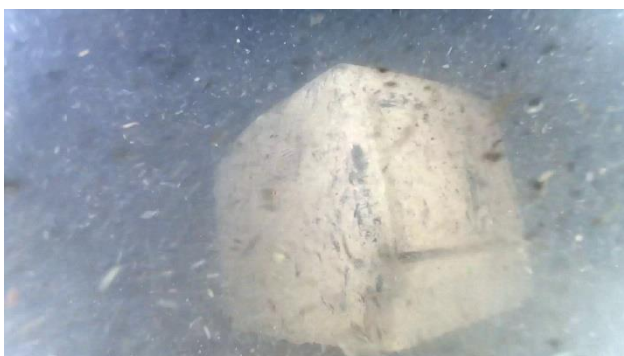
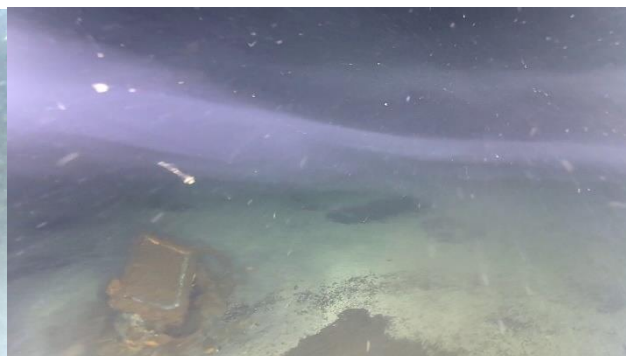
REACH-6629-MAS-P13-0023, Debris
H: 0.79m, W: 3.07m, L: 5.00m

Dive 14 took place in the main debris field southwest of the wreck. Many objects were observed during the dive, e.g., different metallic objects, a box-shaped object (possible ventilation housing from Deck 9), panels, many remains of helicopter deck railings (without Plexiglas), many drawers (one having a plate inside), possible frames of portable chairs, a doorframe, a portable stair for lifeboat embarkation, a collapsed life raft (circular remains on seabed), a floodlight, and a TV monitor.

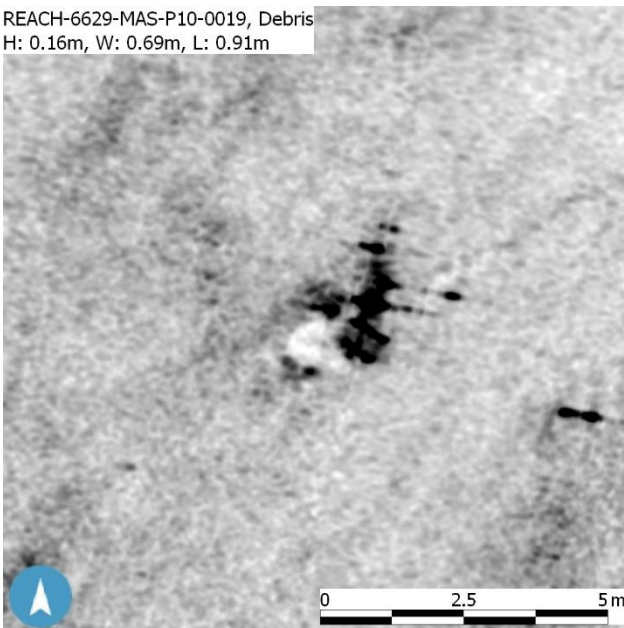
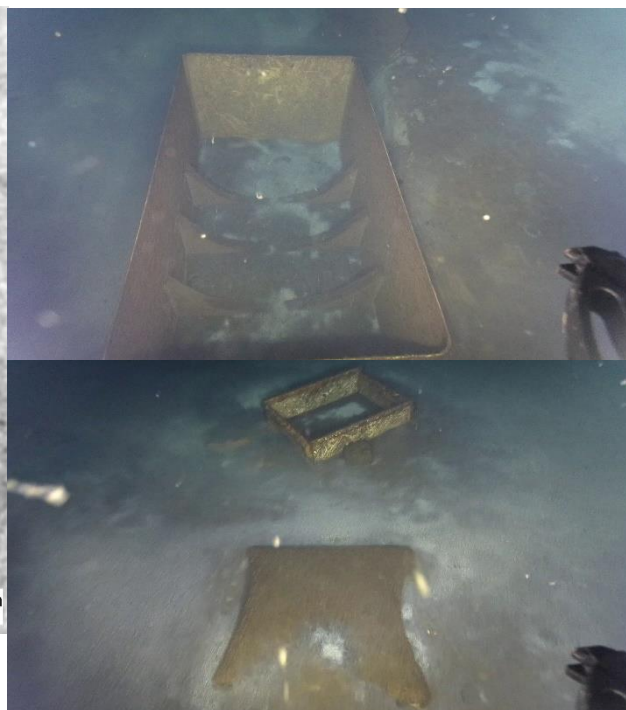
REACH-6629-MAS-P10-0019, Debris
H: 0.16m, W: 0.69m, L: 0.91m

Dive 15 took place in the main debris field southwest of the wreck. Many similar objects were observed as described for Dive 14, in addition to which a pillow-shaped object and a plastic box, possibly for life-saving equipment.

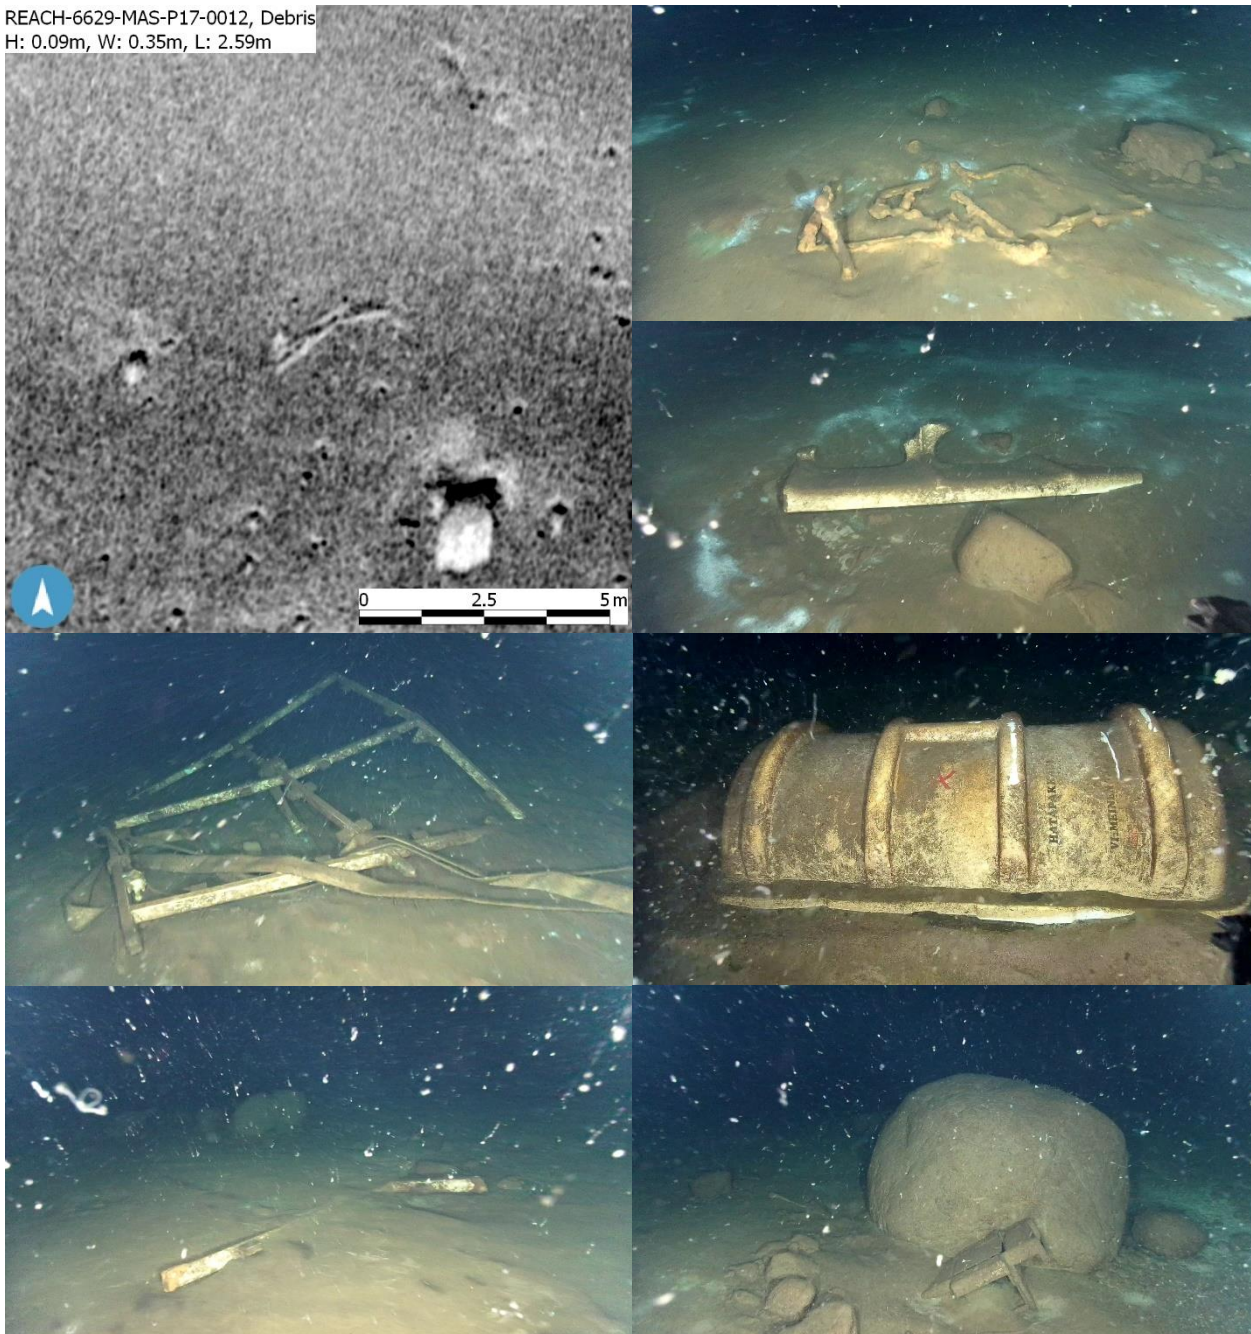
REACH-6629-MAS-P17-0012, Debris
H: 0.09m, W: 0.35m, L: 2.59m

Dive 16 covered a boulder field. Several parts of weather deck benches and helicopter deck railings were observed. Also, an upper side of a life raft container, a fire hose, and a drawer were noted.

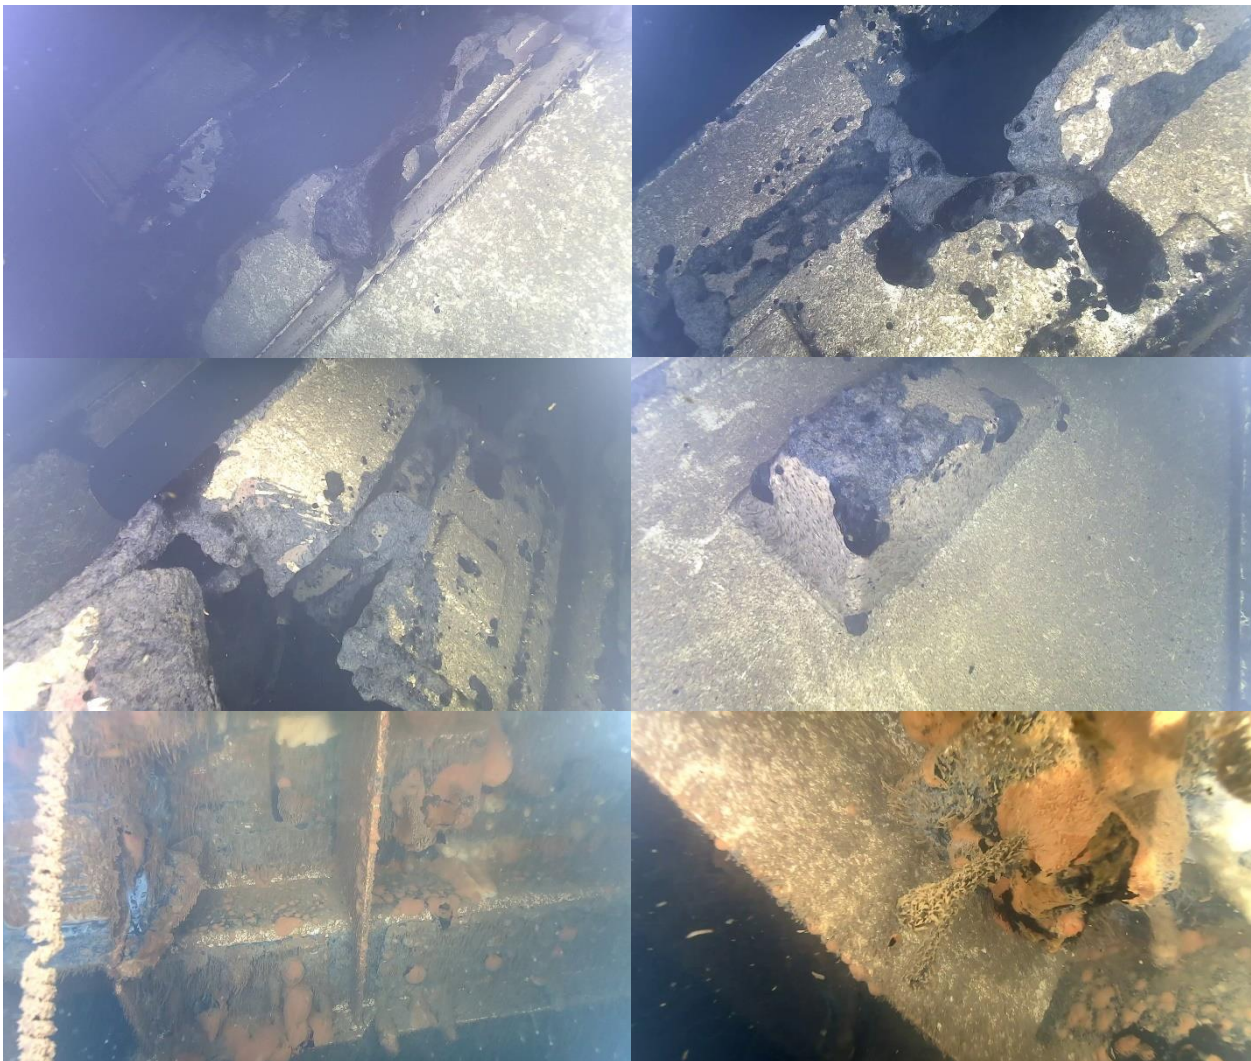
During the last dive, the area of the wreck previously masked by the ship's bow ramp, which was recovered from the seabed in July 2023, was filmed. Filming covered the starboard side of the forward bulkhead next to the bow entrance and the area to the starboard side anchor. Also, the control station of the visor and ramp were filmed at the entrance of the car deck.

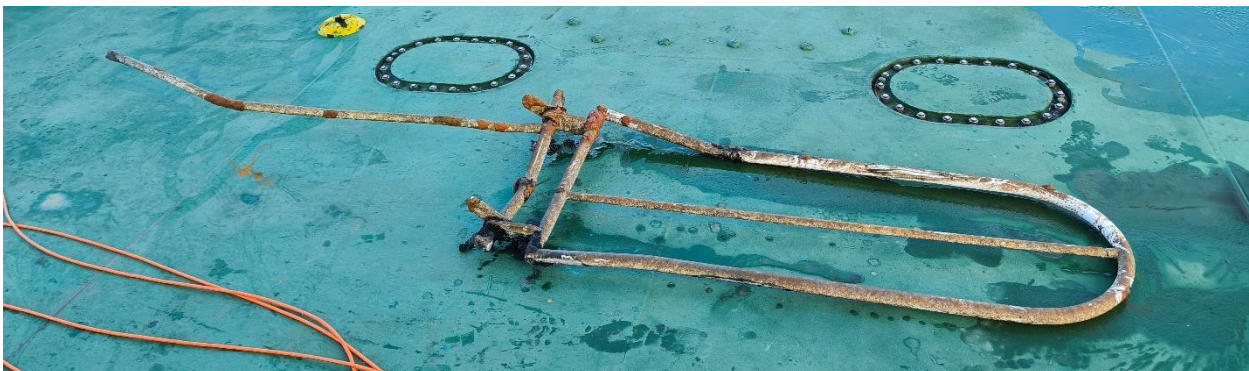
The rotatable part of the ramp railing which was found during Dive 6 was located 485 meters west (268°) from the visor recovery location (sediment depression mark on seabed) and the cross-track distance between the visor recovery location and the railing on the vessel's planned course (288°) was 165 meters. This object is the most westward object found on the seabed that undoubtedly originates from MV Estonia.

Figure 5. Recovered part of the ramp railing on the aft deck of the survey vessel EVA-316. Source: Tauri Roosipuu, ESIB

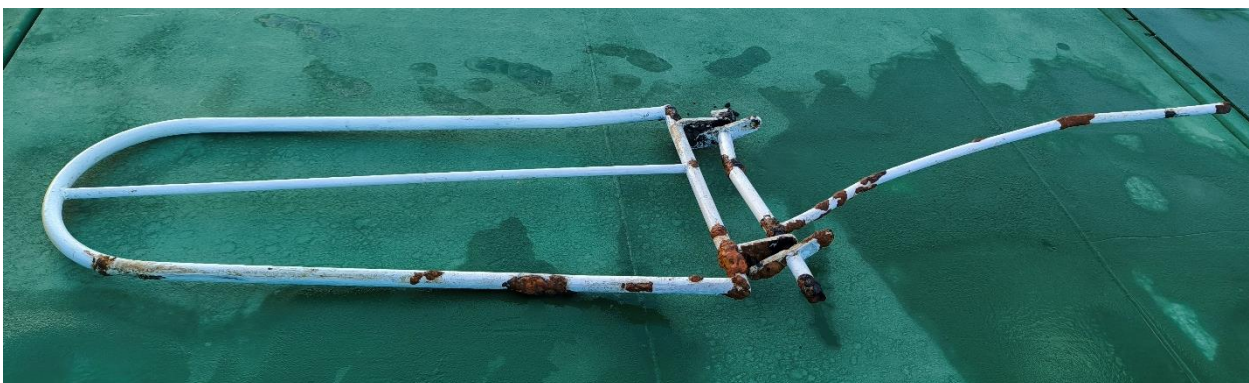
Figure 6. Recovered part of the ramp railing after cleaning. Source: Tauri Roosipuu, ESIB
