ROV VIDEO SURVEY OF THE SELECTED SONAR TARGETS ON THE SINKING TRACK OF MV ESTONIA ON THE BALTIC SEA JULY 1 TO JULY 4, 2024

PRELIMINARY ASSESSMENT
FACTUAL REPORT
OCCURENCE ID: M280994

Document ID: OJK-M280994-FaR-240704-R00-EN
Document version: Revision 0
Document date: 2024-09-03

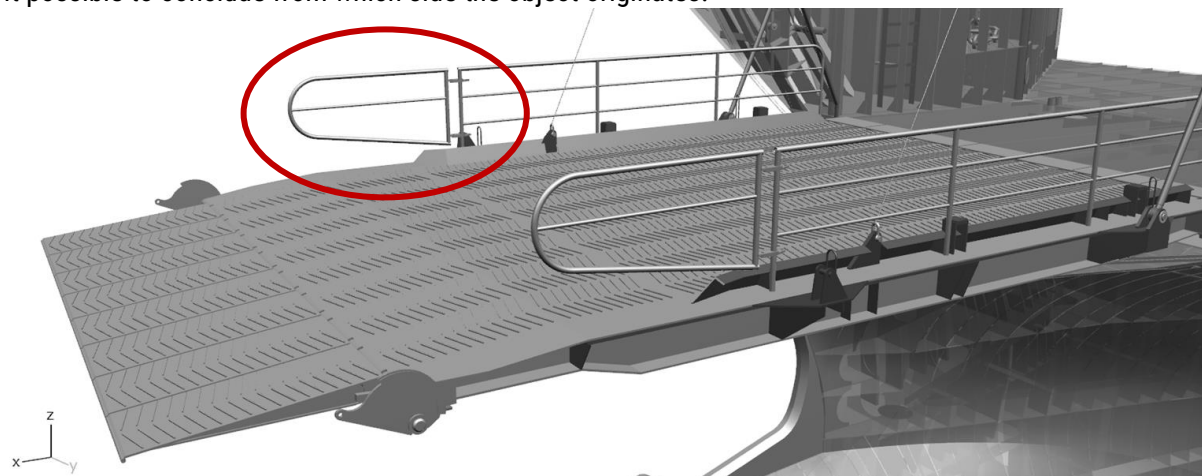
Further analysis showed that this item originates from the starboard side railing arrangement (Figure 7). Ramp railing arrangement was longitudinally symmetrical, but the lugs of the locking pins of the rotatable parts were aligned outwards. Comparing these details of the recovered part with the shipyard drawing made it possible to conclude from which side the object originates.

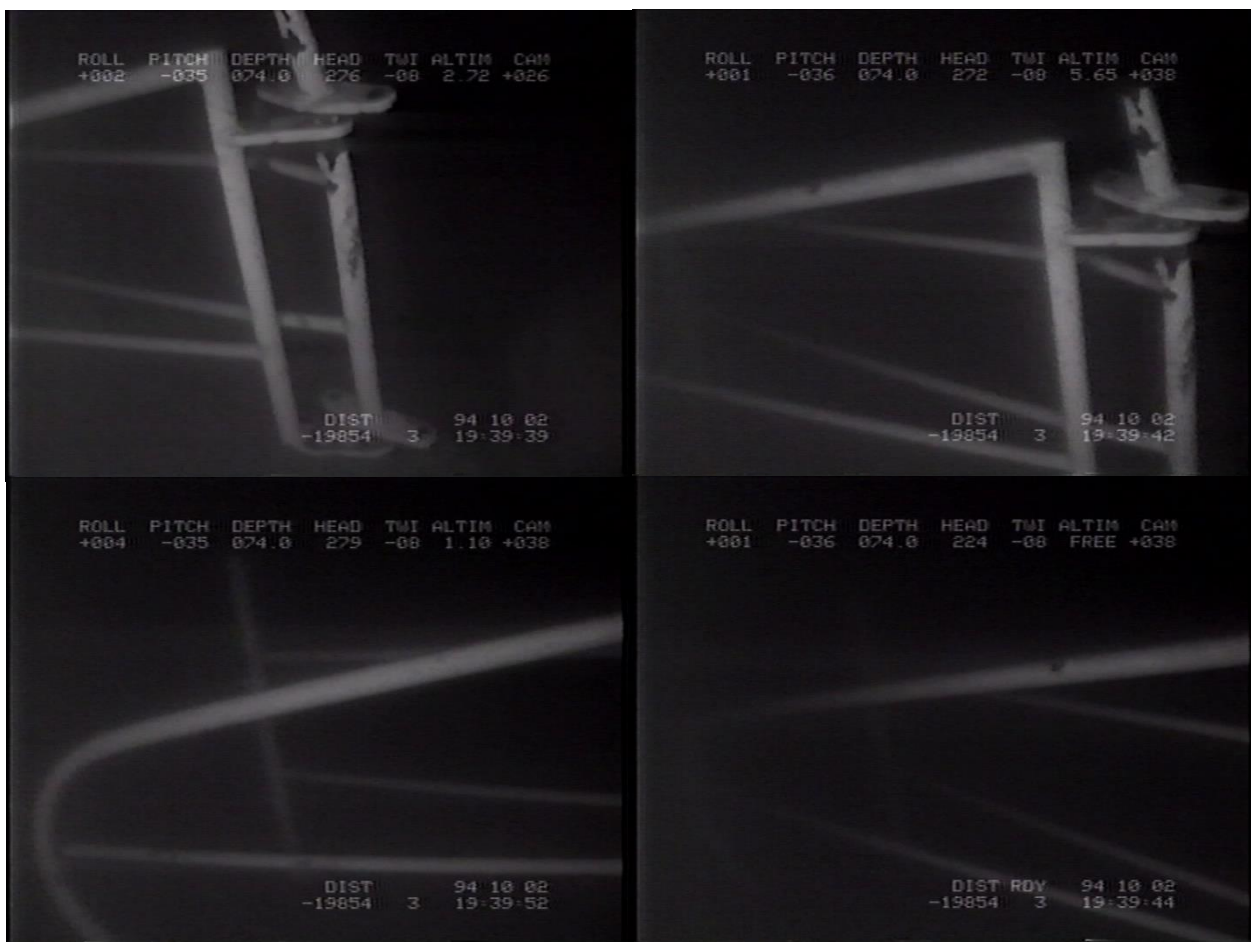
On the video the railing is vertically upside down but not laying on seabed. It is considered to be port side railing according to the alignment of locking pin lugs and not having corresponding damage as the recovered starboard railing – fixed railing side has at least two horizontal bars attached to the forward railing post (starboard one has only one) and the locations of paint damage are different.

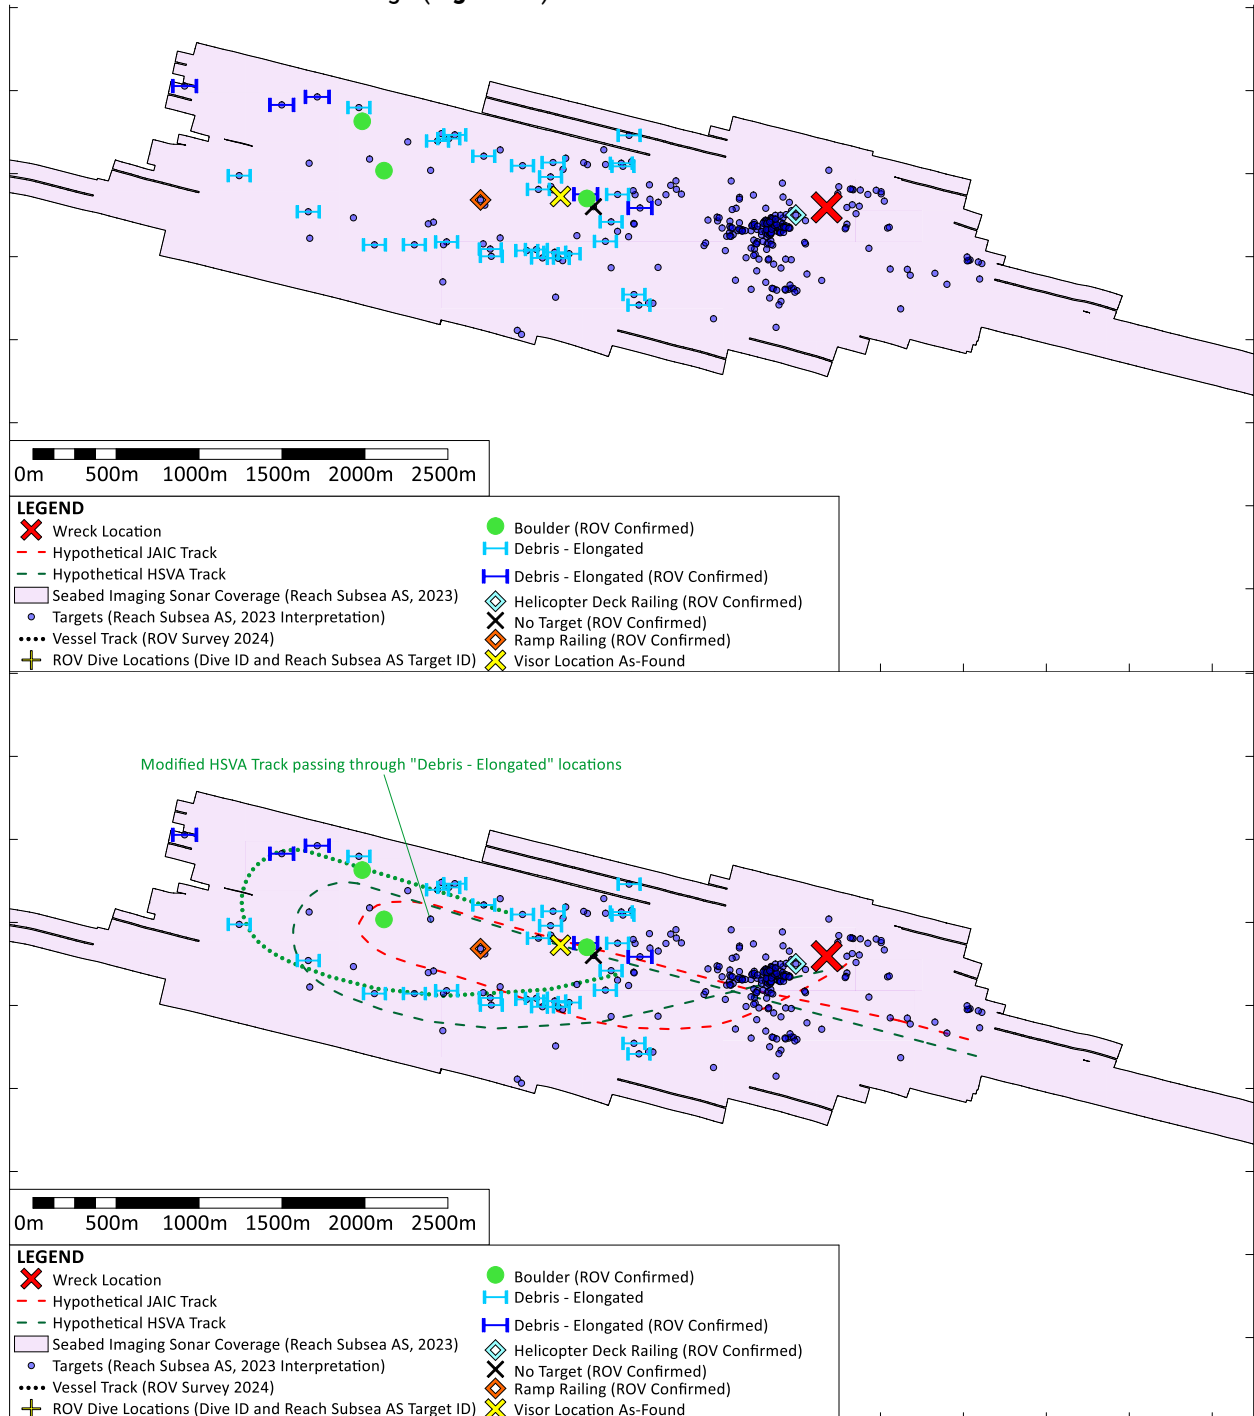
At least 35 elongated objects were recognised from the MAS mosaic. The five visually inspected targets confirmed all of these as wood logs (**Figure 10**).
