# Fire at Liseberg Oceana Waterworld in Gothenburg

The Swedish Accident Investigation Authority has investigated a fire at the construction work site Liseberg Oceana Waterworld in Gothenburg, Västra Götaland County on 12 February 2024

20 March 2025

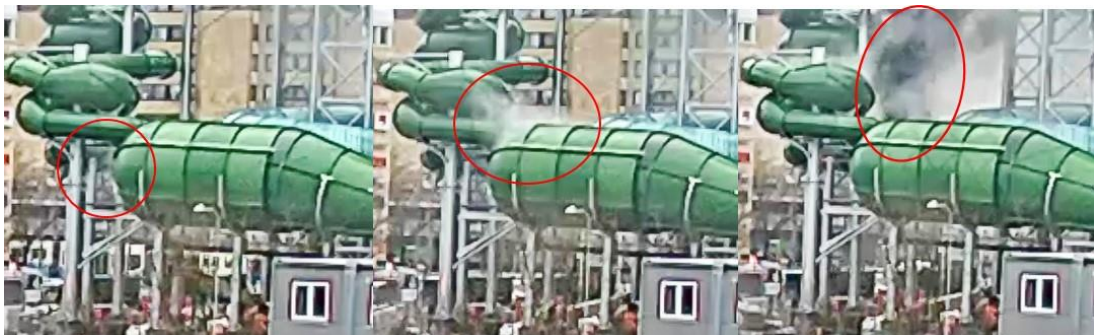
At 10:03 hrs white smoke can be seen coming from Rattler on video from a security camera located in a carpark to the east of the construction site (see Figure 4).

Figure 4. Series of images from a security camera video. Light-coloured smoke can be seen coming from the waterslide Rattler at 10:03 hrs. At 10:04 hrs the intensity of the smoke has increased and at 10:05 hrs it has become darker. Source: Liseberg. The red circles that mark the smoke have been added by SHK.

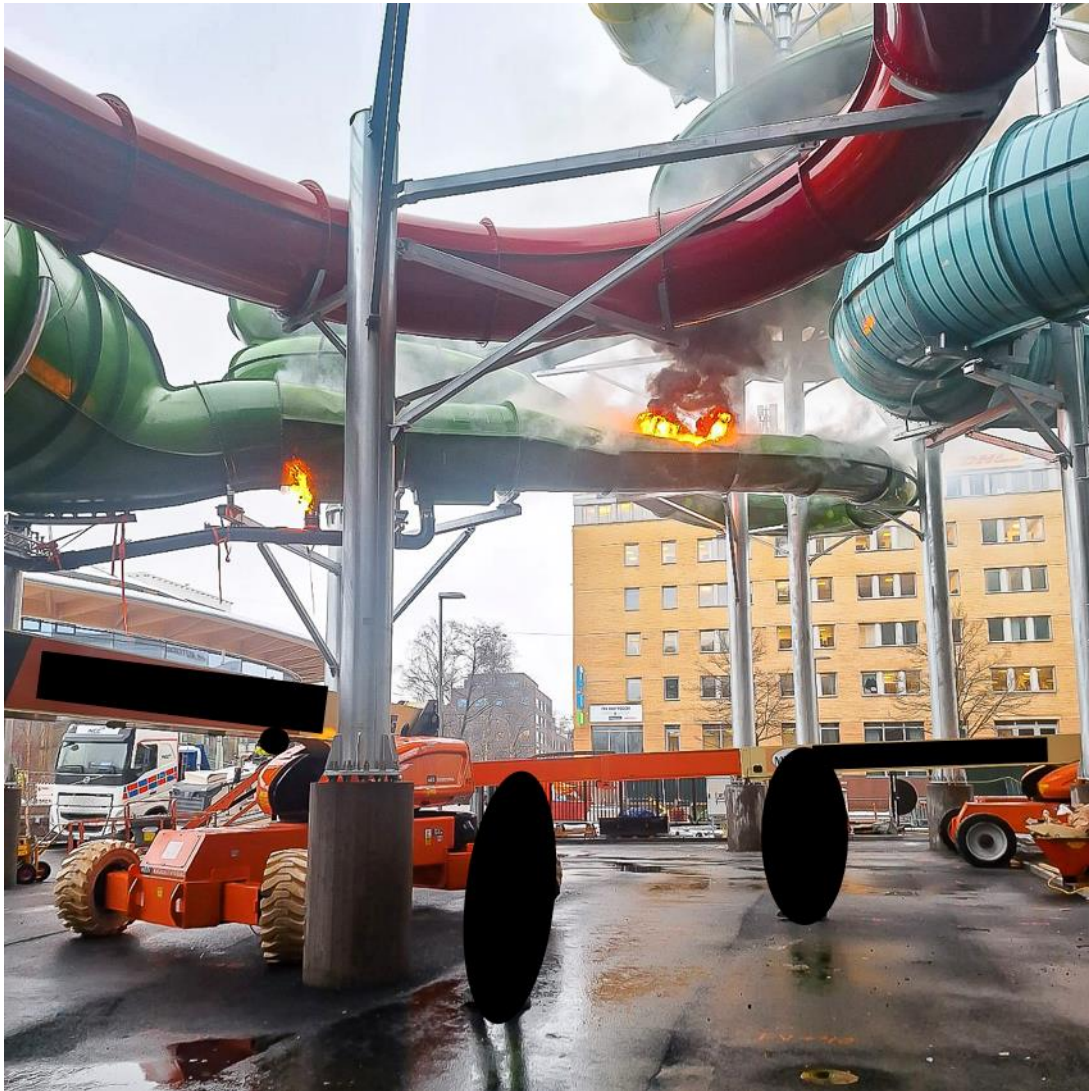
Approximately two minutes later, flames emerged from two places on Rattler (see Figure 5).

Figure 5. Flames emerged from two places on Rattler at approximately 10:05 hrs. People in the picture have been anonymised by SHK. Photo: Tingstad Måleri AB.

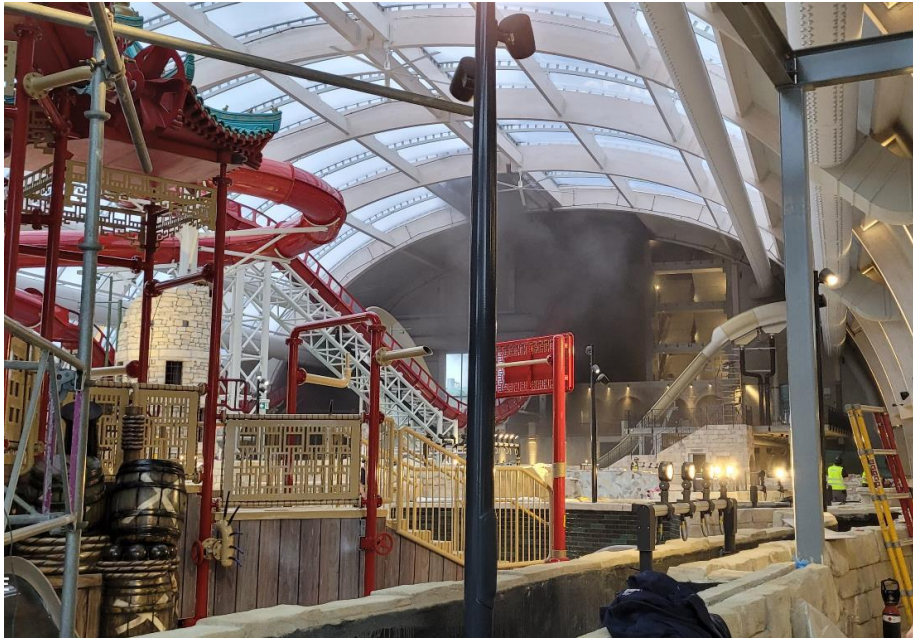
Black smoke is seen entering the pool building in a picture taken at 10:06 hrs (see Figure 6). The first emergency call was received by SOS Alarm at this time.

Figure 6. At 10:06 hrs the tower was filled with smoke and smoke began spreading to the pool building. Photo: EnviroProcess Sweden AB.

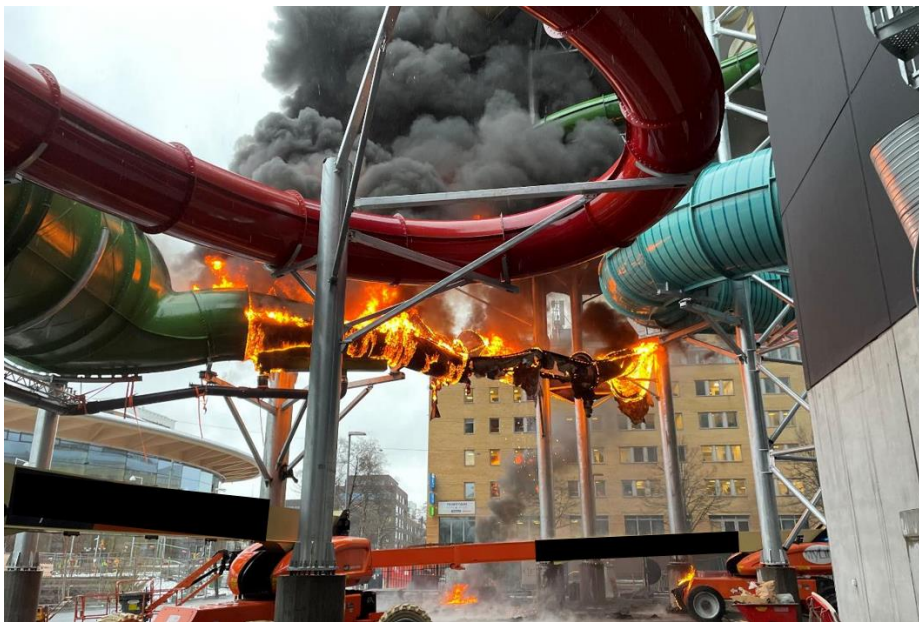
The fire spread rapidly in Rattler. The picture in Figure 7 was taken at 10:11 hrs, six minutes after the first flames emerged from the waterslide. The fire and rescue service was **en** route at this time.

Figure 7. Picture taken at 10:11 hrs, six minutes after the first flames emerged from Rattler. Photo: Sweco AB.

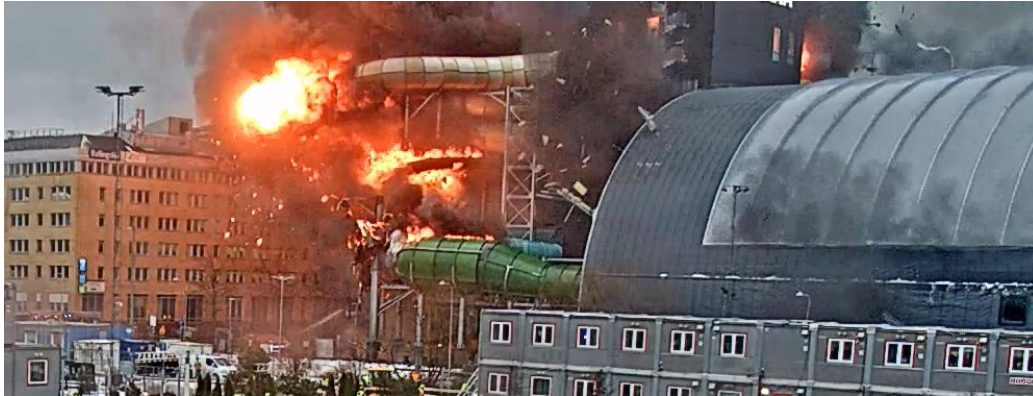
Figure 9. The fire gas explosion at 10:20 hrs. Source: Liseberg.

Windows were shattered and sections of the building were forced out and fell to the ground. The gables of the pool building were forced outwards. All fire and rescue service personnel got out of the buildings and continued external firefighting.

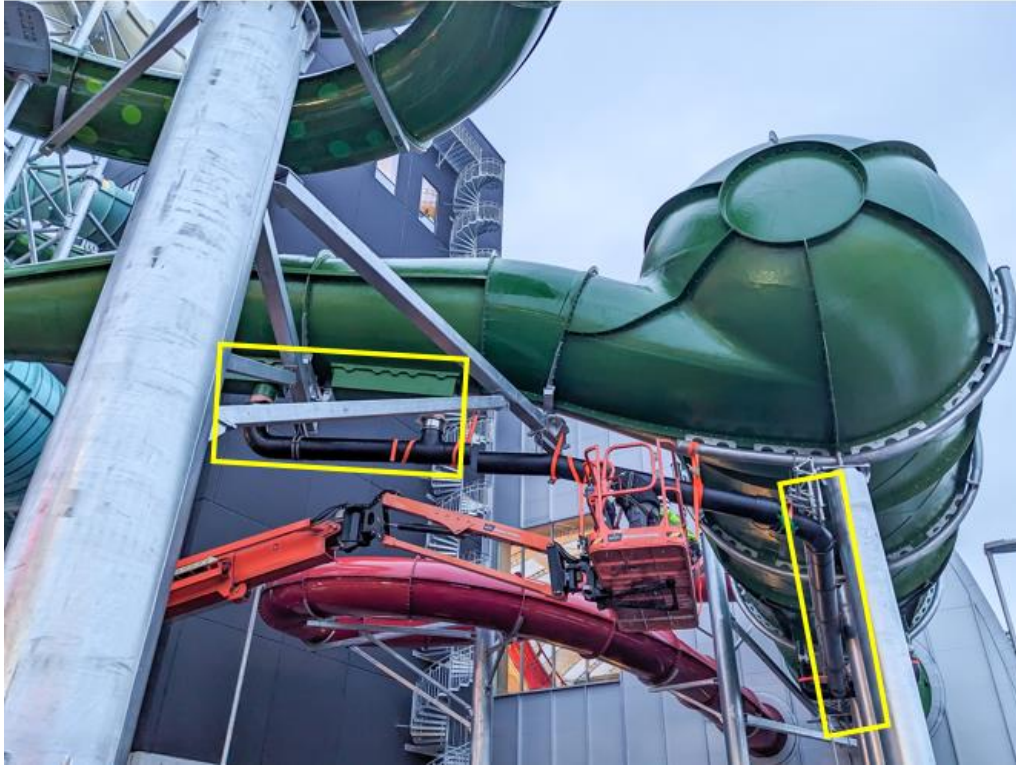
The diversion pipe under Rattler started at two drainage boxes that were located under Rattler, just before the waterslide's final bend. After the bend the diversion pipe was reconnected to Rattler and the waterslide then continued into the pool building (see Figure 11).

Figure 11. The yellow boxes added by SHK show, on the left, a PE pipe connected to the drainage boxes and, on the right, a PE pipe that connects back to Rattler. A suspended pipe in the strap that has been prepared for being fused together with other pipes is visible between the markings. Photo: NCC.

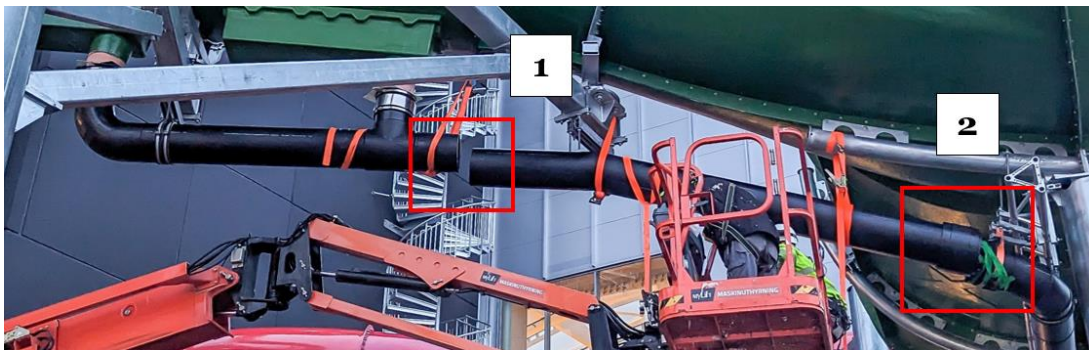
The two joints that were to be electrofused in conjunction with the final installation have been marked (see the markings in Figure 12). It is evident from the picture that there was a gap between the ends of the pipes that were to be joined together. See marking no. 1 in Figure 12.

Figure 12. Cropped and enlarged version of the photo in Figure 11. The red markings added by SHK show the locations of the electrofusion joints. The figures show the order in which the electrofusions were performed. Photo: NCC.

Following measurement of the picture and with the information that the diameter of the pipe is 315 mm as a reference, SHK has estimated that the distance between the ends of the pipes is 10 cm. The length of the pipe that is hanging in the straps in the picture is approximately 4.5 metres. The pipe with an electrofusion coupler weighs approximately 85 kg<sup>5</sup>.

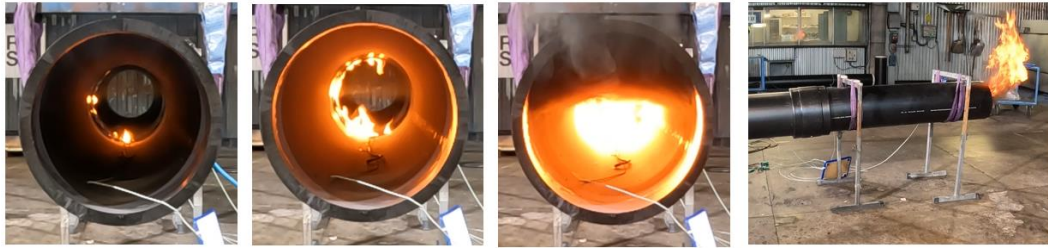
In one of the tests, fire broke out within the specified scanned fusion time (test 6). The fire smouldered for more than 14 minutes and melted burning plastic dripped down from the upper edge of the pipe and formed a small pool fire on the bottom of the pipe. A powerful increase in the fire then took place and flames emerged from the upper end of the pipe (see Figure 17).

Figure 17. Development of the fire in test 6. The picture on the left shows the flames in the joint 7 minutes after the pipe caught fire. There is then a picture that shows the fire 11 minutes after the fire started when a pool fire has emerged. In the third picture, the fire gases are seen in the upper edge of the pipe when the fire increased rapidly in extent. The fourth picture was taken 14 minutes and 20 seconds after ignition when the flames emerge from the upper end of the pipe.

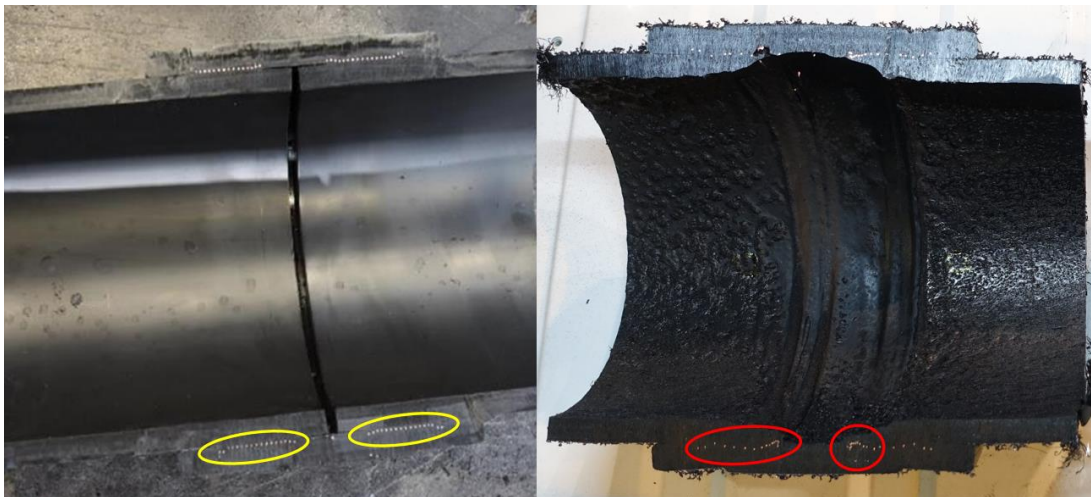
In the pipes, where fire has broken out, there were clear signs that cratering of the plastic had taken place in the area where the metal wires were exposed. It was also possible to establish that the metal wires that were exposed had been displaced from their original location and ended up closer to each other (see Figure 18).

Figure 18. Sawn apart electrofusion couplers following completed tests. On the left after test 1 where no fire broke out and on the right after test 6 where fire broke out. The picture on the left shows how the metal wires are evenly distributed. This is marked by the yellow circles. The picture on the right shows how the metal wires have been concentrated closer to the middle of the electrofusion coupler. This is marked by the red circles.

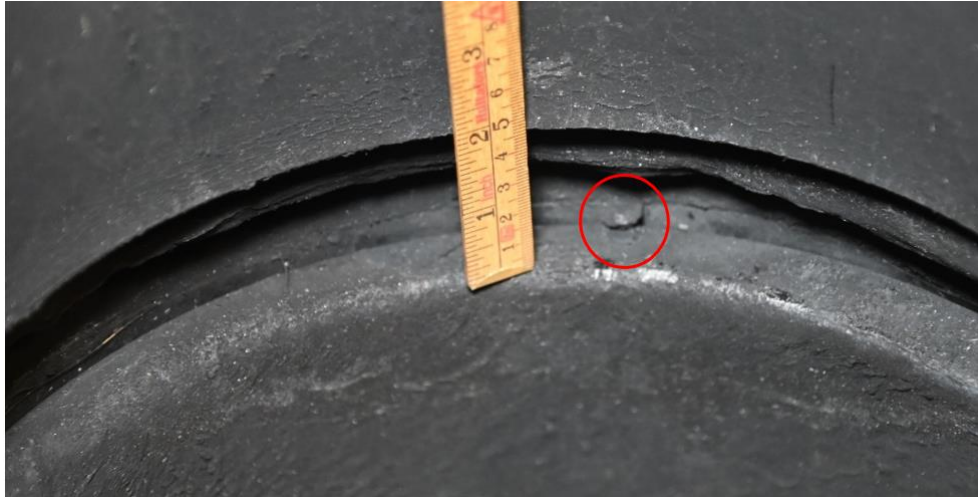
broken out. The gap between the ends of the pipes was not evenly distributed across the middle of the electrofusion coupler. One pipe was up against the heel in the middle of the electrofusion coupler which meant that the end of the other pipe was closer to the fusion zone on that side (see Figure 19).

Figure 19. The joint on the inside of the electrofusion coupler with a gap of c. 45 mm between the pipes. The red marking indicates the heel. Melted plastic that is being forced out is visible at the upper edge of the joint.

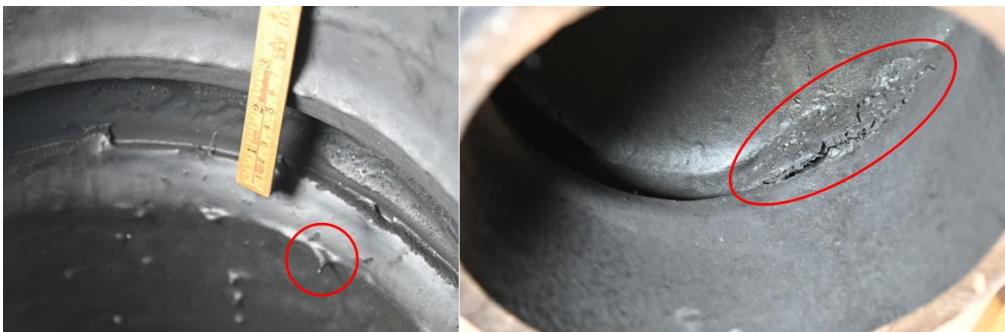
In the second pipe section, the distance between the pipes was closer to 50 mm at the joint in the electrofusion coupler. Here, there were deformations after the plastic in the pipe ends and the electrofusion coupler had melted, and there were signs that it had burned at the joint. There were also droplet formations that can be interpreted as plastic having dripped from that side inside the joint. This indicates that that part of the pipe was positioned upwards and that the electrofusion coupler was placed horizontally. There were also charring on the opposite side of the droplet formations, indicating that the plastic had burned there in a small pool fire that subsequently self-extinguished (see Figure 20).

Figure 20. The picture on the left shows the upper side of the joint in the section of pipe where there were drop formations. The red marking shows the drop shape after melted plastic has run down. The picture on the right shows the opposite side from the drop formations in the joint. The carbonised remains where the plastic has probably burned is visible in the red marking.

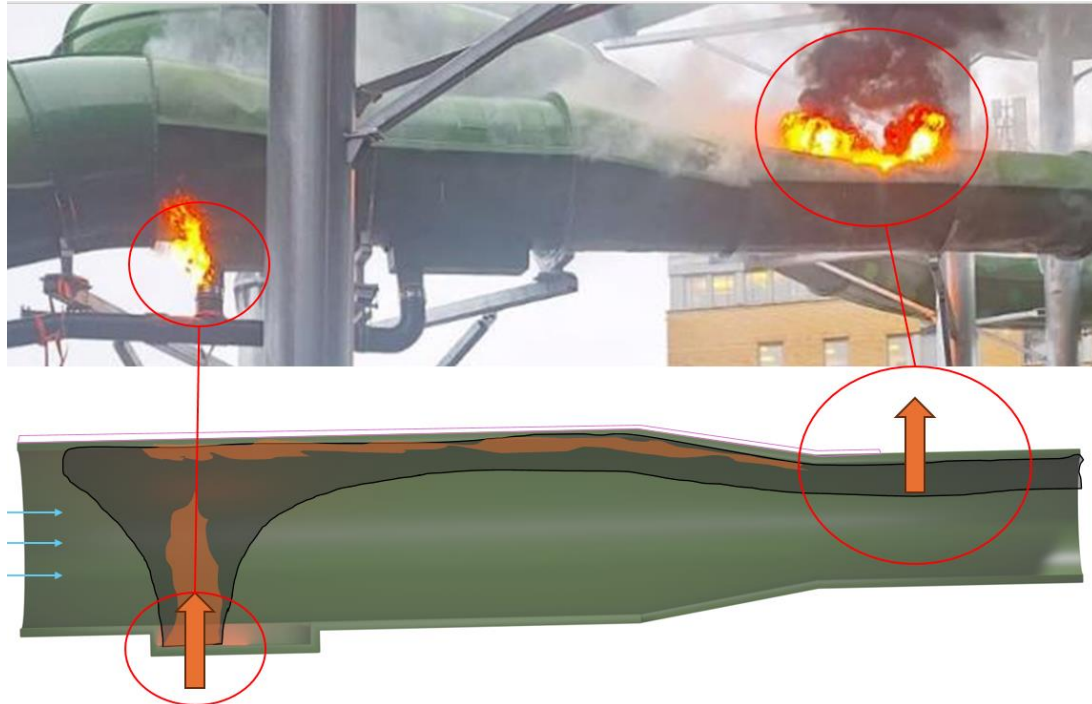
At an early stage of the course of the fire, flames could be observed from two different places in connection to Rattler. Flames were seen in the place where the diversion pipes connected to the waterslide and also on the upper side of the waterslide. The distance between these locations is approximately nine metres (see Figure 21).

Figure 21. The upper picture shows where the first flames emerged from Rattler. The sketch below shows a cross-section of Rattler. The orange arrows on the sketch show where the flames emerged. The blue arrows show the airflow. The dark-green field shows the spread of the fire. Source: Tingstad Måleri AB and RISE.

RISE has modelled the initial course of the fire on behalf of SHK. The modelling shows that the inclination, design and varied thickness of the waterslide, combined with the cooling effect of the weather can result in an initial fire development with flames in two different places.
