## ***Interim Statement SRL 2019:01e***

**Accident near Umeå Airport,  
Västerbotten County, on the 14 July 2019  
involving the aeroplane SE-MES of the  
model GA8-TC 320, operated by Umeå  
Skydiving Club.**

File no. L-96/19

26 September 2019

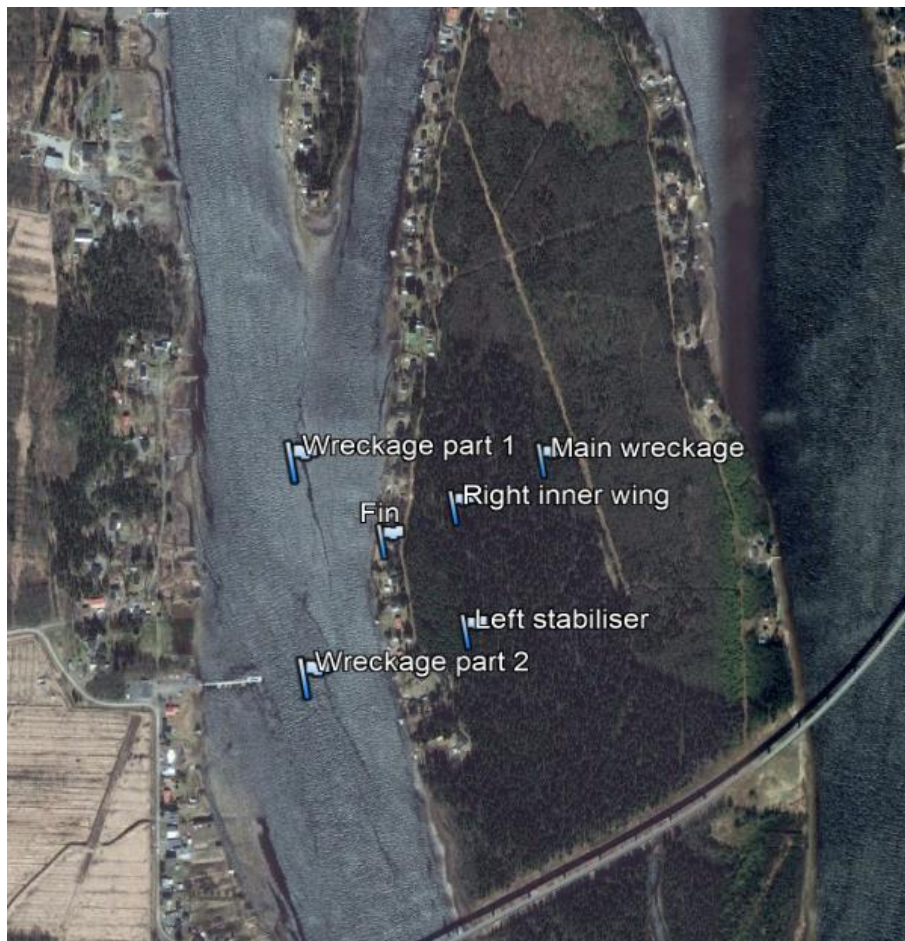
The right wing, the left and right stabilisers and the fin had separated from the fuselage before impact.

The right wing was broken into two parts.

The outer part of the right wing and the right part of the stabiliser were found in the river, west of Storsandskär. The inner part of the right wing was found 125 metres west of the fuselage. The fin was found 225 metres to the west, and the left part of the stabiliser was found 250 metres southwest of the fuselage.

The locations of the different parts of the wreckage are marked in figure 5. It has not been possible to determine whether the parts marked in the figure as wreckage part 1 and 2 comprised the right stabiliser or the right outer wing, respectively. The reason for this is that they were salvaged before SHK arrived on site.

Figure 5. Site of the accident and location of the parts of the wreckage. Photo: Google Earth: © Lantmäteriet Ref. R61749\_190001.

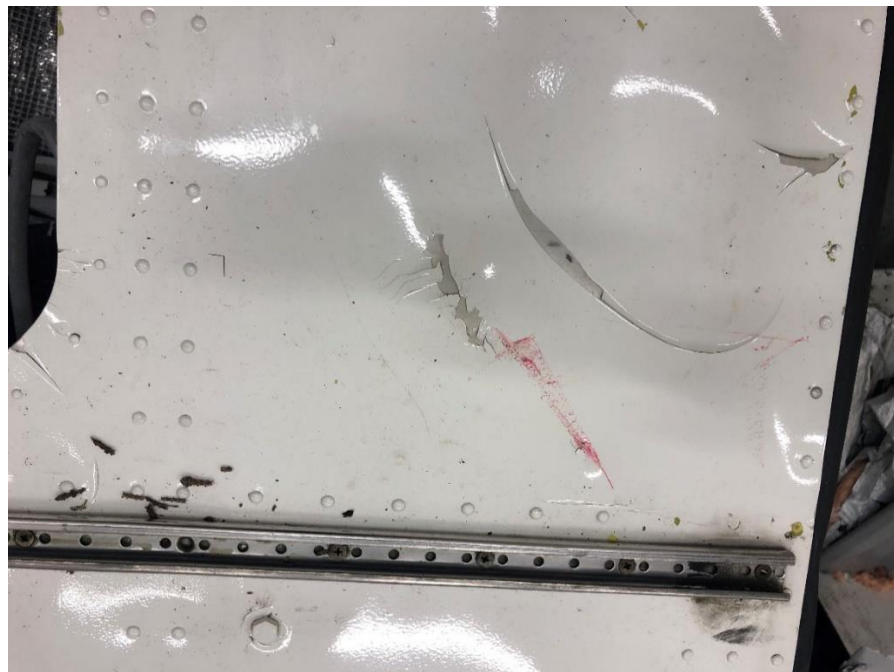
There are clear indications that the rear door was fully open at the time of impact (see figures 6 and 7).

Figure 7. Impact mark from the door handle on the fuselage of SE-MES.

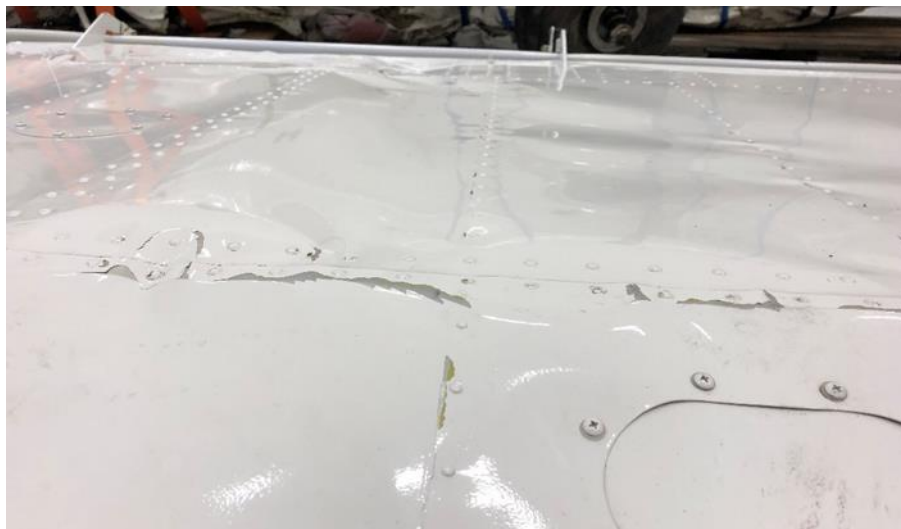
There were deformations on the underside of the outer right wing indicating that the wing had been subjected to abnormal negative load (see figure 8).

Figure 8. Underside of right wing.
