# Intermediate Report of the Preliminary Assessment of MV ESTONIA

*Ohutusjuurdluse Keskus*  
*Statens haverikommission*  
*Onnettomuustutkintakeskus*

2023

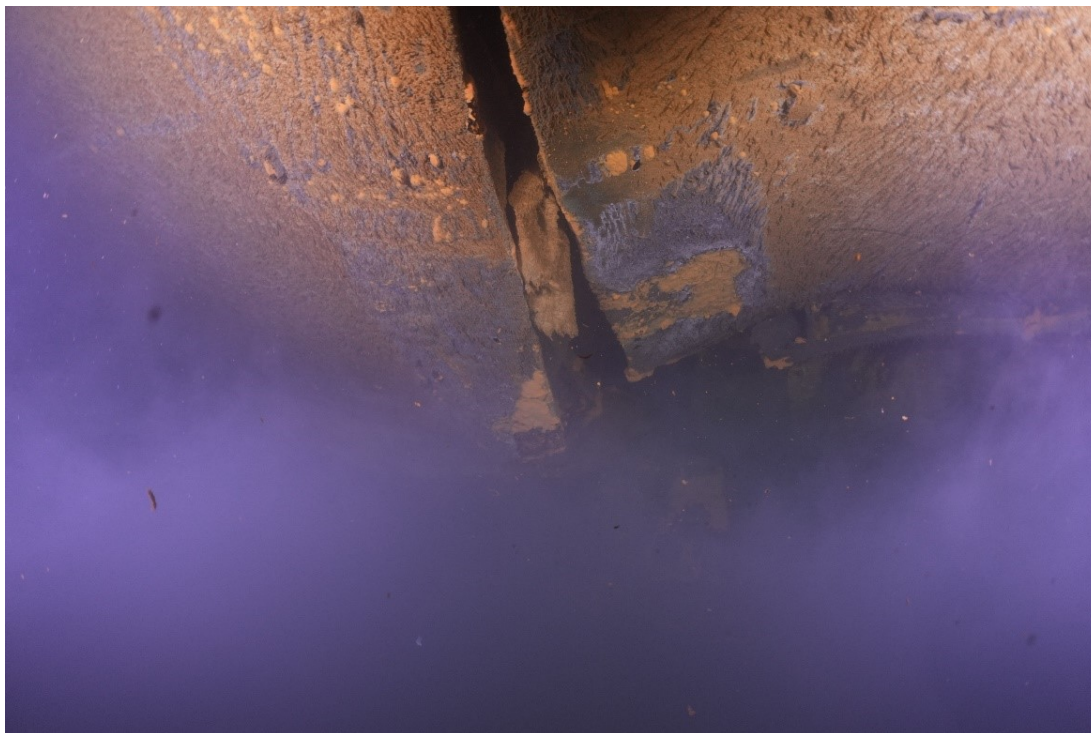
FIG. 1.1: The hole that was displayed in the TV documentary in 2020 as seen in the photogrammetry during 2022. Image from photogrammetry.

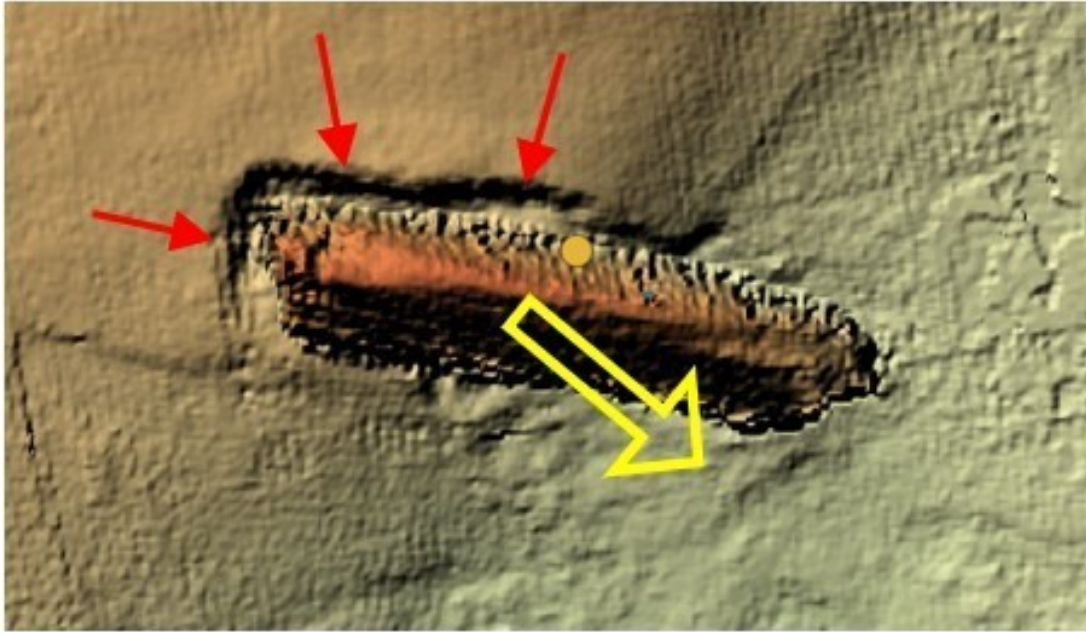
FIG. 2.1: Depression around the vessel (red arrows) and expected direction of movement of the vessel (yellow arrow), based on Traficom (2006). Image from Rudebeck and Kennedy [2].

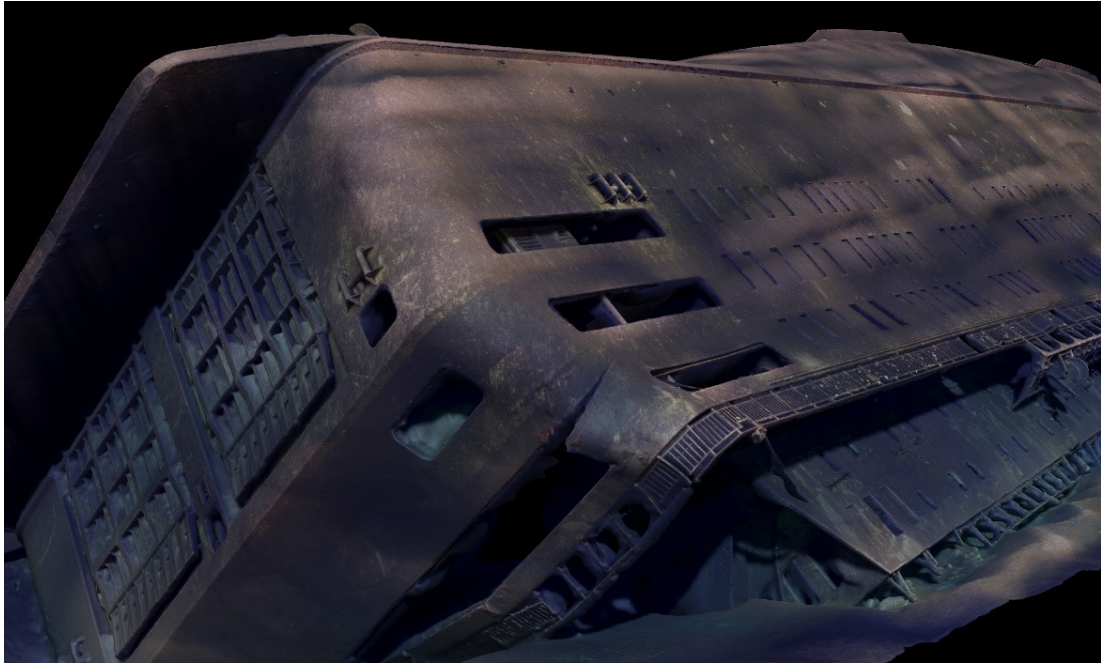
- Numerous deformations and cracks were observed near the edge of Deck 6 on port side;
- A rupture was observed in the stern corner of Deck 6.

FIG. 3.2: Port side stern of MV ESTONIA, showing a crack on deck 6. From the crack, the vessel is twisted along deck 6 and forward. Image from photogrammetry.

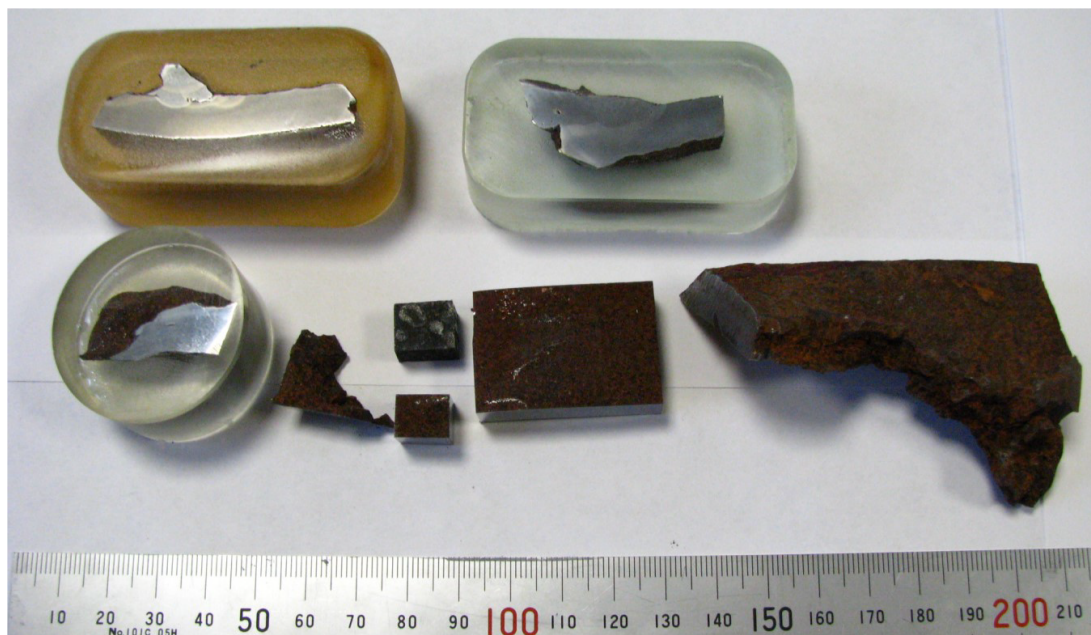
FIG. 3.4: Samples from the bow visor, subject of examination by Norwegian University of Science and Technology as well as Element Material Technology AB. Photo: Element Material Technology AB.

from the bow visor of MV ESTONIA. According to the report, the examined samples had been exposed to high temperatures. These temperatures may have occurred either during construction or maintenance of the vessel.

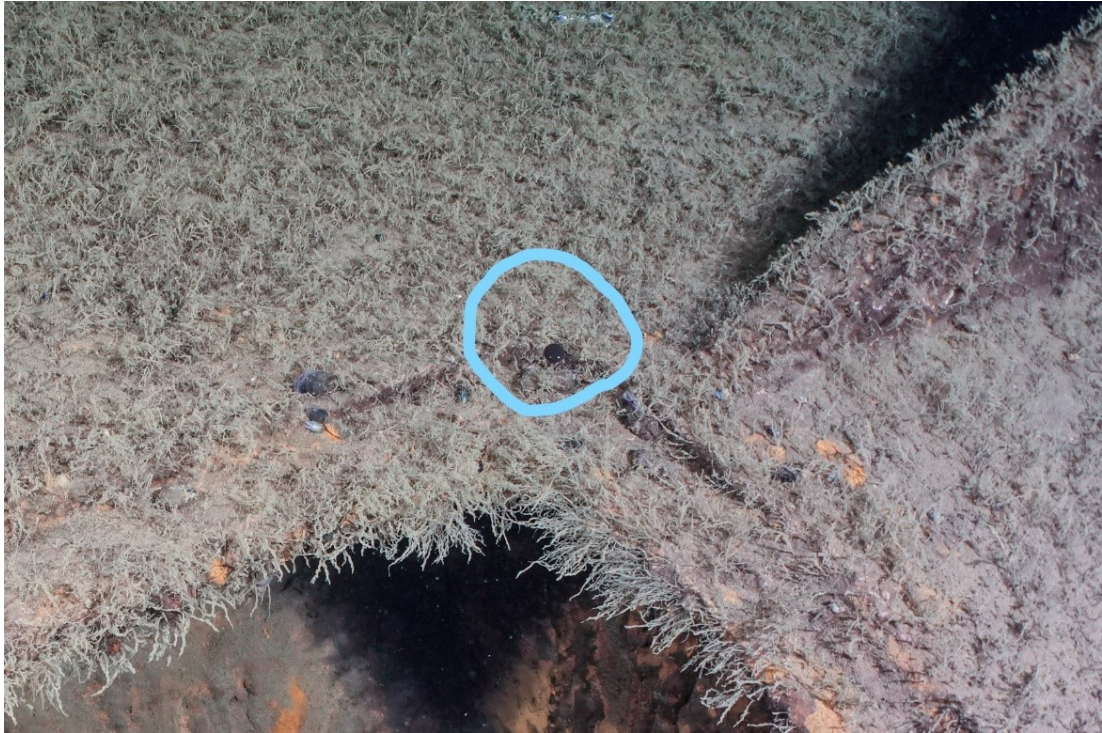
Indications of an oil leak were observed during on-site surveys in 2021. The minor leak was located in the hull's aft section during on-site surveys conducted in 2022 (Figure 5.1). The Finnish Border Guard conducted an aerial survey and subsequently took samples of the oil for analysis.

The results of the analysis indicated that the samples mostly contained lubricating oil mixed with some fuel oil. Effective surface response activities cannot be conducted as the leakage is minimal.

FIG. 5.1: The blue circle shows where a drop of oil is bubbling to the surface. Photo from photogrammetry.

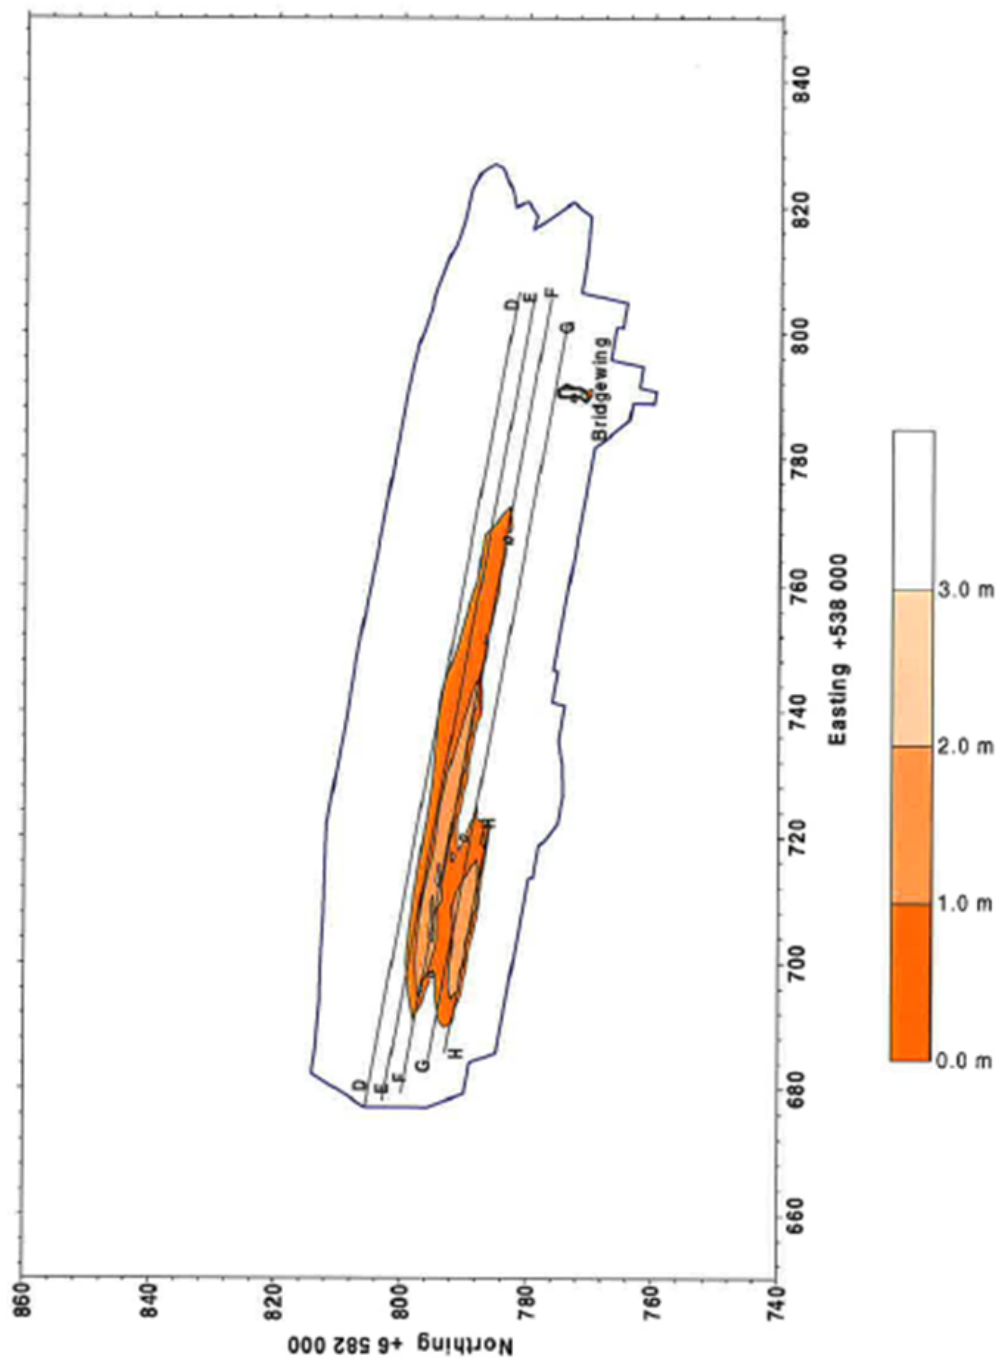
FIG. A.1: The plan shows areas of the hull where the clay layer is thinnest, i.e., where underlying layers are shallowest, based on interpretation in 1997. These areas could be expected to be the most damaged. Image from Velde [13].

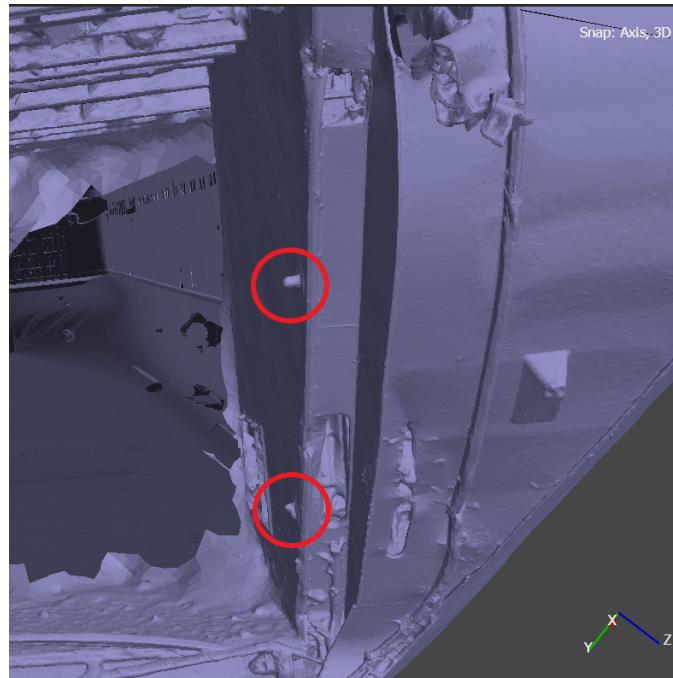
FIG. B.2: An image from the photogrammetry acquired in 2022. The lower red circle displays the same locking as Figure B.1, i.e., the port side lower bow ramp locking.

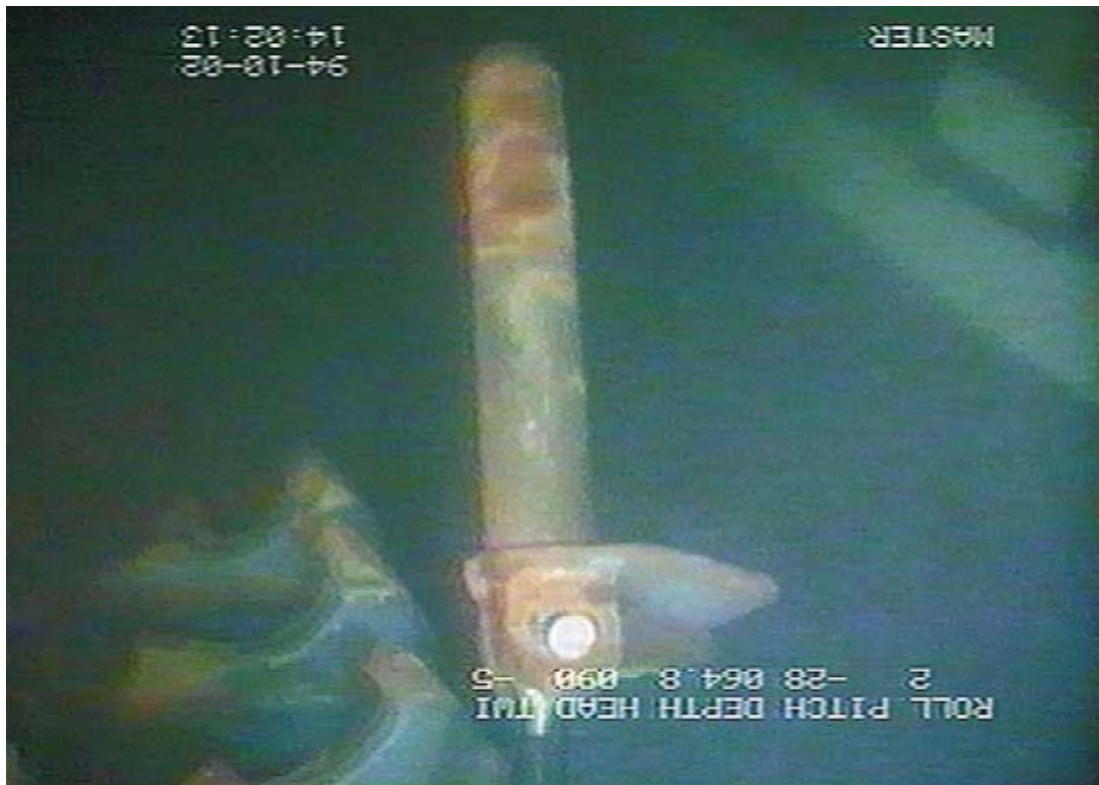
FIG. B.3: The locking bolt for the bottom lock, filmed on the wreck. The bolt was salvaged and examined by investigators, but was not saved. To the left bottom of the picture, the remains from the three broken attachment lugs are seen. The image is from the JAIC report, Figure 8.15, and is turned upside-down (to compensate for the vessel lying effectively upside-down when filmed).

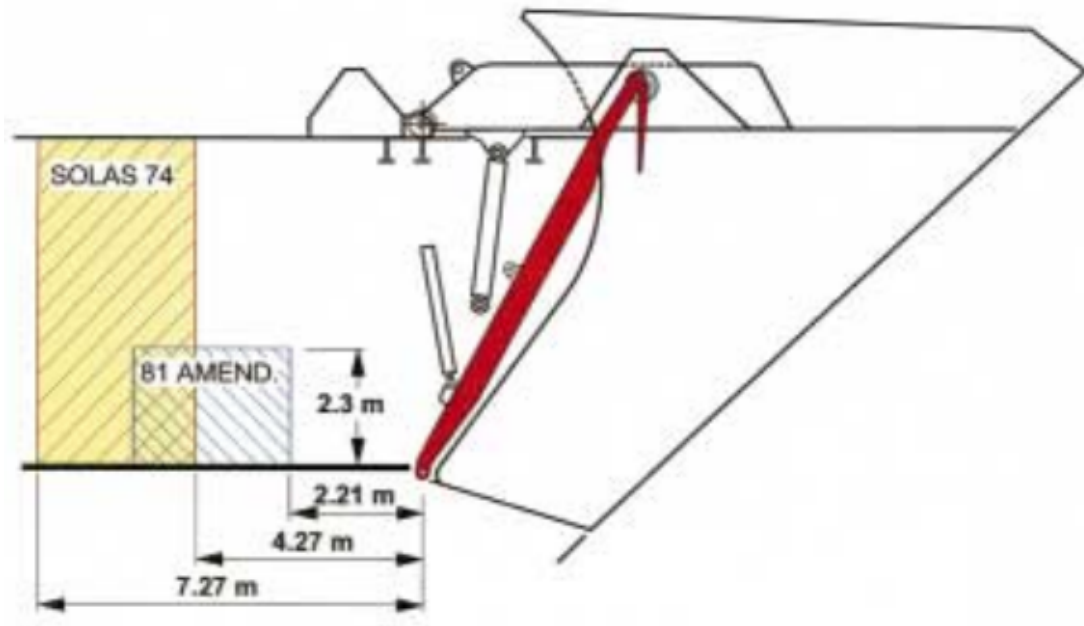
- The location of the bow ramp as the upper extension of the collision bulkhead was based on a practical decision for an exemption from the regulations. Such an exemption entails a condition, which must be recorded in certificates but was not. Therefore, MV ESTONIA was not seaworthy and the certificate was incorrect. If the condition had been noted in the relevant certificate, the vessel would not have been trading the Tallinn–Stockholm route.

FIG. B.4: Placing of the collision bulkhead in accordance with the SOLAS Convention. The bow ramp (marked red) was more than 2 m fore of accepted placing. In addition, it towered above the forecastle deck, thus requiring to be housed partially inside the visor. This meant, that when the visor came loose, it was hanging on the bow ramp. Reproduced from the JAIC report, Fig. 3.13.
