## CHAPTER 6

# SUMMARY OF TESTIMONIES BY SURVIVORS

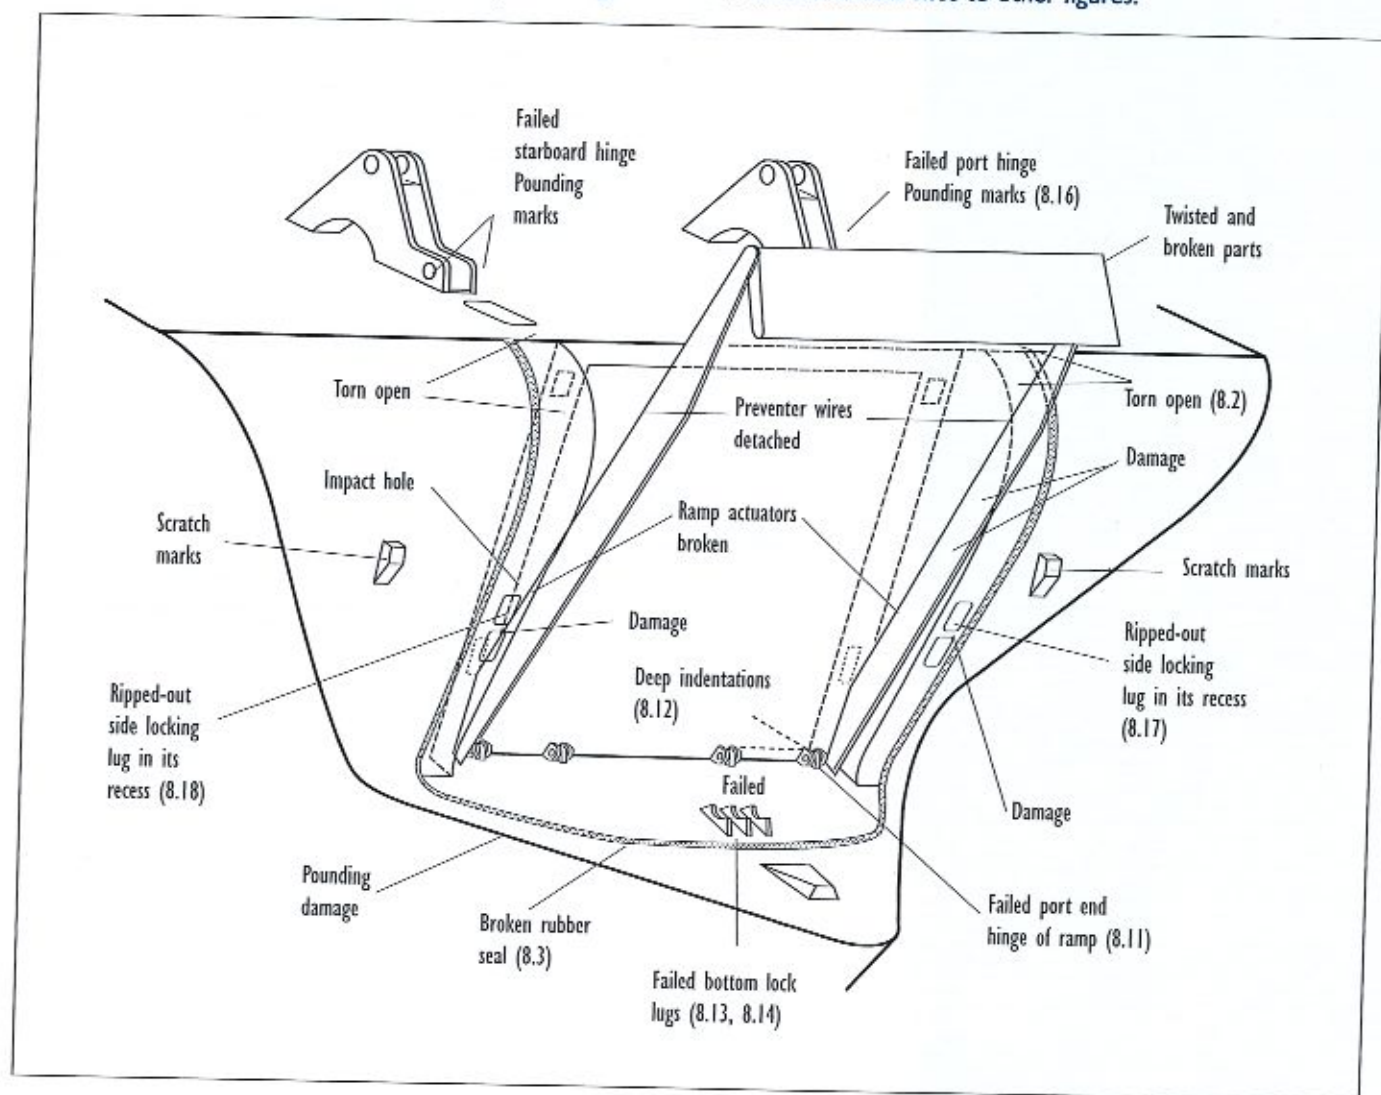
Figure 8.1 Summary of damage in the bow area with reference to other figures.

Diving and ROV inspections of the bow area of the wreck revealed certain damage to the installations in the bow area which are summarised in Figure 8.1.

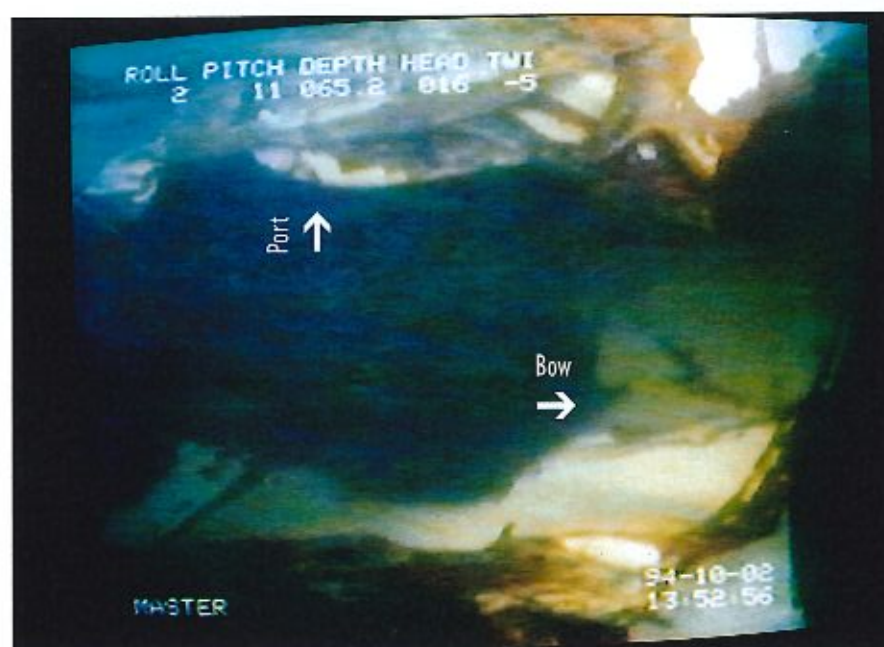
Figure 8.2 Damaged deck and front bulkhead in front of the opening for the visor operating actuator on the port side.

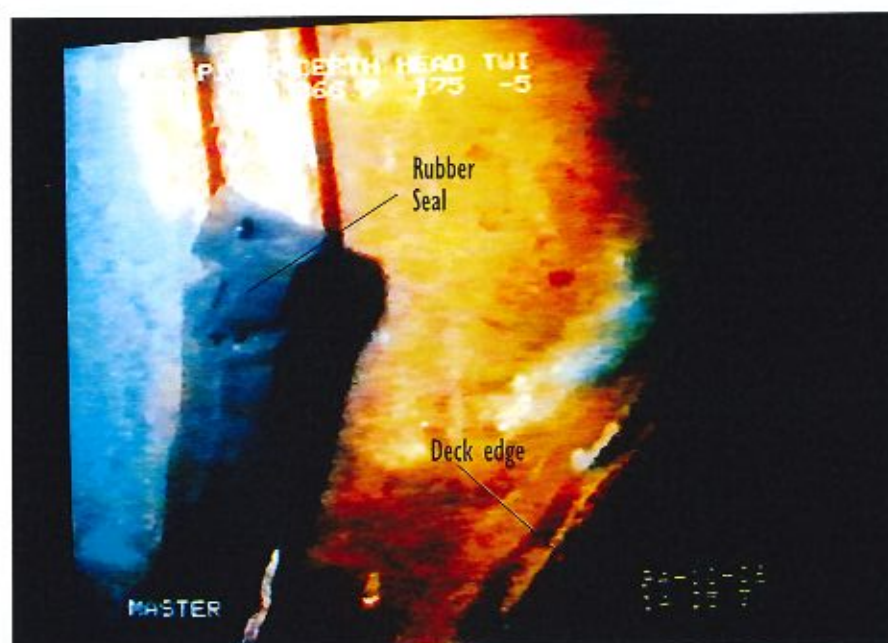
Figure 8.3 Broken visor rubber seal on the starboard side of the forepeak deck.

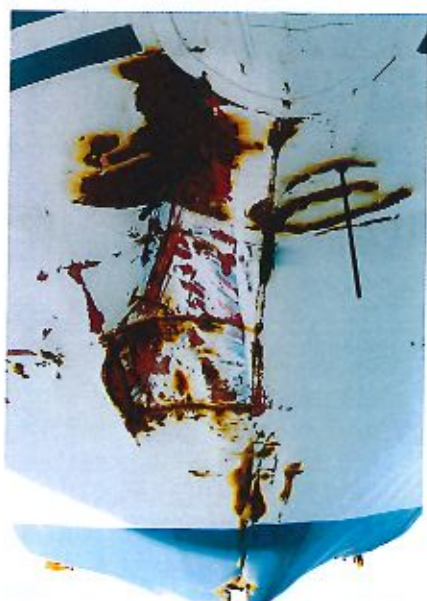
Figure 8.5 Visor damage on the front side.

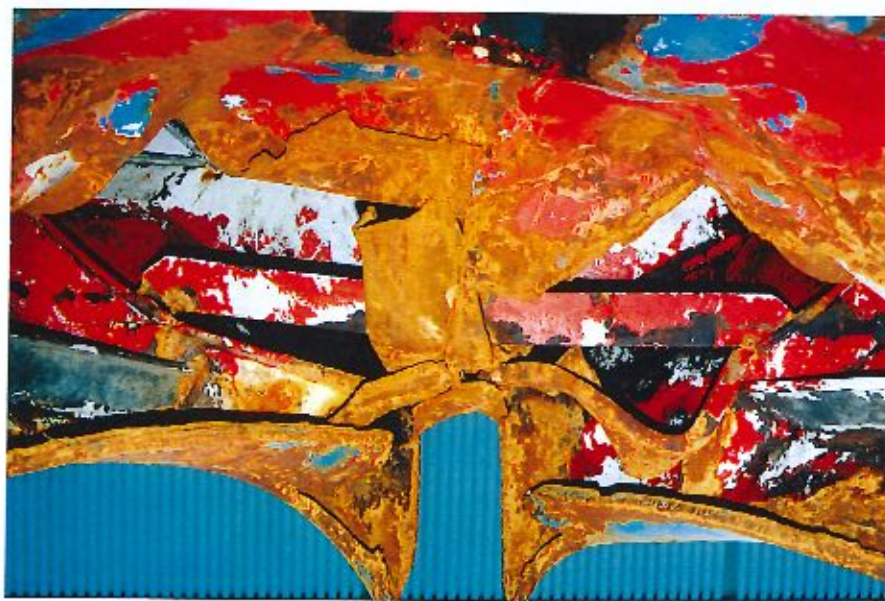
The bottom of the visor was heavily pounded and distorted (Figure 8.6). It was compressed upwards, varying up to about 0.5 m compared to the original shape.

Figure 8.6 Damage to the bottom structure of the visor.

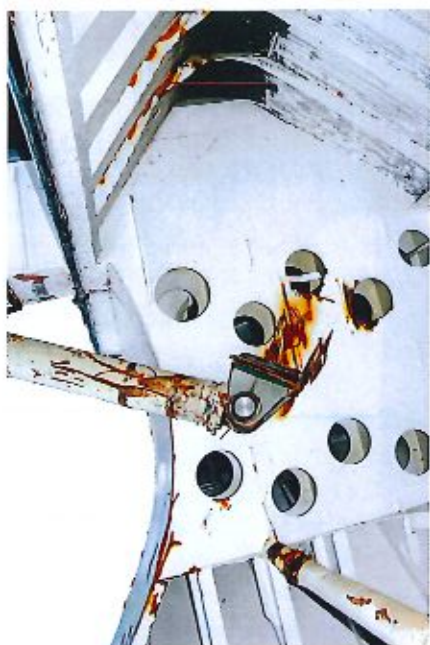
Figure 8.7 Impact marks in the port inner bulkhead, the uppermost cross-bar and the housing on the visor deck.

The inner vertical bulkheads of the visor had indentations and score marks on the port side (Figure 8.7).

The uppermost cross-bar in the visor had heavy impact marks (Figure 8.7). Other cross-bars had lighter marks.

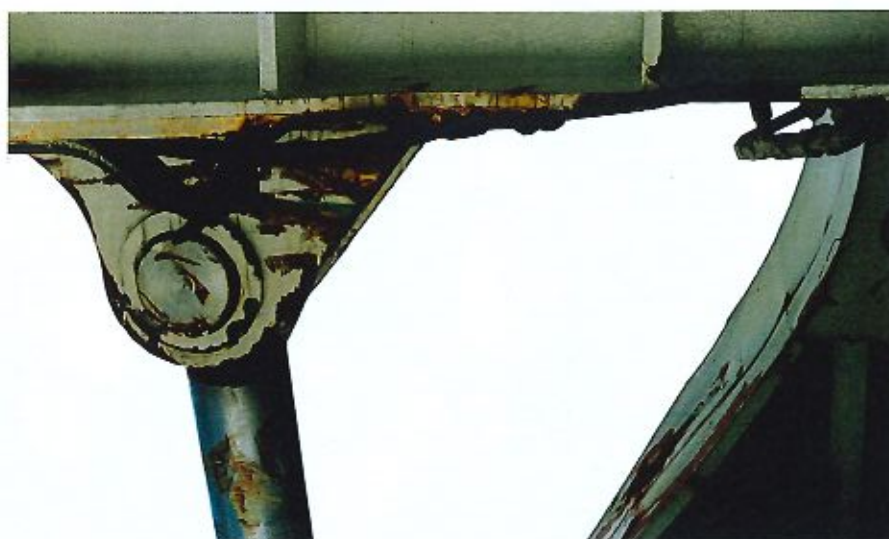
Figure 8.9 Score marks on the starboard side of the port actuator attachment lugs.

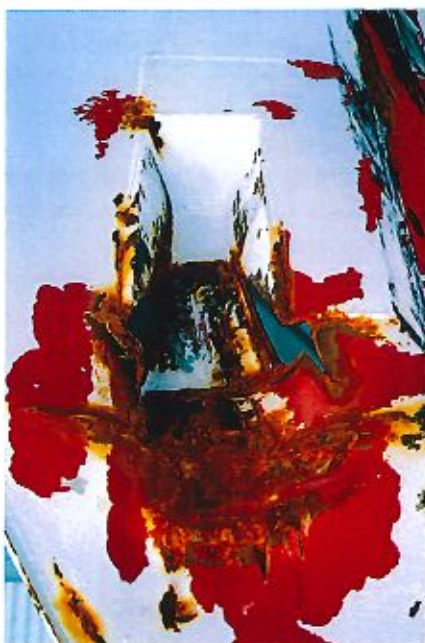
Figure 8.8 Damage to the recess for the port locating horn.

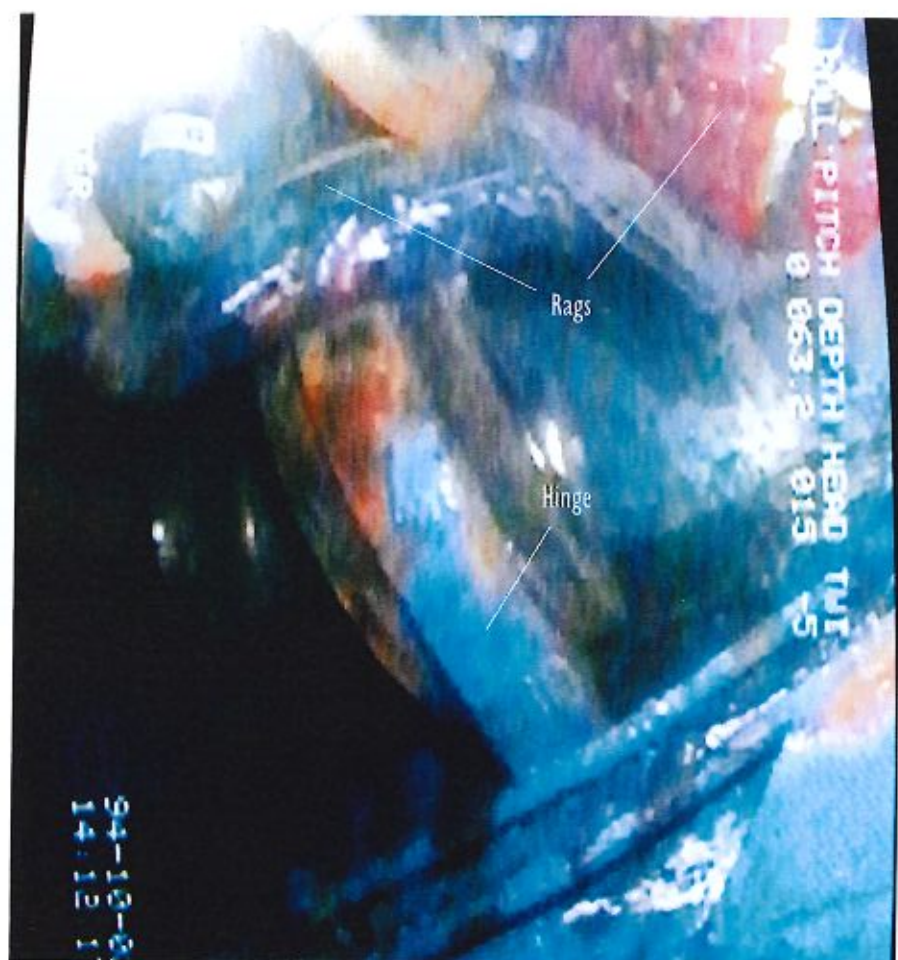
Figure 8.11 The failed port end hinge of the ramp surrounded by rags.

The two port side hinges at the bottom of the ramp were torn apart (Figure 8.11). Both hydraulic actuators for the ramp had failed in their piston rod end

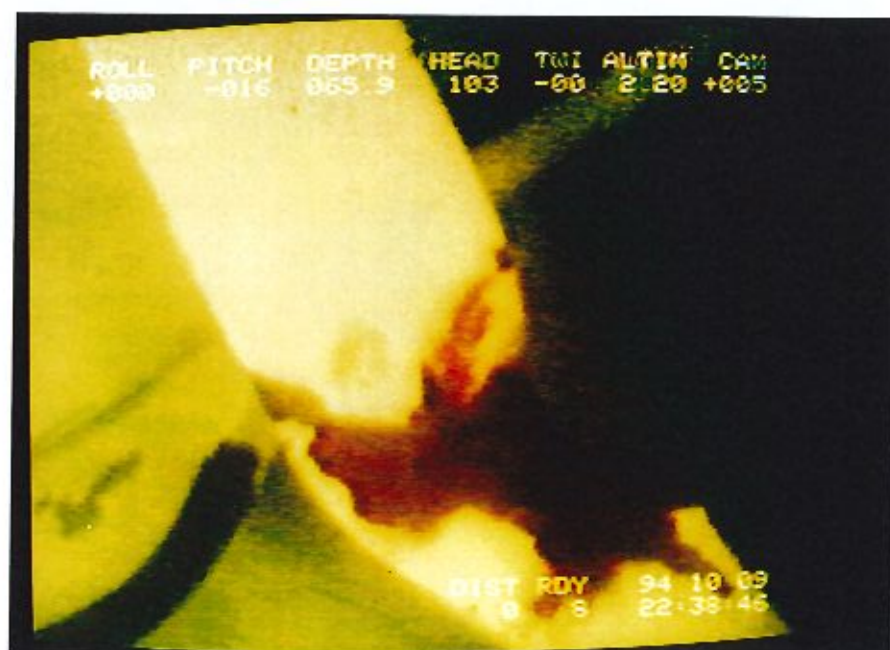
Figure 8.12 Indentations on a beam on the lower side of the ramp.

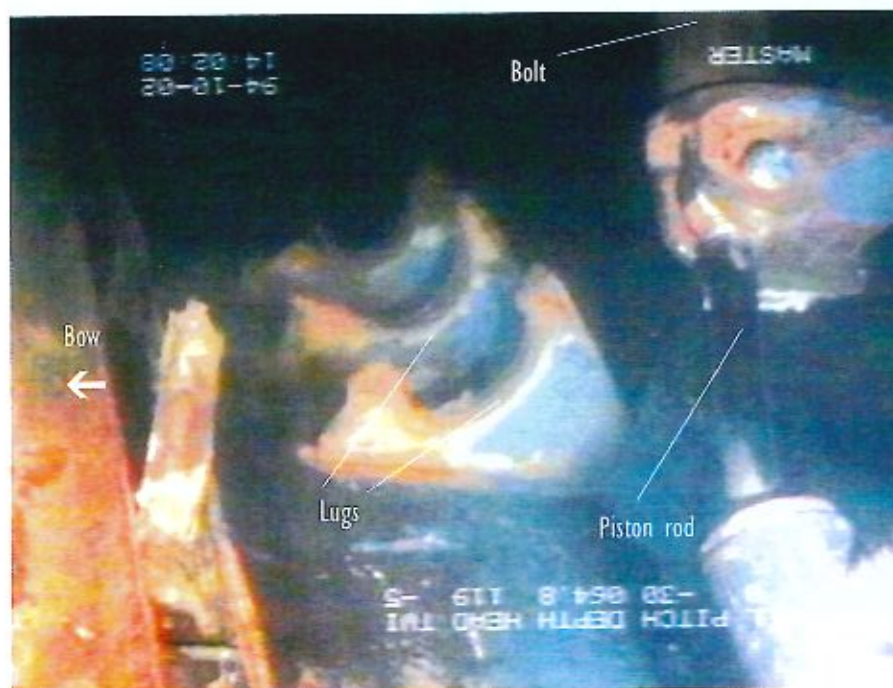
Figure 8.13 Failed bottom lock installation.

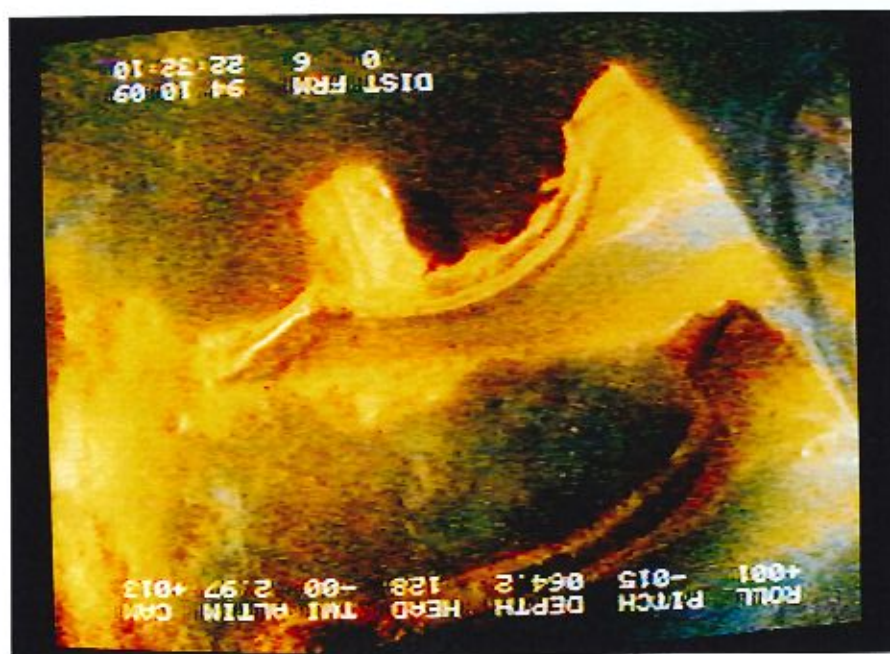
Figure 8.14 Failed starboard and middle lugs for the bottom lock installation.

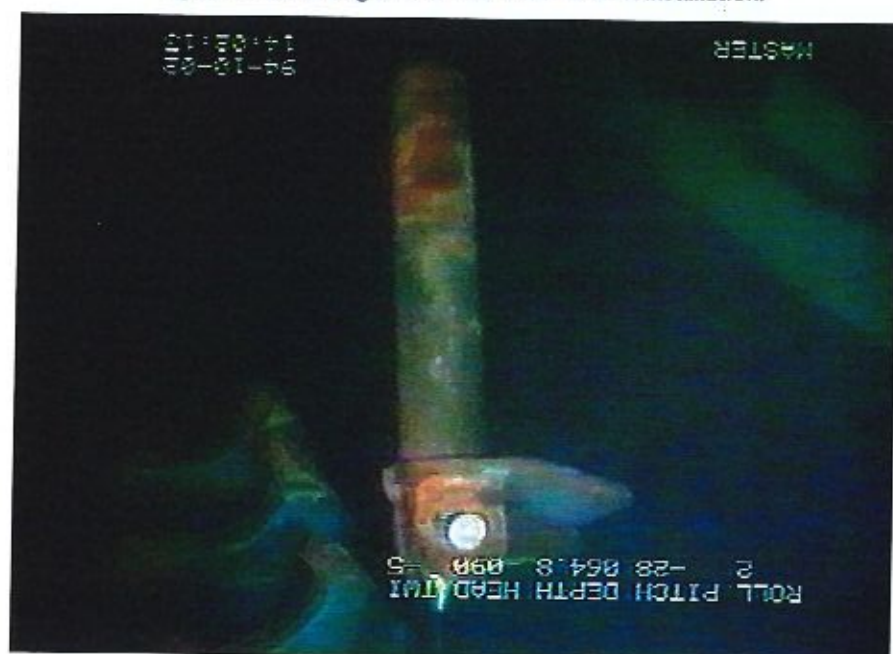
Figure 8.15 Locking bolt for the bottom lock installation.

When the locking bolt was removed from the actuator piston rod, the actuator was in fully extended, i.e. locked, position. The piston rod was bent upwards, away from the forepeak deck. The hydraulic hoses were connected. The bolt was checked for wear and deformation. The bolt was straight. The general diam-

eter of the bolt was about 78 mm. Only a slight variation in diameter was measured at the contact area between the bolt and the visor lug. No other damage to the bolt was noted.

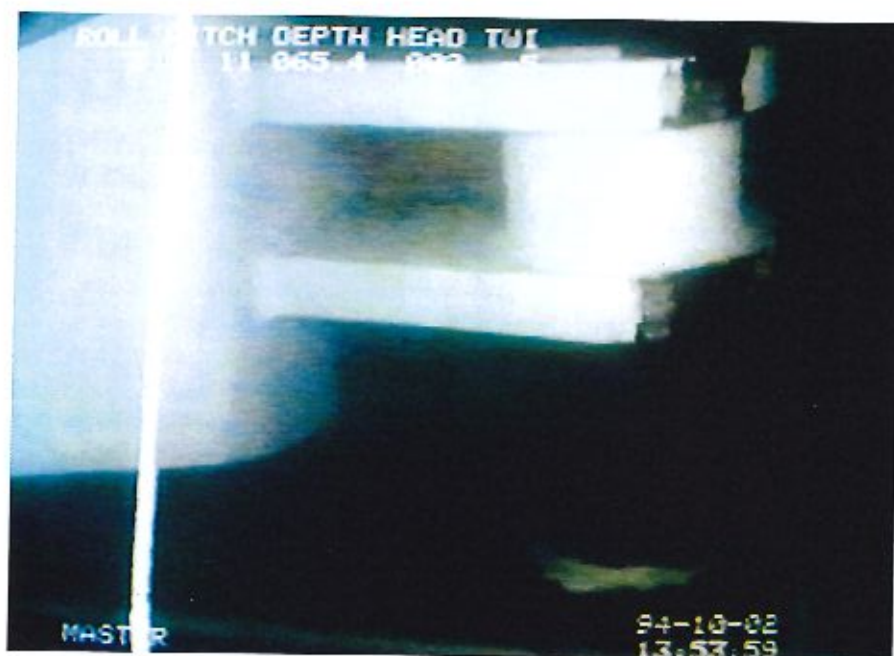
Figure 8.16 Deck hinge fitting, port side. One separated hinge bushing visible at bottom picture.

The visor deck hinge fittings were found during the ROV and diver surveys to be intact except for pounding marks on the side plates, essentially at their upper parts, above the centre of the hinges (Figure 8.16). The hinge shafts had almost fully

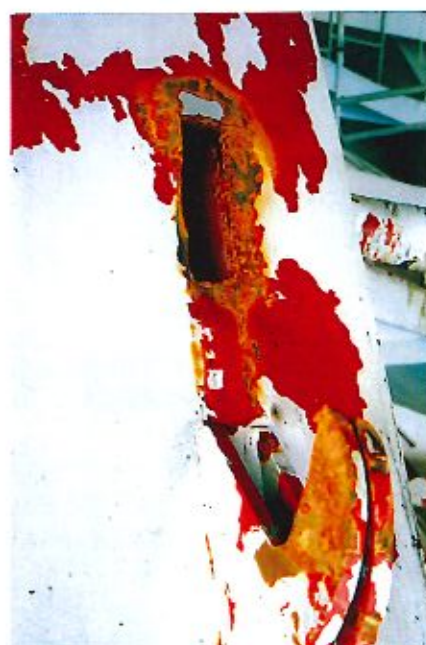
Figure 8.19 Damage due to separation of the port side locking lug, and the lugs of the manual lock.

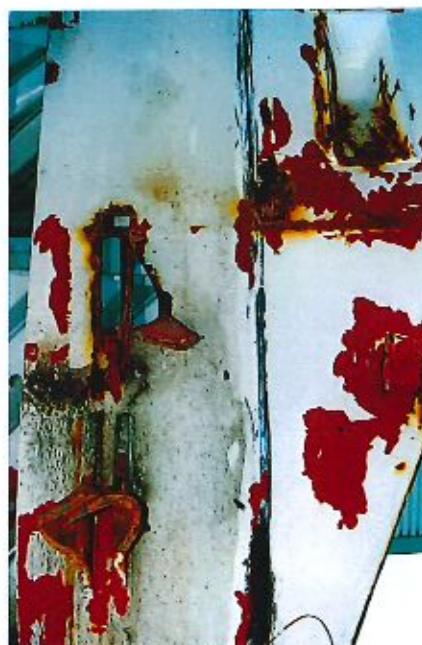
Figure 8.20 Damage on the visor aft bulkhead on the starboard side near the separated side locking lug.

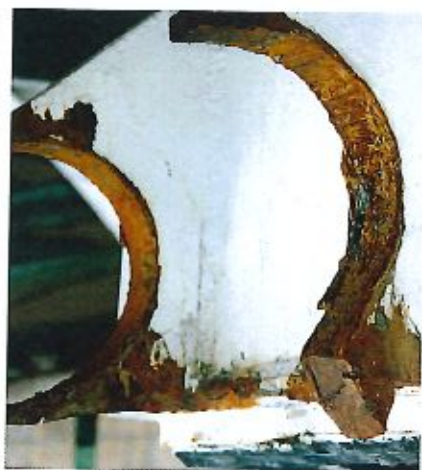
Figure 8.21 Failed visor port hinge lugs.

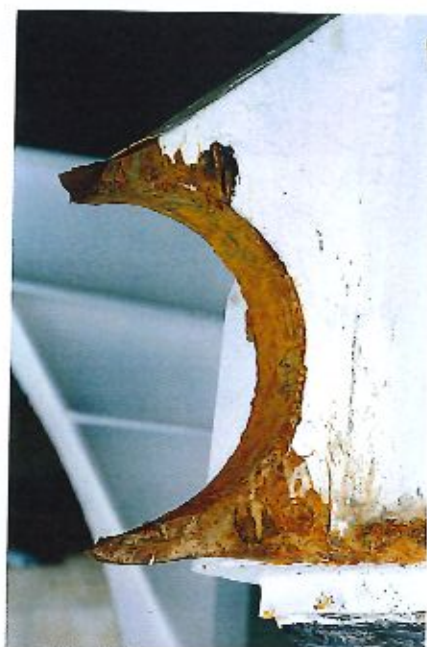
Figure 8.22 Failed port lug of visor port hinge.

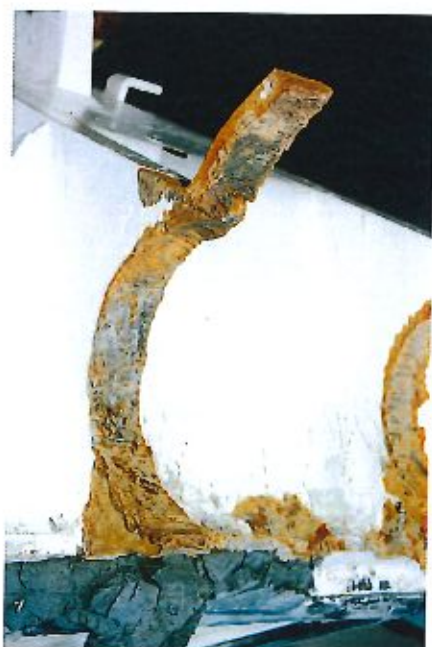
Figure 8.23 Failed port lug of visor starboard hinge.

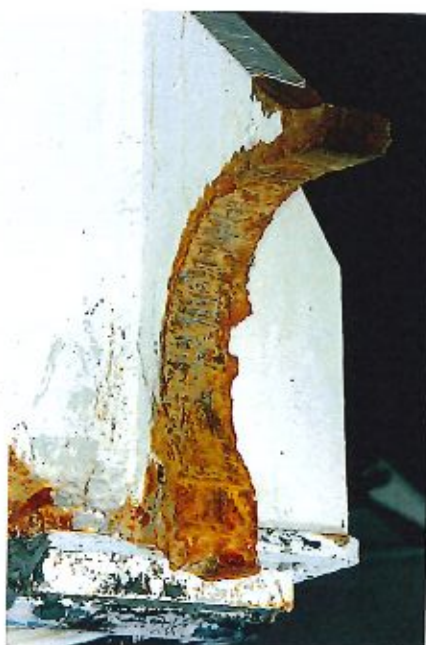
Figure 8.24 Failed starboard lug of visor hinge.

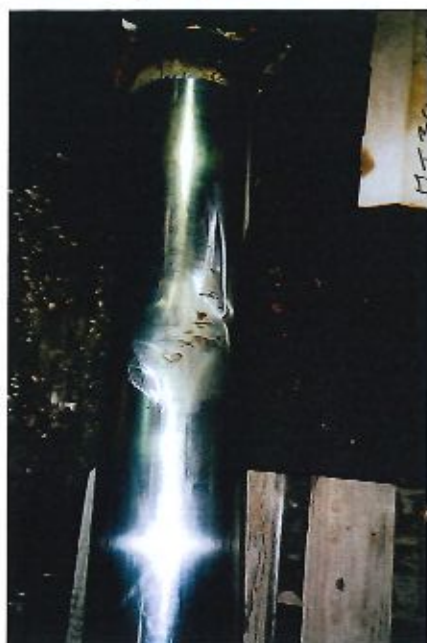
Figure 8.25 Scratch marks on the piston rod of the visor port side opening actuator.
