*final report*

ON THE CAPSIZING ON 28 SEPTEMBER 1994  
IN THE BALTIC SEA  
OF THE RO-RO PASSENGER VESSEL

**MV ESTONIA**

The Joint Accident Investigation Commission  
of Estonia, Finland and Sweden

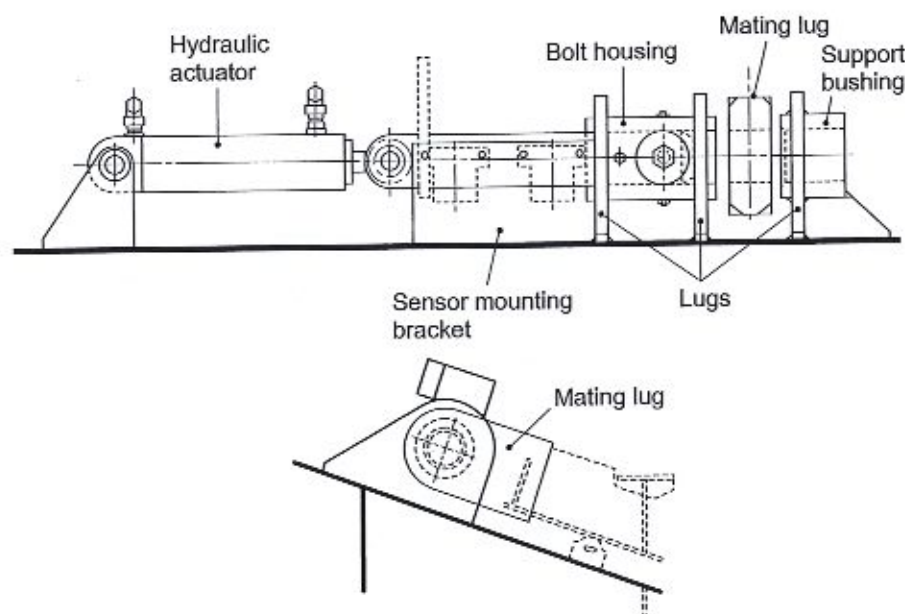
Figure 3.7 Bottom locking device installation on forepeak deck.

position indication and alarm system are covered separately in 3.3.5. The original mechanical switches were replaced by the magnetic sensors in the mid-1980s.

The mating lug in the bottom structure of the visor consisted of a single steel lug, welded to a transverse beam of the visor bottom structure and supported by a bracket as shown in Figure 3.8. The diameter of the bolt was 80 mm in the original von Tell drawing. The lug had a hole for the locking bolt with an original diameter of 85 mm.

The failure mode of the bottom lock installation and related findings are covered in Chapters 8 and 15.

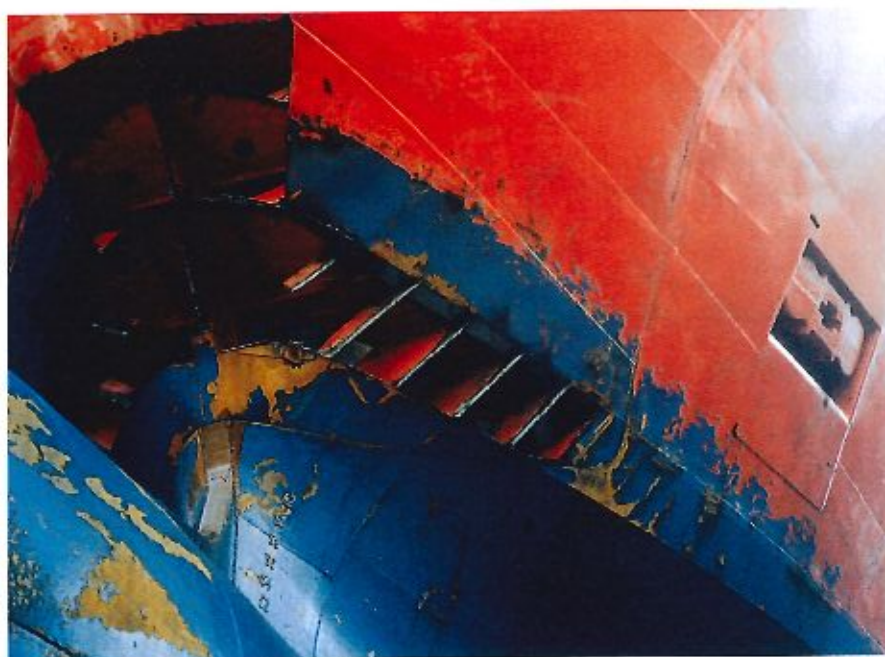
Figure 3.12 The extent of ice damage repair in 1987.

As mentioned in 3.2.10, damage due to ice was recorded in 1982, 1985 and 1987. Damage to the bow visor occurred
