## CHAPTER 16

# ANALYSIS OF THE EVACUATION

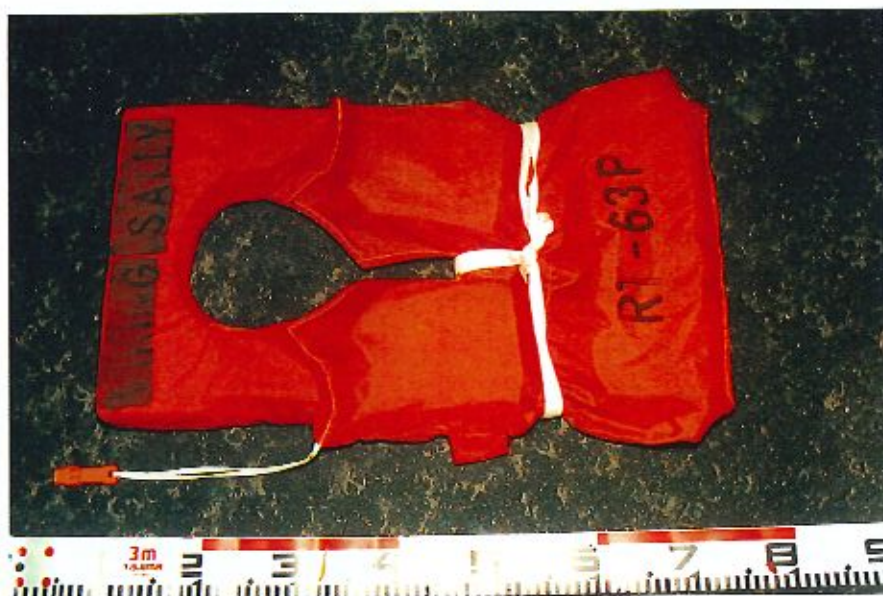
Figure 17.5 ESTONIA's lifejacket for adults.

At least one container with lifejackets came loose and fell into the sea. Many survivors have stated that the lifejackets appeared old-fashioned while a common opinion among those rescued was that it was difficult to understand how to use them and how to put them on. Many lifejackets were tied together in threes and were difficult to separate. Lifejackets

were also torn off when people hit the water. Survivors reported that the lifejackets appeared incomplete, with missing straps or straps that seemed too short. People had to help each other both to understand how to use the jackets and also to put them on.

The reports from witnesses are in line with reports from rescue units and personnel searching the water during the days after the accident. They found several drifting bundles of lifejackets tied together. Members of various rescue units also confirmed that they found very few people wearing lifejackets that had been put on correctly.

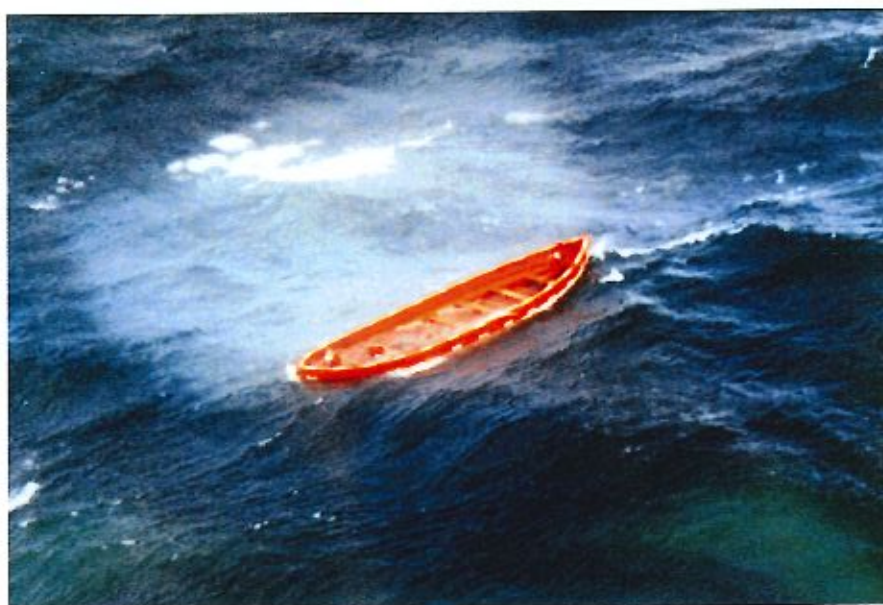
Figure 17.6 A waterlogged ESTONIA lifeboat after the accident.

The crew did not manage to launch any of the ten lifeboats. Nine broke loose when the vessel sank, and the tenth is still attached to its davits. The rapidly increasing list and the lack of time for organising the crew are considered to be the main reasons for this shortcoming. The lifeboats found drifting during the rescue operation had either capsized or were waterlogged (Figure 17.6).

Three lifeboats were found near the place where the ESTONIA sank. A crew member had managed to climb into one of them and on each of the other two, which were floating upside down, six persons were hanging onto the bottom. One person from each was later washed

Once again traditional lifeboats proved to be useless in distress.

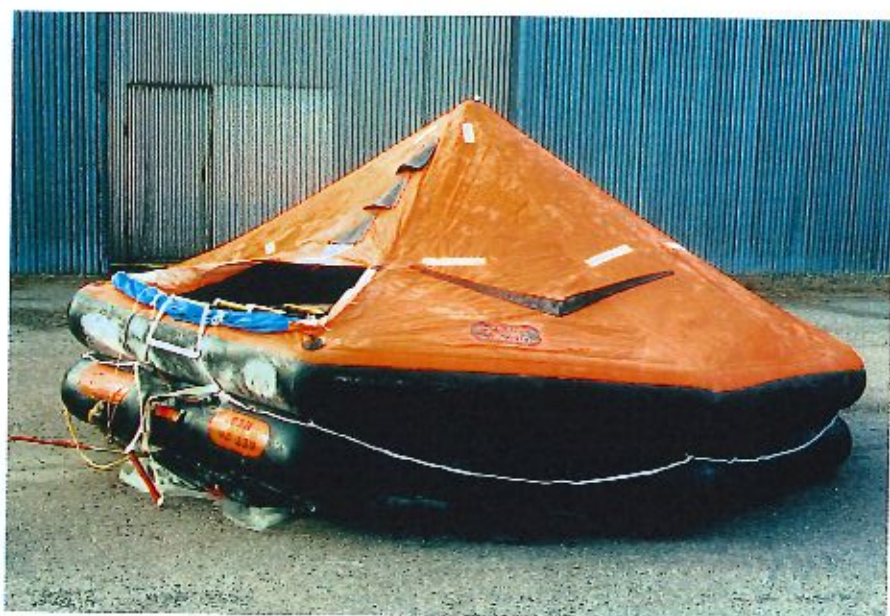
Figure 17.7 ESTONIA's Viking 25-K type liferaft.

The liferafts (Figure 17.7) were launched partly by crew members and passengers and partly by automatic release and inflation when the vessel sank. The rafts were found very difficult to use in the severe sea conditions partly for the following reasons:

- The knives on board the rafts proved to be useless.
- When the rafts were drifting the various lines for inflation and for keeping the raft in position for boarding constituted obstacles for people trying to board. The rope ladder went underneath the raft, swinging the feet of those who were trying to climb on, and thus affording practically no help (Figure 17.9).
- The operating head was not properly tightened to the CO<sub>2</sub> pressure cylinder in many rafts found after the accident. This may be a reason why many rafts were not fully inflated.
- Entangled painter lines were also found around the operating heads.

As mentioned earlier the liferafts had no individual identification and were therefore not distinguishable. The helicopter crews and the mariners were unable to keep track of which rafts had already been searched. Many are believed to have been searched many times, thereby delaying the search of others.

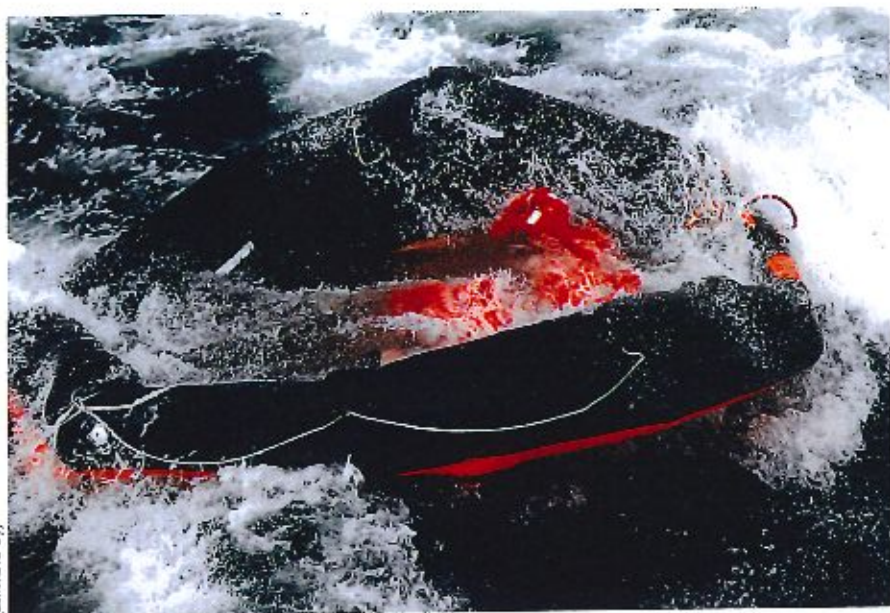
Figure 17.8 ESTONIA liferaft drifting upside-down.

Another problem was that the black colour of the liferafts' bottoms made the rafts difficult to detect when floating upside down.

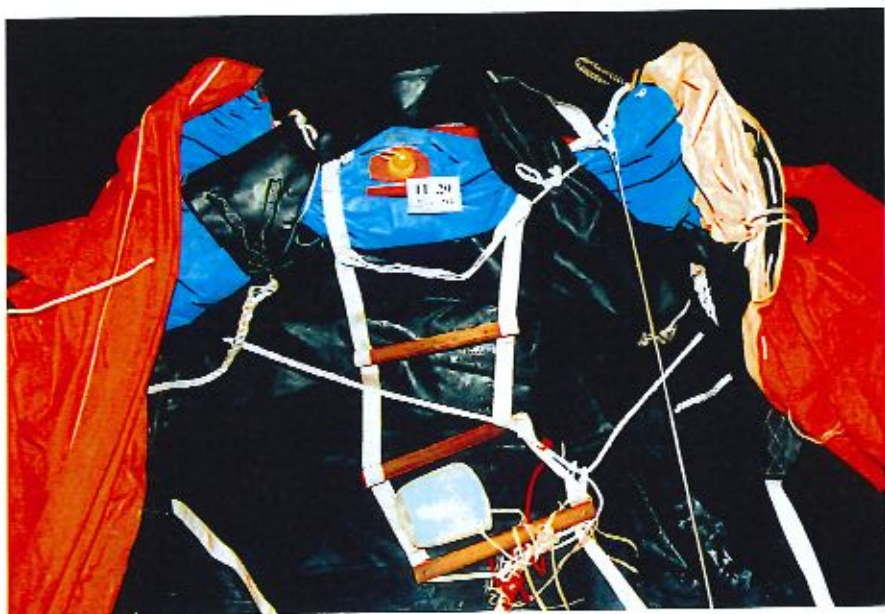
Figure 17.9 Ropes and the rope ladder in an ESTONIA liferaft as found after the accident.

Examination of the recovered liferafts shows that almost all the drift anchors and their ropes were missing. Likewise, many emergency packs were missing.
