## *Final report RM 2018:03e*

**Serious incident involving a near collision on 25 May 2017 between Swedish and French fighter aircraft during the international military exercise ACE 17 in the air-space north-west of Arvidsjaur, Norrbotten County.**

File no. M-14/17

16 March 2018

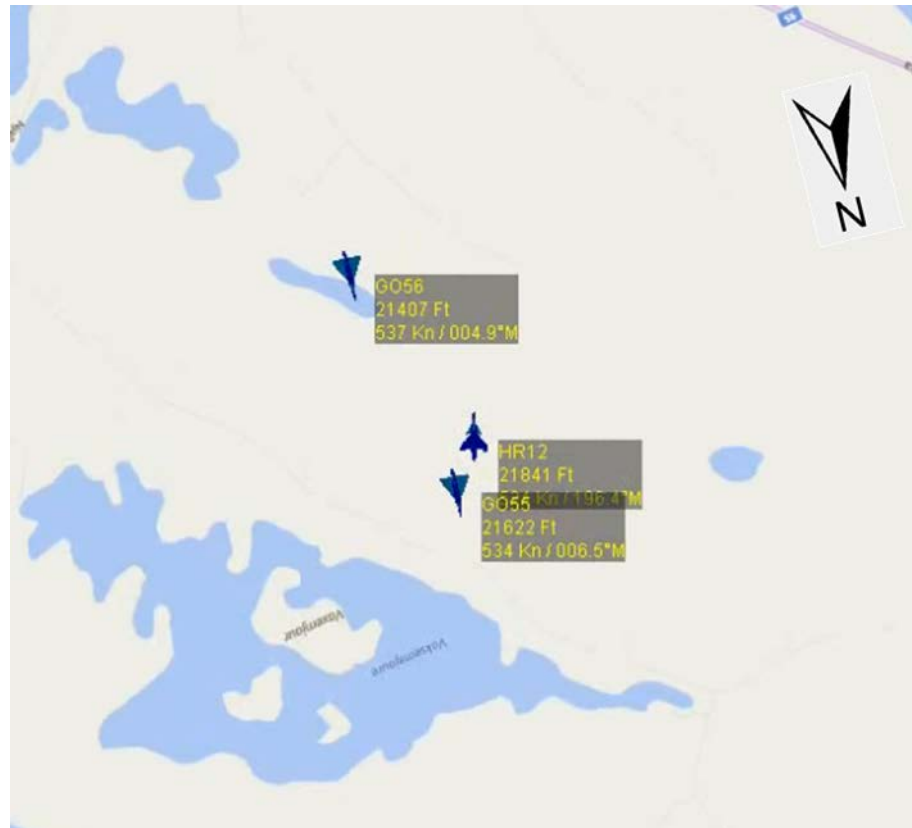
The D-ACMI position is based on downloaded navigation data from the aircraft. The measured horizontal distance has an uncertainty on account of differences in the flight groups' air navigation equipment that can amount to 50–60 metres.

Figure 6. The position image according to D-ACMI centred around HAMMER 12 during the incident at 15:00 hrs. (The Mirage two-ship GUSTO 55/56 is flying north and Gripen HAMMER 12 south). Source: Armed Forces (Sweden).

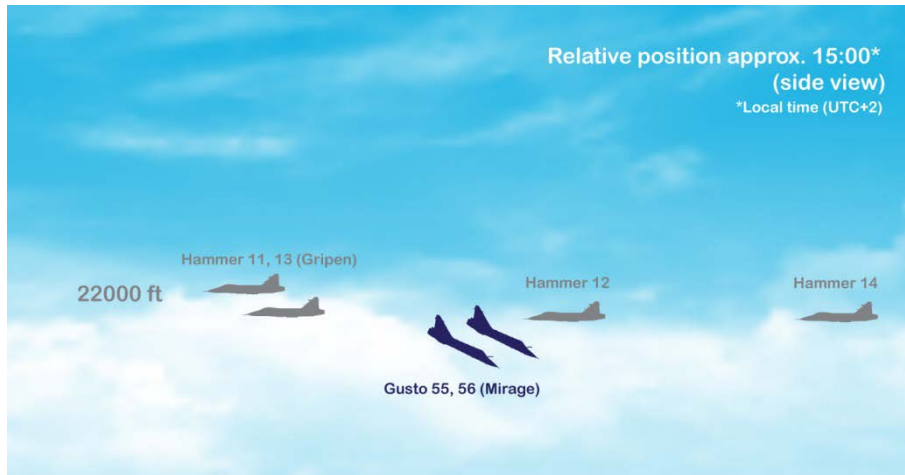
Figure 8. Vertical schematic position image during the incident at approximately 15:00 hrs.

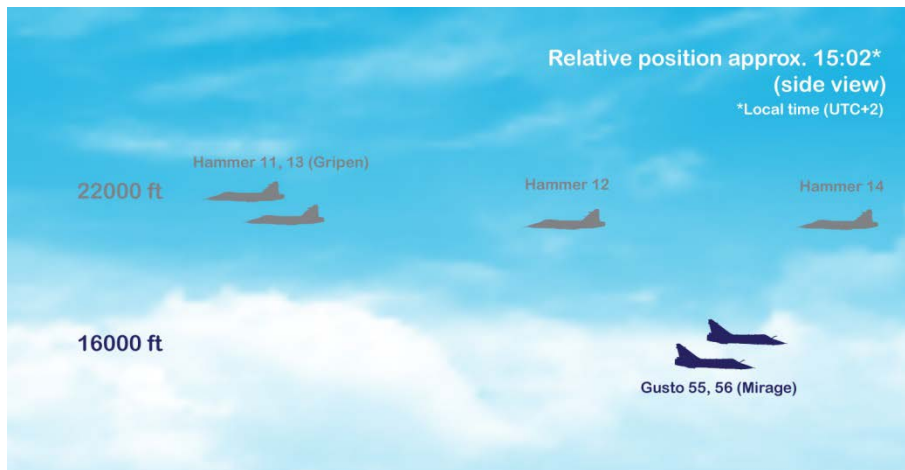
Figure 9. Vertical schematic position image after the incident at approximately 15:02 hrs.

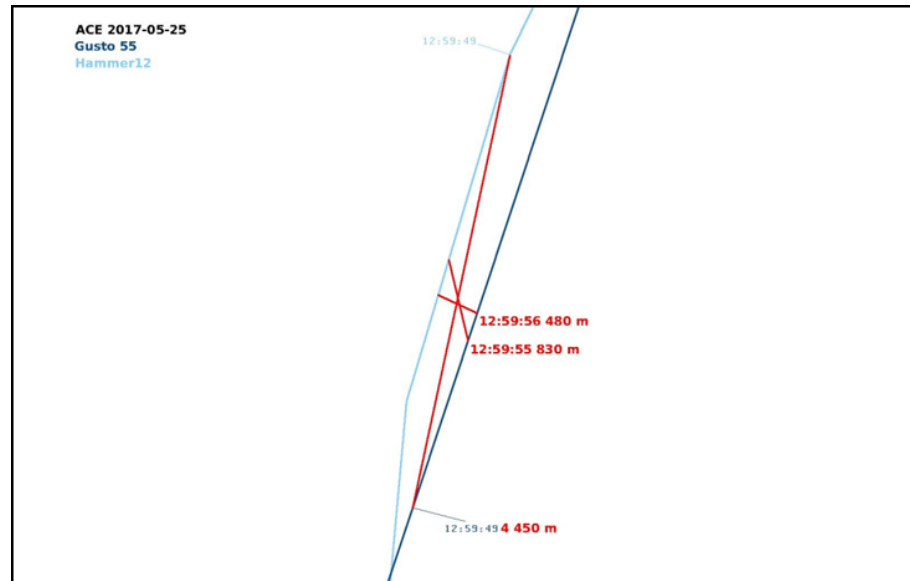
SHK has also examined transponder data where the distance between GUSTO 55 and HAMMER 12 was measured to be 480 metres during the passage (see Figure 10).

Figure 10. Measured distance between GUSTO 55 and HAMMER 12. Source: Armed Forces (Sweden).

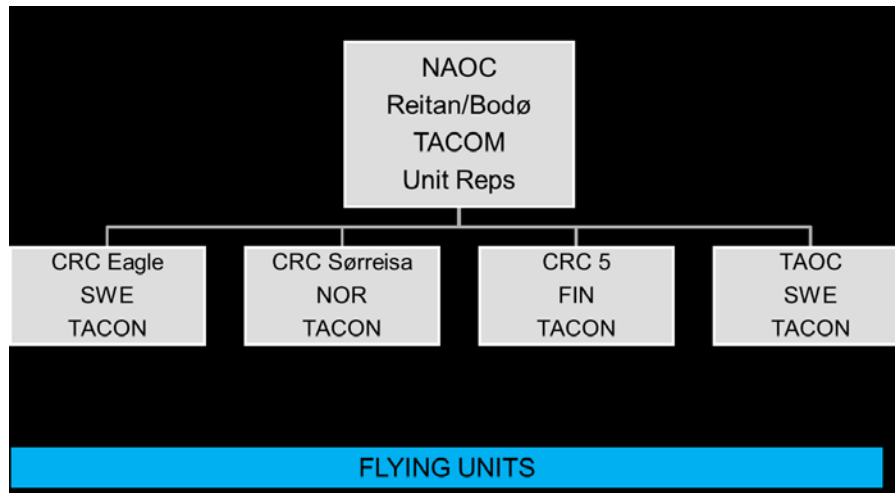
During the exercise, the tactical control responsibility in the Swedish part of the exercise area was delegated from the Norwegian control centre (NAOC) to the Swedish tactical control unit (CRC – Control and Reporting Centre) with the call sign EAGLE (see Figure 13).

Figure 13. Tactical control responsibility during ACE 17. Source: Armed Forces (Finland).

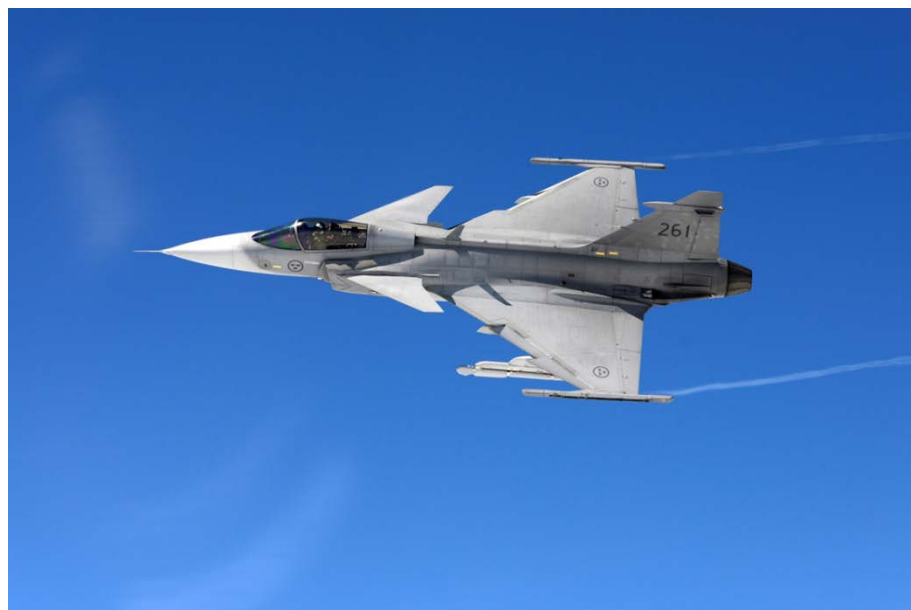
JAS 39 Gripen is a single-engine multirole fighter aircraft manufactured by Saab AB, (see Figure 14). The A and C versions are single-seaters, while the B and D versions are two-seaters. The aircraft is 14.1 metres long and has a span of 8.4 metres. Maximum permitted take-off weight is 14 000 kg.

Figure 14. Gripen C. Photo: Saab AB.

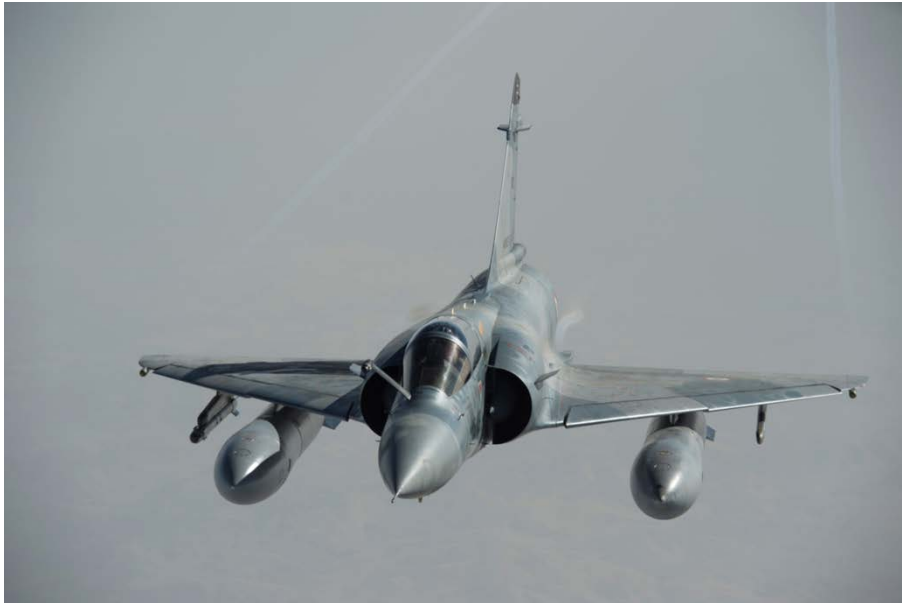
Mirage 2000 is a single-engine multirole fighter aircraft manufactured by Dassault Aviation, (see Figure 15). The model C RDI is a single-seat fighter version with multifunction Doppler radar. The aircraft is 14.6 metres long and has a span of 9.1 metres. Maximum permitted take-off weight is 16 500 kg.

Figure 15. Mirage 2000C RDI. Photo: Armed Forces (France).

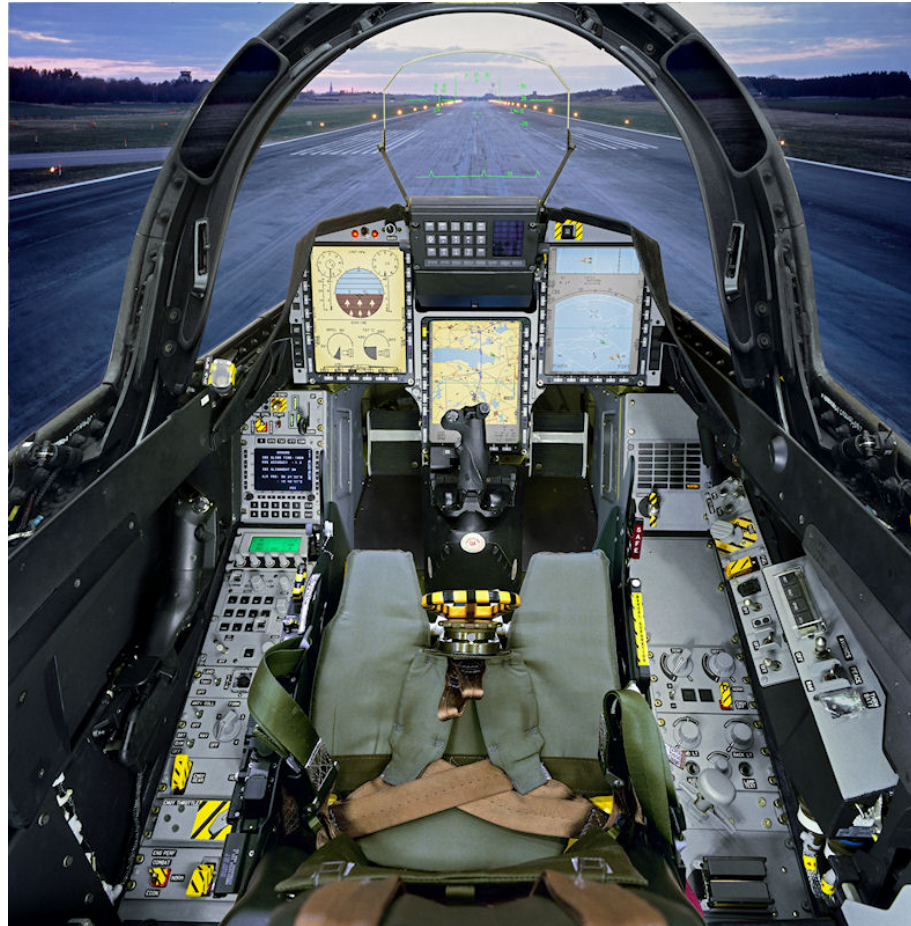
The aircraft is equipped with an inertial navigation system with GPS (INS/GPS). Navigation points are presented to the pilot in different ways in the cockpit, including in the tactical indicator (TI) and on the display indicator (Head Up Display – HUD), (see Figure 16).

Figure 16. Gripen C cockpit. Navigation display in the centre with HUD above and in front of the front windscreen. Photo: Saab AB.

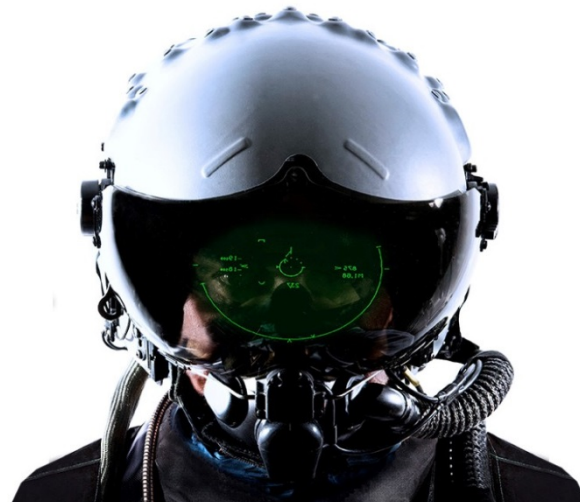
The aircraft is equipped with a main sensor in the form of a multi-function pulse-Doppler radar that, among other things, can detect and follow several aerial targets simultaneously. The aircraft is also equipped with a helmet display (Helmet Mounted Display – HMD) called COBRA. On the helmet display, flight and radar target data, among other things, can be presented to the pilot in the form of various visual symbols, see Figure 17.

Figure 17. Gripen Cobra helmet display (HMD). Photo: Saab AB.

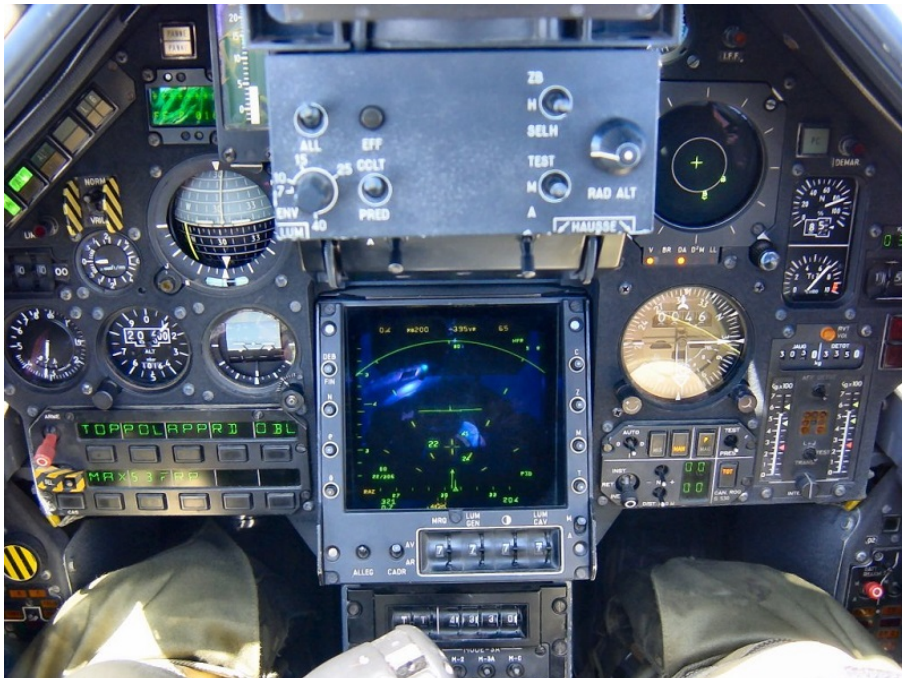
Figure 18. Mirage 2000C RDI cockpit. Photo: Armed Forces (France).

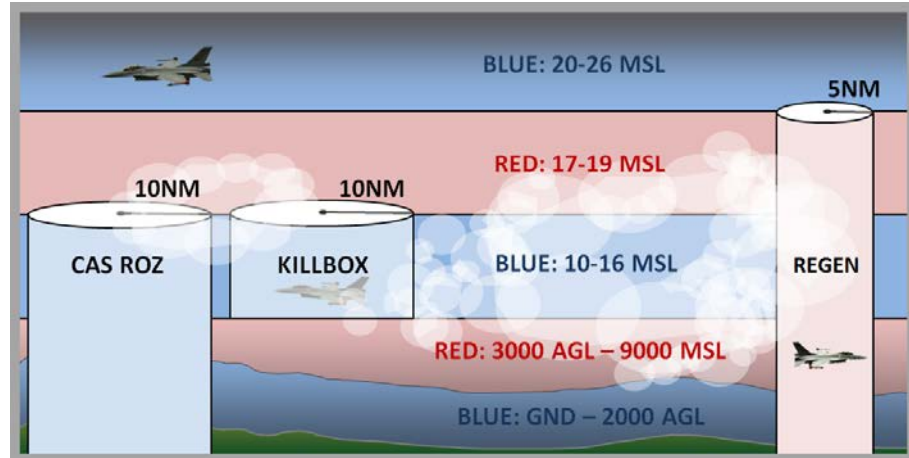
Figure 26. The principle for separation during ACE 17 by means of altitude blocks. Source: Armed Forces (Finland).
