Serious injury following inhalation of smoke in the engine room, Balticborg, Baltic Sea, 19 March 2019

Classification: Serious Injury

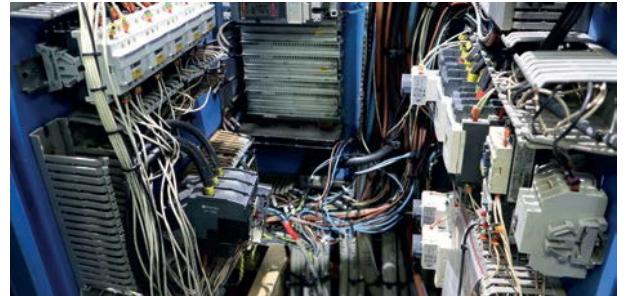
As soon as the heater was switched on, an explosion occurred in the switchboard in the engine control room, at the point where the connection was made to the main electricity distribution network on the ship via a protection relay. Shortly after the explosion, dense toxic smoke was generated by the melting of the cable insulation and (plastic) parts of various components in the switchboard. The explosion also caused a short circuit and total electrical blackout on the vessel, which was partly compensated for by the emergency power supply. Immediately afterwards, the ship's engineers set to work in the engine control room to isolate the short circuit and to restore the ship's electrical power supply. The chief engineer also entered the engine control room. Upon opening the door, he was exposed to thick smoke.

Main switchboard on the Balticborg. (Source: Dutch Safety Board)

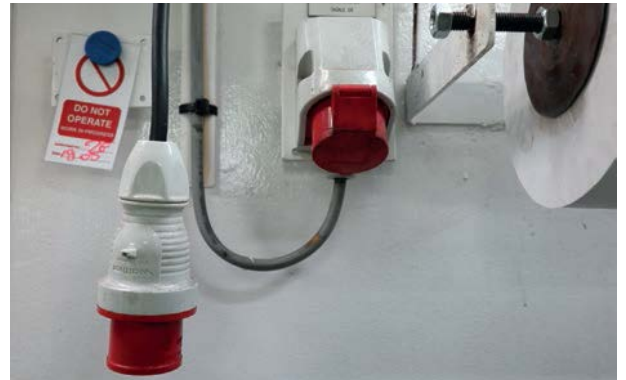
To prevent ice forming in the exhaust gas cleaning installation, a mobile electric heater with an output of 9 kW was put into use. This heater was connected to a fixed mounted connection, intended for the electrical winch in the engine room. This connection had a maximum permitted load of 0.9 kW and was electrically protected up to that load level.

0.9 Kw connection used for the electrical winch. (Source: Dutch Safety Board)

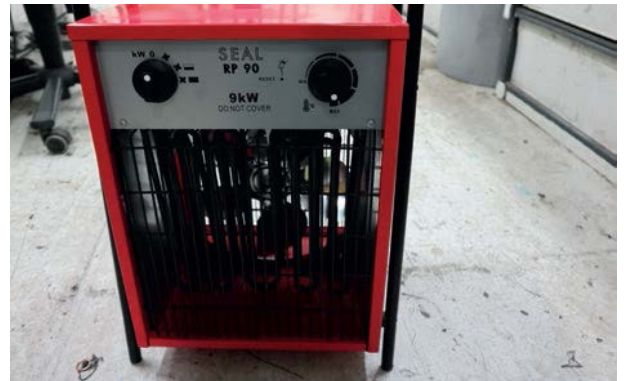
9 Kw electric heater. (Source: Dutch Safety Board)
