Final report RL 2013:02

**Accident involving aircraft EI-DLD
on 8 May 2012
at Göteborg/Säve Airport, Västra
Götaland county, Sweden.**

Ref no L-37/12
2013-01-25

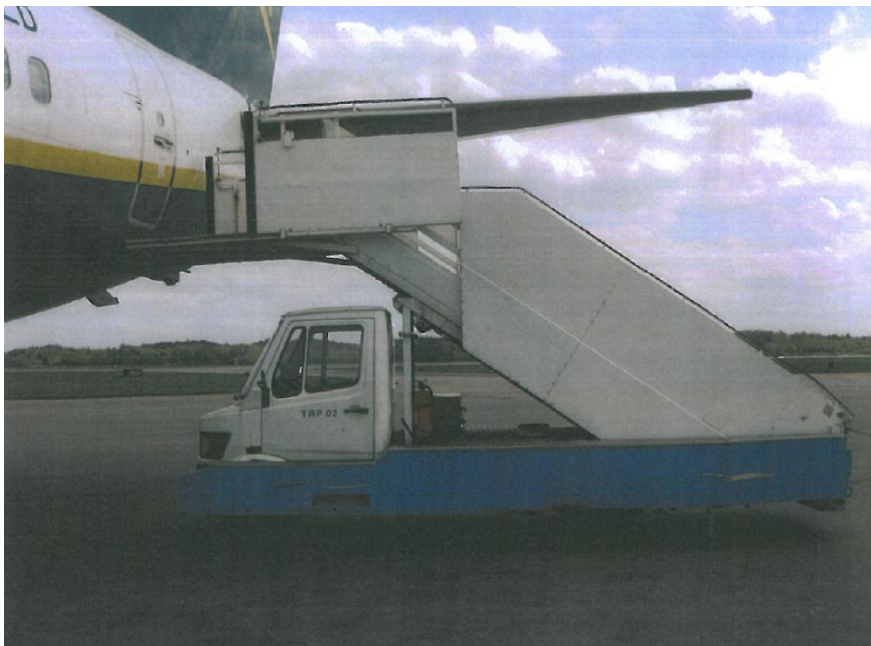
She opened the door and stepped out onto the stair platform to make contact with the ground staff and get the luggage down. The moment she shifted her weight onto the platform, the passenger stairs vehicle moved back from the aircraft, upon which she lost her balance and fell down onto the apron back-first.

Configuration of the aircraft and the mobile passenger stairs when the flight attendant opened the door
