# Accident in the airspace over Östergötland on 18 June 2025

The Swedish Accident Investigation Authority has investigated an accident on board the aircraft SE-RRF, a Boeing 737-800, in connection with an evasive manoeuvre initiated by the TCAS collision avoidance system.

12 June 2026

## Final report SHK 2026:11e

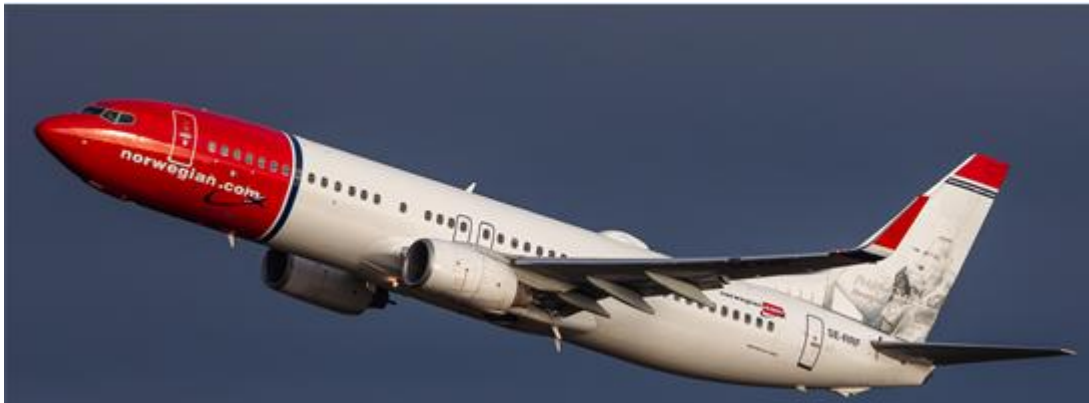
Figure 2. The aircraft. Photo: Airplane Pictures.

The Aircraft	
TC-holder	The Boeing Company
Model	737-8JP
Type	Boeing 737
Serial number	39004
Year of manufacture	2010
Gross mass, kg Max take off/landing mass	78999/66360
Current, kg Max take off/landing mass	63432/55728
Centre of gravity	Within limits

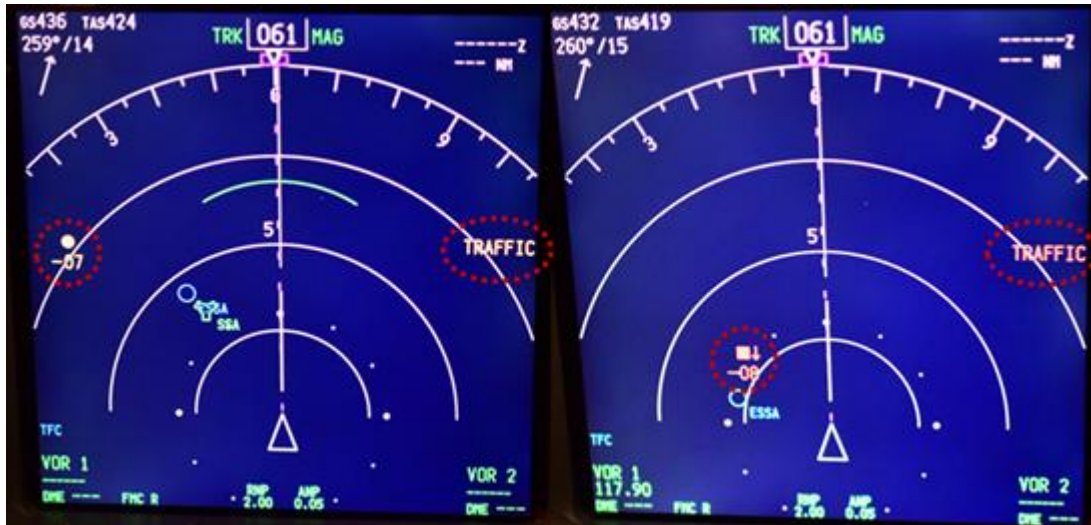
where the other aircraft is depicted by a solid red square, indicating that it is 800 feet below and descending (marked by a red arrow).

Figure 4. On the left, the Navigation Display is shown during a TCAS TA, and on the right, the Navigation Display is shown during a TCAS RA. The symbols are marked by the SHK with a red dashed circle.

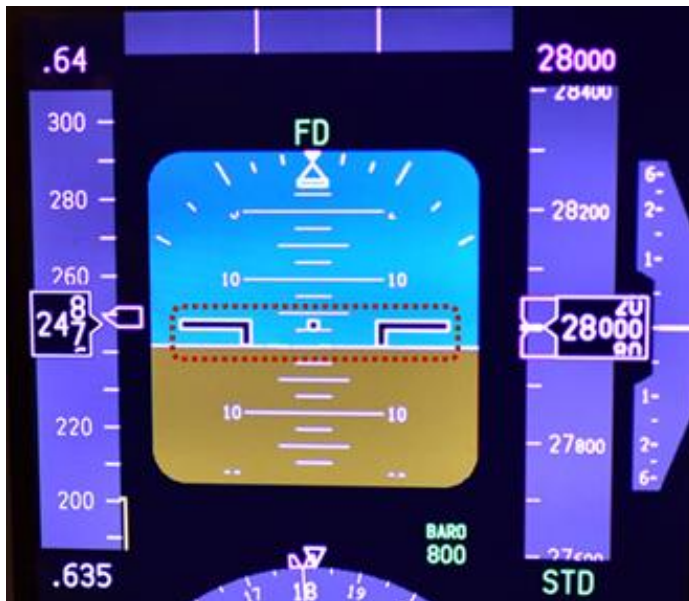
In addition to the information displayed on the ND, resolution advisories are also presented on the pilot's Primary Flight Display (PFD) during a TCAS RA, see Figure 5.

Figure 5. PFD with the aircraft symbol marked by SHK with a red dashed line.

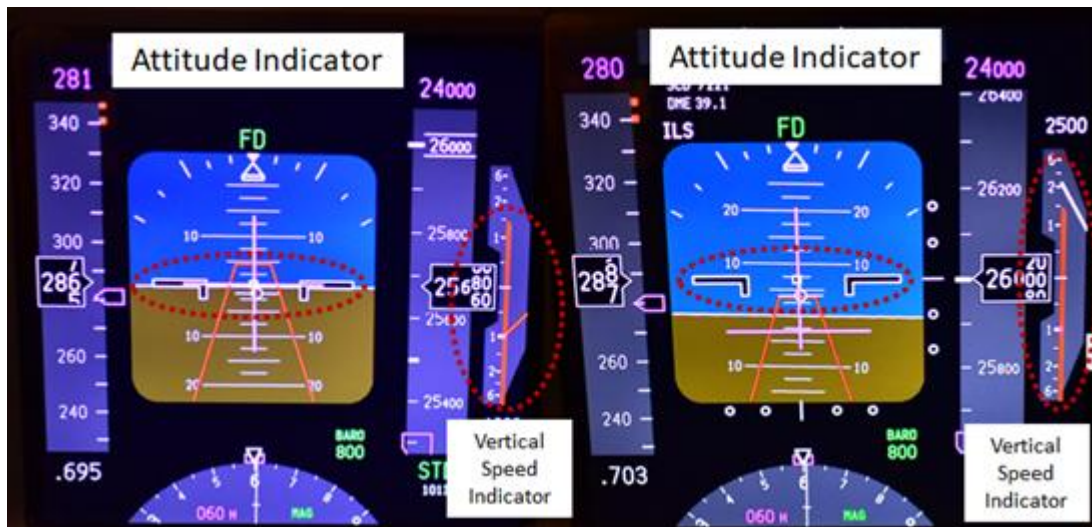
On the Attitude Indicator, a red area is displayed showing the pitch attitudes in which the aircraft symbol must not be during a TCAS RA. In addition, a red band is shown on the vertical speed indicator for those vertical speeds that are to be avoided. This is illustrated in Figure 6. In the image on the left, a TCAS RA has just been activated; the aircraft symbol is within the red area and the rate of descent is within the red band. The image on the right shows the situation when the pilot is following the TCAS RA, i.e. the aircraft symbol is outside the red area and the vertical speed lies outside the red band.

Figure 6. On the left, the pilot’s Primary Flight Display is shown just as a TCAS RA has been activated, and on the right, the TCAS RA is shown when the pilot is complying with the advisory. The aircraft symbol and the Vertical Speed Indicator have been marked by the SHK with a red dashed circle.

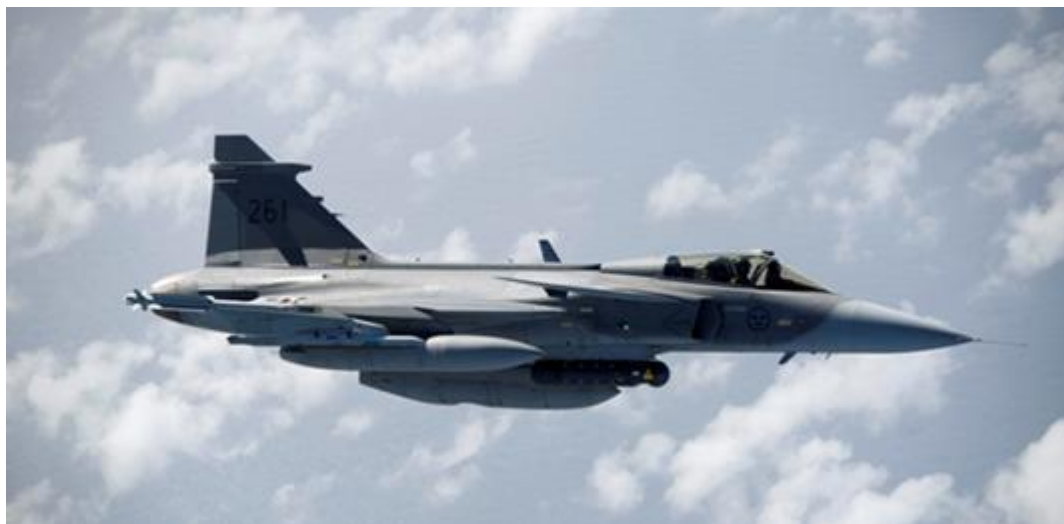
Figure 9. JAS 39 C Gripen. Photo: Swedish Armed Forces.

The JAS 39 C Gripen is a single-engine fighter aircraft manufactured by Saab AB. The aircraft is 14.1 metres long and has a wingspan of 8.4 metres. The maximum take-off weight is 14,000 kg.

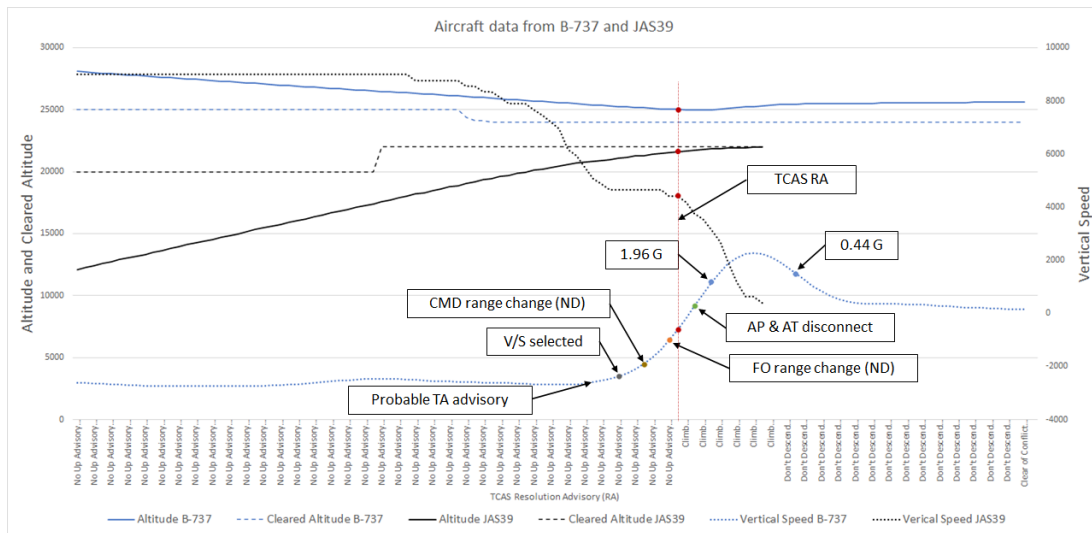
In Figure 11, a compilation of flight data from the passenger aircraft and the fighter aircraft is presented. The X-axis shows the TCAS RA commands. The Don't Descend parameter has been replaced by Level Off in TCAS version 7.1.

Figure 11. Compilation of the aircrafts' flight data, with annotations added by SHK.

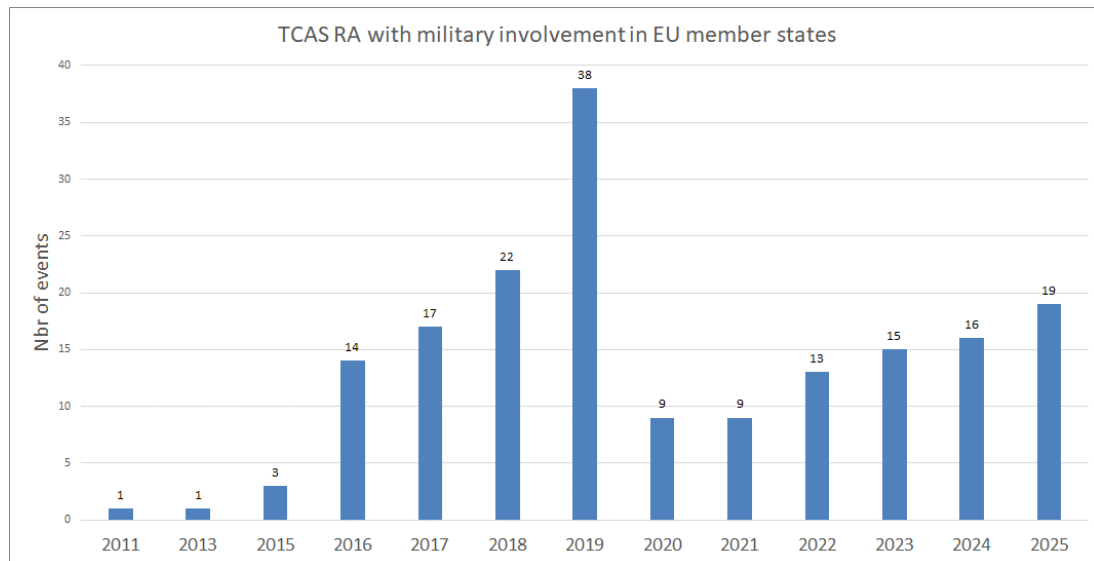
Figure 15. Number of reported TCAS RA events involving military traffic in Europe since the year 2000.

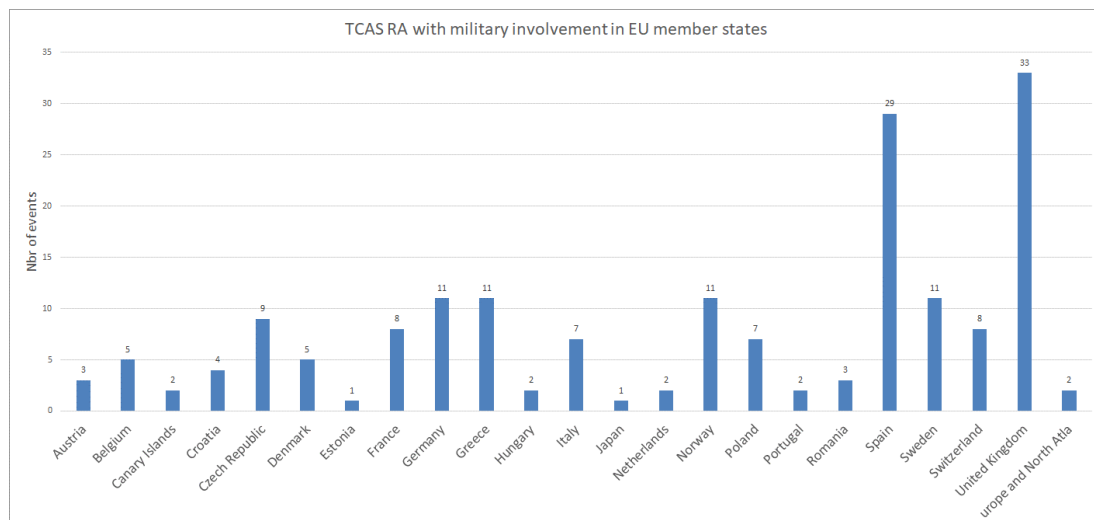
Figure 16. Number of reported TCAS RA events involving military traffic, broken down by country, since the year 2000.

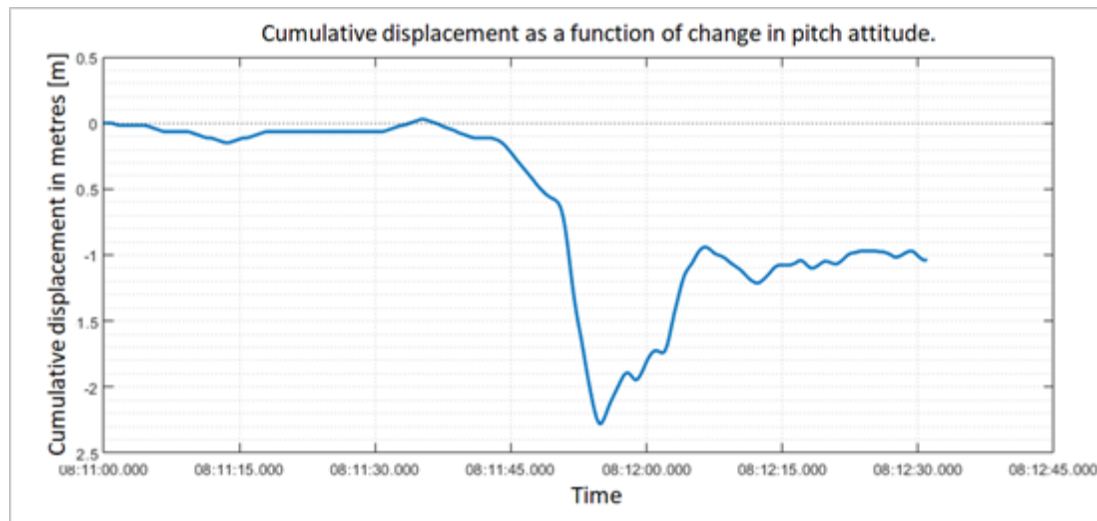
The cabin crew member who was injured was located in the rear part of the aircraft. The rapidly increasing pitch attitude caused the floor to move downwards. Even though the actual forces were not negative, this could create a sensation of weightlessness. The Commander carried out three changes in pitch attitude within a short period of time. The graph below shows the calculated relative displacement of the floor in connection with these changes. During the first change in pitch attitude, the floor moved just over 2 metres. It was probably at this point – when the floor quickly reversed direction upwards – that the cabin crew member was injured, which is also consistent with the crew member's own account, see Figure 17.

Figure 17. The accumulated displacement of the floor in the aft galley of the passenger aircraft as a function of the change in pitch attitude over time.

This movement probably coincided with other circumstances that influenced the course of events. The aircraft may also have moved to some extent laterally, which could further have impaired the crew member's ability to counteract the movement and maintain balance.
