# Final Report

## MV ESTONIA High Resolution Seabed Imaging Survey

REPUBLIC OF ESTONIA  
SAFETY INVESTIGATION BUREAU

25 January 2024

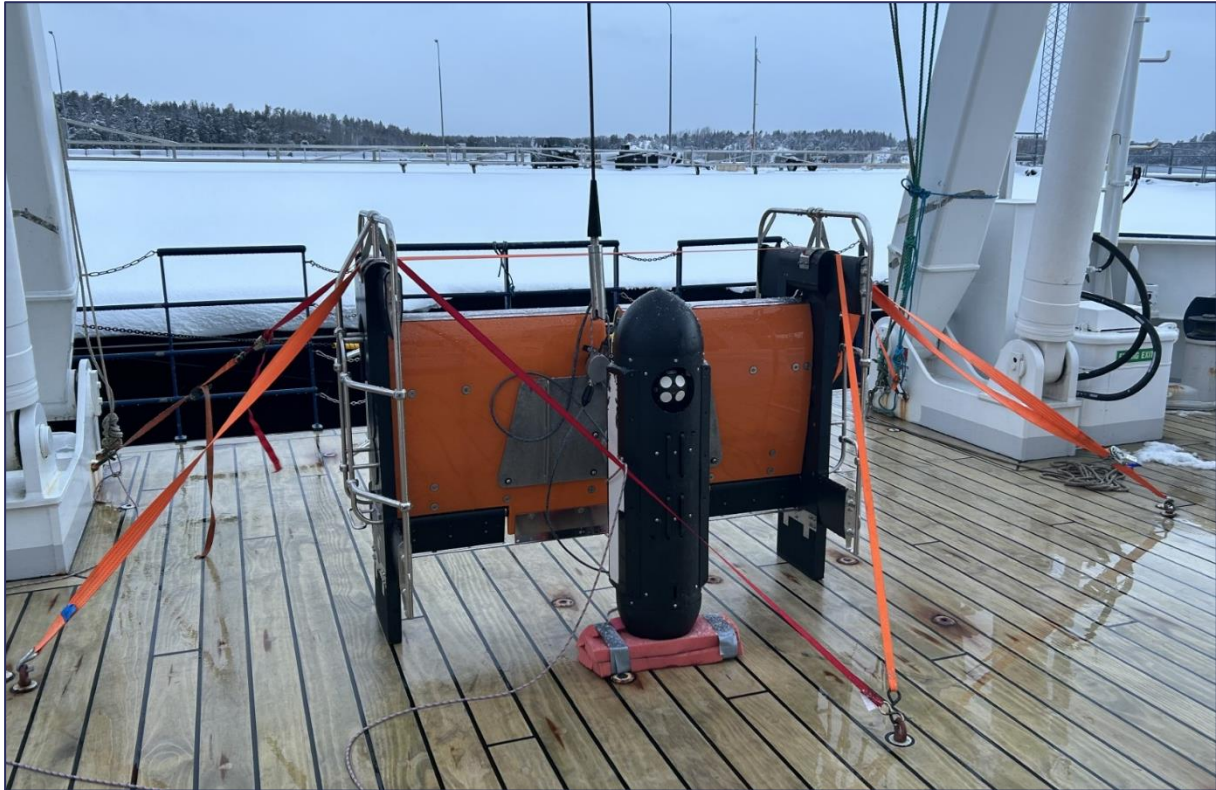
The Equinox system is a towed sidescan sonar solution that utilizes a Solstice MAS in combination with the EIVA scanfish 3D steering (Figure 3-2). The system was used with the purpose to detect and position objects and features within the survey area as well as enable a classification of seafloor conditions. The so was tightly integrated with INS navigation to provide real-time motion compensation and it is fitted with underwater positioning capable to provide positional accuracy better than 0.5% of the slant range. The MAS is a system that provides a high-resolution image by using a back-projection beamforming technique to extend the focus along the whole swath.

Figure 3-2 EIVA Equinox

The Equinox system covered approximately 100 m per side, gaining >200% coverage. The Solstice MAS produces along-track resolution of 0.15° and a constant across track resolution of 37.5 mm. The MAS setup is detailed in Table 3-5.

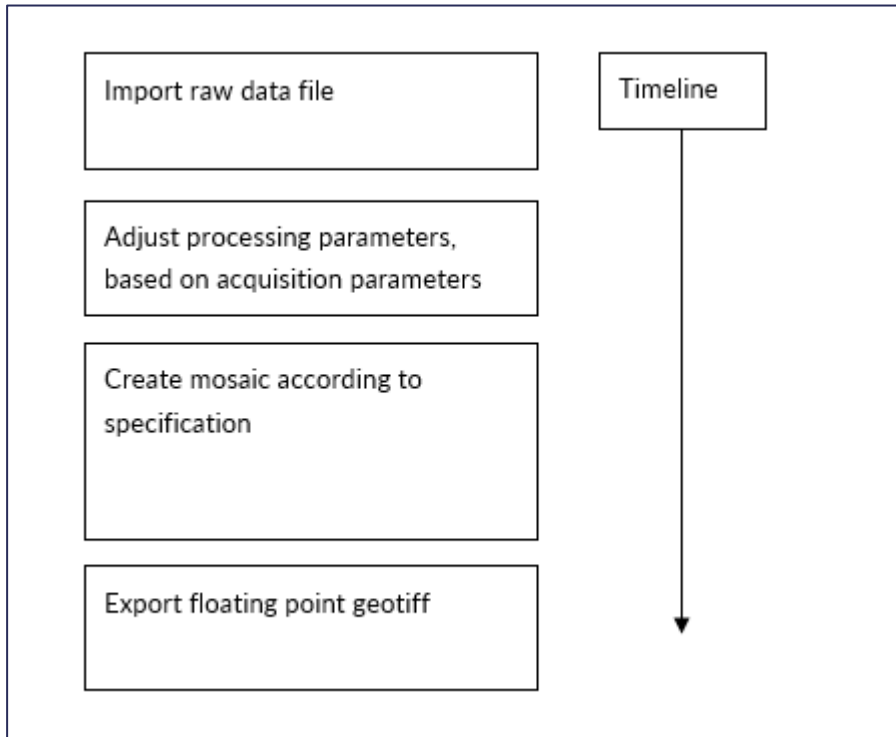
Backscatter data was produced from the collected multibeam data using QPS FMGT. The data was merged into grayscale GeoTiffs, one for each required resolution.

Figure 4-5 Backscatter processing workflow

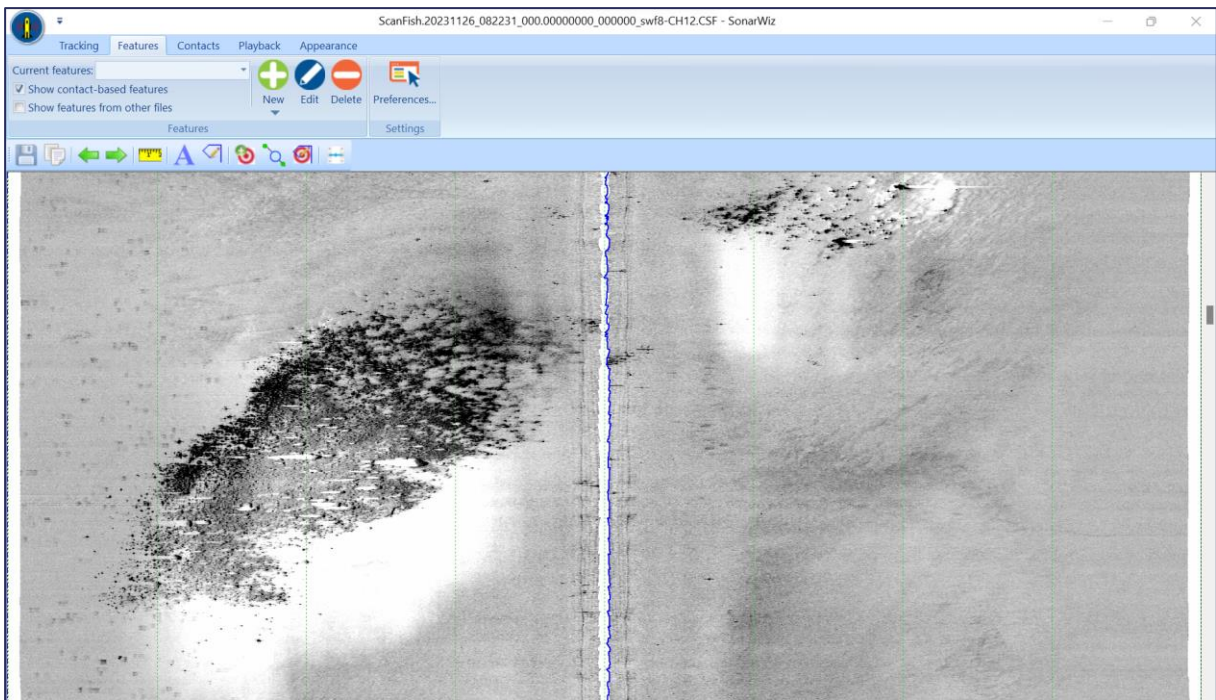
Figure 4-10 SonarWiz example post navigation processing

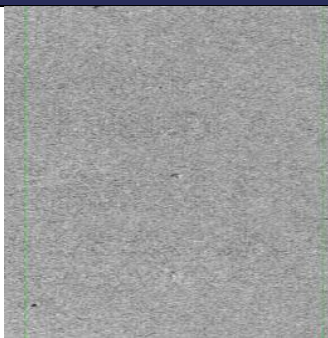
Lithological Interpretation	Acoustic Description	MAS Example Image
CLAY	Glacial/Postglacial CLAY. Low to medium acoustic reflectivity. Smooth and even texture. At locations few occasional boulders (glacial CLAY). 25 m between green lines.

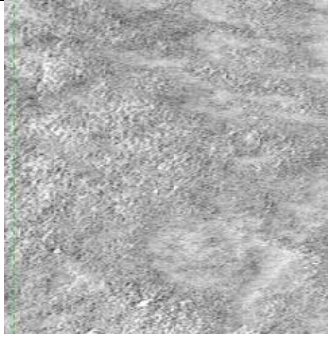
SAND	Medium and even acoustic reflectivity. Grainy texture. This sediment type is present south of the MV ESTONIA wreck after dumping. 25 m between green lines.

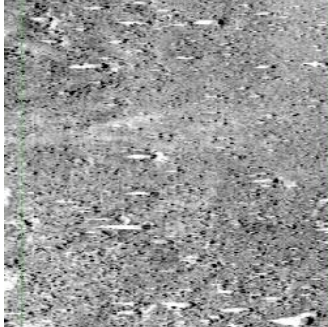
TILL	High acoustic reflectivity. Grainy to coarse texture with frequent acoustic shadows. 25 m between green lines.

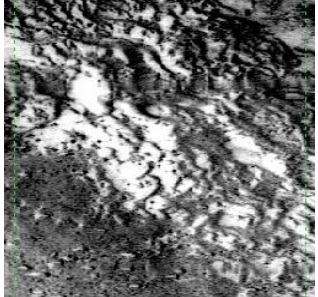
Lithological Interpretation	Acoustic Description	MAS Example Image
BEDROCK	Igneous BEDROCK. High acoustic reflectivity. Hard textures and large acoustic shadows. 25 m between green lines.

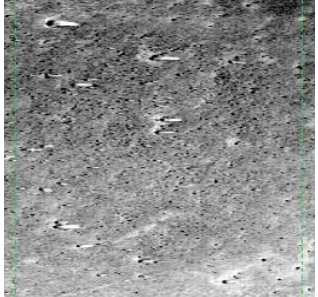
Boulder field	Area with high density of boulders, >30 boulders per 25×25 m and the boulders are >0.2 m. 25 m between green lines.

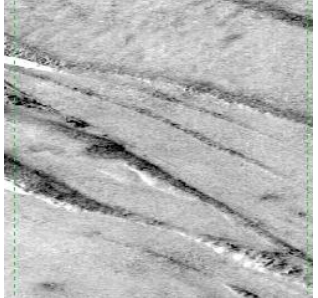
Mass waste scar	Scars from mass waste. Present south-west on the MV ESTONIA wreck. 25 m between green lines.

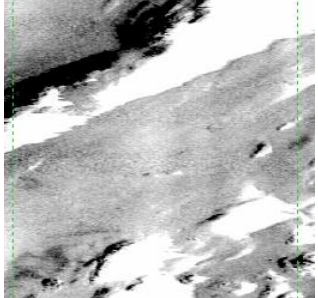
Pressure banks	Pressure bank installed to stabilize the wreck area, Present south of the MV ESTONIA. 25 m between green lines.

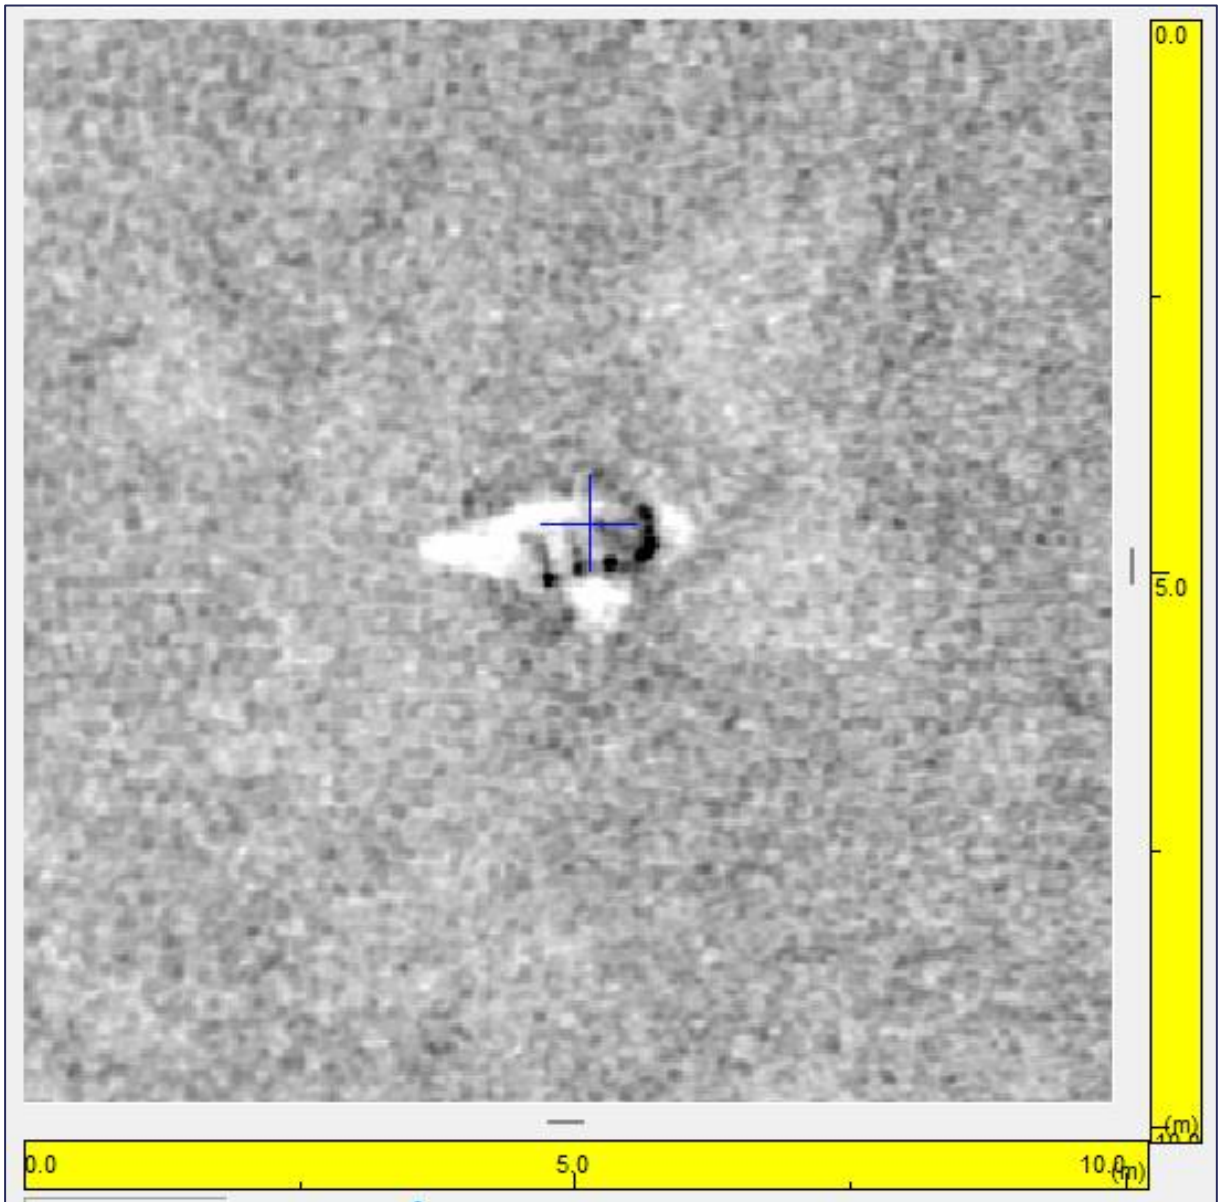
A total number of 19 targets in the class Debris are interpreted as possible life raft/vest or storage boxes, example in Figure 7-6 to Figure 7-8.

Figure 7-8 Target in MAS data, possible life raft box, picture 10x10m

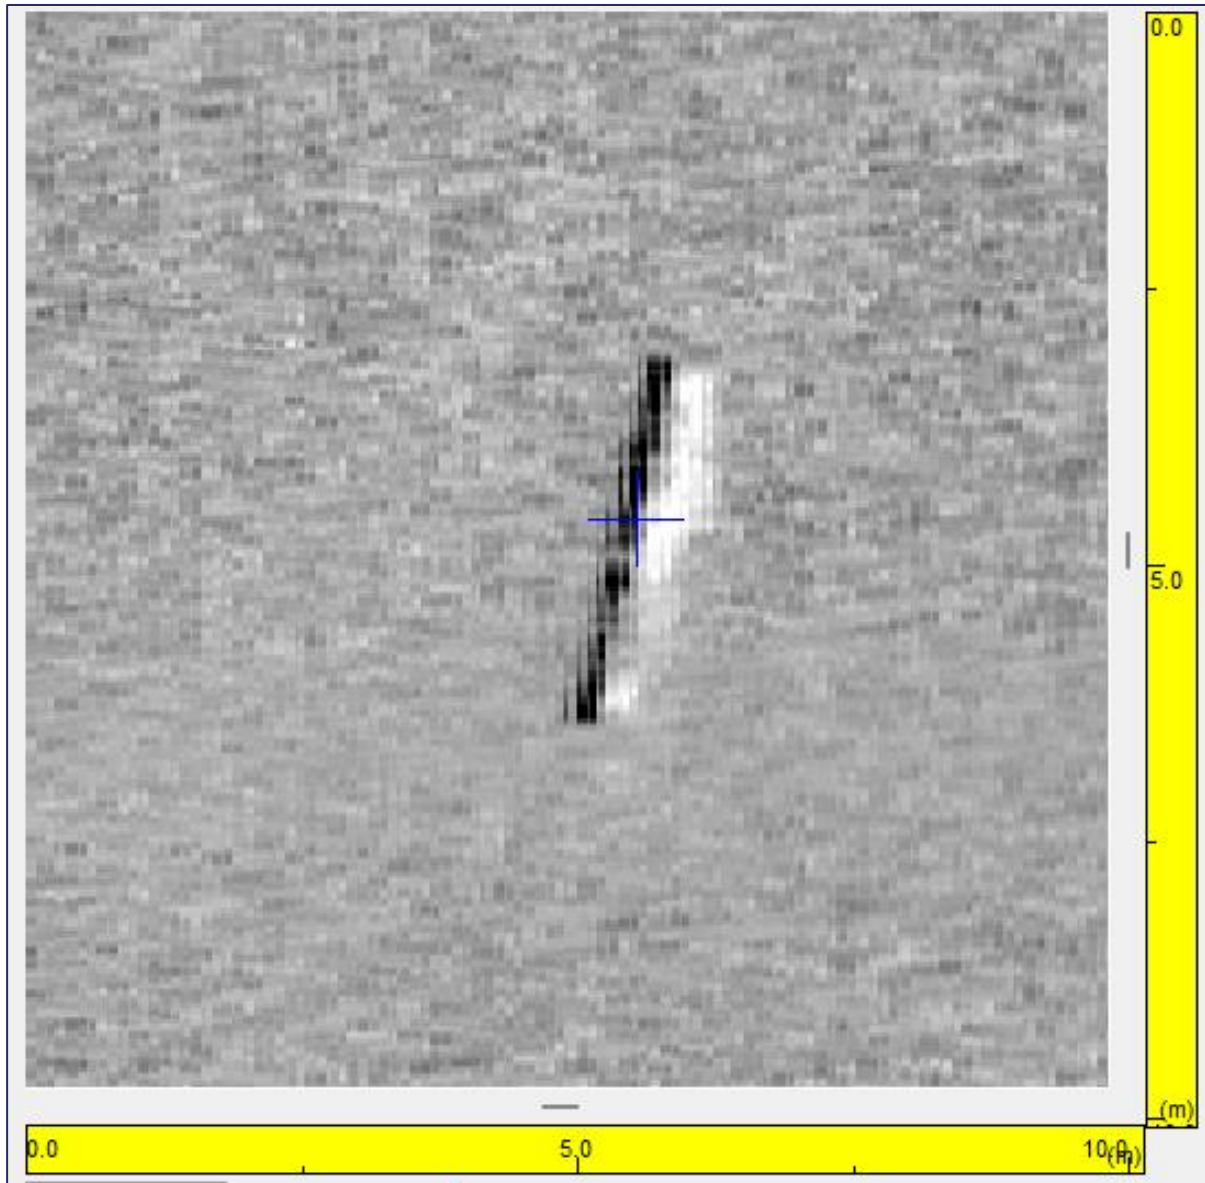
A total of 33 items in the class Debris is very similar to each other and can be of origin from the cargo on MV ESTONIA. These items are elongated straight objects with length between 2.2 to 3.5 m and a width of about 0.3m. Example in Figure 7-9.

Figure 7-9 Target in MAS data interpreted as Debris, possible item from MV ESTONIA cargo, picture 10x10 m
