Final report RS 2017:01e

NORDIC STANI – Man-over-board in the
Sea of Åland 09 April 2016

File no. S-56/16

16 March 2017

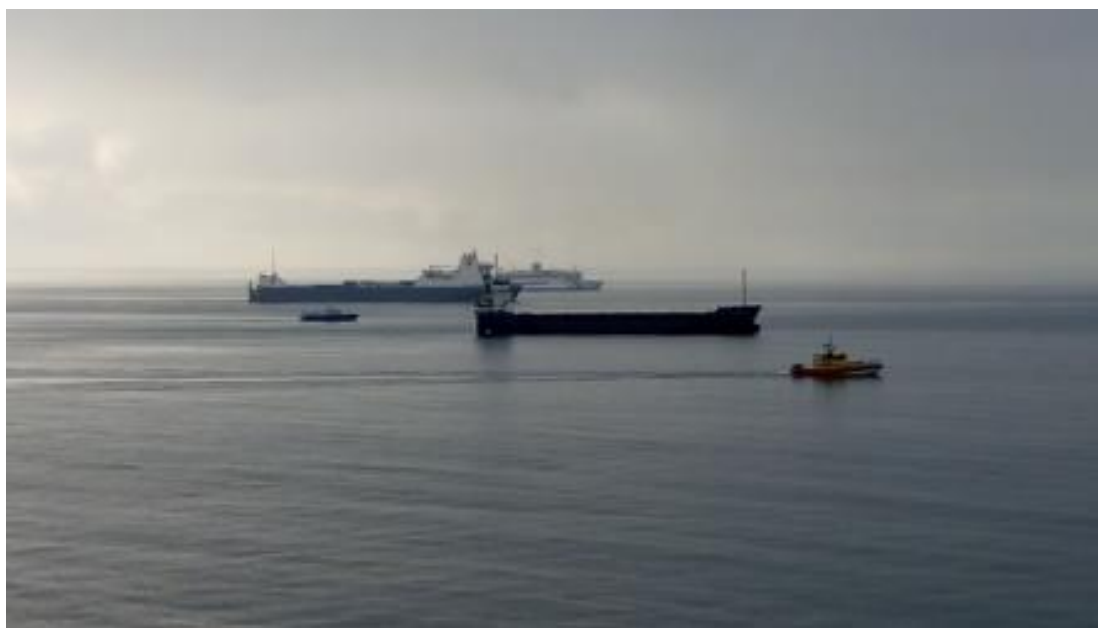
Figure 2. Vessels at the SAR-operation. The picture is taken from NORDIC STANI. Image: Nordic Hamburg Shipmanagement (HK) Ltd.

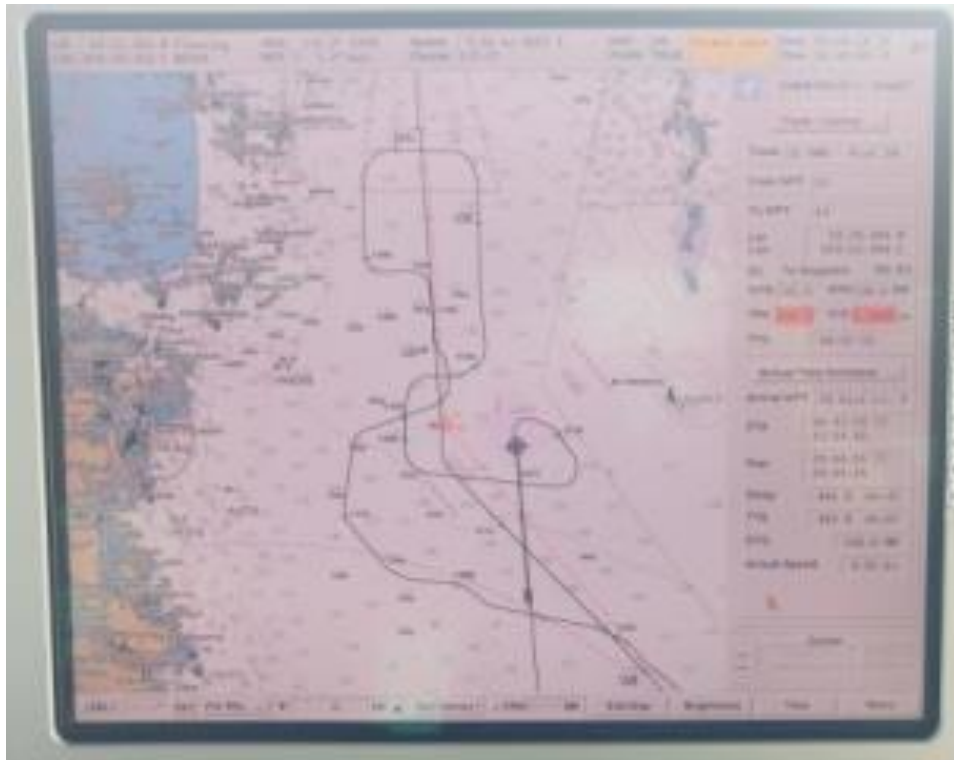
Figure 3. NORDIC STANI's search pattern from the vessel's electronic chart. Image: Nordic Hamburg Shipmanagement (HK) Ltd.

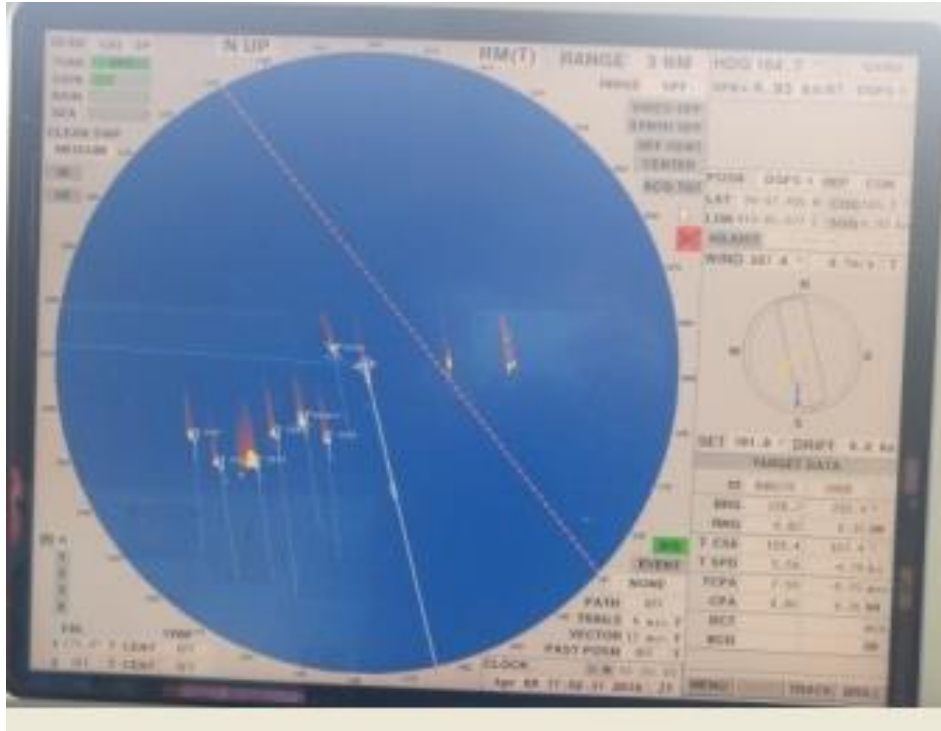
Figure 10. Search patterns on NORDIC STANI's radar screen. NORDIC STANI is in the centre of the circle. Image: Nordic Hamburg Shipmanagement (HK) Ltd.

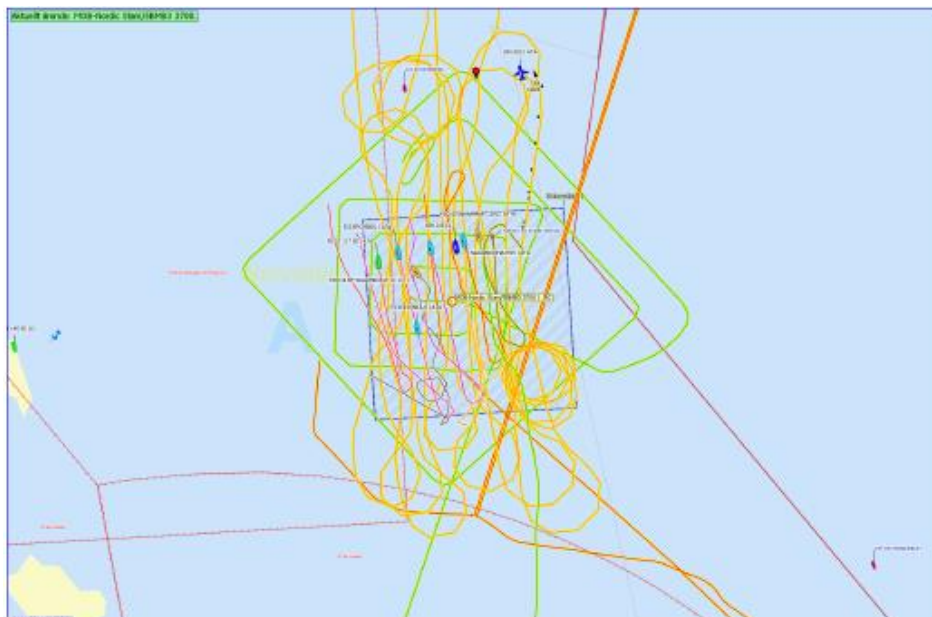
Figure 11. Search patterns consisting of AIS-tracks from different units in the SAR-operation. The operation is including amongst others the position where the vessel changed course. Image: Swedish Maritime Administration nr: 10-01518.
