Final report *SHK 2023:01e*

Fire on the vessel ALMIRANTE STORNI in
December 2021, off Gothenburg

File no. S-302/21

18 January 2023

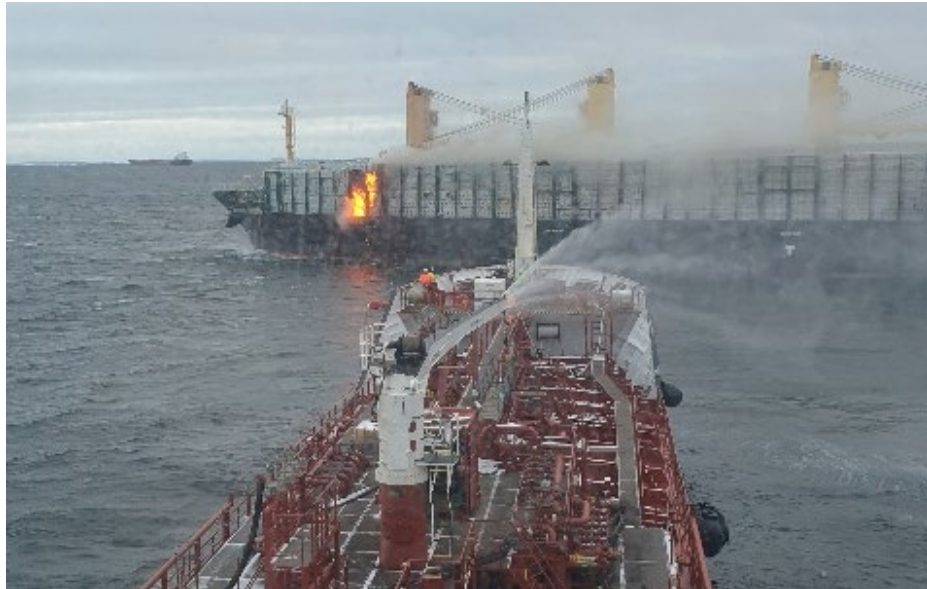
Figure 1. The situation viewed from the bridge on AMAK SWAN shortly after the fire was detected. Image: Private.

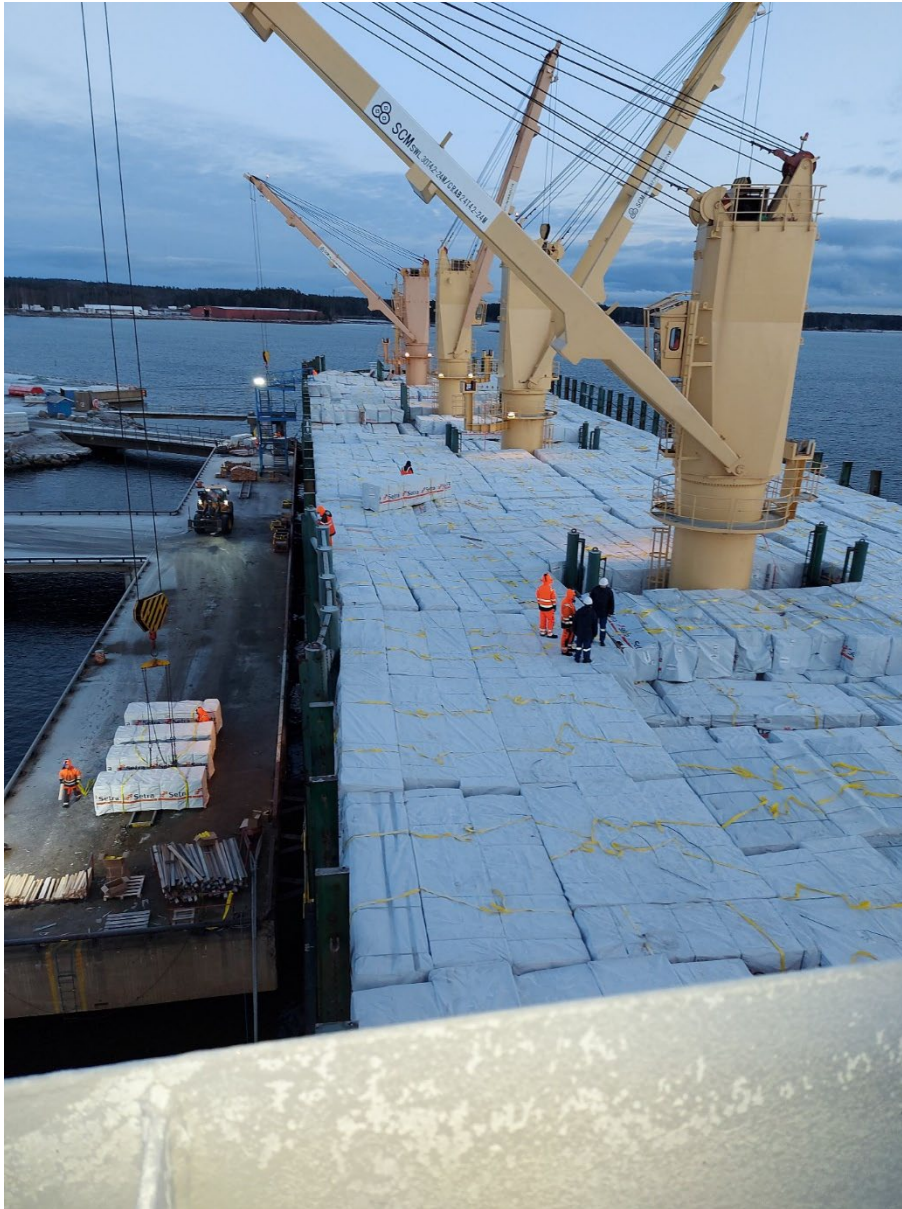
At the same time as ALMIRANTE STORNI was docked, maintenance work was being conducted on the quay, and the electricity needed to be disconnected. To compensate for the lack of floodlights, an extension cable from the vessel was connected to a mobile floodlight on the quay (see section 1.5.2).

Figure 7. Picture of the vessel being loaded in Orrskär. Image: Photograph courtesy of the owner of ALMIRANTE STORNI.

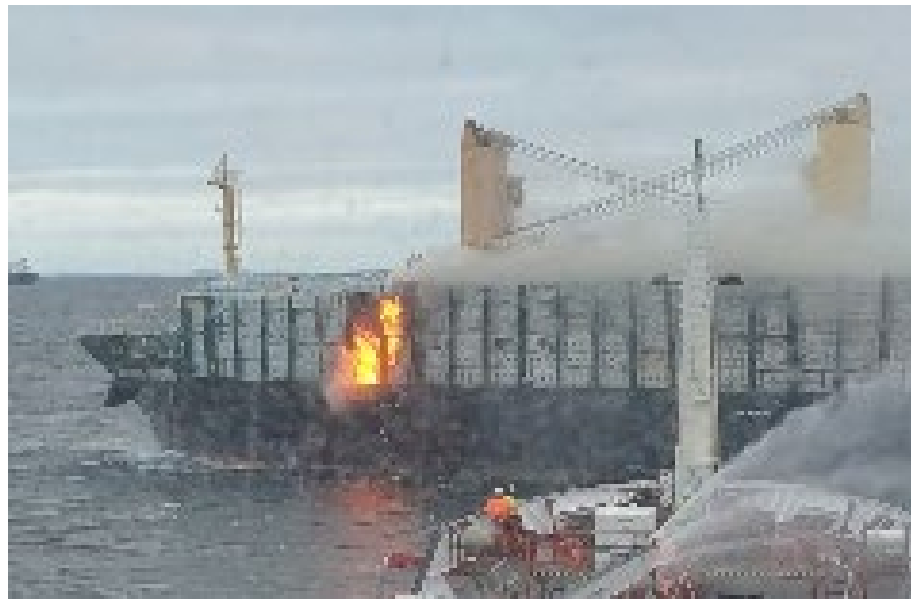
The fire was detected by the crew of AMAK SWAN who initially noticed a smell of smoke and shortly afterwards saw flames emerging from the deck cargo. The flames were emerging from the port side, close to the gunwale, in line with crane 1.

Figure 2. The fire at 14:44 hrs, ten minutes after the crew of AMAK SWAN had informed VTS Göteborg. Image: Private.

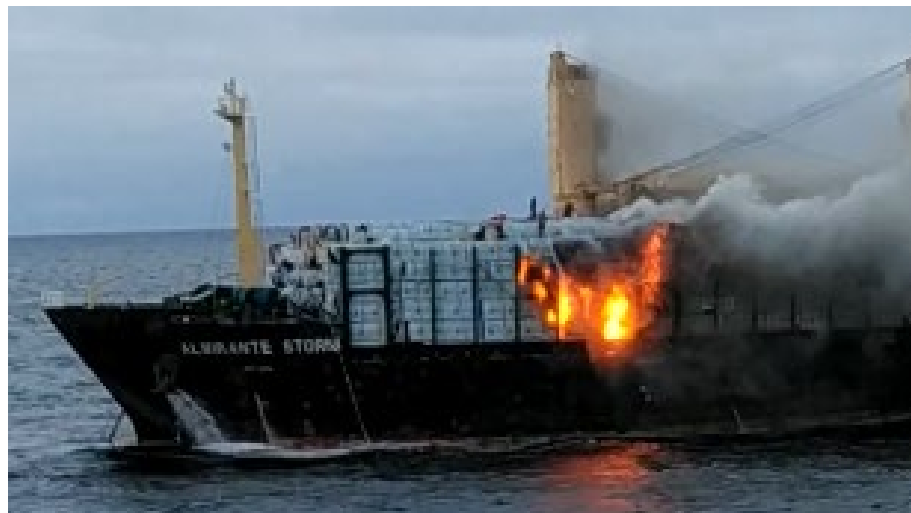
Figure 3. The fire after 30 minutes. Image: Private.

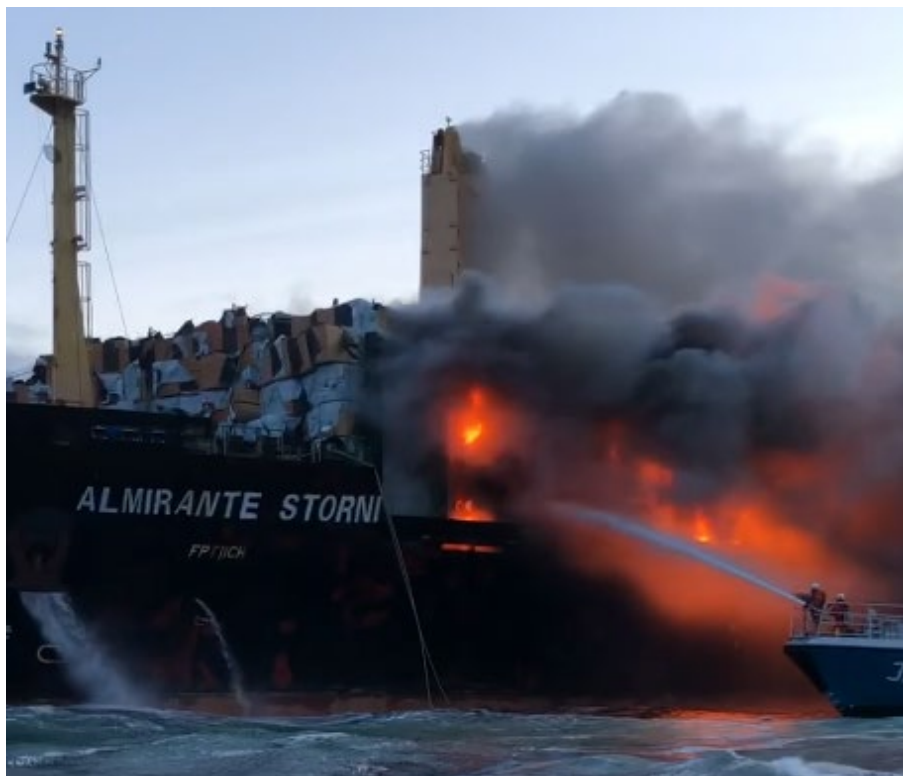
Figure 4. The fire after 90 minutes. Image: Greater Gothenburg Rescue Service.

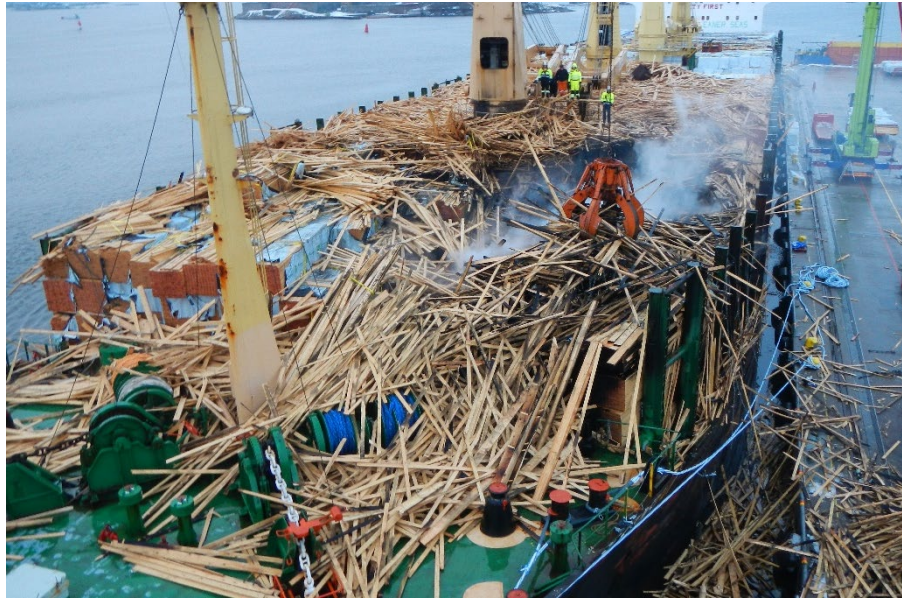
The area forward of the middle of the vessel was monitored and examined during unloading at Skandia Harbour. The packages of timber that were not fire damaged were unloaded using a crane with a hook. The damaged timber was unloaded using a crane with a claw. This unloading method did not allow careful exposure of the fire area. In addition, a large portion of the timber that was lifted up was dropped back down into the fire area while working with the claw. Consequently, it is not possible to rule out that findings linked to the cause of the fire were lost, despite the timber being inspected when it was being placed on the quay.

Figure 54. Unloading of the timber cargo in the fire area surrounding crane 1.

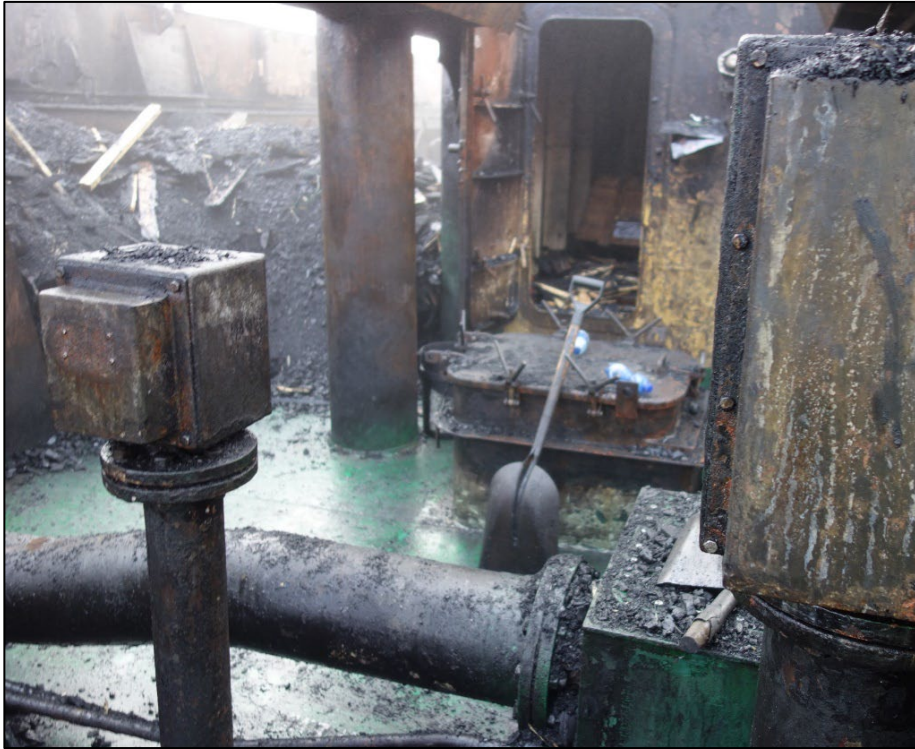
Figure 18. The port side deckhouse by crane 1 and the deck surface under the support structure for the cargo after the area had been cleared of carbon residue. The open door to the deckhouse is in the background.

In the carbon residue, it was possible to follow the extension cable from the deckhouse out to the outermost part of the support structure on the port side. The cable lay in coils on the deck but also ran over a number of bundled chains that had been placed on the deck. The insulation was intact on those parts of the cable that had been lying on the deck closest to the deckhouse. The insulation was burnt off on those parts of the cable that had been lying on the piles of chain and on a pipe by the outer part of the support structure on the port side. The extension cable was cut off close to the deck by the outer side of the support structure on the port side. The end showed signs of carbonisation and melting. No

additional electric cable or objects that the extension cable could have been connected to were found.

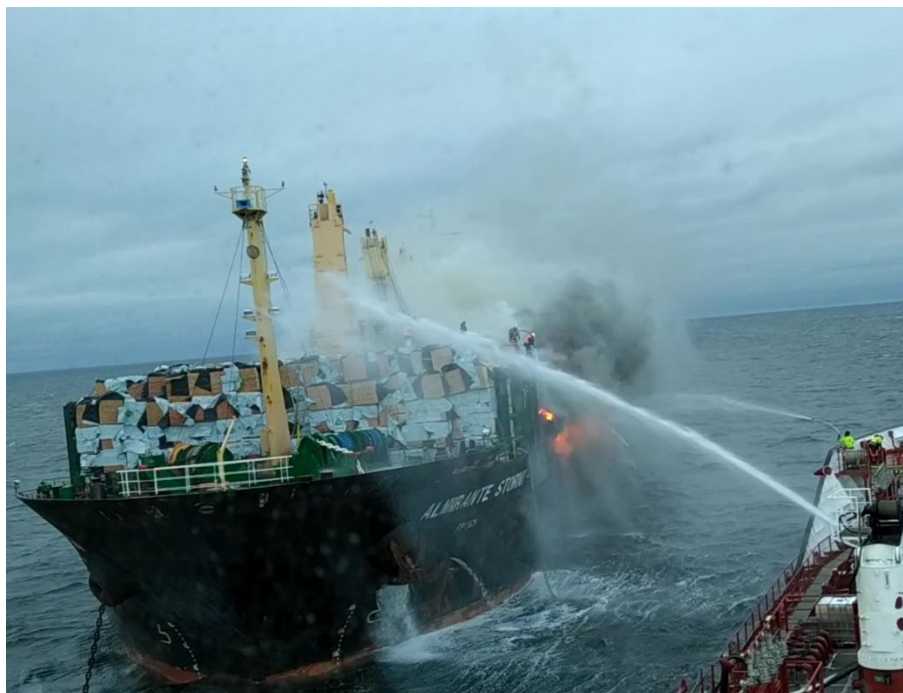
Figure 27. Picture from AMAK SWAN shortly after the fire broke out. The crews of both vessels have begun trying to extinguish the fire. Image: Private.

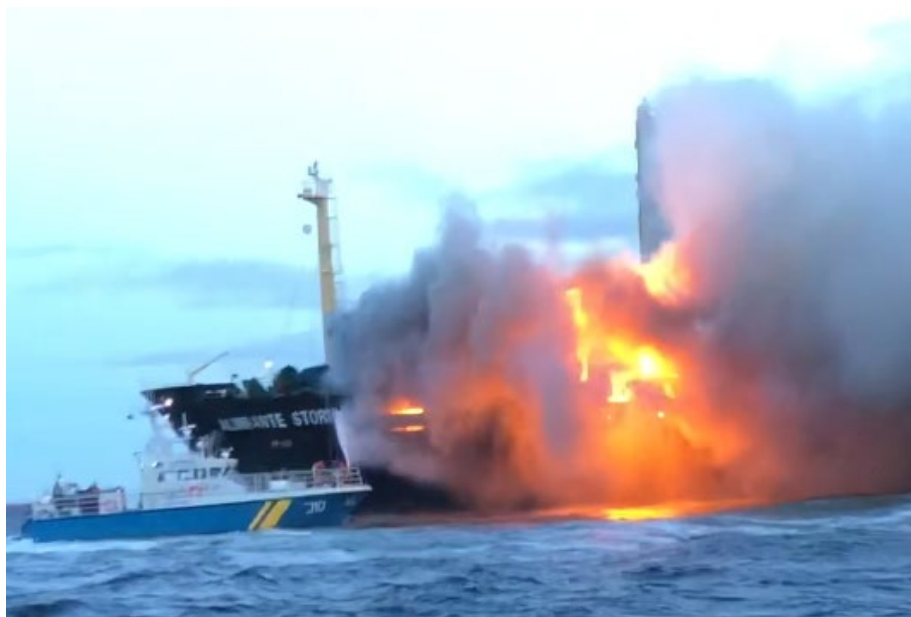
The tanker FOX SUNRISE arrived at the site and relieved AMAK SWAN. They also came alongside the burning vessel and sprayed the fire with water. In turn, the Coast Guard vessel KBV 310 relieved FOX SUNRISE and continued the firefighting operation. The other vessels that were in the area did not have any firefighting equipment that was adapted to reach up to the fire with its water jets. However, they were on standby to conduct life-saving and were also able to convey information about the situation to the JRCC. Spraying water from KBV 310 had no effect in terms of extinguishing the fire, which instead grew in size.

Figure 28. The first Coast Guard vessel arrived just over an hour after the fire was detected. Image: Greater Gothenburg Rescue Service.
