Final report RS 2016:04e

OSLO WAVE – collapsed loading crane in Bollstabruk, Sweden, 9 of June 2015

File no. S-86/15

03/06/2016

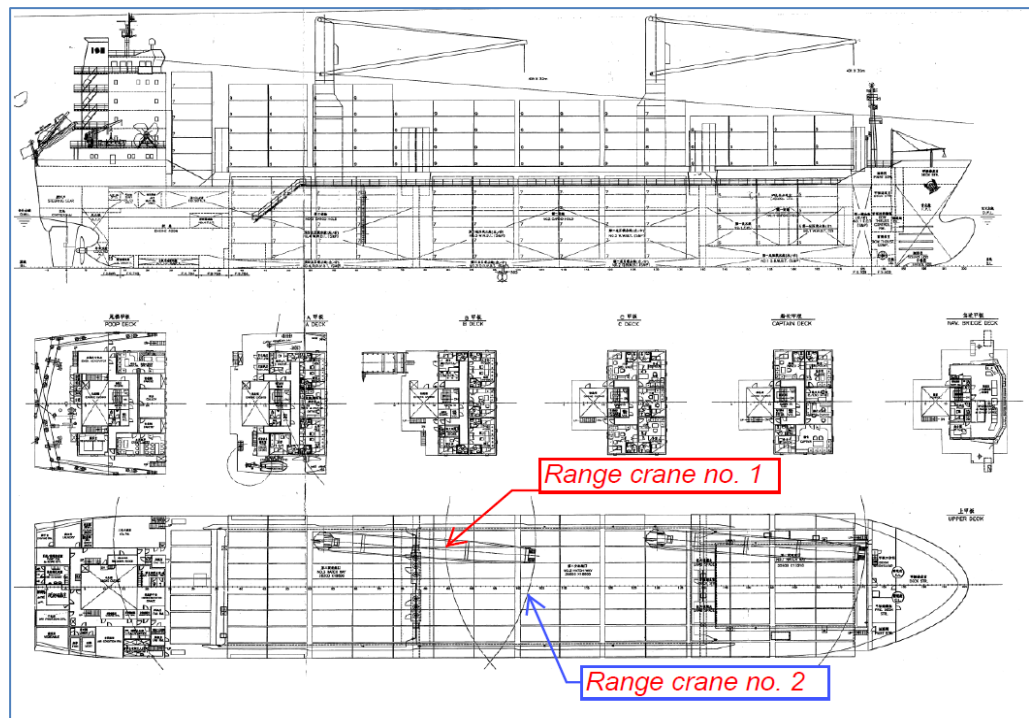
Figure 7. Reach of the cranes. Image: Marshall Islands

The maximum reach for each crane are shown in figure 7. The forward crane has range throughout the forward cargo hold, but has not full range throughout the second cargo hold. The aft crane has full range throughout the third cargo hold and some range in the aft part of the second cargo hold. This causes that the aft part of the second cargo hold must be loaded with the aft crane, or a crane from shoreside. When the cargo hatch covers are open, they are folded in a vertical position and limit to some extent the visibility from the crane's control cabin down into the cargo hold. The largest limitation of visibility is from the aft crane if used in the second cargo hold (see figure 8).

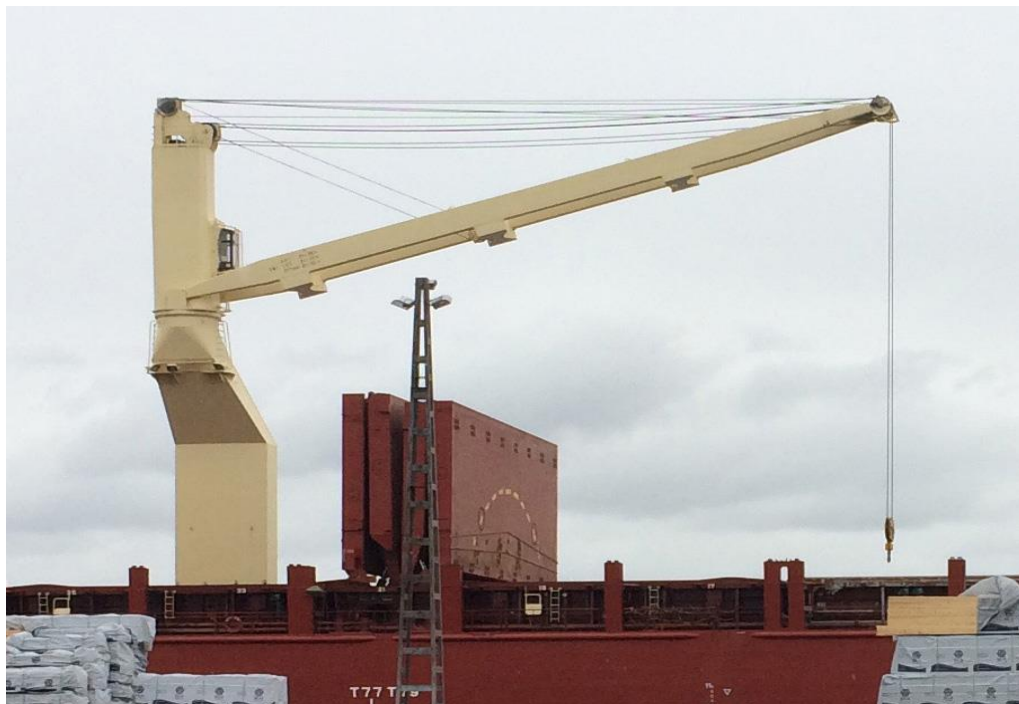
Figure 8. Ship crane no. 2 in the 32 m position. Lowest position for cargo handling. Cargo hatch covers in vertical position – means limited visibility into the second cargo hold. Image: MacGregor.

however, the aft crane cannot be used in this area as the visibility down in this part of the cargo hold is restricted by the open cargo hatches (see figure 9). It can be noted in this context that it is dubious as to whether it would be at all possible to load in the farthest corner, as seen from the forward crane, if the limit switch was functioning normally. This is something which does not appear to have been taken into closer consideration when planning the loading operation.

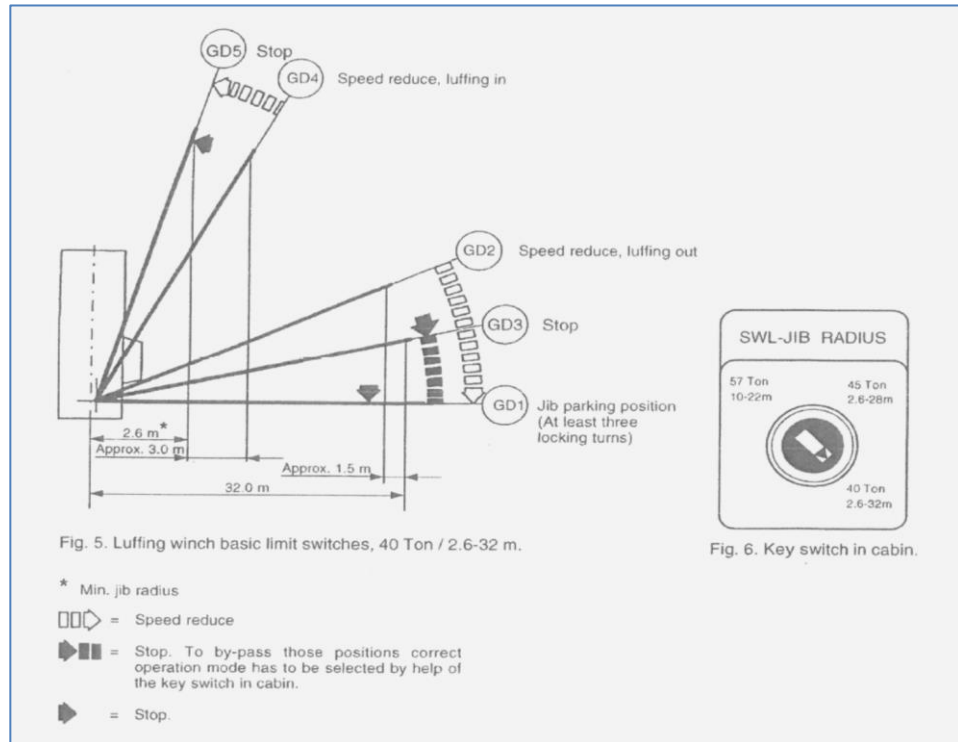
Figure 9. The crane's lower limit switch for 32 m extension position and keyswitch for various lengths/load on the crane arm. Image: MacGregor Service Manual.

The three different positions provide a maximum reach of 22 m, 28 m or 32 m with the crane arm, and a lifting capacity of 57, 45 and 40 tons respectively. Figure 9 shows ship's crane no. 2 set in the 32 m position, which is the lowest position and angle at which the crane arm can be operated during cargo handling.

When lowering the crane arm, lower limit switch GD2 is activated, which reduces the crane arm's downward movement speed. If the arm is lowered further, switch GD3 will be activated, stopping the crane arm in its lowest permissible position for cargo handling. In this position, the crane arm can have an extension limit of 32 metres and a lifting capacity of 40 tones SWL, if the keyswitch is set to this mode. If the setting is at 22 m or 28 m, other limit switches will be activated earlier in order to stop the crane arm at the correct angle.

What has emerged during interviews is that both crane operators have assumed that the crane arm's lowest operating level for load handling was the horizontal level. This is not in line with the crane arm's lowest operating position as the crane arm stops correctly at its lower limit position (see figure 9).

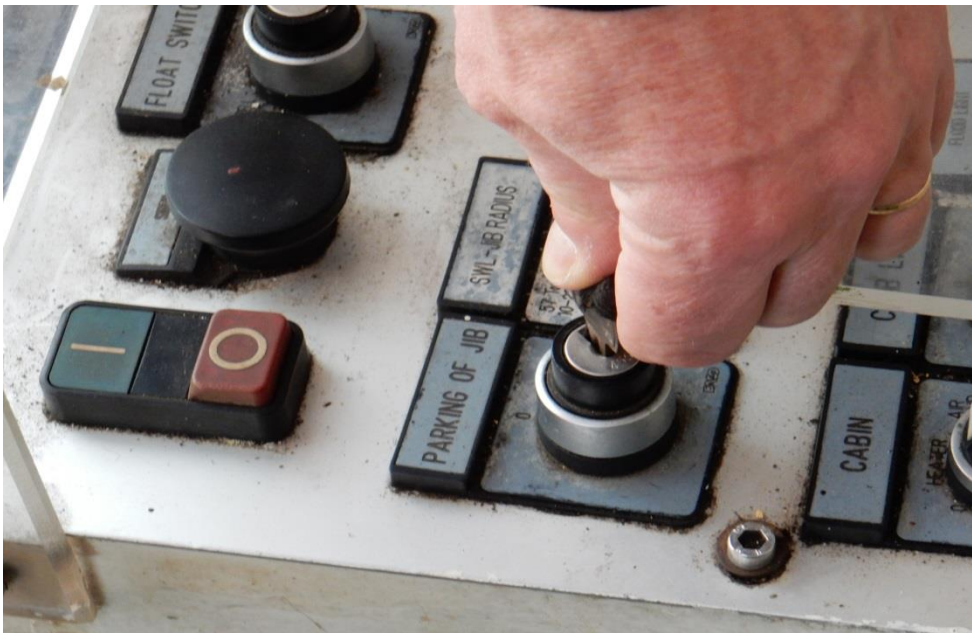
The crane was started up and the crew released the crane arm from its lashing. The crane operator activated a spring loaded key switch (see figure 10) to enable manoeuvring of the crane arm from its parked position to operational position. The crane arm was manoeuvred upwards and the function of the limit switch for the upper limit position was tested. However, testing of the lower limit switch via maximal lowering of the crane arm was not performed. Shortly thereafter, the cargo handling commenced by lifting the sling equipment ashore, from the ship to the barge, where the timber packages were linked.

When parking the crane arm in its support base on the ship's deck, the crane operator activates a "parking" switch (see figure 10) which allows the crane arm to be lowered past the GD3 all the way down to the parking position at "horizontal" level. When it is within this angle, the crane arm must not be loaded.

Figure 10. Keyswitch for activation of parking position.
