Final report RS 2016:01e

BONDEN/ ASIAN BREEZE - collision in
the fairway off Malmö 16 March 2015

File no. S-37/15

22/03/2016

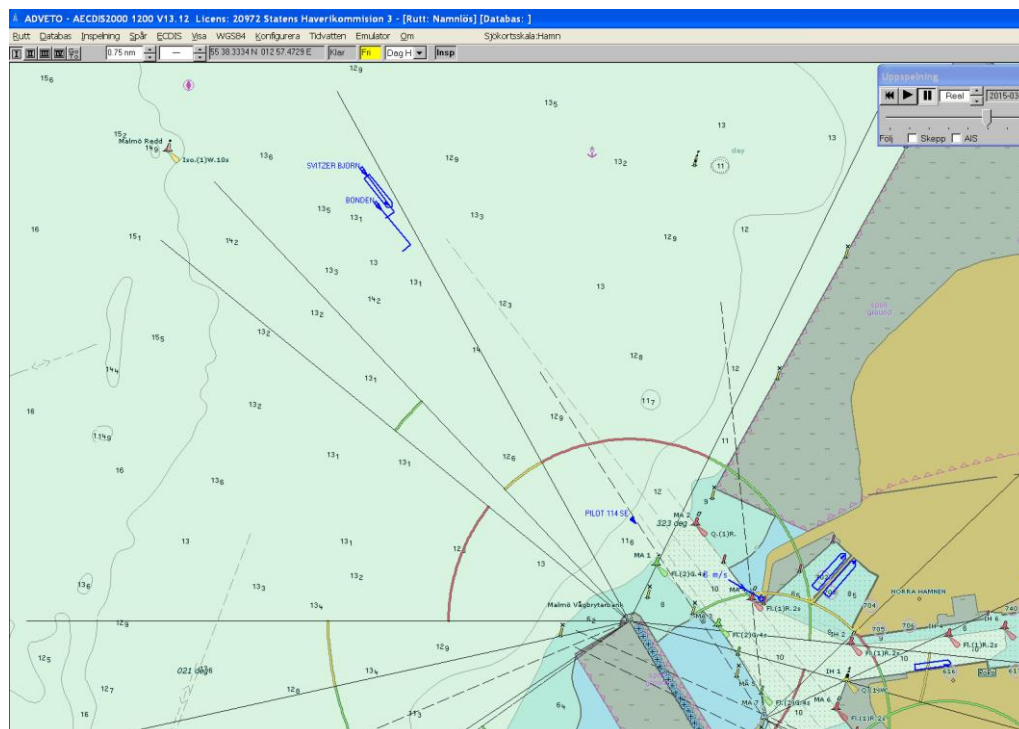
Figure 5. BONDEN on its way to couple up. Image: AIS

At 15.00, SVITZER BJÖRN was coupled astern via the central fairlead; see fig.5. At this point, the car carrier had a speed of 5 knots.

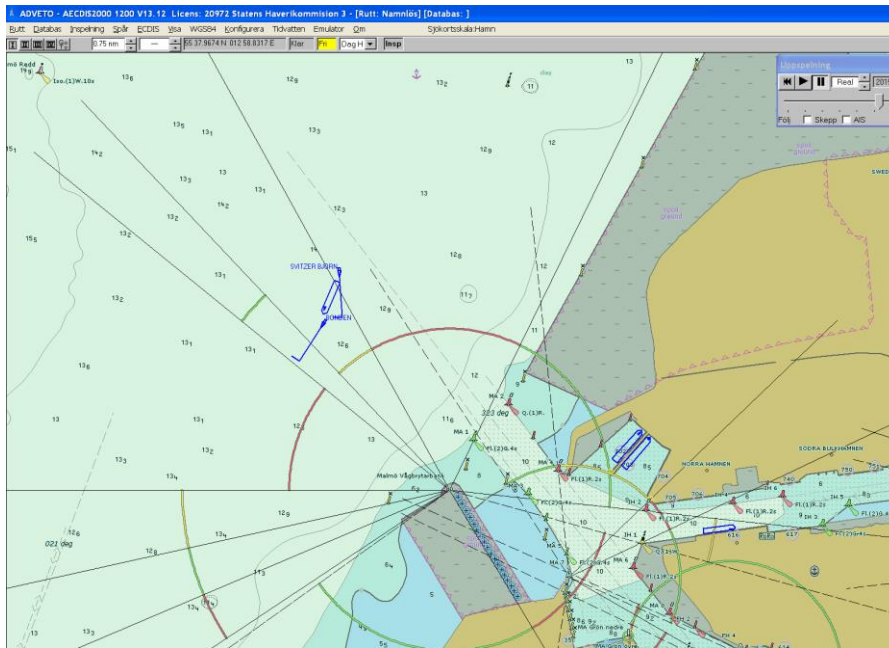
Figure 6. ASIAN BREEZE turned to starboard. Image: AIS

When ASIAN BREEZE was approx. 0.5 M⁴ from the first pair of buoys – MA1 and MA2 – the pilot decided to abort the harbour entry. The pilot announced that ASIAN BREEZE would turn to starboard; see fig. 6. Nevertheless, the tugboat's line was successfully secured shortly thereafter. The connection was thus completed during the turn.

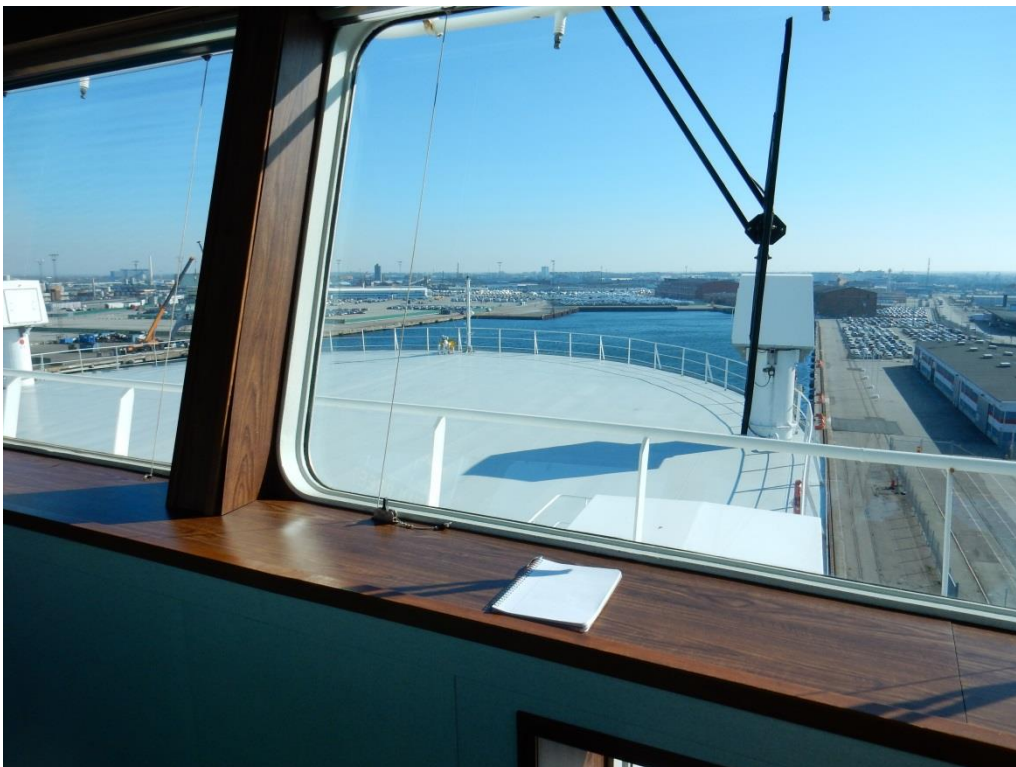
Figure 14. ASIAN BREEZE, view from the bridge.

ASIAN BREEZE is a PCTC⁸ with a capacity of 3,242 passenger cars. The vessel was equipped with a 770 KW bow thruster which was not functioning at the time. The vessel and the construction of the bridge mean that the bridge crew has limited opportunities to see objects close to the ship's bow. ASIAN BREEZE operates primarily within northern Europe and had called at Malmö a number of times.

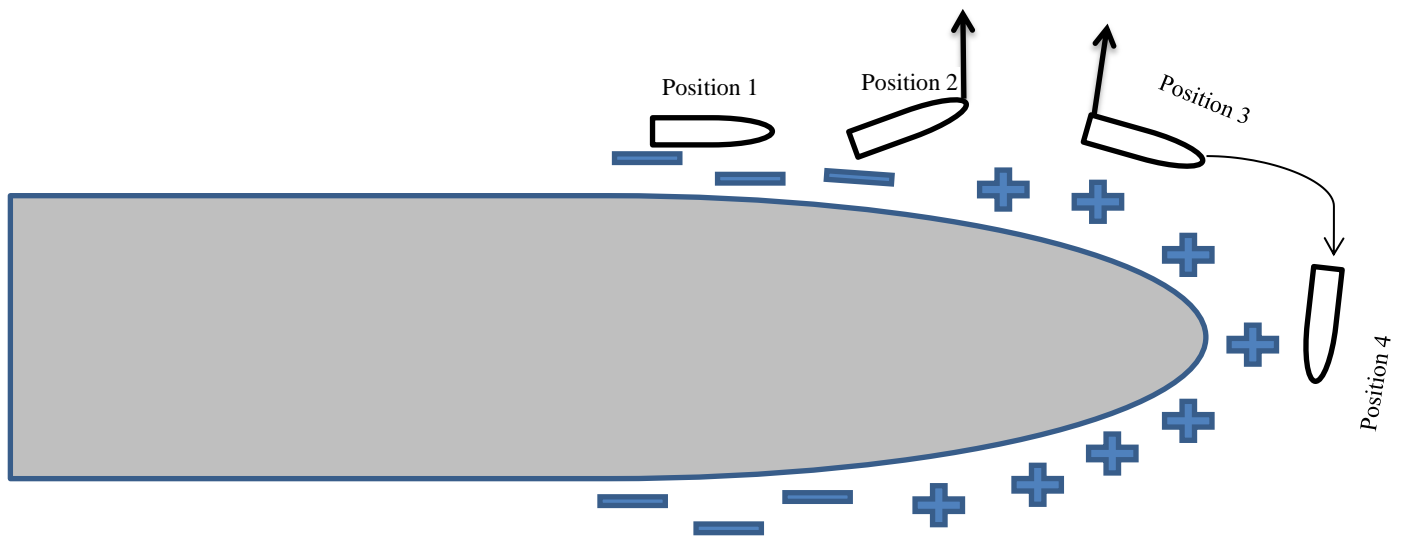
Figure 15. Interaction along the ship's exterior.

Position 1: The same conditions prevail all the way along the side of the ship. If the tugboat comes too close to the ship, it can be dragged in towards its side.

Position 4: This position, i.e. ahead of the bow, is naturally hazardous due to the risk of collision and should be avoided.

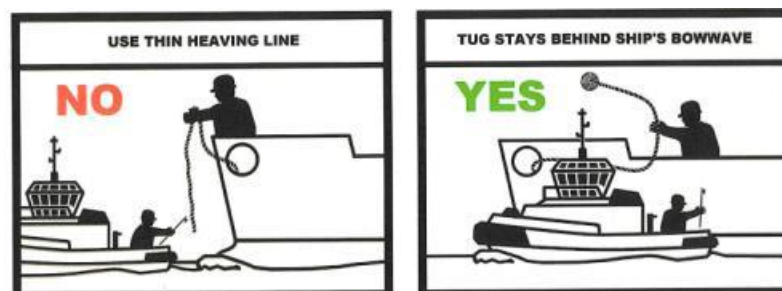
Figure 16.

According to the Guidelines for Safe Harbour Towing Operations, a heaving line with an appropriate weight should always be used and

thrown down to the tugboat as far astern as possible from the bow; see figure 16. According to the guidelines, it should also be checked beforehand – preferably via VHF – whether the tugboat has a messenger line on its towline. The weight attached to the heaving line should be made of leather, woven fabric or plastic and filled with a maximum 0.2 kilos (approx.) of sand so that it does not entail a risk of injury to the tugboat crew. The ship's speed should only be 2-6 knots through the water and a steady course should be pursued.
