AAR-21-05

# Runway Overrun During Landing

## Peninsula Aviation Services Inc. d.b.a. PenAir flight 3296

### Saab 2000, N686PA

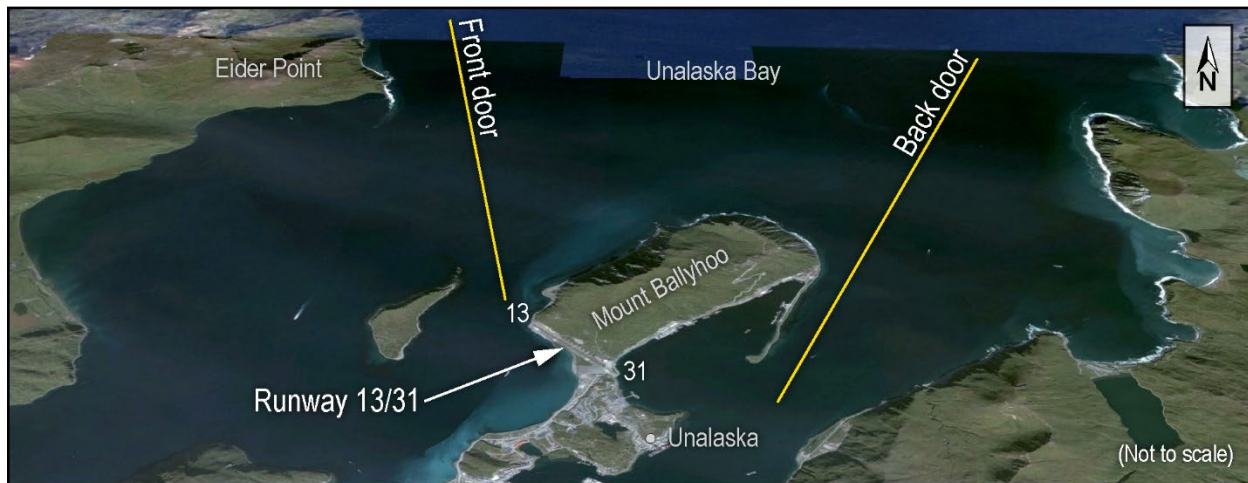
**Figure 1.** Front door and back door paths to DUT.

Note: The missed approach point for the RNAV approach to runway 13, which the accident airplane flew, was about 1.5 miles north-northeast of Eider Point, which is about 5 miles northwest of DUT.

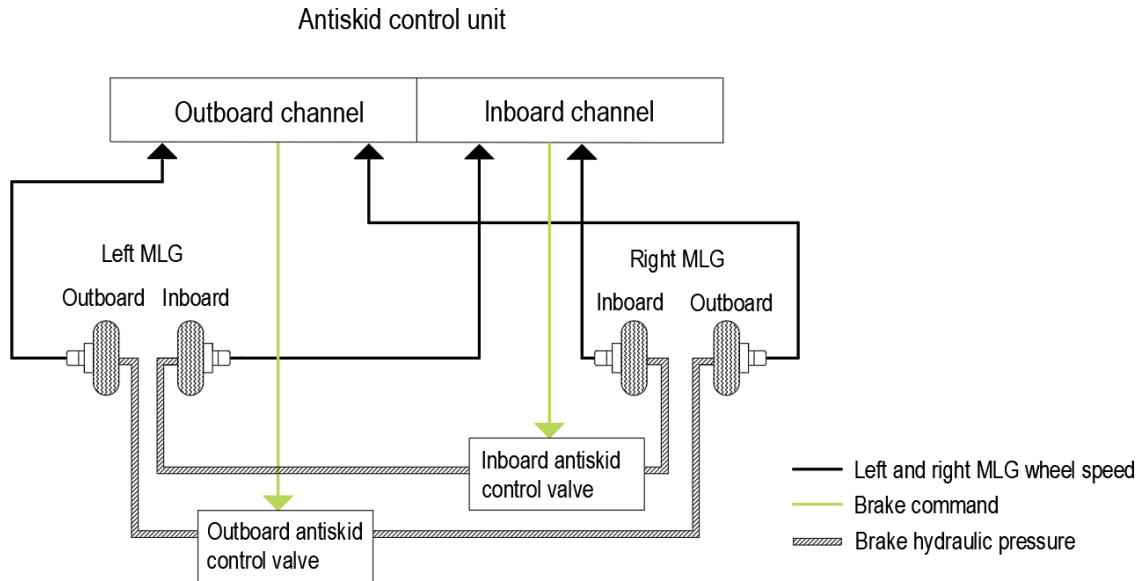
**Figure 8.** Wheel speed transducer wiring as designed.

Figure 8 shows the correct wiring for the left MLG wheel speed transducer. The crossed wiring of the left MLG wheel speed transducers, as described in the previous section, is shown in figure 9; the crossed wiring is shown in red.

Postaccident examination of the wire harnesses for the wheel speed transducers showed that the left MLG outboard and inboard harnesses were incorrectly routed (see figure 9) at the top of the MLG shock strut. This incorrect routing caused the left outboard wheel speed transducer to be connected to the inboard channel of the antiskid control unit and the left inboard wheel speed transducer to be connected to the unit's outboard channel. As a result, the antiskid system was incapable of relieving a skid that was sensed by either of the left MLG wheels. This cross-wiring condition was not discovered until after the accident in part because the airplane was not in revenue service between the left MLG overhaul in January 2017 and PenAir's first revenue flight in June 2019.

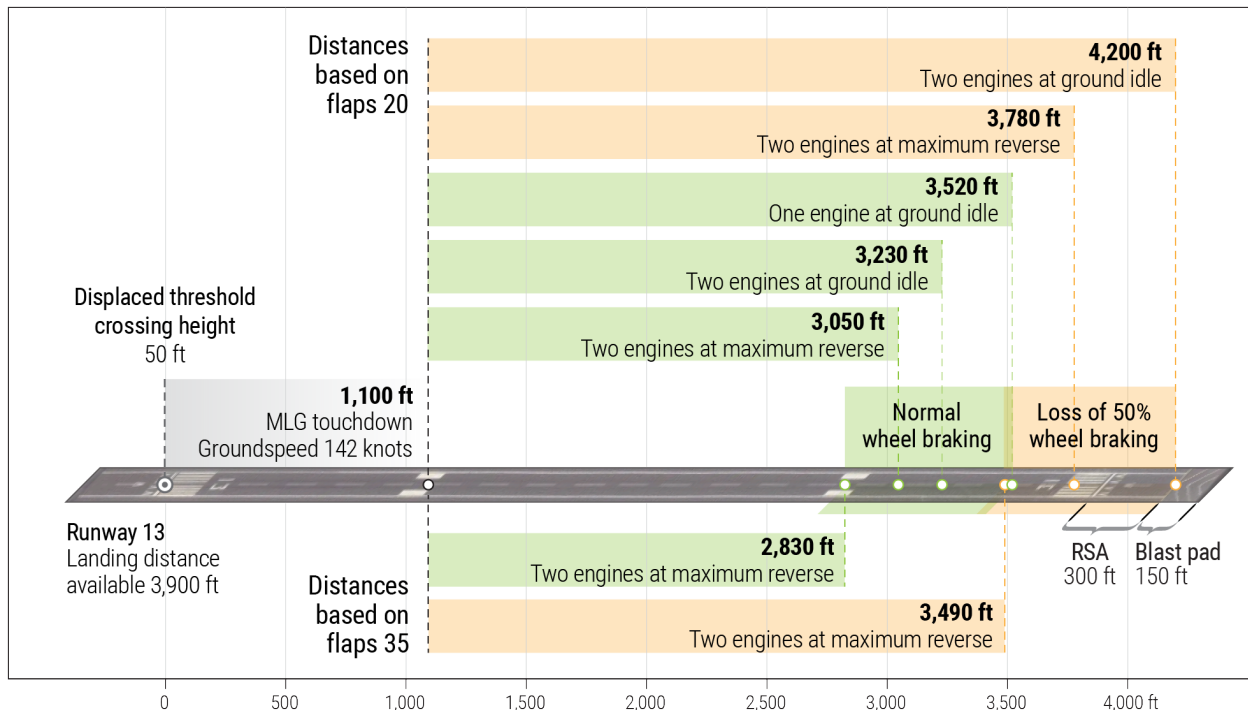
**Figure 13.** Aircraft performance study calculations for various landing configurations.

For the flaps 20 configuration, the calculations indicated that the accident airplane should have had adequate performance capability to stop within the landing distance available on runway 13 for all cases in which both antiskid circuits were operating and for the case in which one antiskid circuit was inoperative (no braking for two of the four wheels) and both engines were operating at maximum reverse power. Also, the airplane should have been able to stop on the paved surface near the RSA/blast pad transition point with one antiskid circuit inoperative and both engines operating at ground idle power. The landing distance required for the accident airplane to stop (based on the average deceleration it demonstrated from MLG touchdown to RSA departure) with a flap setting of 20° was 4,490 ft, which exceeded the landing distance available.
