Final report RL 2021:08e

Incident at Gällivare airport on 10 September 2020 involving ES-ACD of the model RJ Series 900, operated by Regional Jet OÜ.

File no. L-78/20

9 September 2021

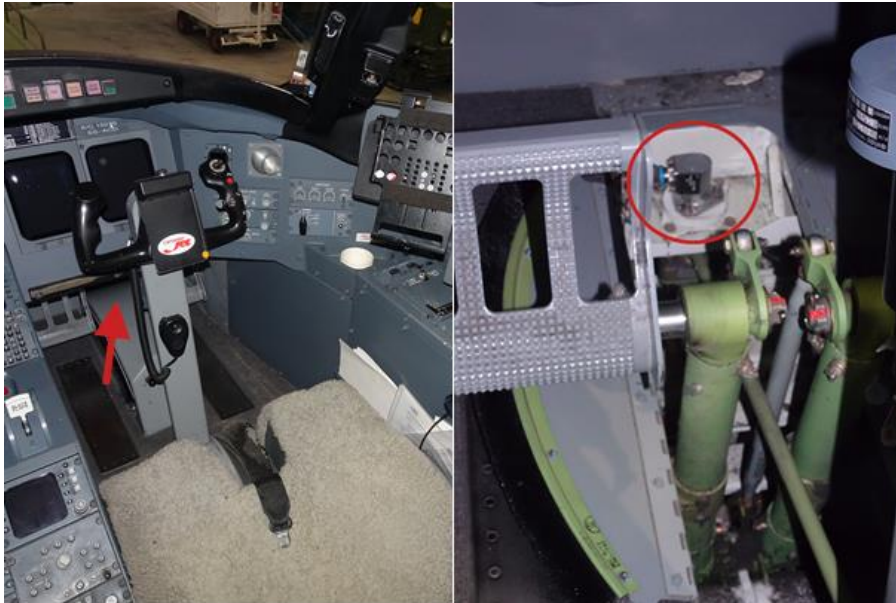
Figure 3. The picture on the left shows where the sensor is installed in the aircraft, in front of the rudder pedals on the right-hand side, see arrow. The picture on the right shows the sensor installed in the aircraft with panels removed.

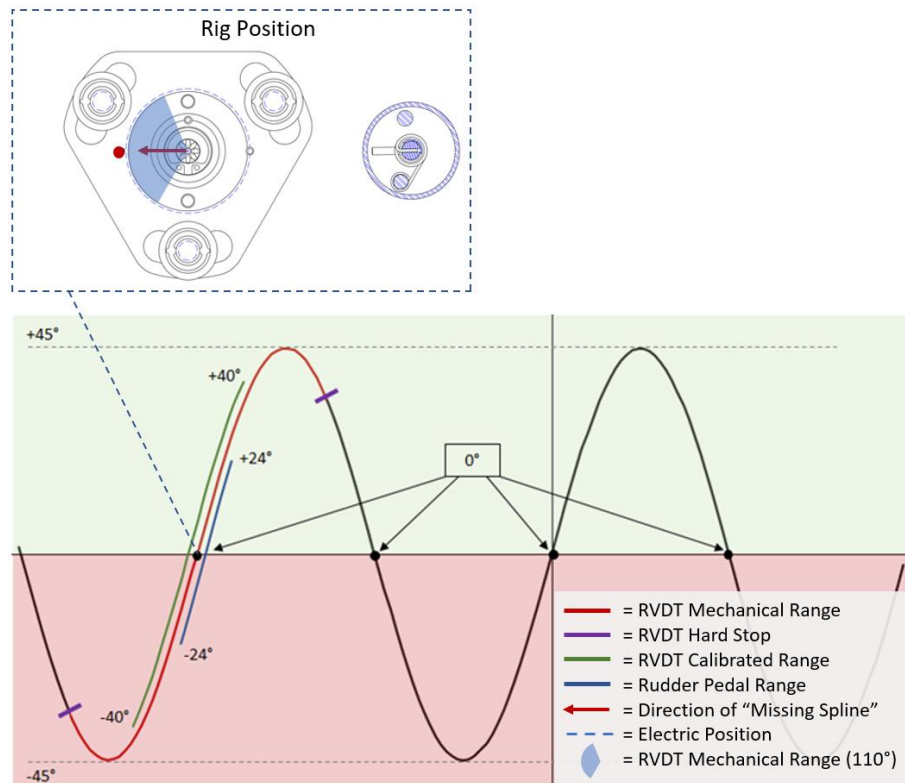
Correct Rig Position

Figure 5. Electrical and mechanical characteristics with rudder control sensor correctly installed. Clockwise rotation of the shaft results in positive electrical output. Illustrated in the figure are four electrical zeros (four quadrants). The figure illustrates the sensor installed in the correct mechanical rig position and at the correct electrical zero point.

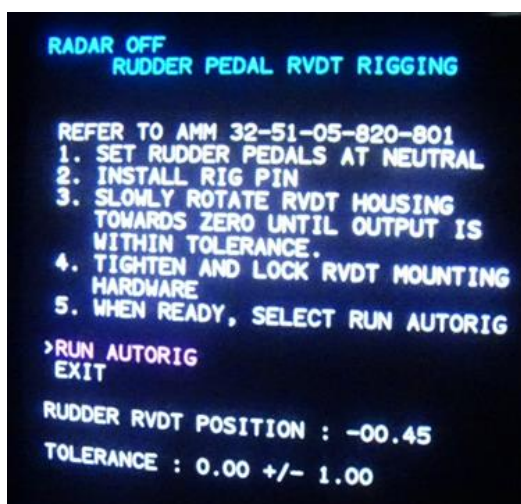
According to the technician, the sensor went in easily when the shaft was pushed down into the pivot assy. The sensor was rigged using the aircraft's computer for maintenance within approved tolerance and result, which meant that he did not need to remove the sensor again (see Figure 7).

Figure 7. Picture from the rigging page for the rudder control sensor taken by SHK during the technical examination. The approved range is 0.00 degrees with a tolerance of +/-1.0 degrees.

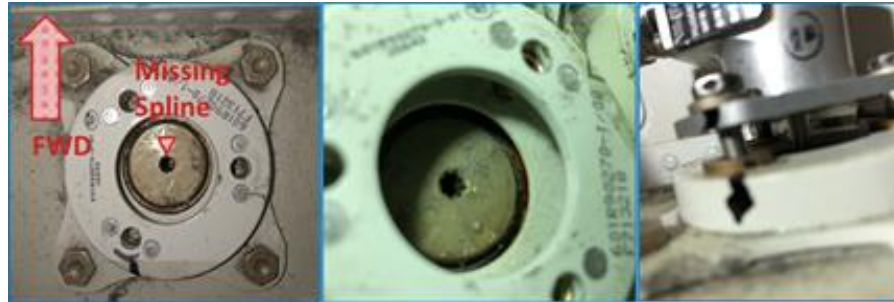
It is noted in the installation section that it is possible to install the sensor in the pivot assembly even if the missing splines are not aligned.

Figure 10. The photo to the left shows the pivot assembly with the sensor removed. The photo in the middle shows the depth to the splines from the flange on the pivot assembly. The right image shows the sensor partially installed. If the sensor is raised a little more from this position, the splined shaft will disengage from the pivot assy.

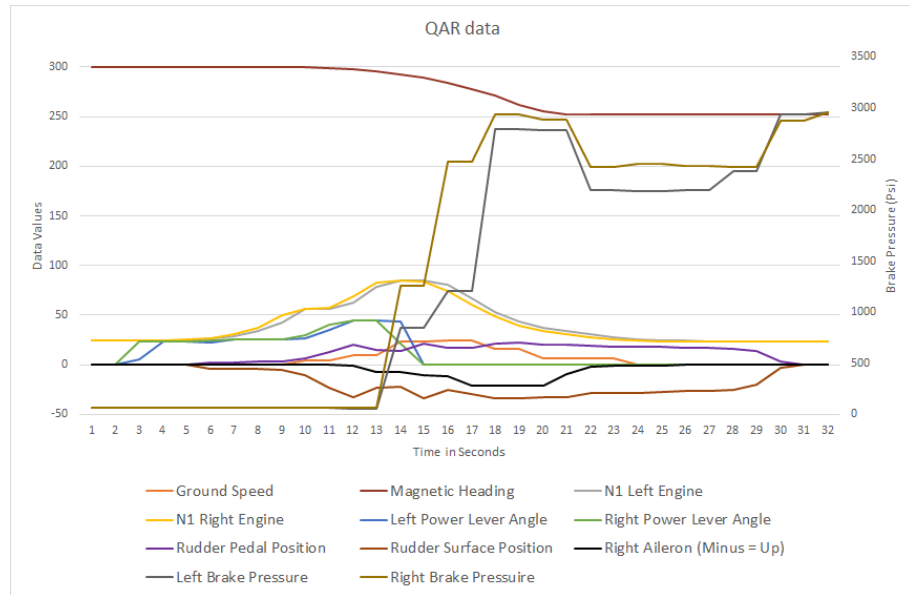
Figure 13. QAR data. Relevant parameters for the incident.

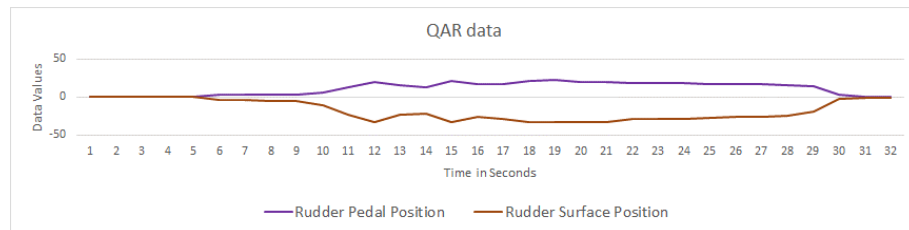
Figure 14. QAR data. The brown line illustrates the Rudder Surface Position and the purple line illustrates the Rudder Pedal Position.

The conversion document CRJ700/705/900/1000-31-008 Rev I describes the interpretations of the data stored in the DFDR and QAR. The parameters Rudder Surface Position and Rudder Pedal Position have the same sign direction. When pressing right rudder pedal both parameters shall have a negative value. In figure 14 the Rudder Pedal Position has positive value.

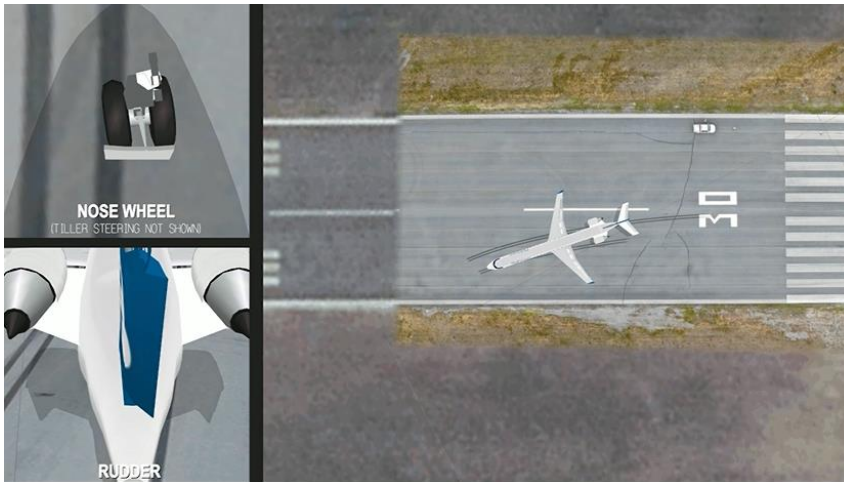
Figure 16. The nose wheels are turning to the left and the Rudder Surface Position is to the right. Image: TSB Canada.

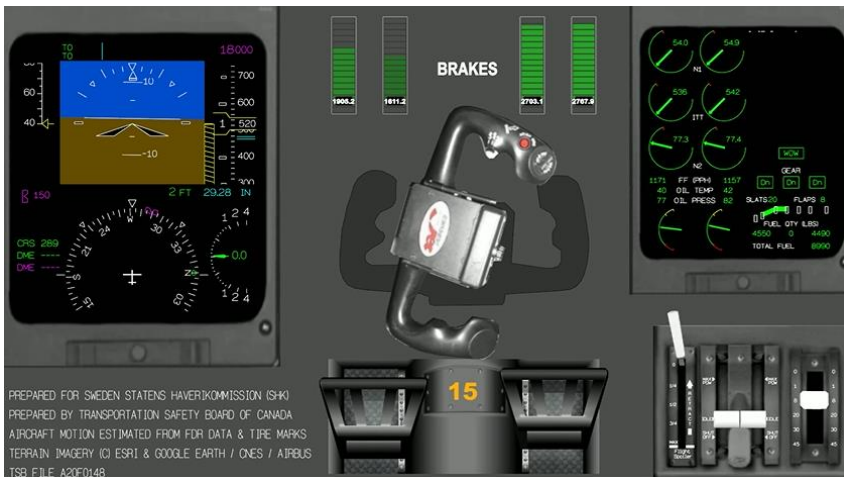
Figure 17. Right rudder pedal depressed, pilots control wheel turned fully to the right and right-hand brake applied more than the left. The flight instruments do not correspond to the aircraft's installed instruments. Image: TSB Canada.

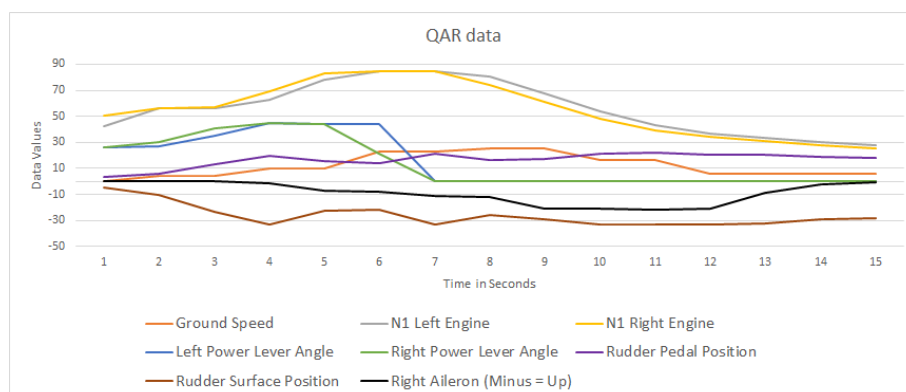
In Figure 29, flight data from section 1.11 are presented to show relevant parameters during take-off. The flight data shows that even before the aircraft begins to accelerate, there is a small rudder pedal deflection to the right. It is not possible to determine the position of the nose wheel when the aircraft has stopped because it is not registered. The rudder pedal deflection to the right may still indicate that the pilot has intended to steer the aircraft towards the centre line at take-off. When the first acceleration is registered, the thrust is relatively symmetrical between both engines and the right rudder pedal deflection increases. In the flight data, there is a connection between the rudder pedal deflection and the change of course of the aircraft to the left. When the turn to the left cannot be cancelled, the pilot continues to press the right rudder pedal to full deflection.

Figure 29. Registered QAR Data.
