Final report RS 2022:07e

Very serious marine casualty involving a lifeboat in Frihamnen harbour, Stockholm den 12 April 2021

File no. S-76/21

2022-07-13

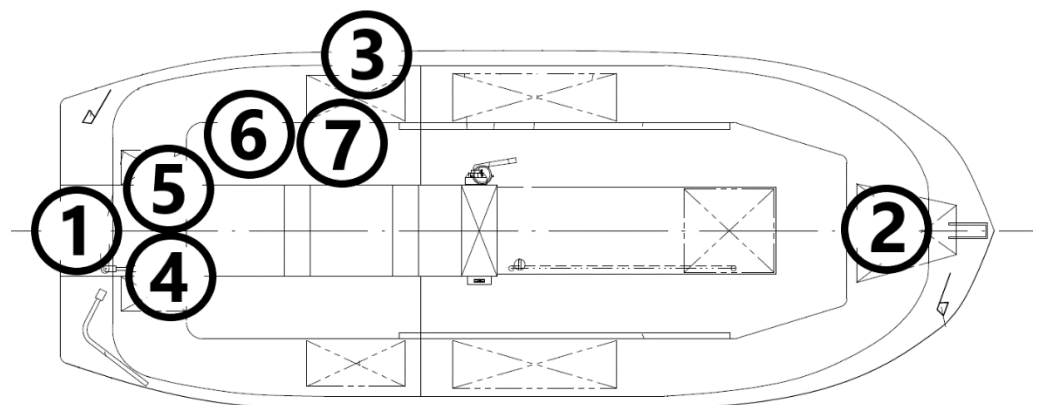
Figure 3. The location of those on board. Image: Viking Life-Saving Equipment A/S. Markings showing where people were located added by SHK:

Person 1 was the instructor and was standing on the small platform in the stern. Fell overboard.

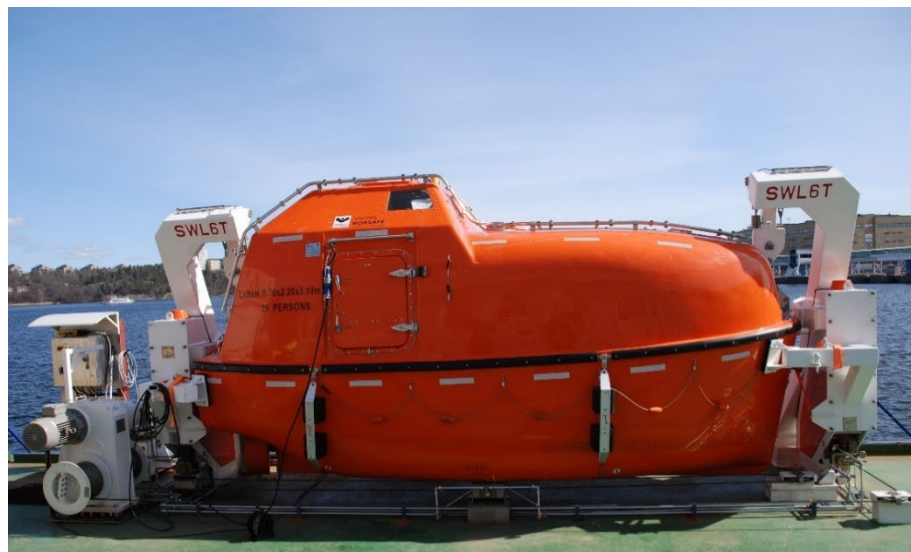
Figure 6. The lifeboat, a Viking-Norsafe JYN 57T mk I.

The lifeboat is of a totally enclosed model with side hatches and is intended for bulk carriers and tankers. Around 160 units of this model of boat have been built and it has been on the market for over 20 years. This version of the lifeboat has been manufactured since 2009. Before this, there was a version for 28 persons. The rules for weight per person were changed in 2010, from 75 kg to the current 82.5 kg, and the number of spaces was reduced at that time to 26. In conjunction with this, the boat model underwent new testing and certification.

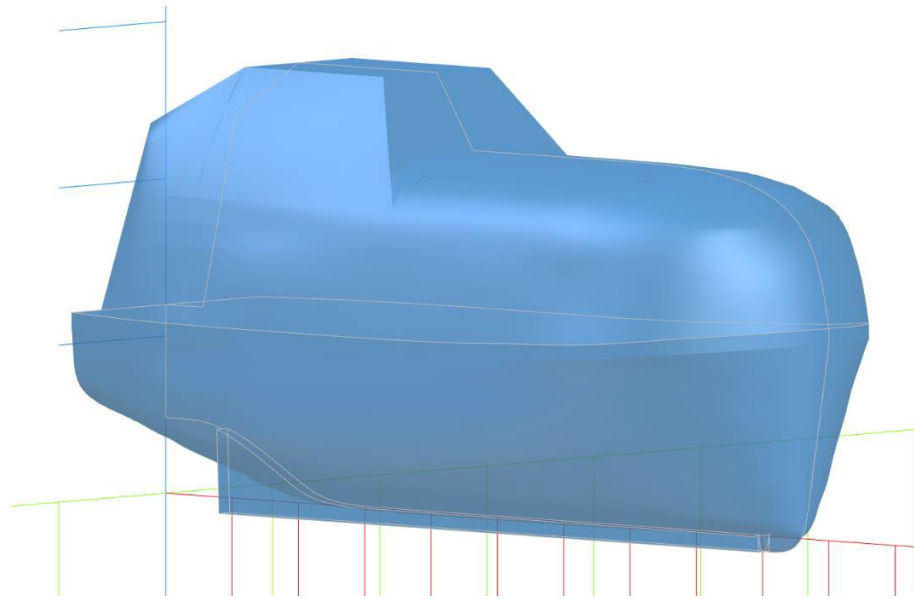
Figure 14. The digital model used as a calculation model for the stability investigation.

The investigation indicates that the stability properties deteriorate the fewer people are loaded in the lifeboat. The worst stability calculated was under loading condition LK5, with extreme lists and a high risk of the lifeboat to heel over or water coming in through the side openings. A risk of large angles of heel was also calculated under loading condition LK7.

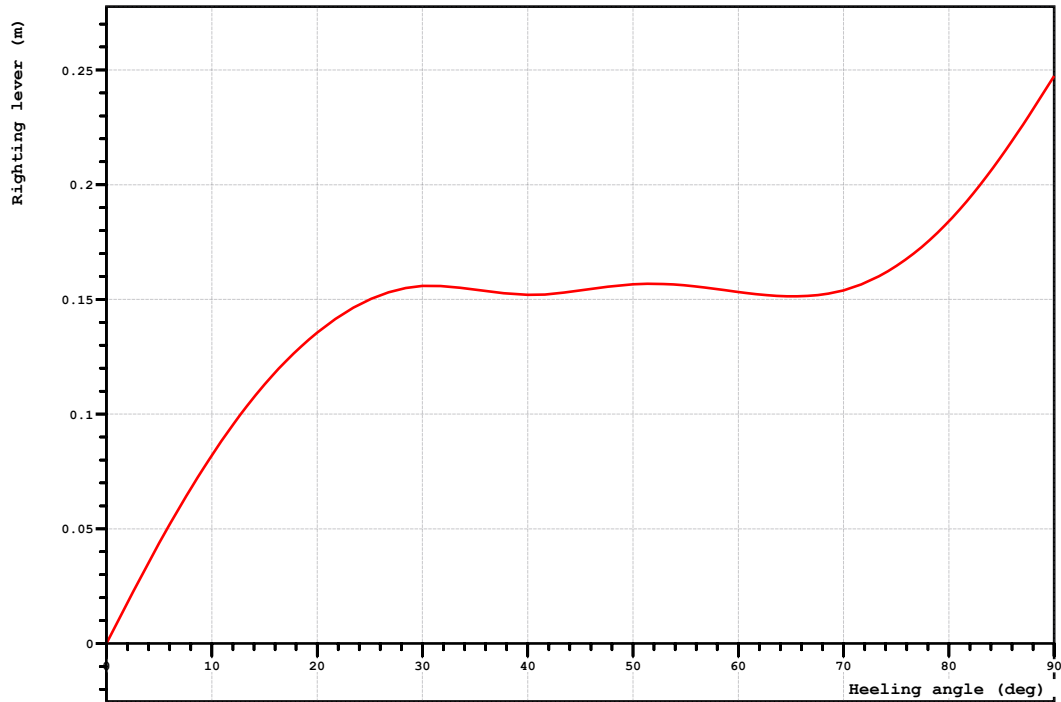
GZ CURVE

LOADING CONDITION: LK0_A, Lightweight A.

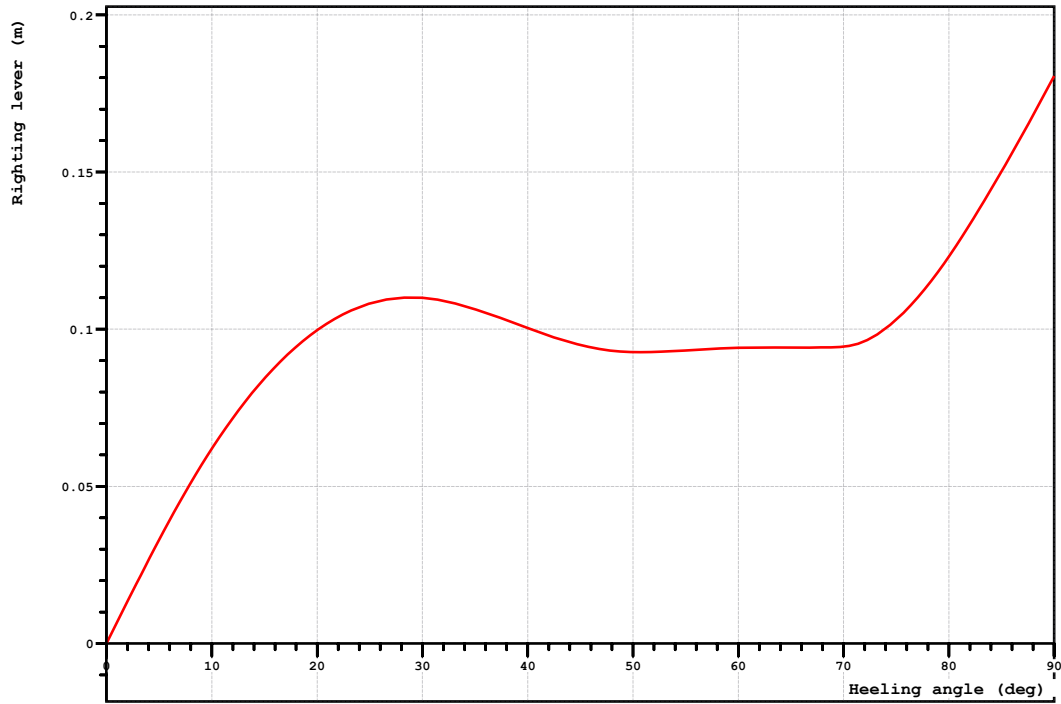
GZ CURVE

LOADING CONDITION: LK0_B, Lightweight B.

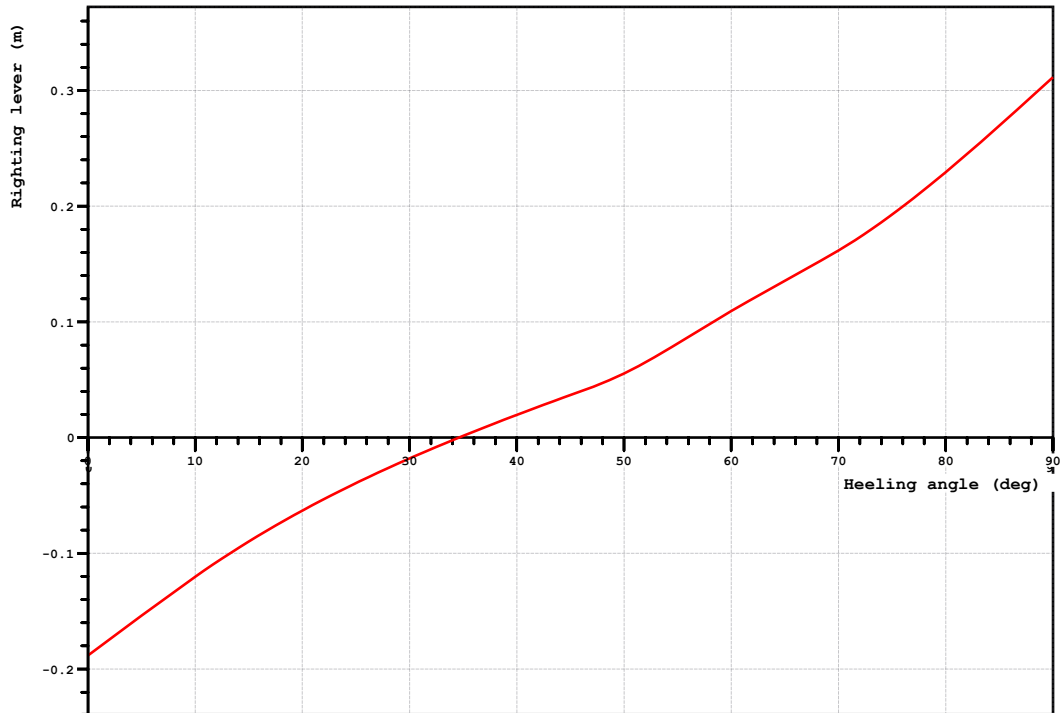
GZ CURVE

LOADING CONDITION: LK1_A, Load test, lightweight A.

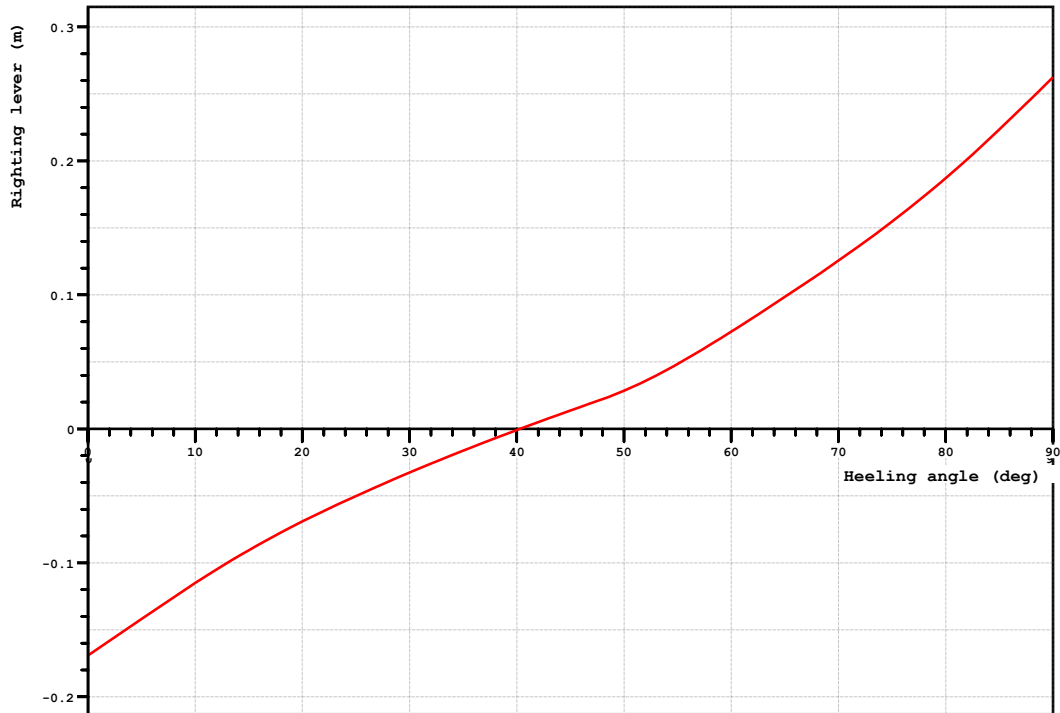
GZ CURVE

LOADING CONDITION: LK1_B, Load test, lightweight B.

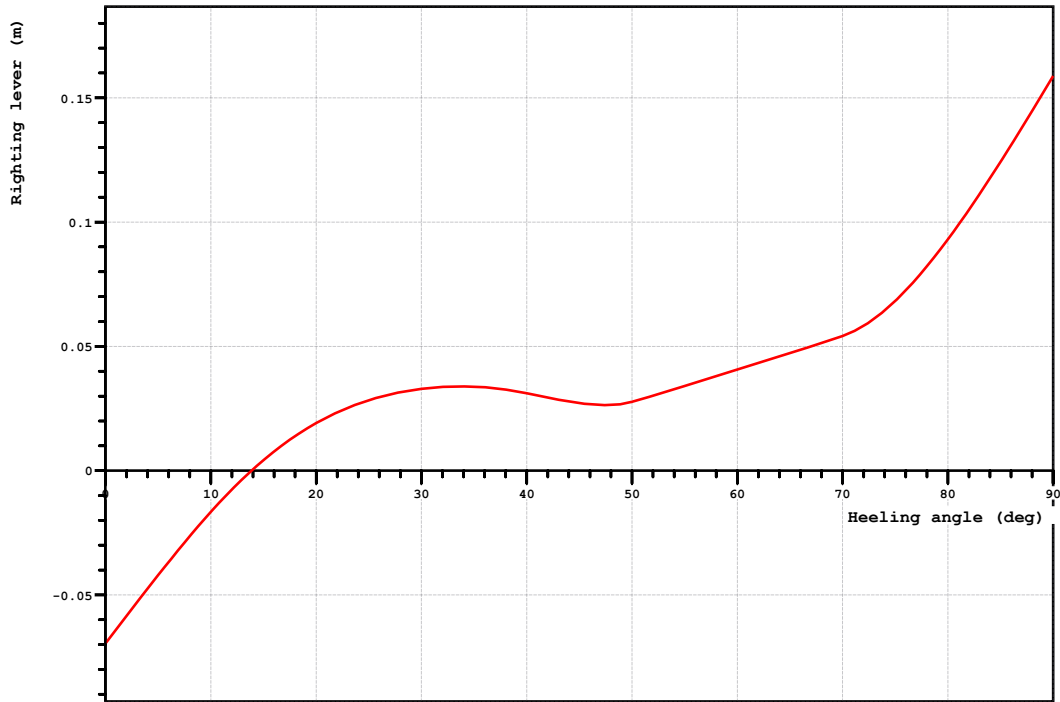
GZ CURVE

LOADING CONDITION: LK2_A, Accident, lightweight A.

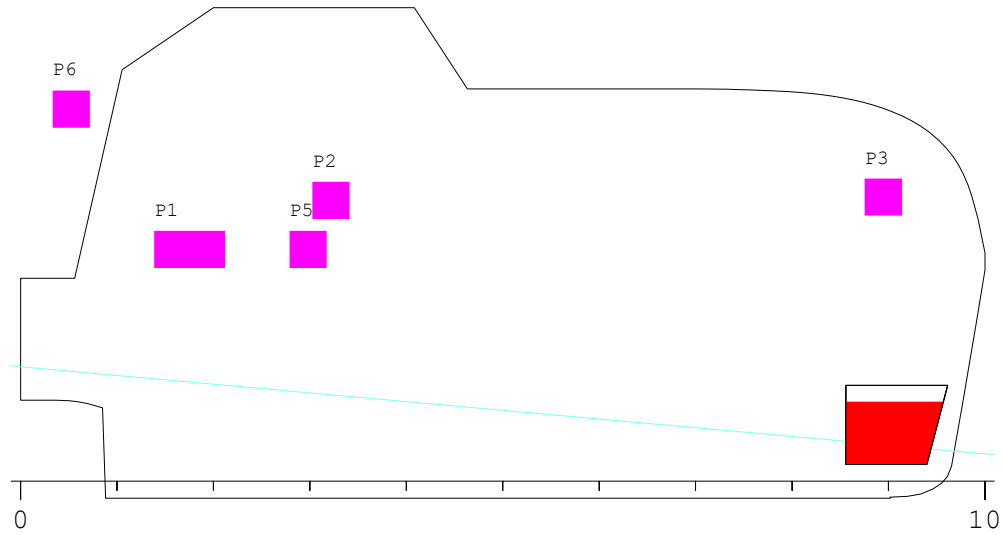
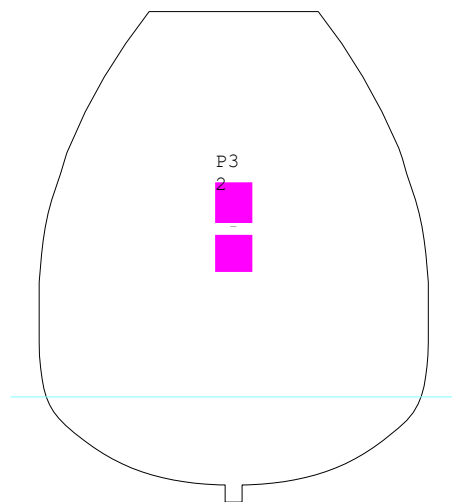
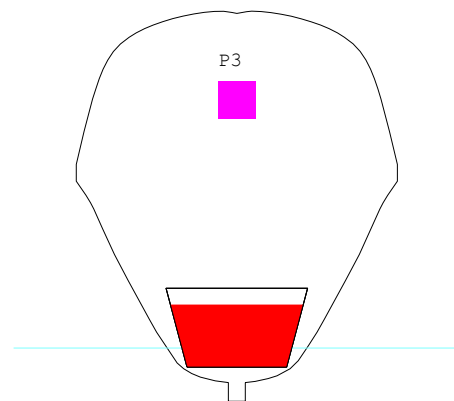
LOADING CONDITION: LK3_A, Accident with passengers in CL, lightweight A

For loading conditions LK3_A and LK3_B, it can be concluded that the GZ curves have a similar shape to the respective cases in LK2_A and LK2_B yet shifted more vertically. Consequently, there is a larger stability margin when the lifeboat is not listing.

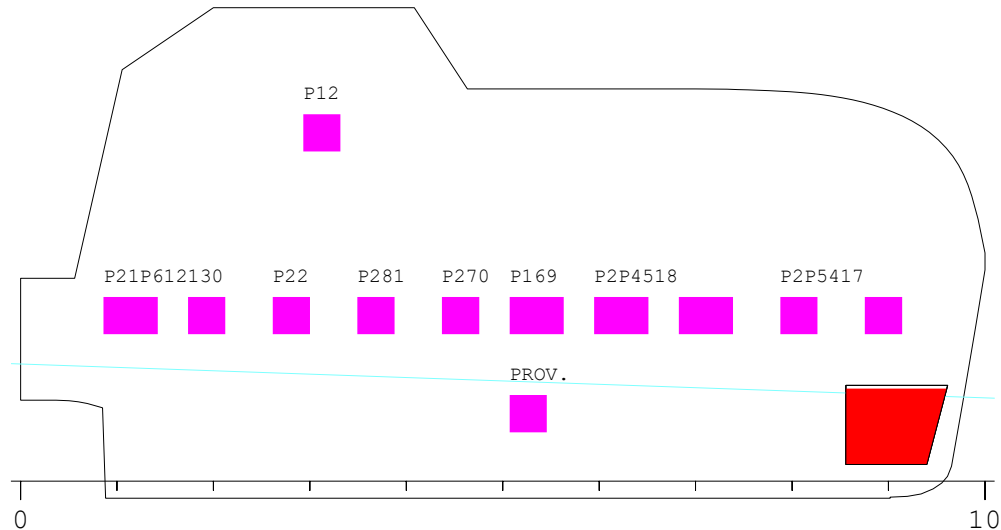
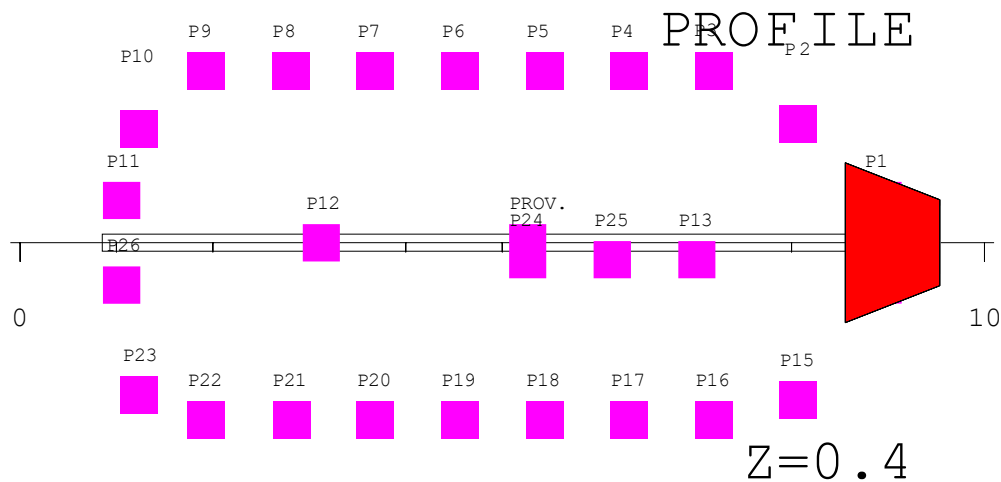
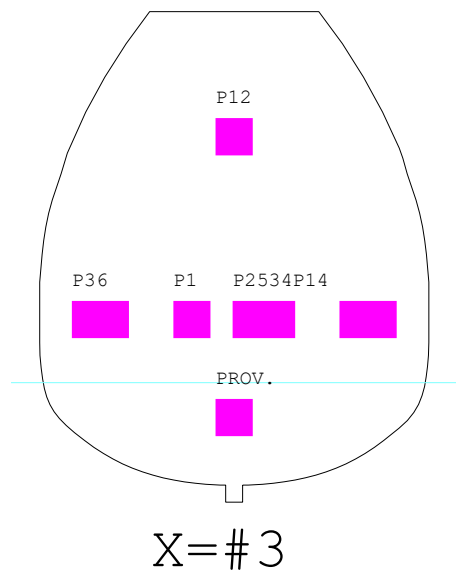
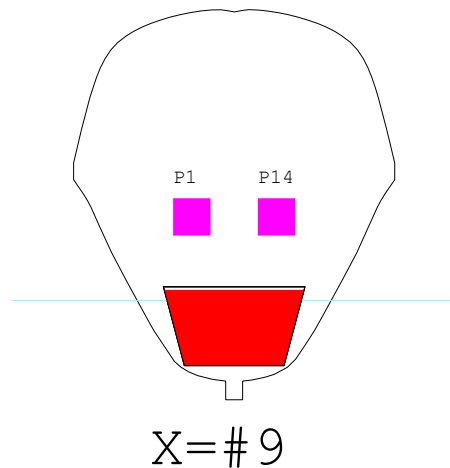
LOADING CONDITION: LK4_A, Max. number of passengers, lightweight A

LK4_A and LK4_B display the conditions that are deemed to have the best properties with respect to stability. When the lifeboat is fully loaded and all passengers are sitting in their designated places, the centre of gravity is so low that the righting lever increases as the angle of heel increases. This requires passengers to be strapped in as they are a substantial load that can easily be displaced and generate a large moment of heel.

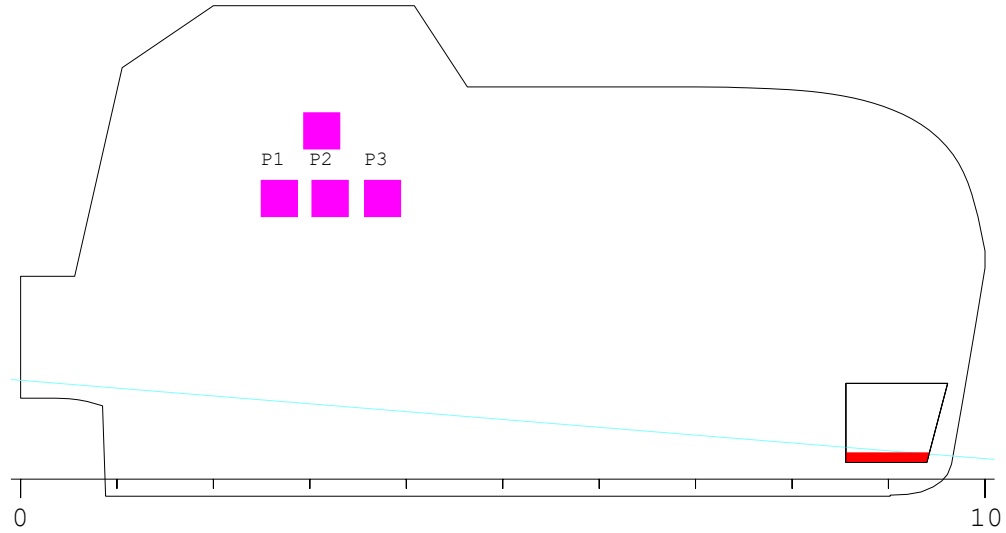
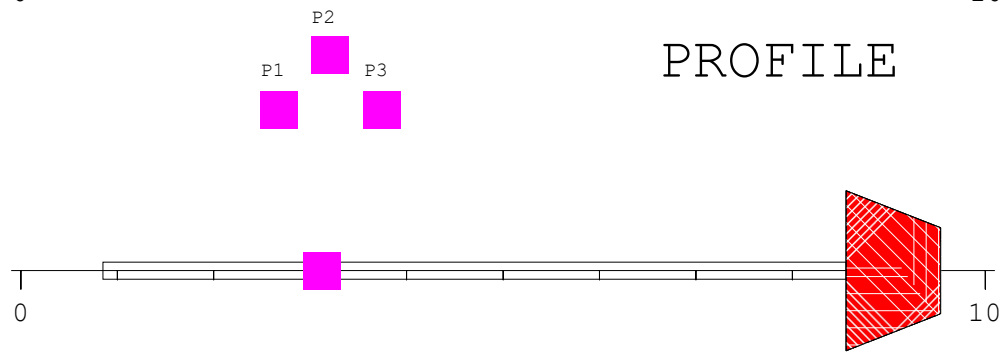
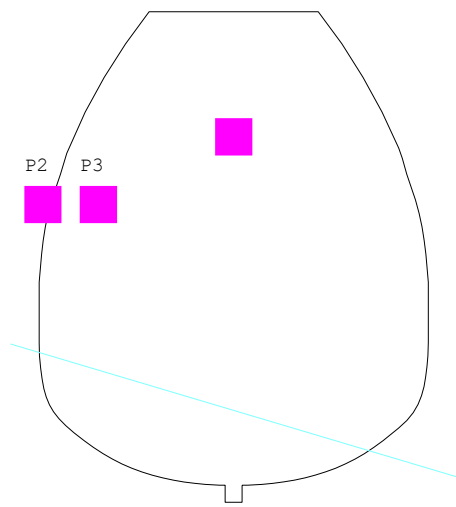
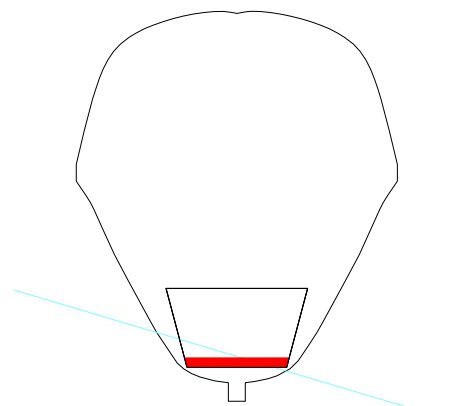
LOADING CONDITION: LK5_A, Maritime rescue in hatch, lightweight A

The final scenario with LK5_A and LK5_B displays major differences. For LK5_A the righting lever is small but still present and at the equilibrium, and for LK5_B the equilibrium is long after the openings have reached the surface of the water. The GZ curve is almost horizontal for both loading conditions, which leads to the large difference in equilibrium. This is a scenario that generates a major risk of capsizing or water entering through the openings.

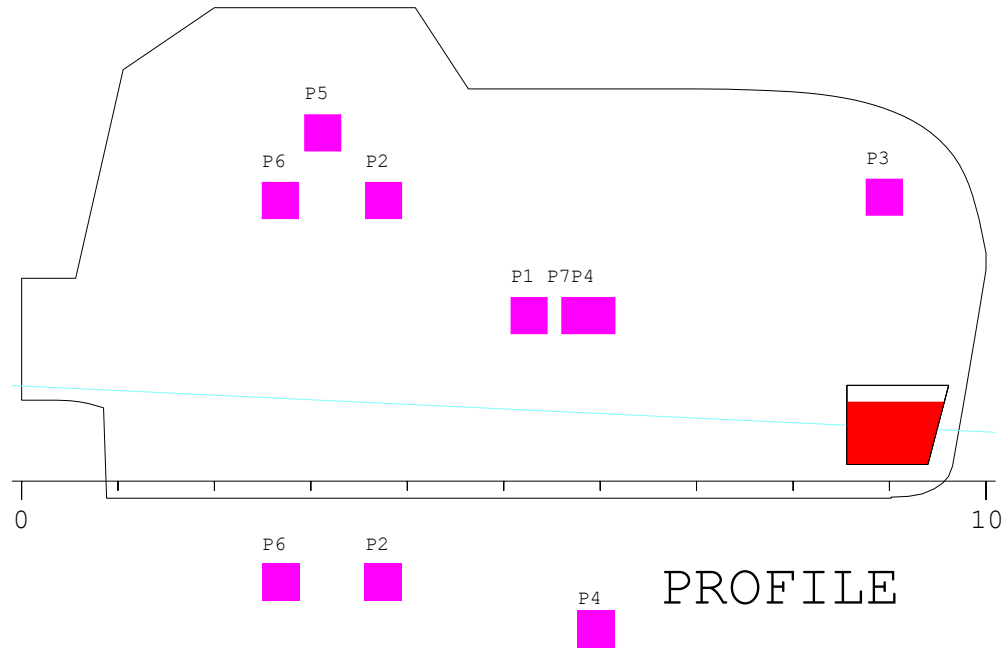
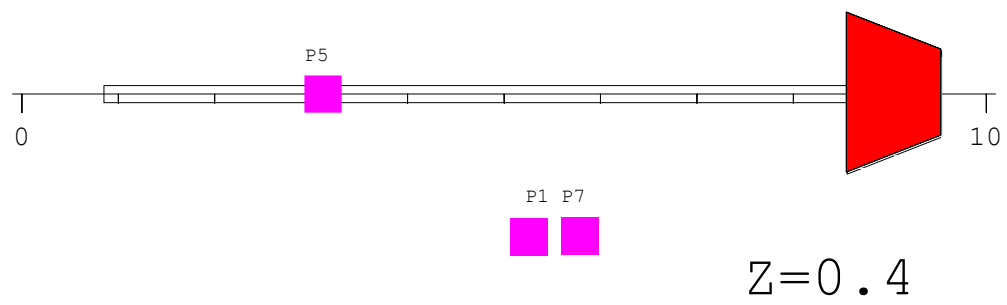
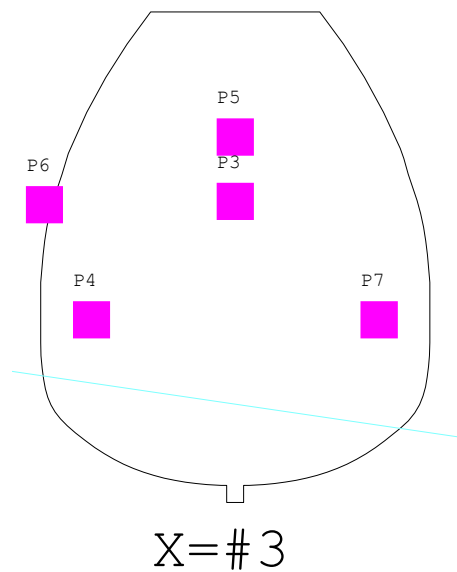
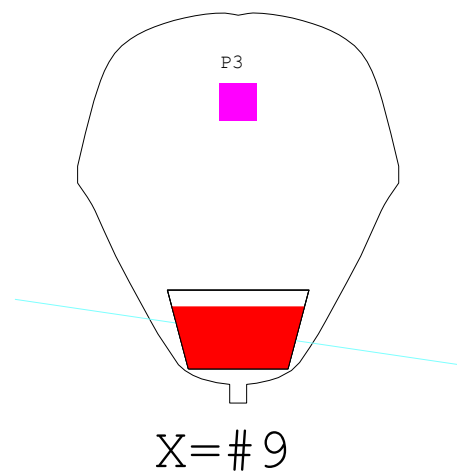
LOADING CONDITION: LK6_A, Accident, alt. placement, lightweight A

The loading conditions LK6 and LK7 demonstrate a simulated alternative placement of the people at the time of accident and how this would have affected stability. The alternative placement results in some improvement to stability.
