Final Report RL 2017:05e

**Serious incident at Vilhelmina Airport,
Västerbotten County, on 6 April 2016
involving the aeroplane SE-LLO of model
BAe ATP, operated by NextJet AB.**

Reference no. L-35/16

5 April 2017

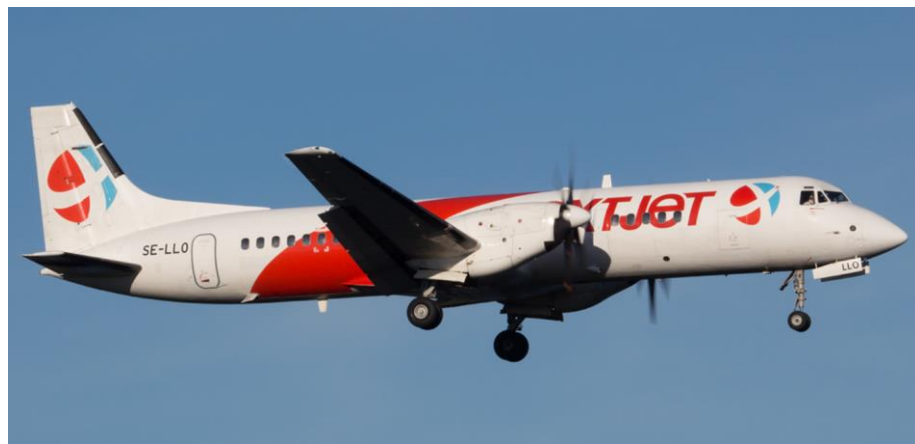
The aeroplane, a BAe ATP from NextJet AB (see Figure 1) with registration SE-LLO, took off from Hemavan Tärnaby Airport on a scheduled flight to Vilhelmina. The flight number was 2N773H and there were 19 passengers and four crew members on board.

Figure 1. The aircraft in question. Photo Joel Vogt.

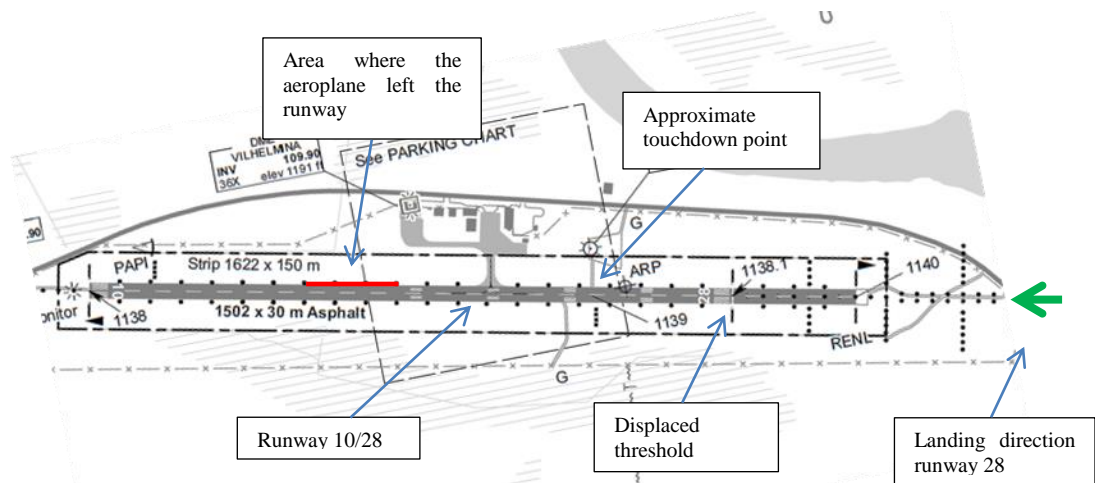
Vilhelmina Airport is owned and operated by Vilhelmina Municipality. Runway 10/28 is positioned in an east–westerly direction and has the dimensions 1,502 x 30 metres, where the threshold of runway 28 is displaced, giving an available runway length for landing of 1,260 metres (see Figure 11).

Figure 11. Vilhelmina Airport. Picture from the IAIP.
