Final Report RS 2017:05e

ASKÖ – Grounding at Hässelby holme,
Stockholm County, Sweden, on 9 December
2016

File no. S-205/16

15 November 2017

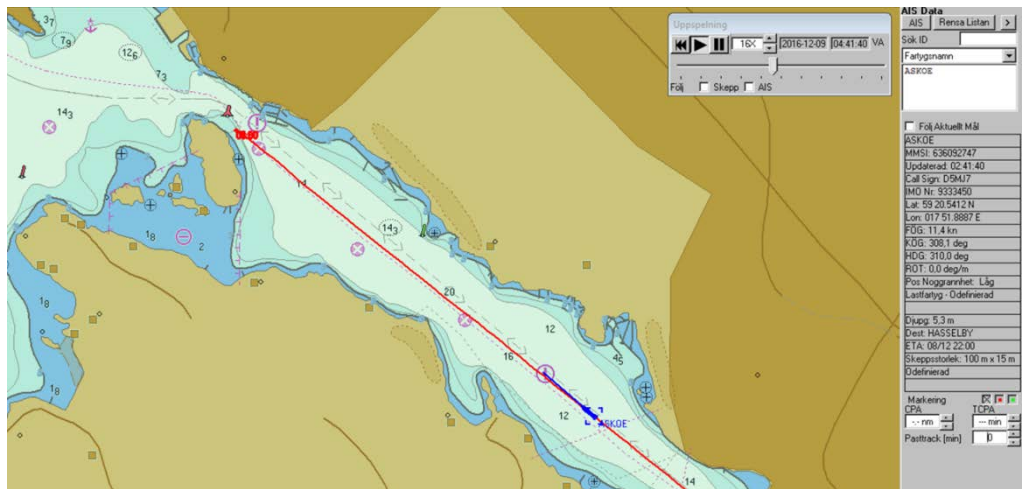
Figure 2. ASKÖ's AIS track at 04:41.

Quite soon after Nockeby Bridge, the pilot sighted the red buoy (see Figure 2), at Hässelby holme. The pilot's plan was to use the buoy as a steering mark in order to, when they were getting close to it, make a small course correction to starboard and then turn to port after passing the buoy, before finally turning to starboard round and in to the quay.

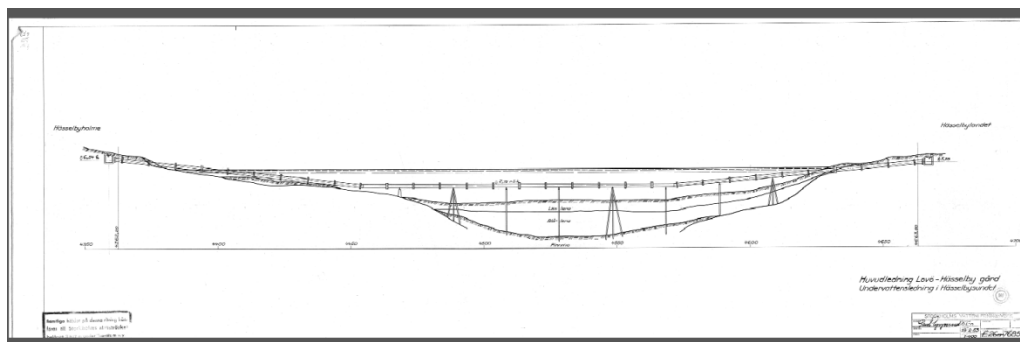
The water pipe in question is one of Stockholm Vatten's feeder pipes from Lovö Waterworks in Lake Mälaren. The pipe extends from Lovö Waterworks, which is on the western side of the island of Lovön, across the island to Hässelby holme. From there, the pipe proceeds underwater across to the mainland at Hässelby. The pipe has a diameter of approximately one metre and is located in a wooden structure on the lake-bed (see Figure 9). The pipe lines at a depth of approximately 6.5 metres in the fairway. Out of the fairway and at the place where the grounding occurred, the pipe is on a shallower depth.

Figure 9. The location of the water pipe on the lake-bed in the fairway. Image: Stockholm Vatten.
